Preliminary Roost Assessment and Ecological Walkover  
Rose Kiln Court, Reading

Reference:80-535-R1-1  
Date: June 2021

Rose Kiln Court  
Reading

Prepared for:  
**Strenpop Ltd**

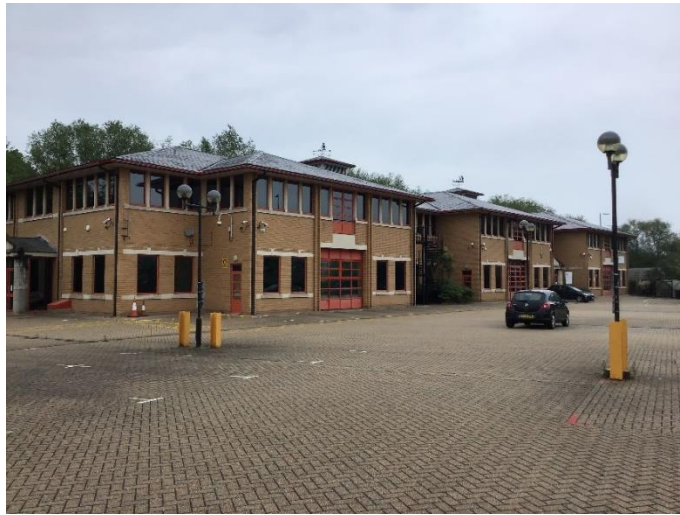
PLATE 1      SHOWING B1

Building 1 (B1) comprised a two-storey brick office building with a pitched tiled roof. The brickwork and roof tiles were found to be in good condition, with metal window and door frames that were well sealed.

All on-site buildings and structures (B1-B6) were found to have Negligible bat roosting potential, as no Potential Roosting Features were identified within the structures.

All on-site buildings were assessed as having Negligible bat roosting potential. As such, no further surveys or mitigation with regards to bats is required on the buildings for the redevelopment to proceed.

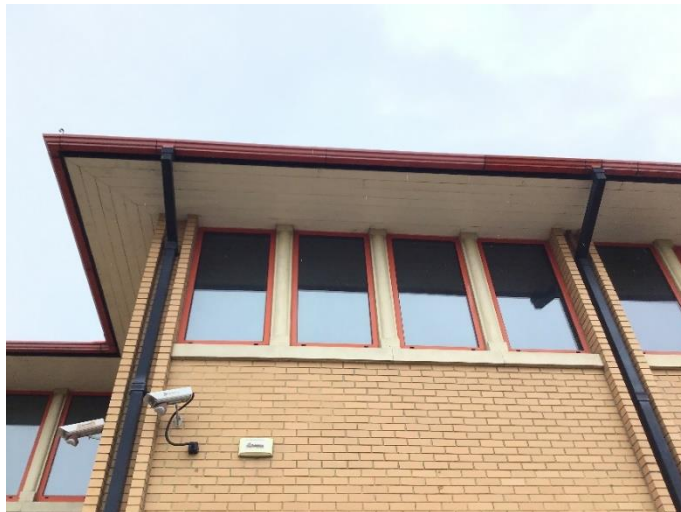
PLATE 2      SHOWING WOODEN BOARDING

Wooden boarding was present under the eaves, which was found to be in good condition with no crevices present.

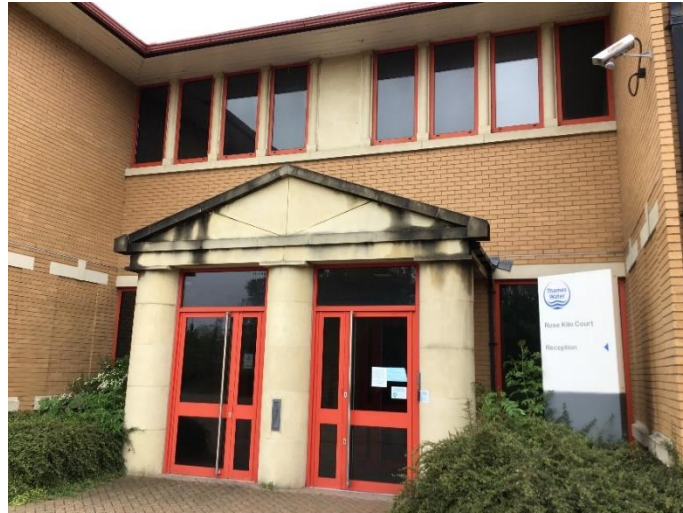
PLATE 3      SHOWING STONE ENTRANCEWAYS

Stone features were present at the entranceways, found to be in good condition with no crevices present.

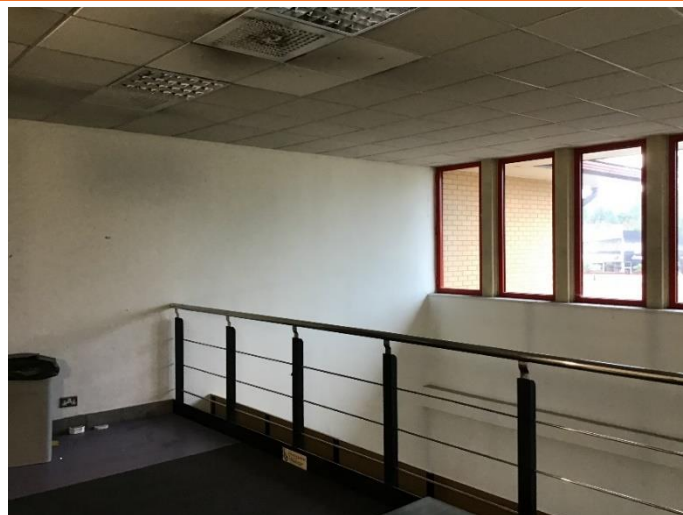
PLATE 4      SHOWING B1 INTERNALLY

Internally, B1 was in good condition, with plastered walls and hung ceilings. No roof voids or basements were present within B1.

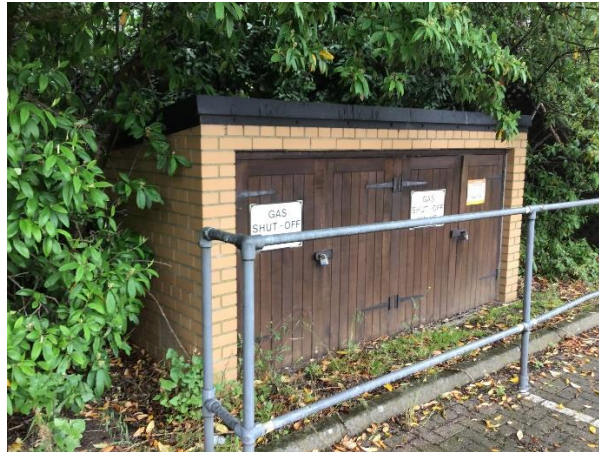
PLATE 5      SHOWING B2

B2 and B4 comprised single-storey brick structures with mono-pitched metal roofs.

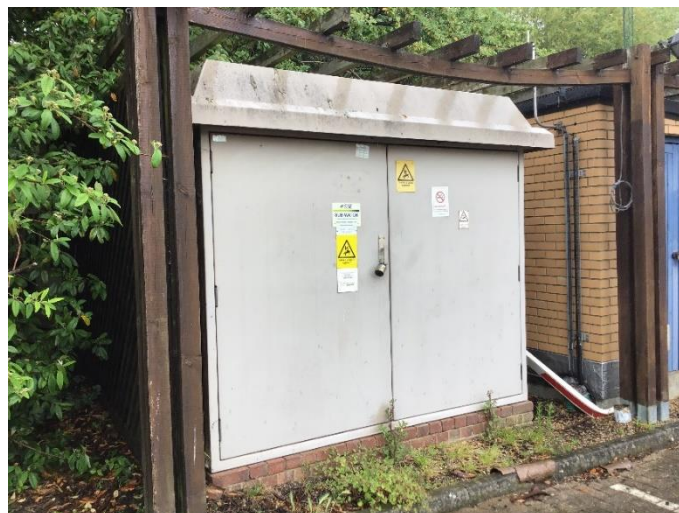
PLATE 7      SHOWING B3

B3 comprises a single storey metal structure with a flat roof.

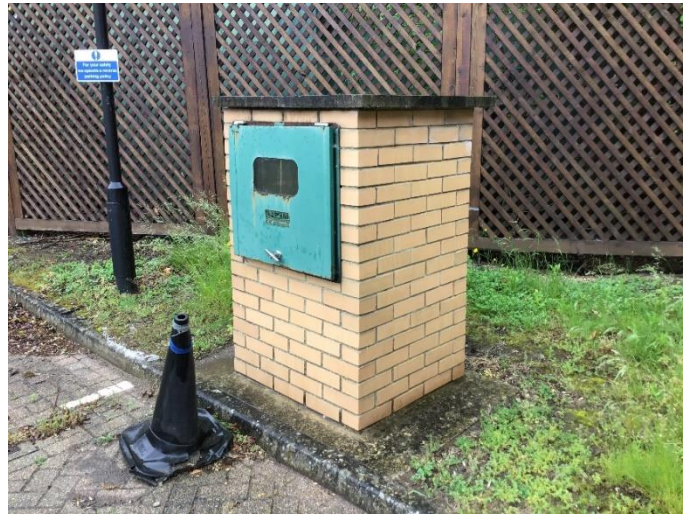
PLATE 8      SHOWING B5

B5 comprises a small brick structure.

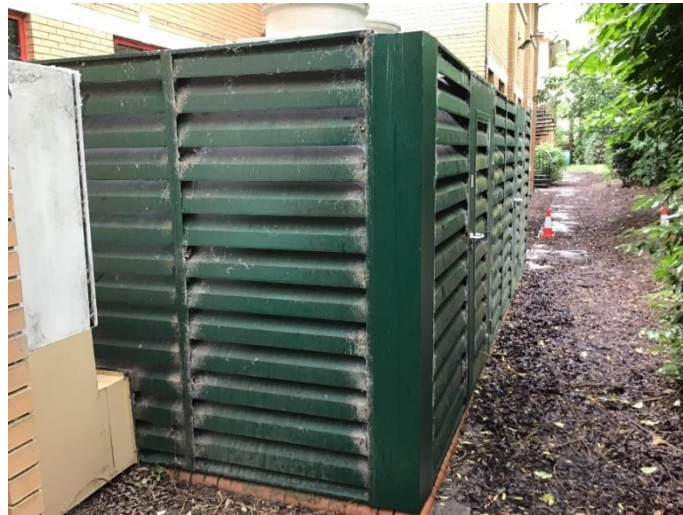
PLATE 9      SHOWING B6

B6 comprises a single storey metal structure.

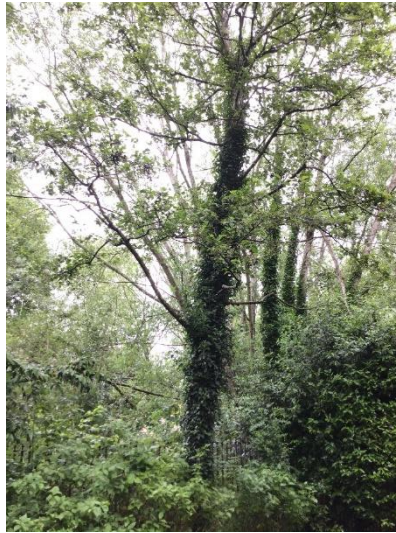
PLATE 10      SHOWING T30

The on-site trees were assessed for their suitability to support roosting bats (Collins, 2016). Two common alder (*Alnus glutinosa*) trees on the northern site boundary, T30 and T29, were found to have Low bat roosting potential due to dense ivy coverage on their main stem. Tree reference number are taken from Tree Constraints Report (E3P, 2020) (report reference: 80-535-R2-1).

Two on-site trees (T29 and T30) were determined to have Low bat roosting potential. If these trees require removal to facilitate development, the trees should be soft felled under ecological supervision. The trees should be cut into sections, lowered down to the ground, and left overnight to allow any bats to escape, prior to chipping. The cutting should be carried out to avoid the area of roosting potential.

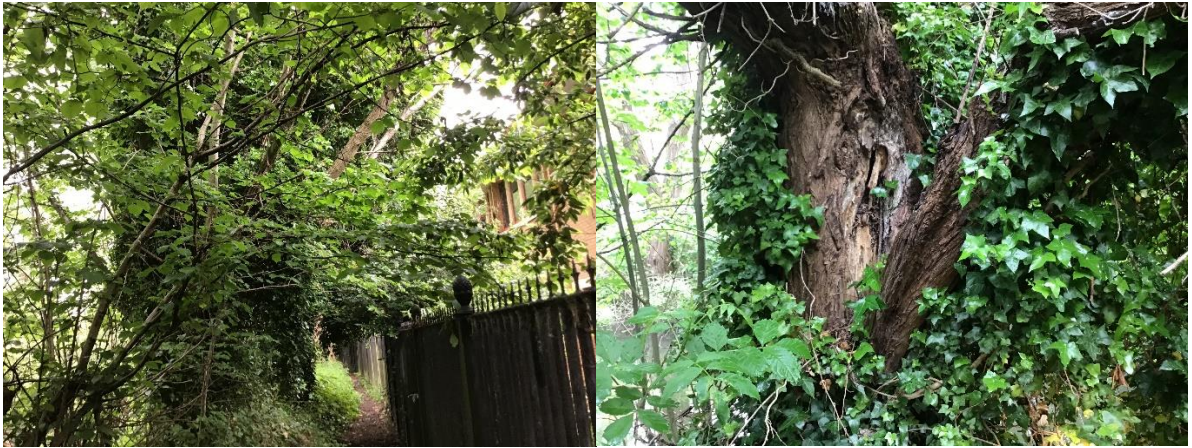
PLATE 12      SHOWING TREES ON HOLY BROOK EMBANKMENT

A number of off-site trees located on the southern bank of Holly Brook approximately 5 m north of the site, that overhung the site, were also assessed for their bat roosting potential. 18 mature crack willow (*Salix fragilis*) trees (T31, T32, T33, T35, T36, T37, T39, T40, T41, T42, T43, T44, T45, T46, T47, T48, T49 and T50) were assessed as having moderate bat roosting potential on a precautionary basis due to their age and species and the dense ivy coverage on their main stems.

A total of 18 mature crack willow trees located on the southern bank of Holy Brook, just outside the northern boundary of the site, were assessed as having Moderate bat roosting potential on a precautionary basis due to the age and species of tree and the dense ivy coverage on their main stems.

Development proposals include the thinning/felling of a number of trees on the southern bank of Holy Brook, that overhang the site. If the trees with Moderate bat potential require felling, two nocturnal bat surveys are required on the tree between May and September, with at least one of the surveys between May and August. The surveys would be valid for two years to inform a planning application. If bats are identified roosting within the tree, a final additional nocturnal survey would be required to inform a European Protected Species Licence (EPSL). An ESPL would require up to date surveys from the survey season prior to the application submission.

If any of the Moderate bat roosting potential trees require thinning, a Method Statement must be produced outlining the proposed works on the tree and the mitigation in place to protect roosting bats, namely:

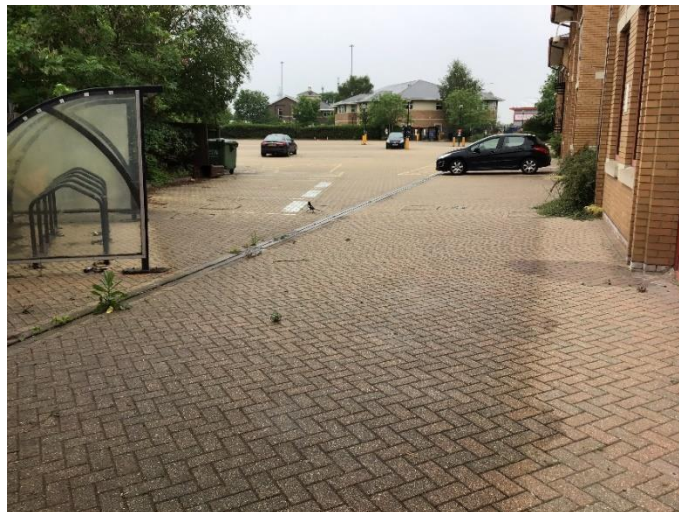
PLATE 13      SHOWING HARDSTANDING CAR PARK

A concrete hardstanding car park was present to the south of B1. The hardstanding was colonised at its edges by willowherb species (*Epilobium sp. (annual)*), herb-Robert (*Geranium robertianum*), smooth sow thistle (*Sonchus oleraceus*), dandelion (*Taraxacum officinale agg.*), butterfly bush saplings (*Buddleja davidii*), bristly oxtongue (*Helminthotheca echioides*), groundsel (*Senecio vulgaris*), wall lettuce (*Mycelis muralis*), vetch species (*Lathyrus sp.*), black medick (*Medicago lupulina*) and common poppy (*Papaver rhoeas*).

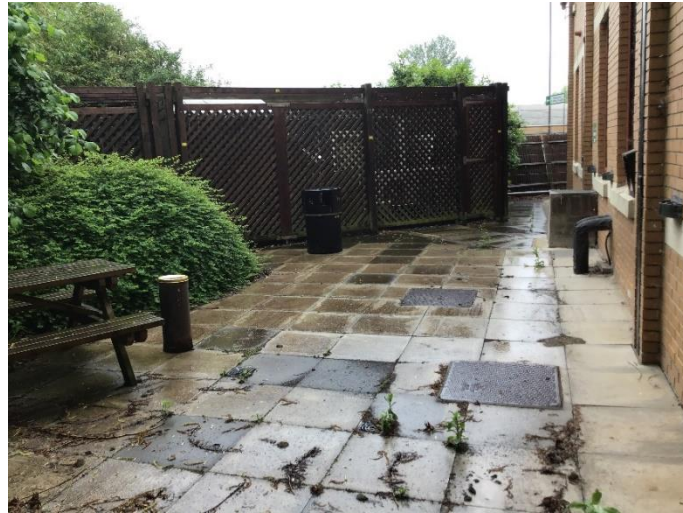
PLATE 14      SHOWING HARDSTANDING PAVING

A paved hardstanding path led from the car park in the west, around the northern aspect of B1, terminating a paved smoking area in the east of the site.

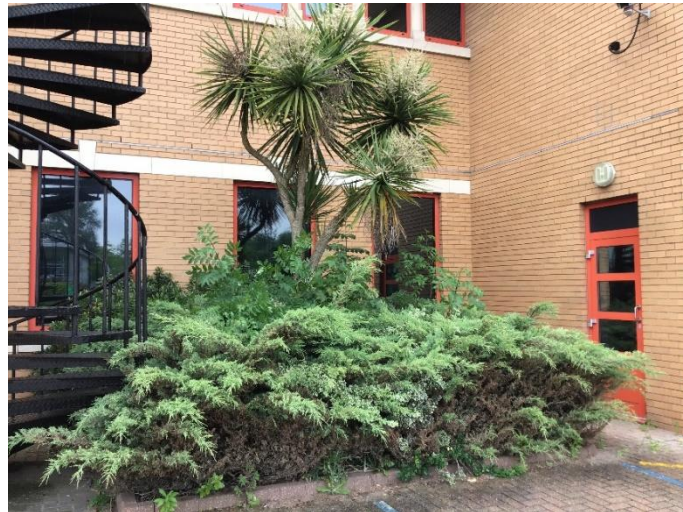
PLATE 15      SHOWING INTRODUCED SHRUB

Sections of introduced shrub were present at the borders of the site within planting beds. Species present included coralberry (*Symphoricarpos orbiculatus*), cheery laurel (*Prunus laurocerasus*), red barked dogwood (*Cornus alba L.*), old fashioned weigela (*Weigela florida*), red leaved rose (*Rosa glauca*), cypress species (*Chamaecyparis/Cupressocyparis sp.*), gorse (*Ulex europaeus*), with an understory colonised by cleavers (*Galium aparine*), dandelion, bramble (*Rubus fruticosus agg.*), wall lettuce, willowherb species, herb Robert, greater periwinkle (*Vinca major*), wall barley (*Hordeum murinum*), common ragwort (*Jacobaea vulgaris*), common mouse-ear (*Cerastium fontanum*), yarrow (*Achillea millefolium*), daisy (*Bellis perennis*), read dead-nettle (*Lamium purpureum*), ivy (*Hedera helix*), butterfly bush saplings, bindweed species (*Calystegia sp.*), poppy, vetch species and scentless mayweed (*Tripleurospermum inodorum*).

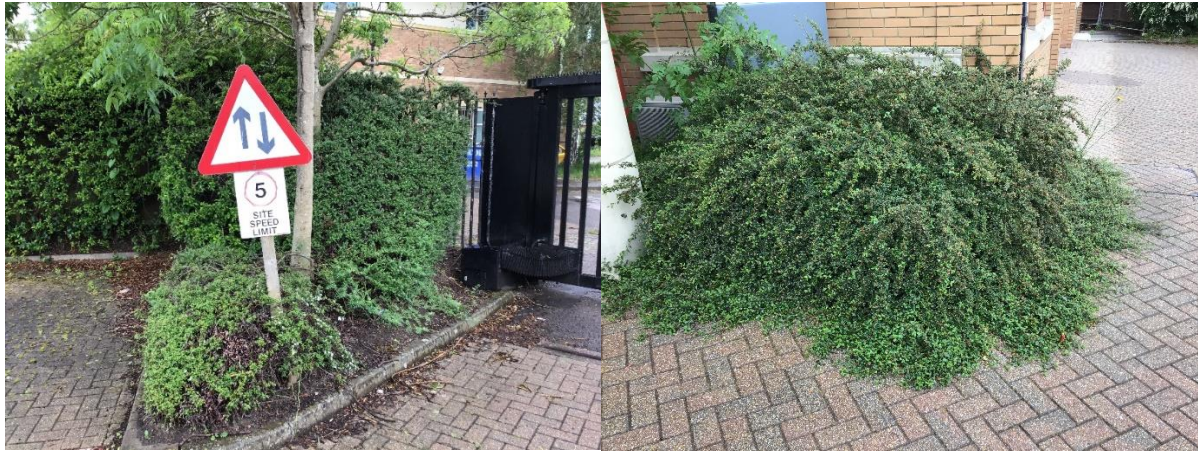
PLATE 16      SHOWING COTONEASTER

Small leaved cotoneaster (*Cotoneaster microphyllus*) was present at the entrance to the site and entire-leaved cotoneaster (*Cotoneaster integrifolius*) was present at the entrance to B1.

Small-leaved cotoneaster and entire-leaved cotoneaster were identified during the site walkover. As such, it is recommended, prior to the development, that these species should be eradicated following the most current guidance set out by the Environment Agency by a qualified contractor.

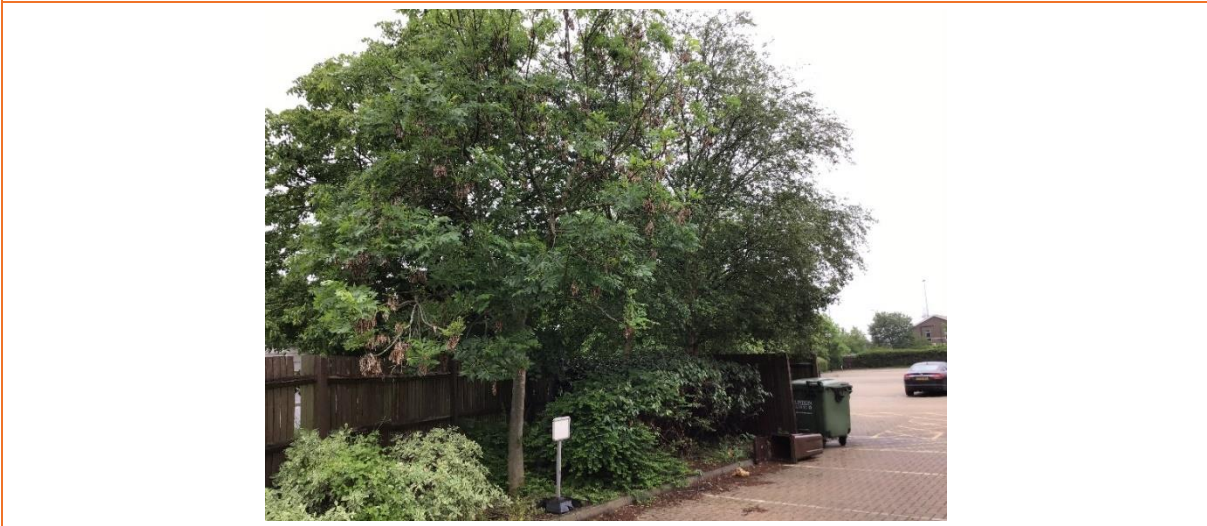
PLATE 17      SHOWING SCATTERED TREES

Scattered trees were present within the introduced shrub planting beds at the peripheries of the site. The trees were found to be immature and comprised species including ash (*Fraxinus excelsior*), silver birch (*Betula pendula*) lime species (*Tilia sp.*), cabbage palm (*Cordyline australis*), tree cotoneaster (*Cotoneaster cornubia*) wild cherry (*Prunus avium*), English oak (*Quercus robur*) and common alder.

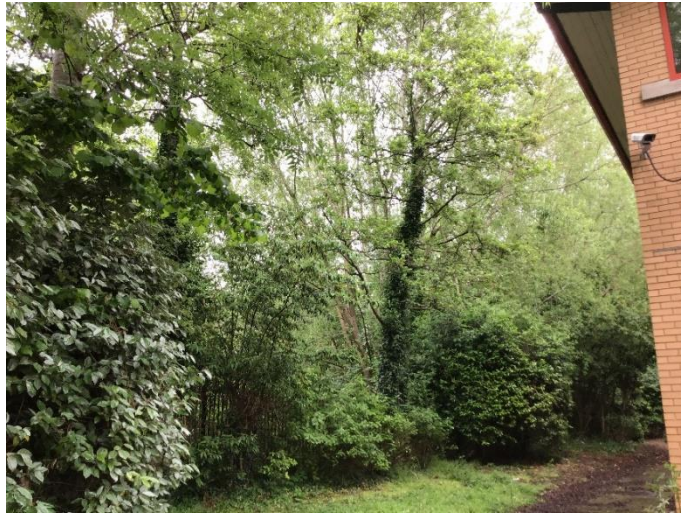
PLATE 18      SHOWING TL1

A treeline, Treeline 1 (TL1) was present on the northern boundary of the site. The trees were mature and species included sycamore (*Acer pseudoplatanus*), crack willow, hawthorn (*Crataegus monogyna*), tree cotoneaster, common alder and ash. Ground flora included common nettle (*Urtica dioica*), wall lettuce, daisy, groundsel, meadow buttercup (*Ranunculus acris*), bulbous buttercup (*Ranunculus bulbosus*), common mouse ear, willowherb species, bristly ox tongue, cock's foot (*Dactylis glomerata*), poppy, dandelion, ragwort, cinquefoil (*Potentilla reptans*) cleavers, ivy and petty spurge (*Euphorbia peplus*).

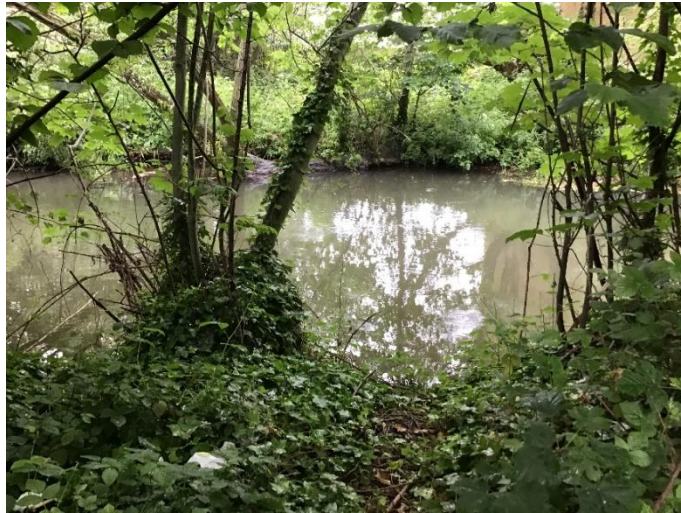
PLATE 19      SHOWING HOLY BROOK

Holy Brook located approximately 5 m north of the site was assessed as providing suitable habitat for otter. Development proposals include the thinning/felling of some of the trees located on the southern bank of Holy Brook, that overhang the site. As such, to ensure the development does not impact otter, it has been recommended that an Otter Survey of Holy Brook is completed, to identify any potential otter holt locations and assess the potential presence of otter within the watercourse. The brook will be surveyed where it flows adjacent to the site and 500 m up and downstream of the site. Any field signs of the species should be mapped and any potential otter holts or resting places should be identified. Otter Surveys can be conducted at any time of year.

If potential otter holts or resting places had been identified during the survey, further survey effort in the form of camera traps would be recommended to confirm the absence/presence of the species on the features of interest. This survey has been undertaken and ensures that the development does not impact otters.

To protect Holy Brook during the construction phase, an 8 m buffer zone is recommended to be maintained adjacent to the watercourse, in which no works should be permitted. This would be excluding the works to thin/fell some of the trees on the southern embankment of the brook which overhang the site. Best practice protection measures as detailed within PPG5 Pollution Prevention Guidelines (2007) should be put in place to protect the watercourse. The following control measures are recommended during any groundworks and during the construction phase to ensure there are no impacts on the watercourses and water table or any wildlife utilising it:
