**87 Balmore Drive**  
Caversham  
Reading  
RG4 8NN

Dr Stacey Dawn Waring  
21-014-BAS  
July 2021

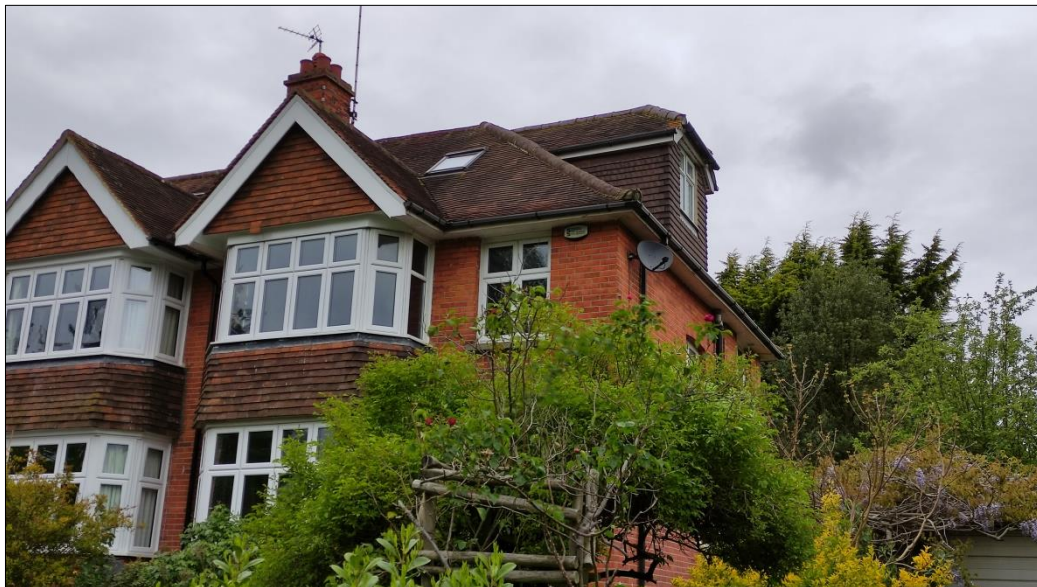
**Figure 2** – Front (southern) elevation of 87 Balmore Drive

The site consists of a 20th Century (1930s), semi-detached, two storey building of brick construction with a pitched roof, consisting of timber rafters resting on the walls and clay tile covering (Figure 2).

The exterior walls on the front and side elevations have hanging tiles around the bay windows, pediment and dormer window (Figures 2, 3 and 4). To the rear of the main house there was also a brick outbuilding and garage, both of which were deemed to have negligible potential for bats and as such are not included in this report.

However, any hanging tiles should be removed during the summer months as a precautionary measure.

The only precautionary measure that should be taken is to remove hanging tiles that will be disturbed during the works, before October. This will prevent them being used by hibernating bats.

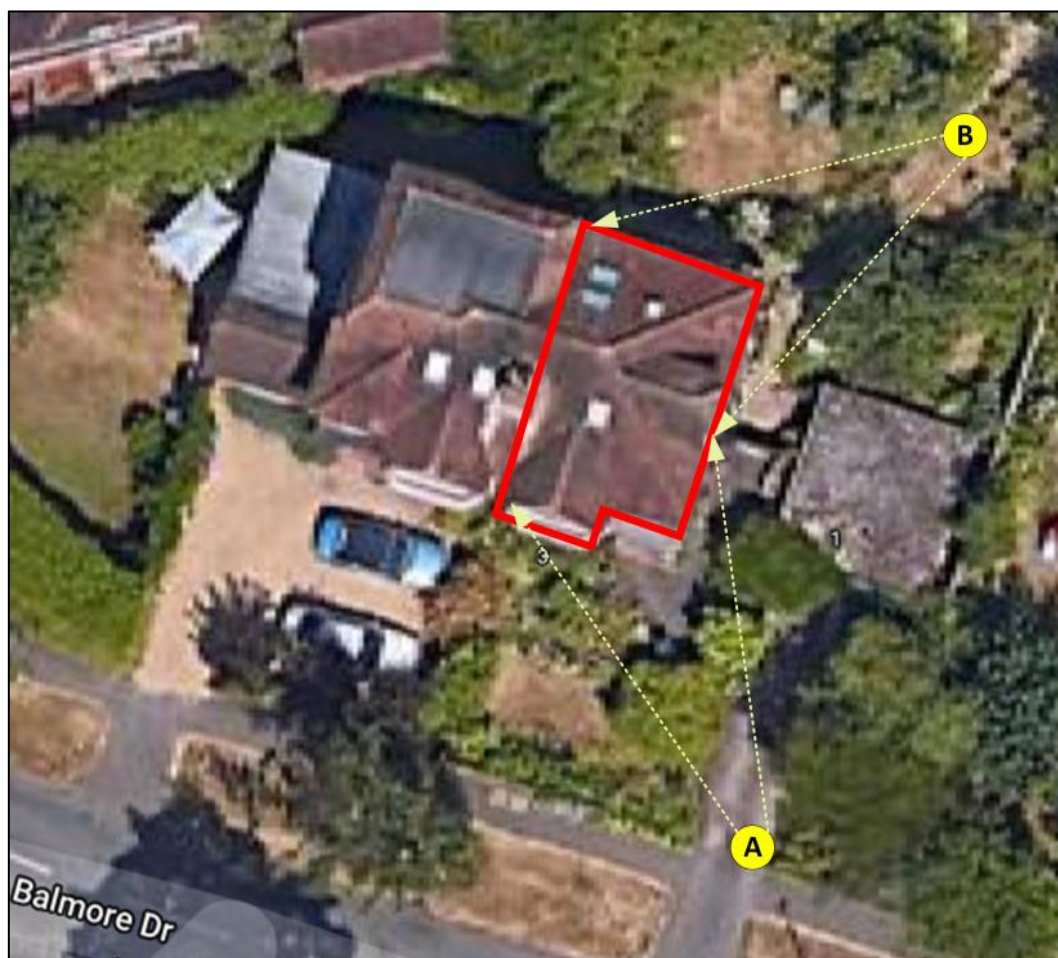
Figure 5 – Surveyor locations during the two activity surveys at 87 Balmore Drive

Two surveyors were present (locations shown in Figure 5) and Echo Meter Touch 2 Pro (full spectrum) detectors were used during both activity surveys. Recordings were analysed on Kaleidoscope Pro ultrasound analysis software to facilitate species identification.

Two surveyors were used for the two surveys conducted, the positions of which are indicated in Figure 5. The positioning of the surveyors ensured a good view of all elevations was achieved and features with roosting potential were observed. These features were determined from both the initial bat

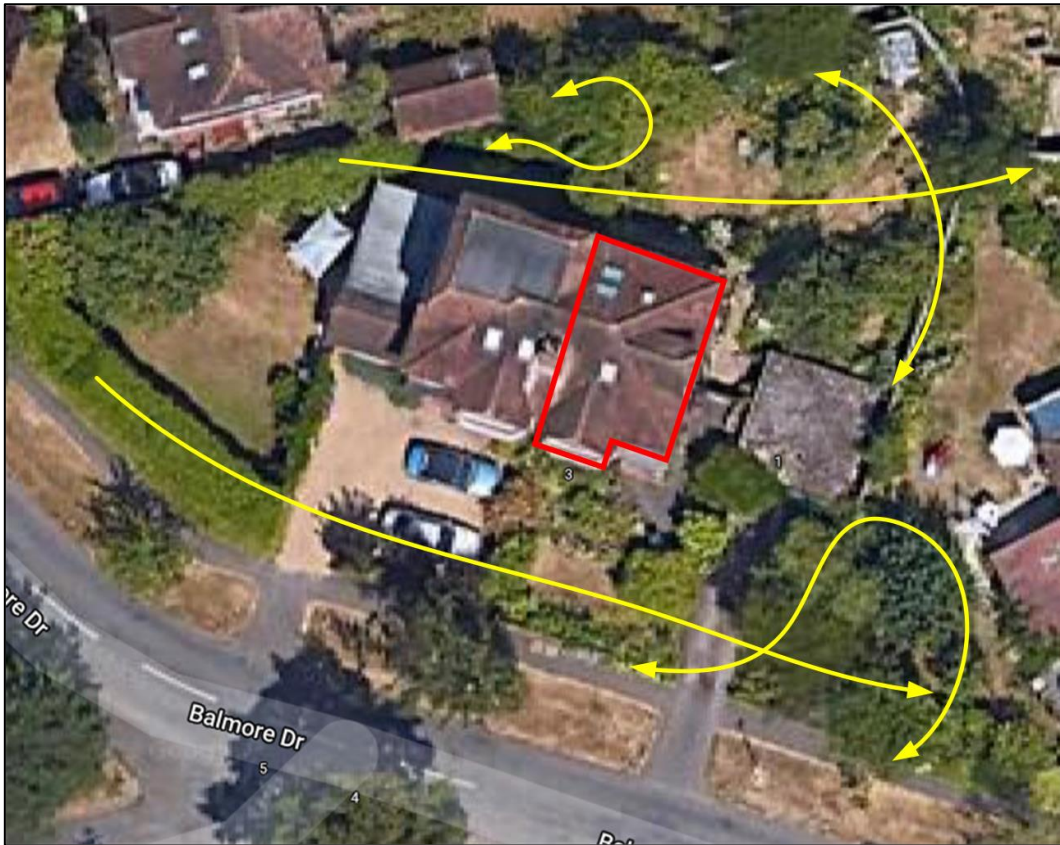
**Figure 14 –Main flight paths used by bats observed during the two activity surveys at 87 Baltimore Drive**

During both surveys there was a low level of bat activity, primarily using the gardens surrounding the house to commute and forage. Whilst foraging within the garden was recorded, this seemed a secondary function for the flight paths. At least three species, including; Common Pipistrelle (*Pipistrellus pipistrellus*), Soprano Pipistrelle (*Pipistrellus pygmaeus*) and Noctule (*Nyctalus noctule*), were recorded flying in the gardens surrounding 87 Balmore Drive.

The full results of the three activity surveys are detailed in Table 1 and Figure 6, which shows the main flight paths used by bats during the surveys. Below are the date, time and weather details for the two activity surveys conducted -
