## Historic Building Record Level 2

86 – 87 Broad Street,  
Reading, RG1 2AP

Sept 2021 | Project Ref 06362B

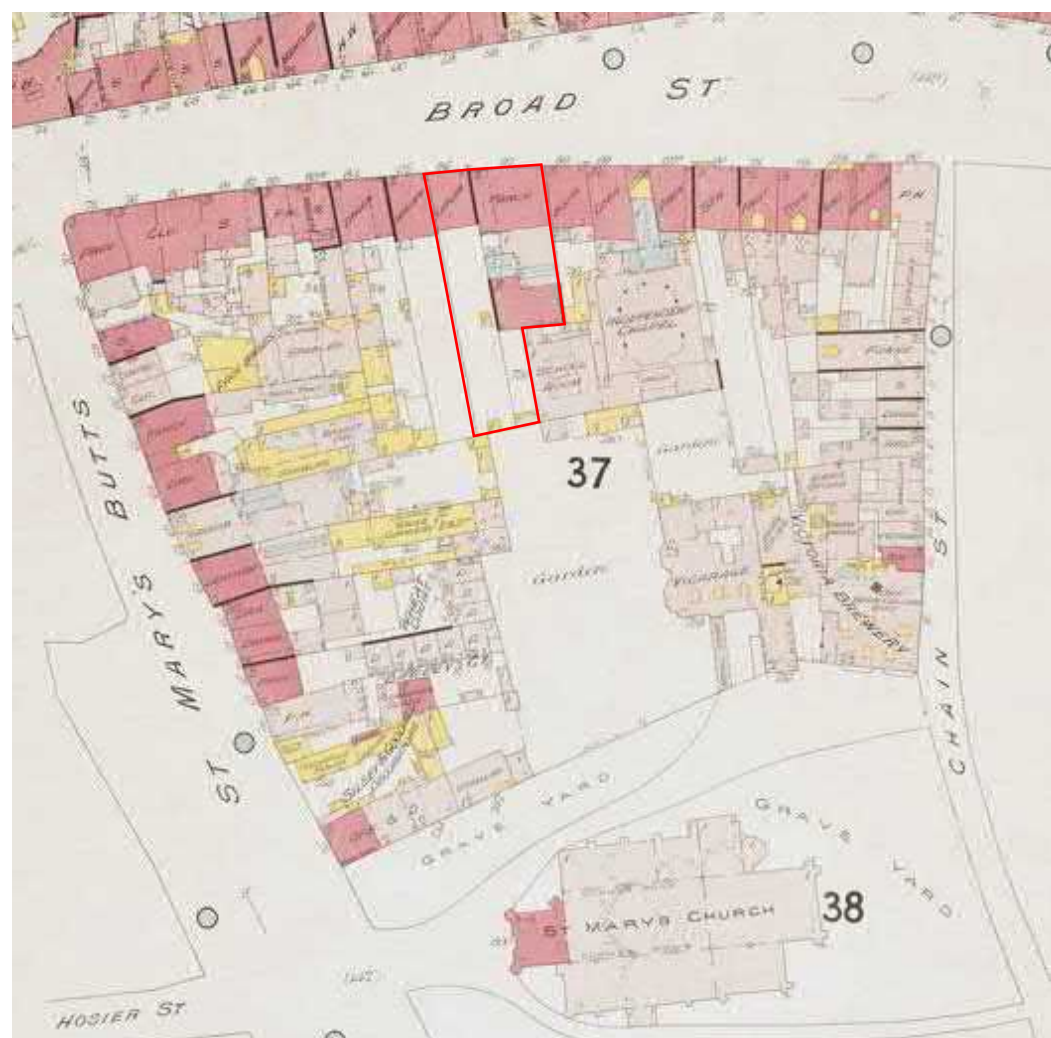
Figure 8: 1895 Charles E Goad Ltd. Insurance Plan © British Library

**3.15** The 1895 Goad Insurance Fire Plan (Figure 8) provides more information and shows No 86 as a relatively small building on a square footprint on the street front and with 'cutler' written within it. No 87 is a larger building with the additional structures to the rear as shown on the 1879 OS map and 'fancy' written within the building. A dotted line on the western side of No 87 may also represent the covered passageway through the building shown on the 1879 map.

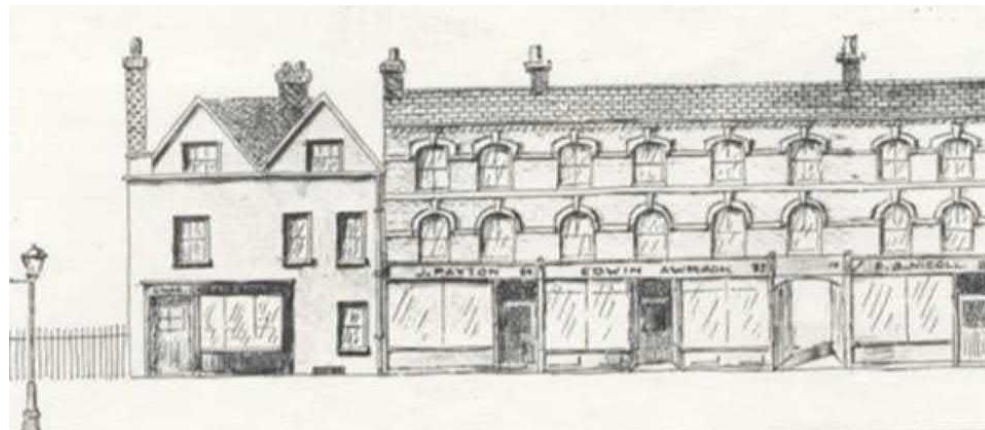
Figure 9: Sketch of c.1885 showing part of the terrace of the application site and, to the left, the location where the current 1892 frontage of the Congregational Chapel now sits (source: Reading Library – Archival Photos). Note that the illustration contains the name Edwin Awmack on No 87 and Nicholl on No 86, corresponding with the 1899 Kelly's Directory

**3.19** A single sketch and two historic photographs of the site have been sourced (Figures 9-11). These demonstrate the high levels of alteration undertaken to the wider area throughout the 20th century and some changes to the building. Of particular relevance are the following points:

- The terrace containing the site was originally longer and included No 88 (the façade of which has been significantly altered and is no longer visually in keeping with Nos 87 and 88) and No 85 to the west, which has been completely altered;
- The original shopfronts have been replaced with modern detracting shopfronts at ground floor level;
- The rear of No 86 has been partially eroded through the provision of a large scale rear extension. Additions have also been added to No 87, but the majority of the buildings may be of late 19<sup>th</sup> and early 20<sup>th</sup> century date.

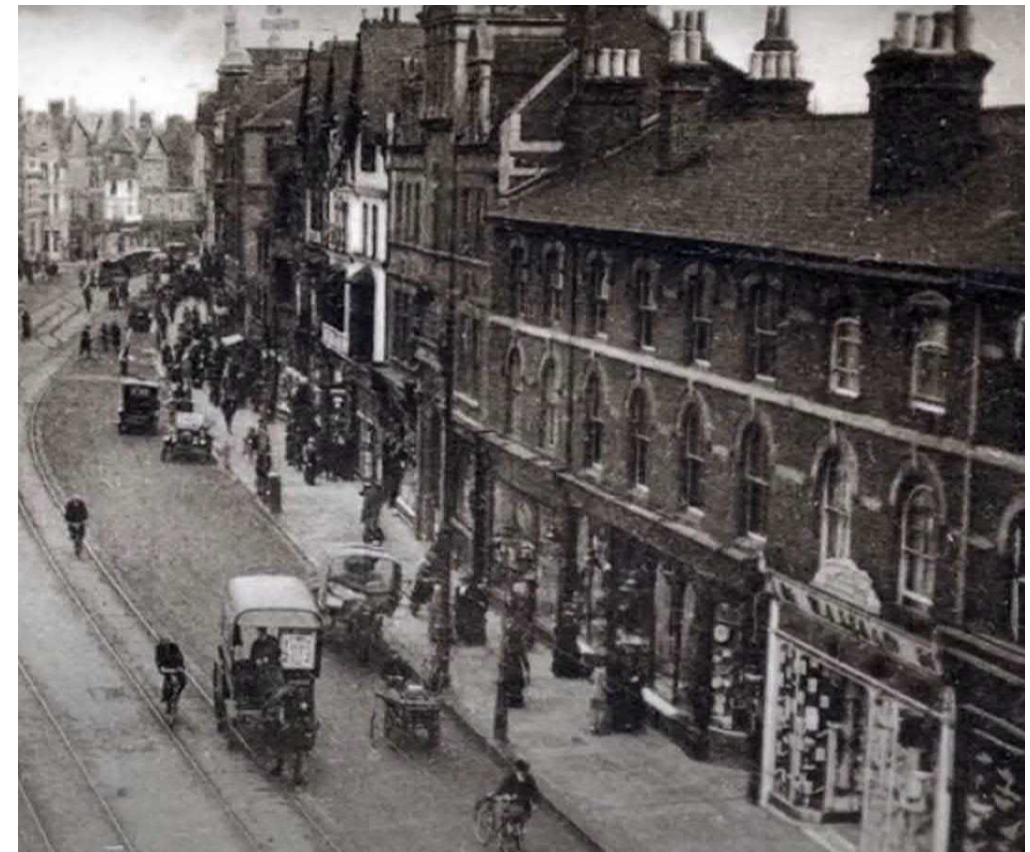
Figure 11: Historic photograph (early 20<sup>th</sup> century) showing the application site – including Nos 88, 87, 86 and 85 (on right hand edge) as a matching terrace

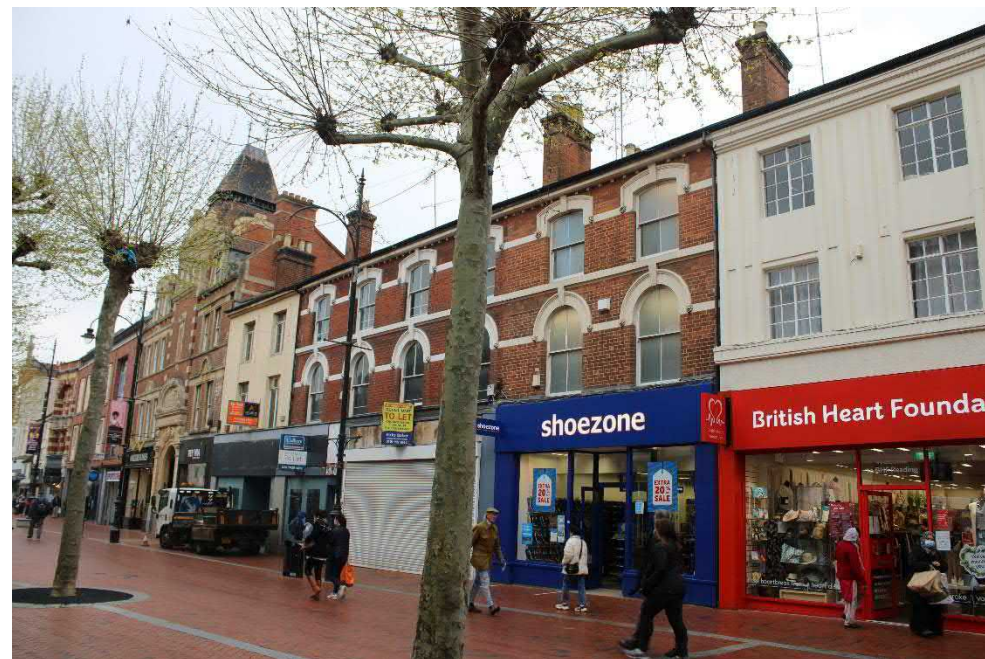
Photo 1: View southeast across the Broad Street facade of Nos 86 and 87 with red brick frontages with former elements of the original terrace (No 85 to right and No 88 to left) with later square headed windows and rendered facades

- 4.1** The Broad Street frontages of Nos 86 and 87 are matching in style above the ground floor shop fronts (Photos 1, 2 and 3). The first and second storeys were brick built with round headed sash windows at first floor and swept head sash windows to second. A widely spaced dentil course was visible below the eaves of the slate roof, with grey ceramic ridge tiles.

- 4.2** There was a projecting string course between the two floors painted white. The window heads were all quite ornate comprising moulded projections mirroring the arch of the first floor and swept head windows of the second floor (Photo 4). Each had a decorative moulded key stone centrally placed in the window heads and raised outer edge leading down to ornamental projecting label stops. These were all vegetal in style and comprise a number of different designs. A further string course joined the bases of the moulded window heads from the label stop.

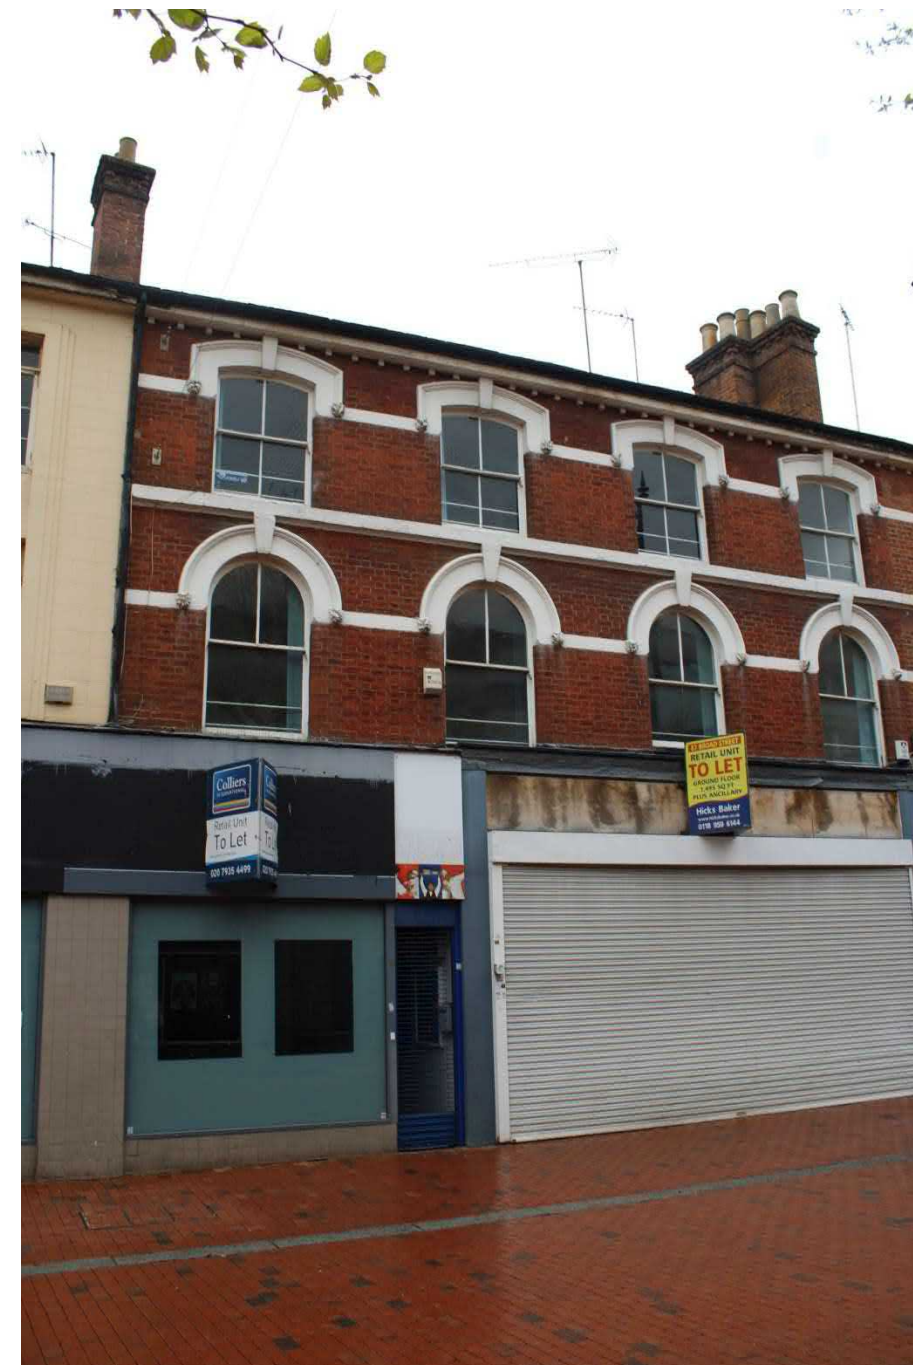
Photo 2: View of the Broad Street facade of No 87

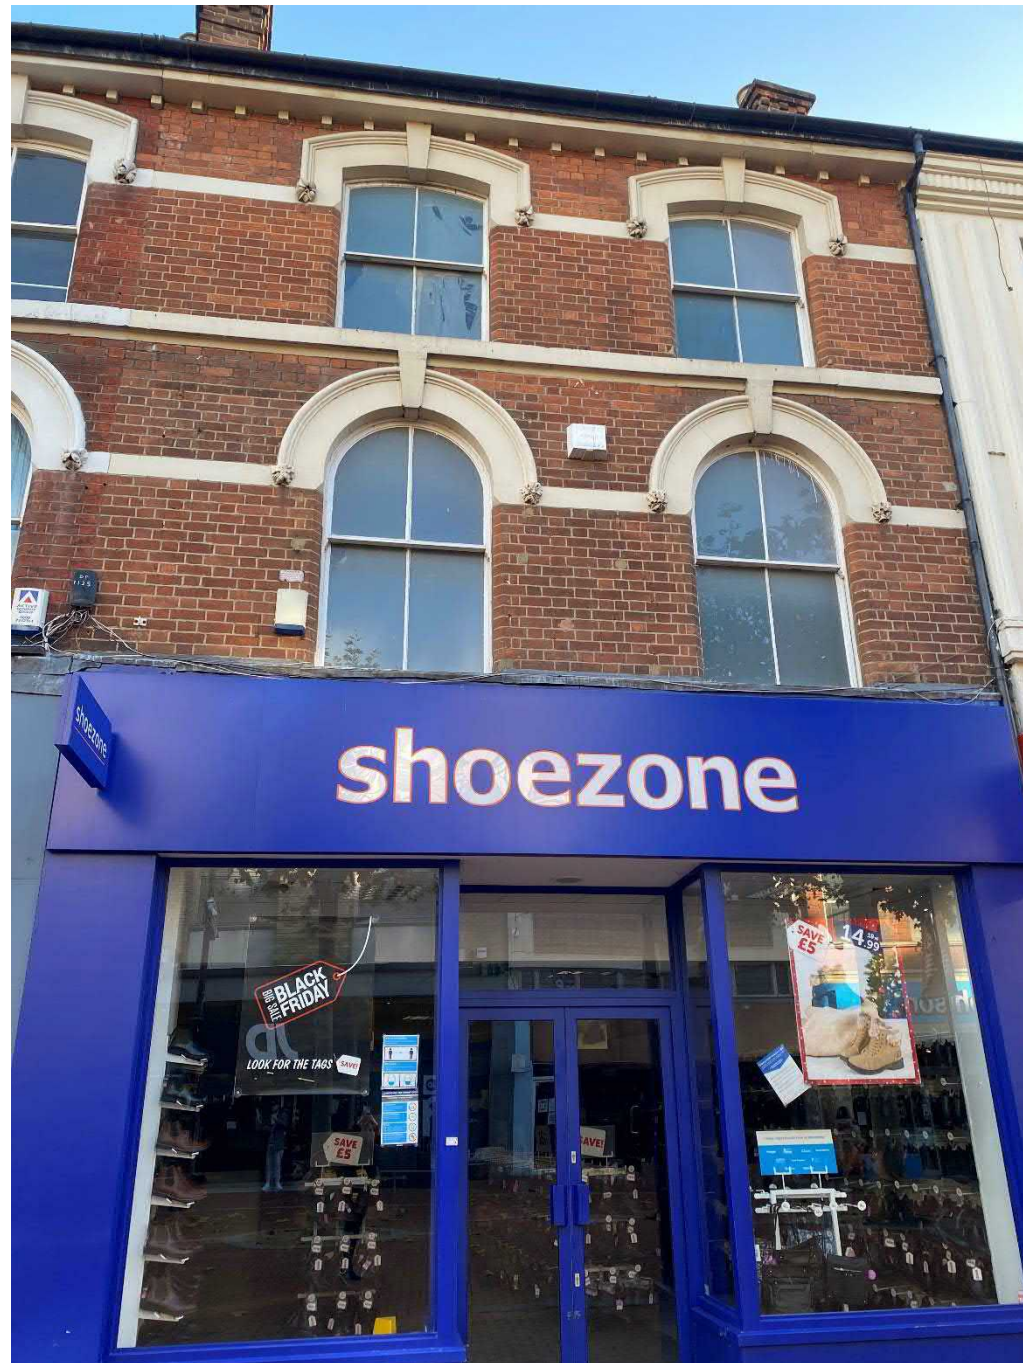
Photo 3: View of the Broad Street façade of No 86

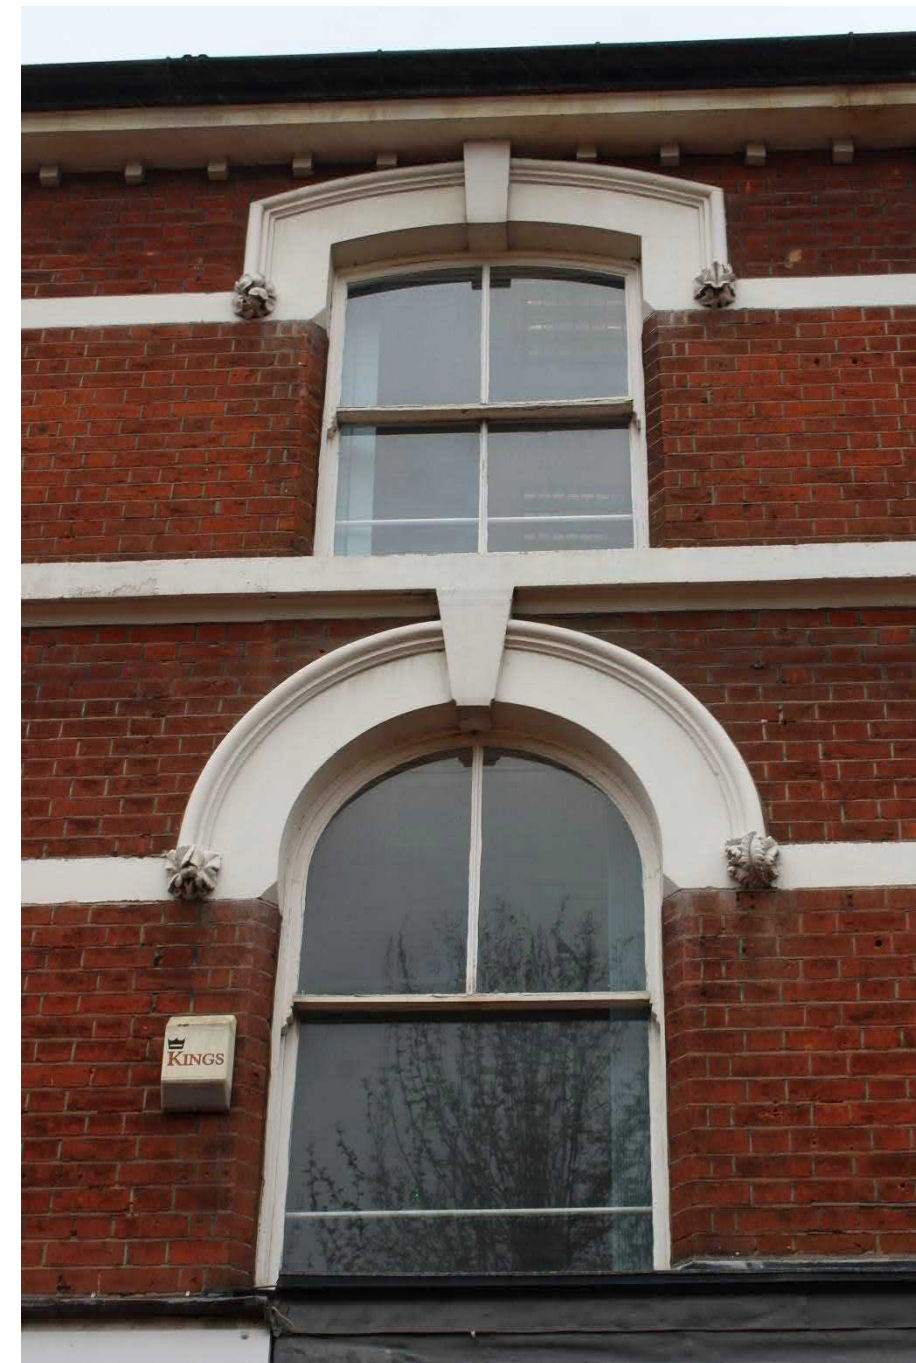
Photo 4: Detail of window arrangement on upper part of Broad Street façade, with round headed, 3-light sash window to first floor and swept head 4-light sashes to second floor. Also visible are the projecting hood moulds and vegetal label stops.

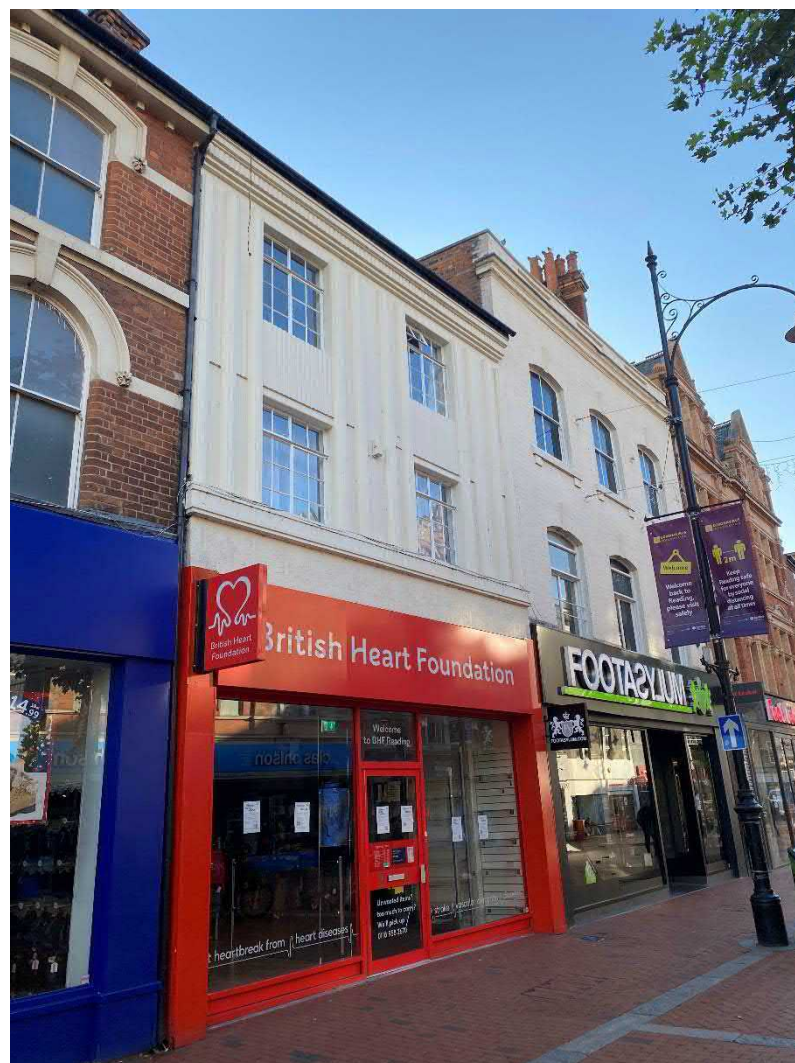
*Photo 5: Broad Street façade of No 85*

- 4.3** To the east and west of Nos 86 and 88 the facades of the adjacent structures had been rendered and the windows replaced with square headed ones (Photos 5 and 6). The rendering on these buildings had the appearance of early 20<sup>th</sup> century additions, possibly attempting an art deco finish. The finishes of the two buildings do not match.

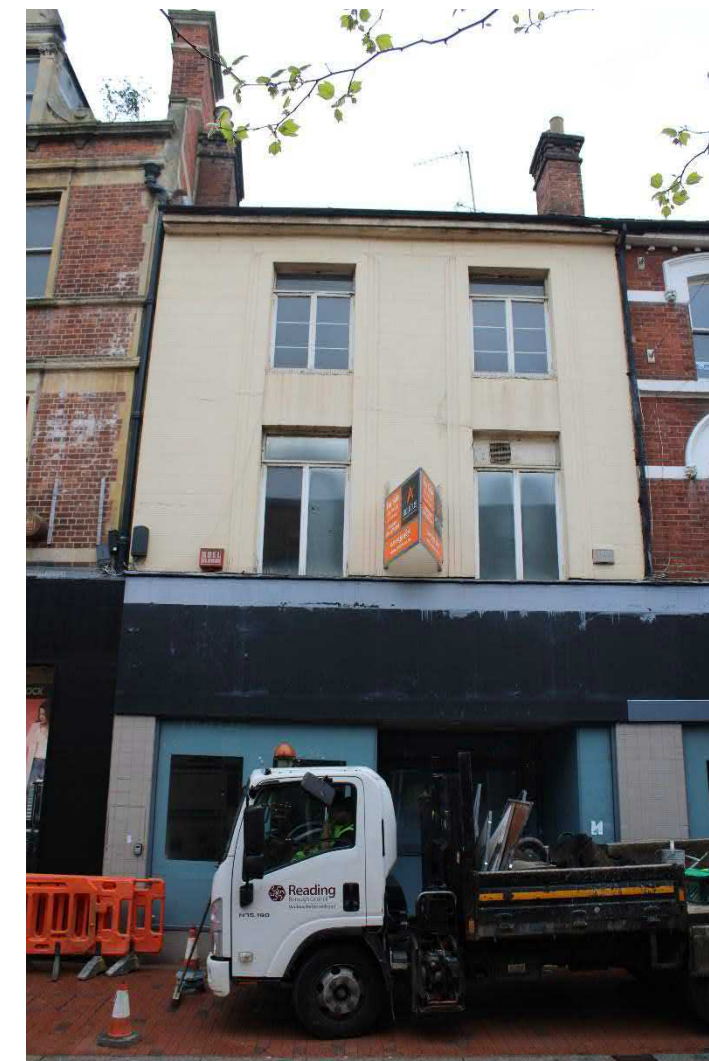
*Photo 6: Broad Street façade of No 88*

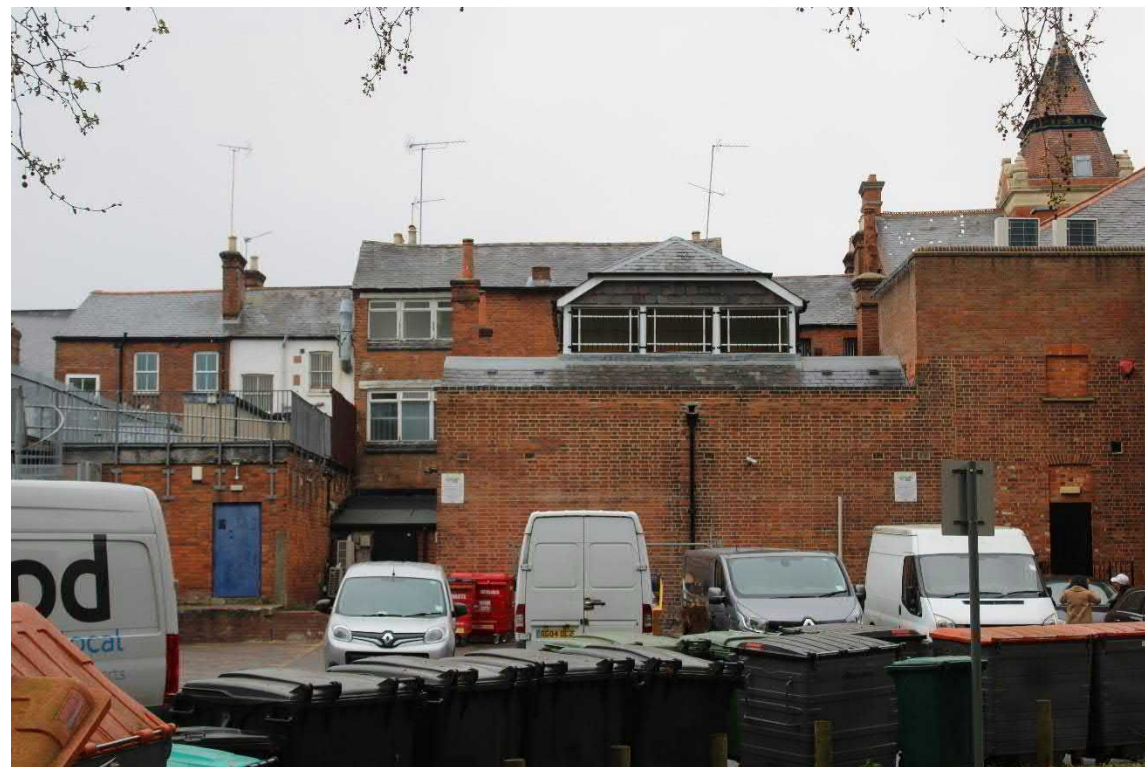
*Photo 7: View north from the churchyard towards the rears of Nos 86 and 87 Broad Street, with only the partially rendered rear of No 86 visible on the left hand side of the photo, the building to the rear of No 87 left of centre and the school room for the chapel directly in front*

**4.6** The general areas to the rears of Nos 86 and 87 Broad Street were visible from the area to the north of the church. There were no clear views of the actual rear of the frontage properties, as they were obscured by 19<sup>th</sup> century and later additions, including the three storey structure to the rear of No 87, the School Room addition to the Chapel (lying on the former grave yard area) and a modern single storey store room extension behind No 86 (Photos 7, 8 and 9).

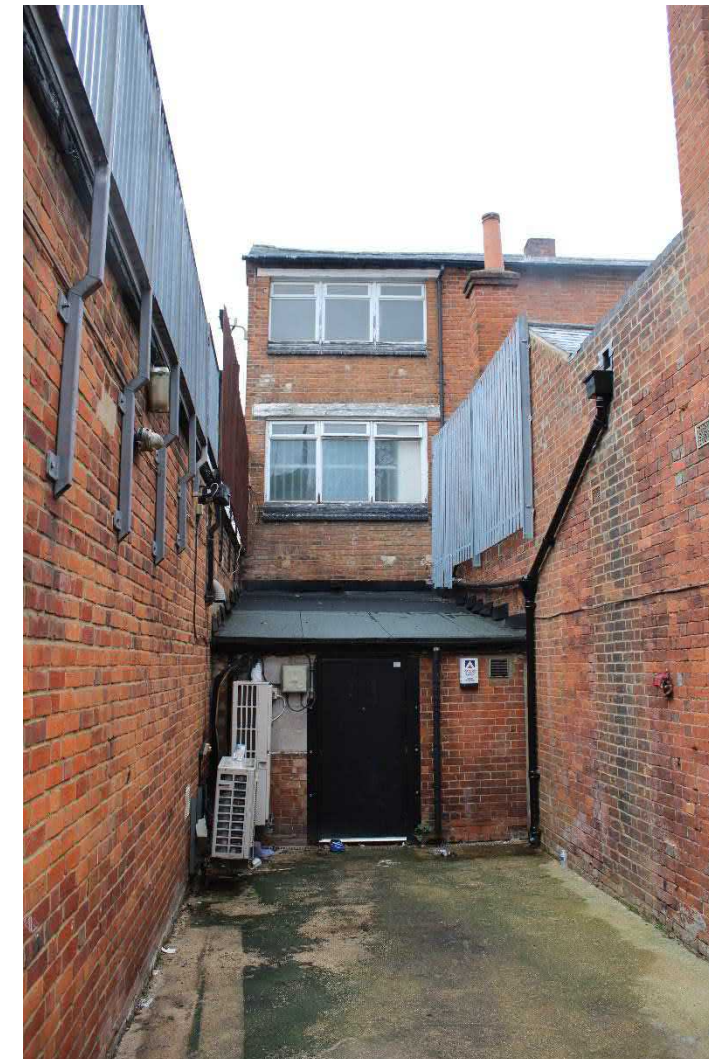
*Photo 8: View north along passageway leading to rear ground floor door of No 87 located in modern extension, with later 19<sup>th</sup> century building visible behind and with the modern store room for No 86 to left and the former school room for the chapel to the right*

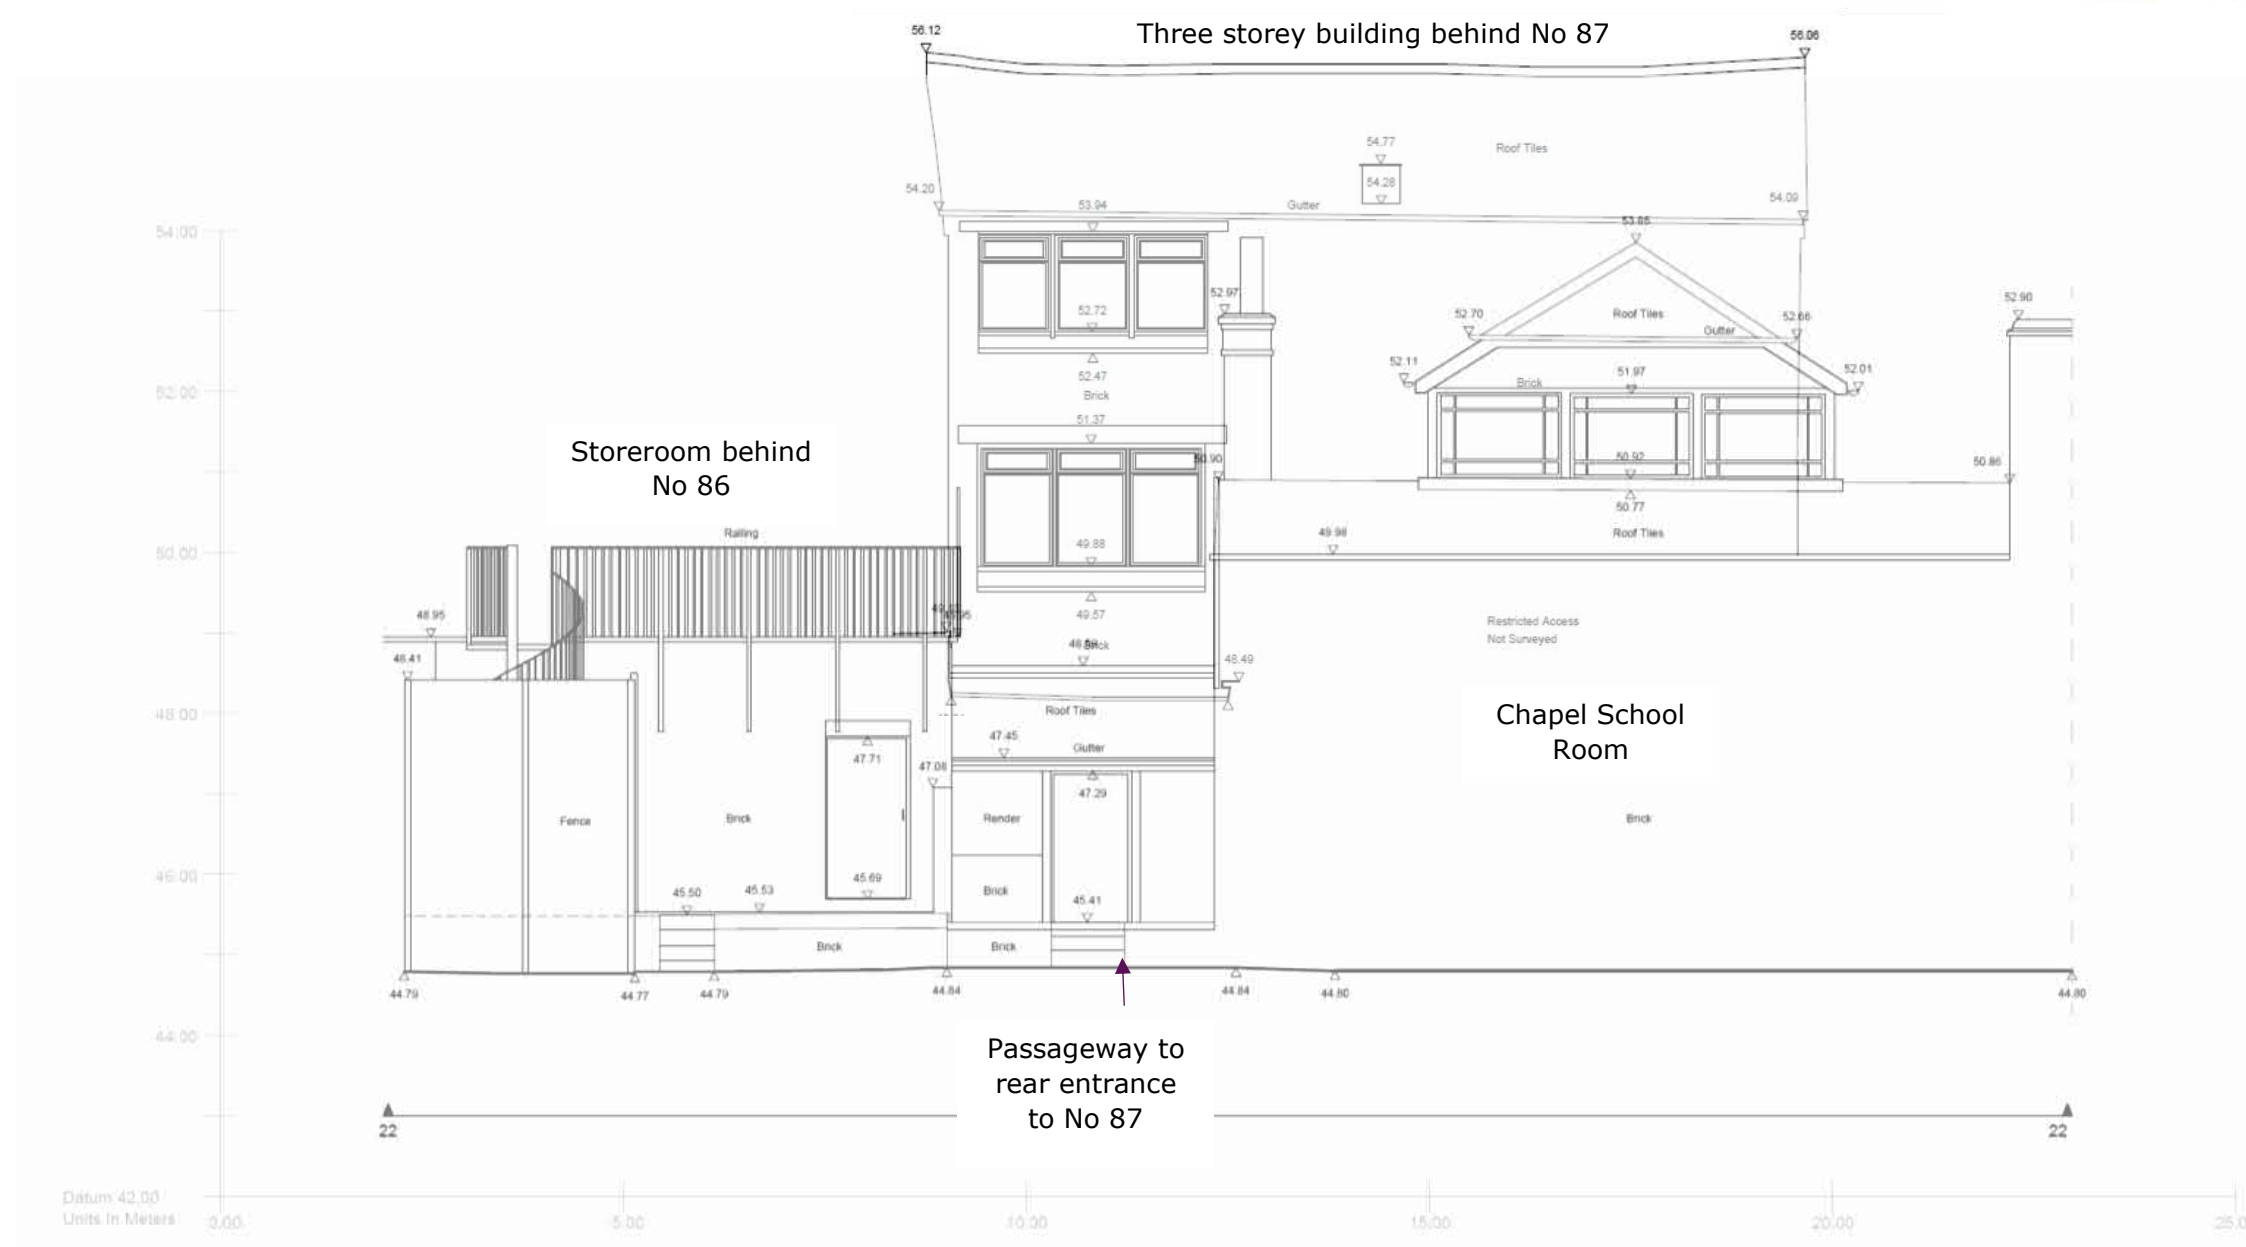
Figure 15: Rear elevation showing the rear of the storeroom behind No 86 and the three storey structure behind No 87 and later corridor between the storeroom and former school room for the chapel that was built on the former graveyard (Elevation Surveyed and drawn by MK BIM Solutions and amalgamated for this illustration)

**4.7** The rear of the frontage building of No 87 was only visible from within the three storey building behind it (as shown on the 1879 OS map). This building comprised a number of large windows, although modern replacements, on its southern façade suggesting it has been used as a workshop or for manufacturing (Photos 7 and 8; Figure 15).

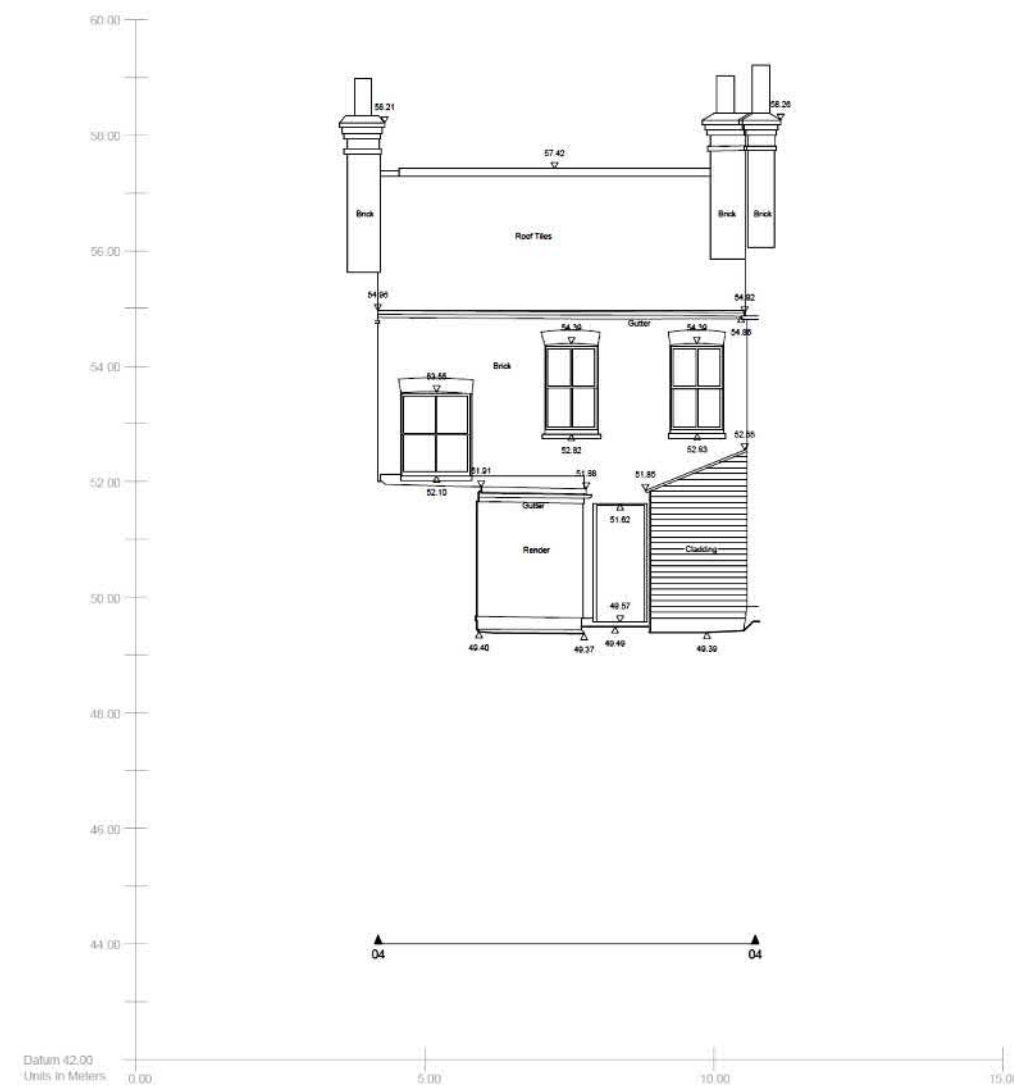
*Figure 16: Rear elevation of upper two storeys of No 86 Broad Street (Elevation Surveyed and drawn by MK BIM Solutions)*

**4.8** The rear of No 86 was not clearly visible from any angle during the site visit. Based on the elements of photographs that just show its rear elevation and the elevations drawn by MK BIM Solutions, at first floor level modern additions covered the former window layout. On the western side of the façade was a large window between first and second floor probably representing a light to an internal staircase. At second floor were two identical windows on the eastern side of the façade (Figure 16, Photo 9). All were square headed windows and the elevation had been painted.

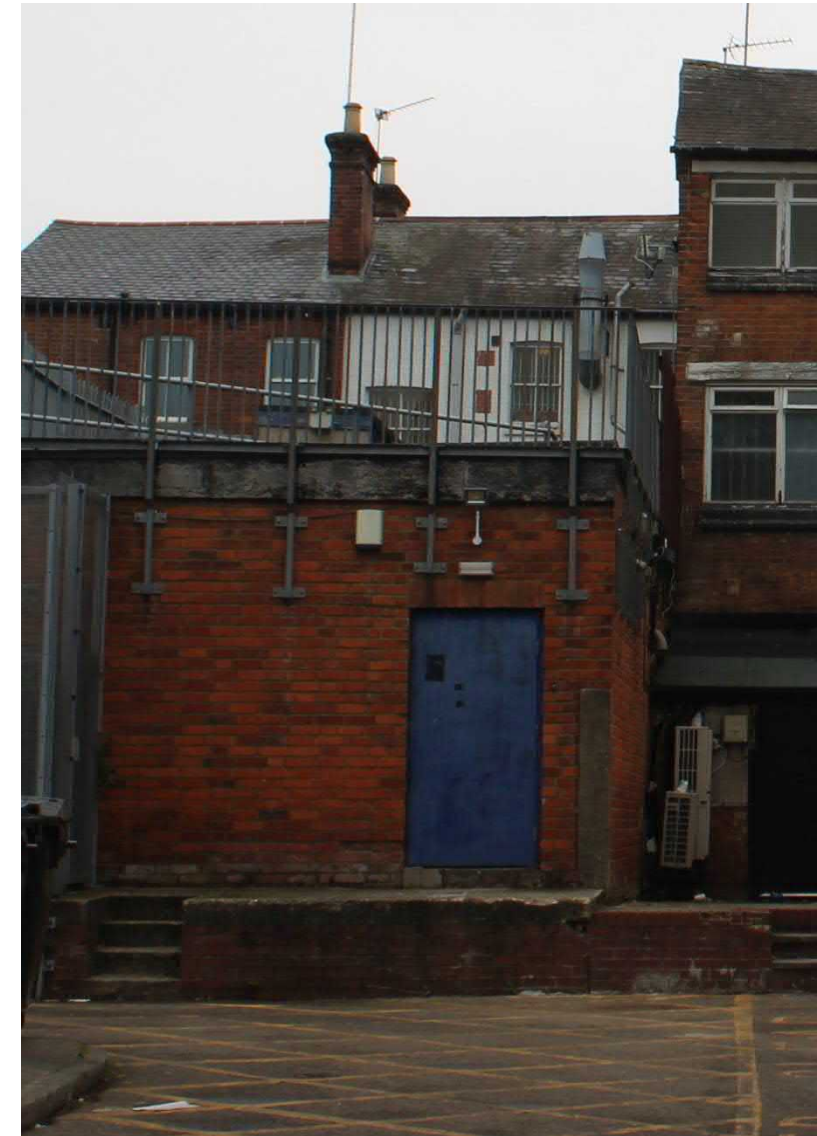
*Photo 9: View of part of rear elevation of No 86 Broad Street, with single storey modern extension in front*

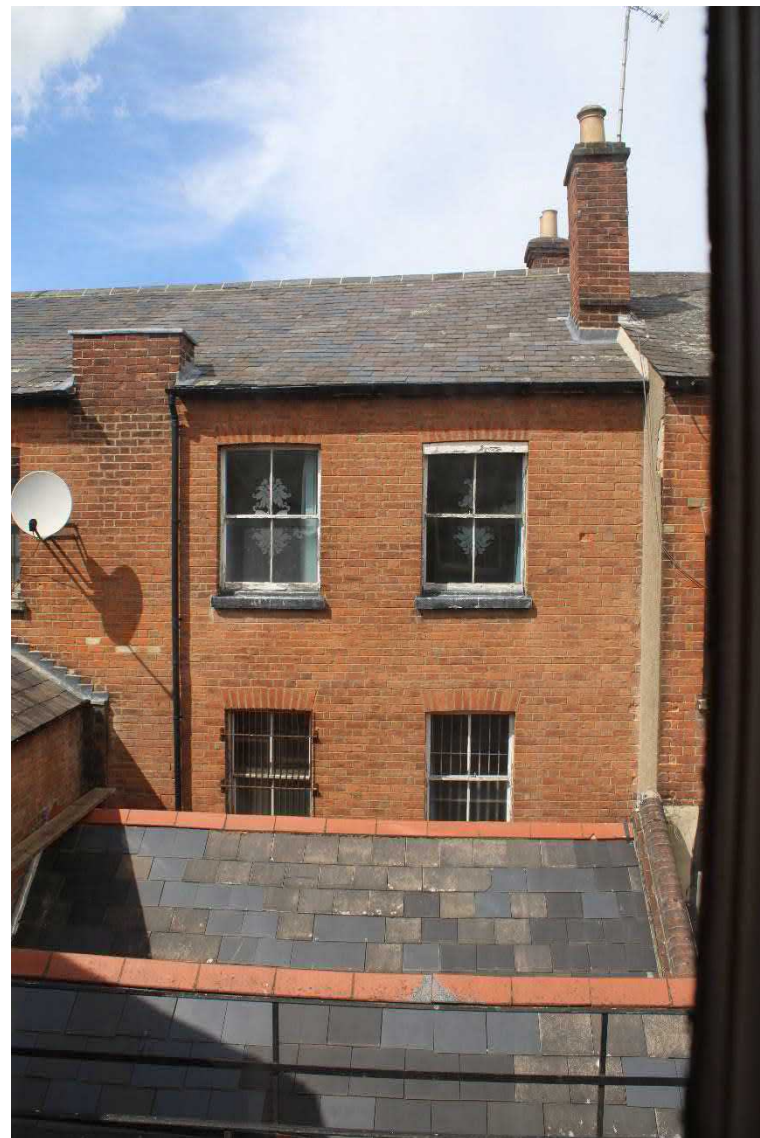
*Photo 10: View north from second floor of three storey building to rear of No 87 showing the eastern half of its southern elevation*

- 4.9** The southern elevation of No 87 was visible from within the three storey building to its rear (Photos 10 and 11). This indicated that the building had a roughly symmetrical façade at first and second floor levels with square headed four-light sash windows. One of the windows was not visible with an extension projecting out from it. The windows had simple brick heads. Those of the second floor were slightly wider than those at first.

- 4.10** Down the centre of the elevation was a slightly projecting brick column possibly a narrow chimney (Photos 10 and 11). This had the effect of splitting the windows of the elevation into two, with the four to east and three to west with the projection.

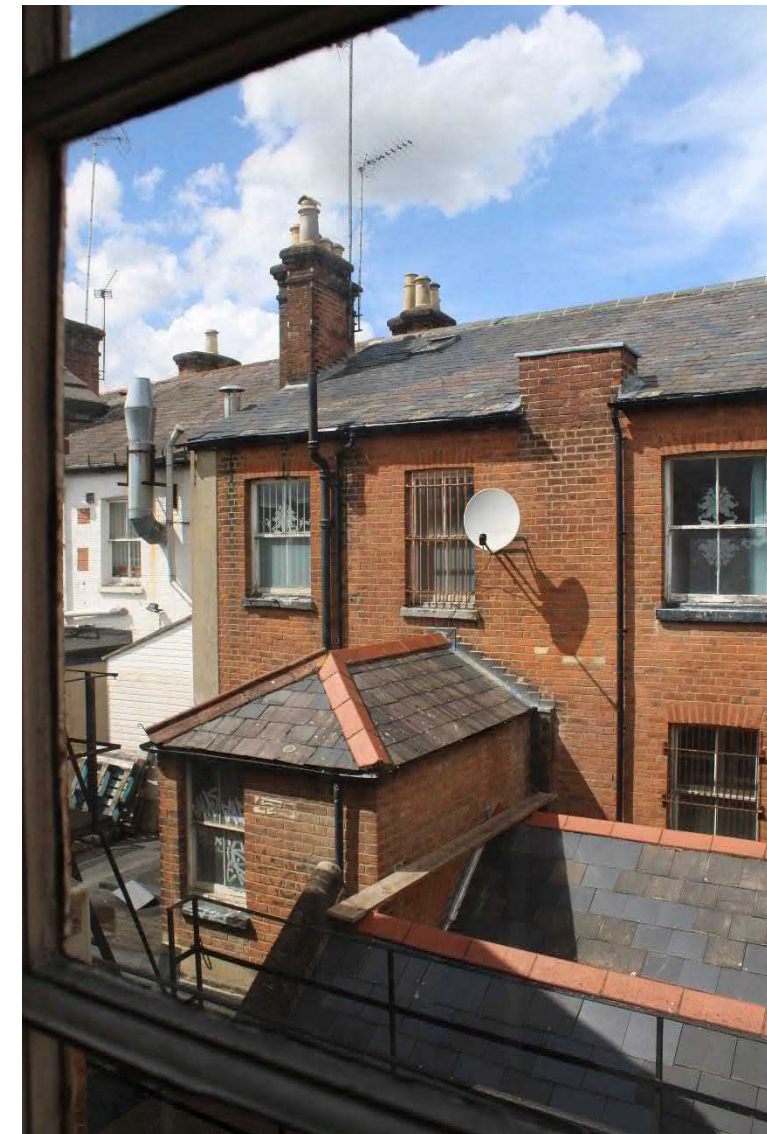
*Photo 11: View northwest from second floor of three storey building to rear of No 87 showing the western half of its southern elevation, including projecting toilet block and part of the rear of No 86*

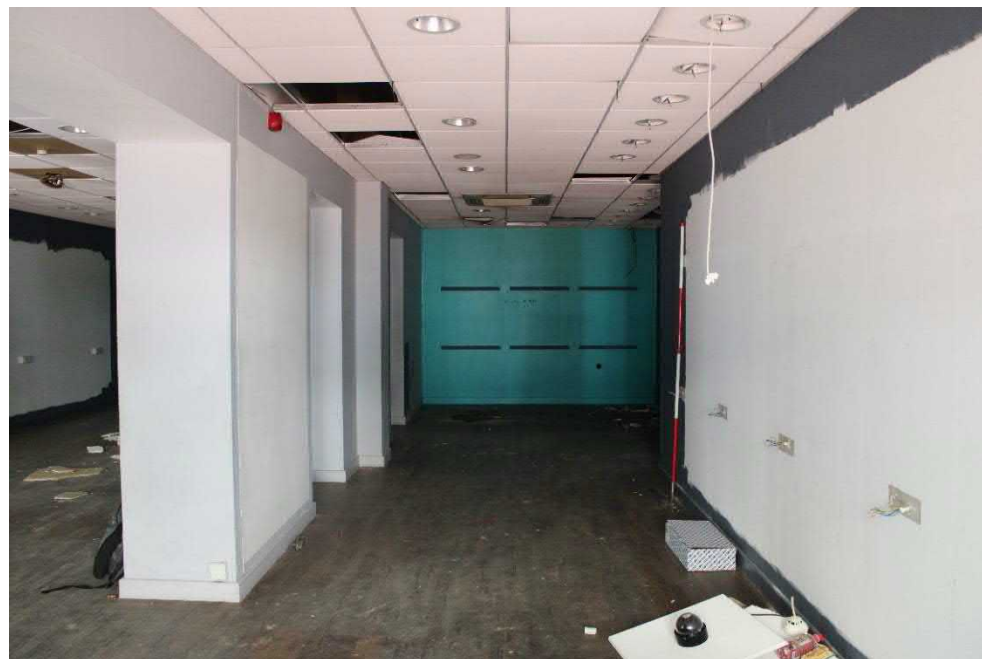
*Photo 13: View south along western side of retail unit accessed from No 88, which is the ground floor of part of No 87*

- 4.12** The eastern side of the ground floor of No 87 was accessed via the adjacent property of No 88, as the ground floor retail space combined both areas. The western side was a further retail unit running the full length of the property to the rear door.
- 4.13** The eastern side of the ground floor of the original No 87 was defined by the former dividing wall which had been cut through in a number of places to provide access into the area of No 88 (Photos 13 and 14). The room area had been gutted and modernised so that no original features survived. Little could be seen of the roof structure within the voids in the roof. In the room to the rear (Photo 15) a saw tooth roof line (VVV) could be seen through gaps in the ceiling tiles. This was also located within the area of No 87. Part of this room lay beneath the three storey building to the rear of No 87.

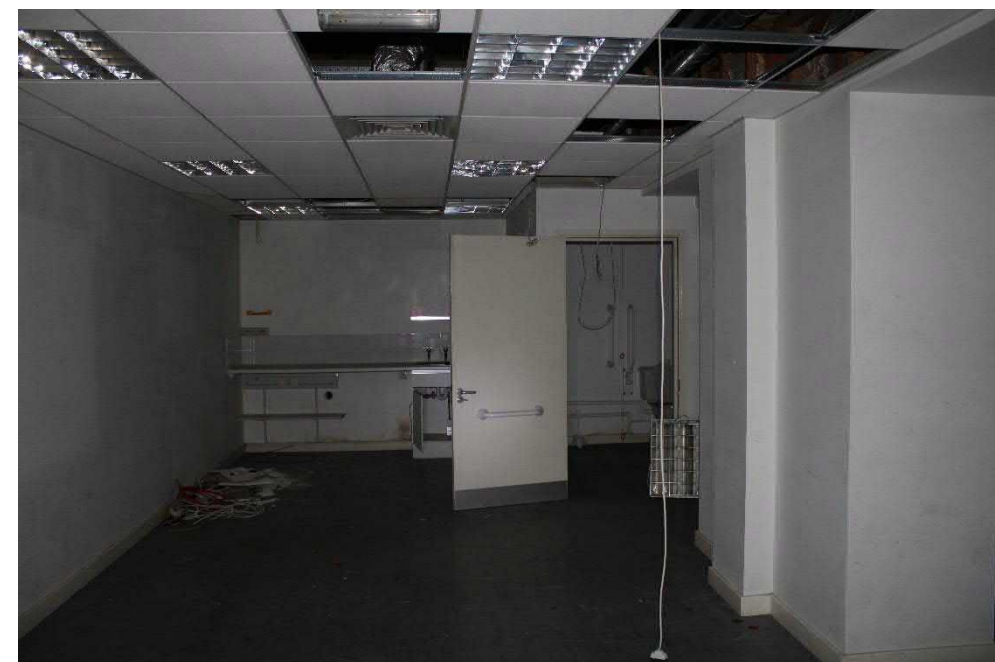
*Photo 15: View north along rear room behind eastern part of shop floor with saw tooth roof line above visible through missing ceiling tiles*

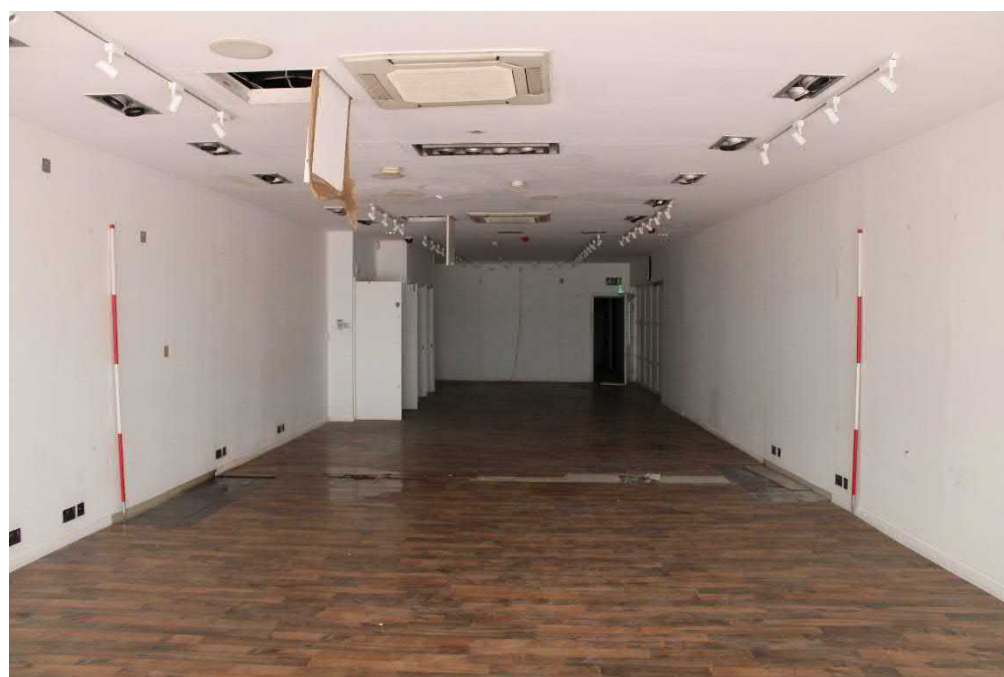
*Photo 16: View south along retail unit below the majority of No 87 Broad Street*

- 4.14** The western retail area below the rest of No 87 was again a large open space running from the shop front to the location of the three storey building to the rear of No 87 (Photos 16 and 17).
- 4.15** The main retail area had been modernised and gutted and no original features survived. At the southern end of the retail area was a single doorway leading into the ground floor of the three storey structure to the rear of No 87. Part of the southern end of this retail area also incorporated part of its ground floor. This is discussed separately later on.
- 4.16** The stair to the first floor of No 87, accessing the full width of the property lay between the two retail units with the stair lying directly above the steps to the cellar seen in Photo 14 (Photo 18).

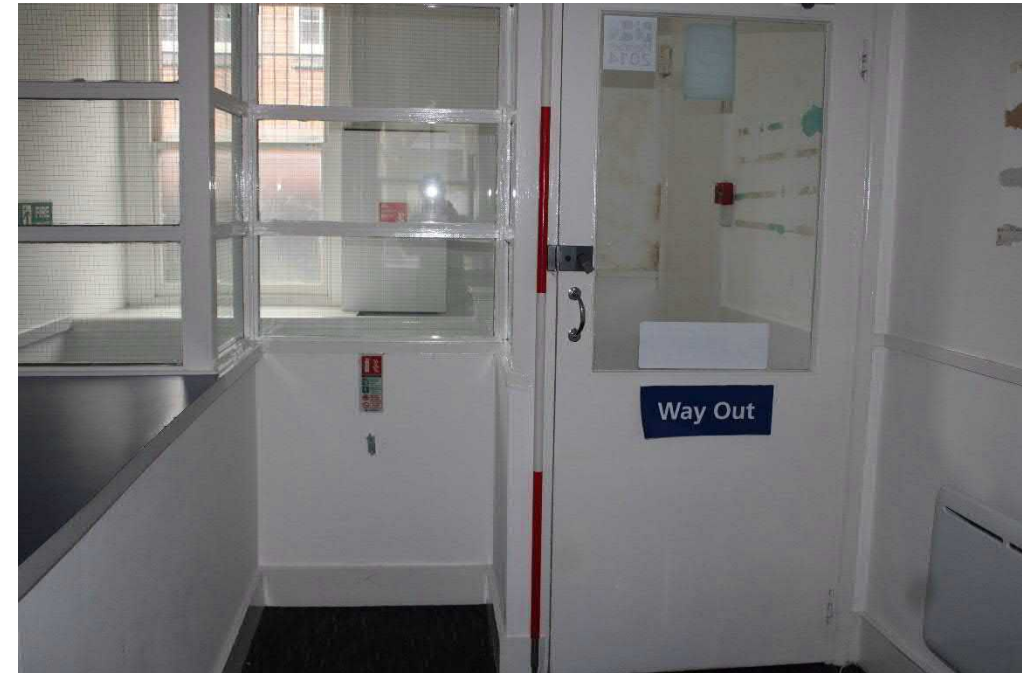
*Photo 20: View south of entrance vestibule to first floor of No 87 Broad Street accessed from the entrance stair, with window to rear*

- 4.17** The first floor of No 87 was accessed via the stairs noted above (Photos 18 and 19) which led up to an entrance vestibule, a modern addition to the building. The entrance vestibule had a raised area over the rising stairs with glass partitions and doors separating the floor from the stairwell (Photos 20 and 21).

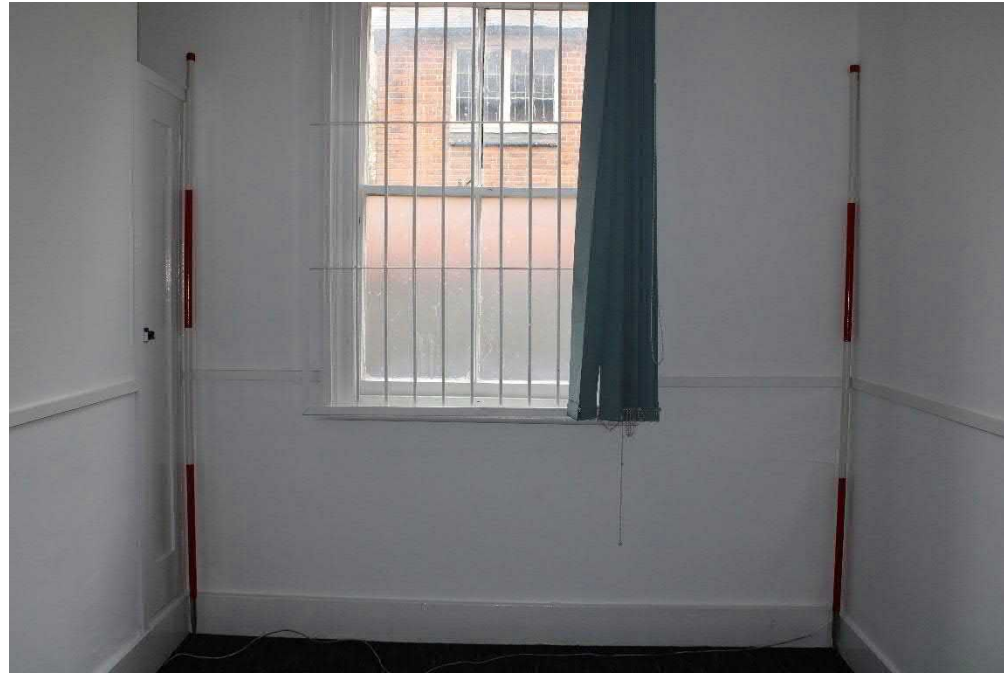
*Photo 22: View south across eastern room leading off entrance vestibule with window to south elevation and three storey rear building visible through it*

- 4.18** To the east of the vestibule was an open space with window to the south (Photo 22) and a small narrow cupboard between the chimney breast and the end wall (Photo 23). The fireplace that would have been present had been covered over (possibly removed).
