## Historic Building Record Level 2

86 – 87 Broad Street,  
Reading, RG1 2AP

Sept 2021 | Project Ref 06362B

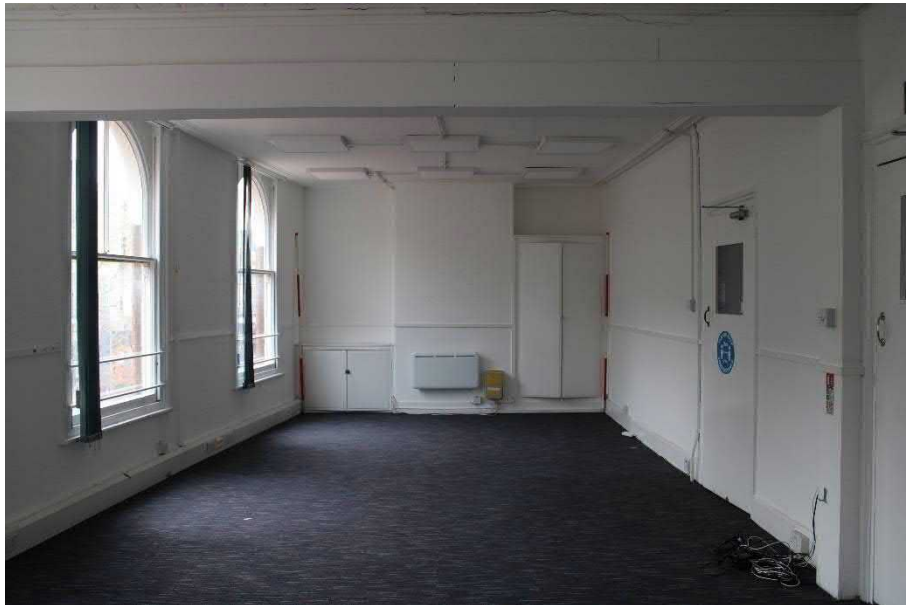
*Photo 24: View east across front room of first floor of No 87 towards chimney breast, with former dividing wall location visible in foreground*

- 4.19** Leading to the north of the vestibule was a doorway leading into a large open room that covered the entire first floor frontage looking onto Broad Street. The chimney breasts survived at either end, but fireplaces had been covered over (possibly removed) (Photos 24 and 25). All four of the first floor round headed sash windows were visible within this room, with large glass panes and stops on the sashes (Photos 26 to 29).

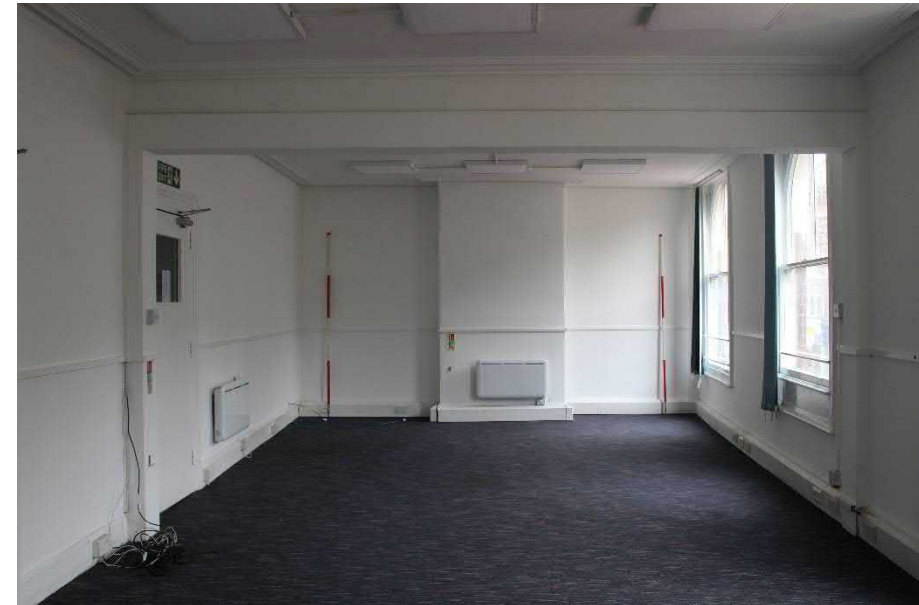
*Photo 25: View west across front room of first floor of No 87 towards chimney breast, with former dividing wall location visible in foreground*

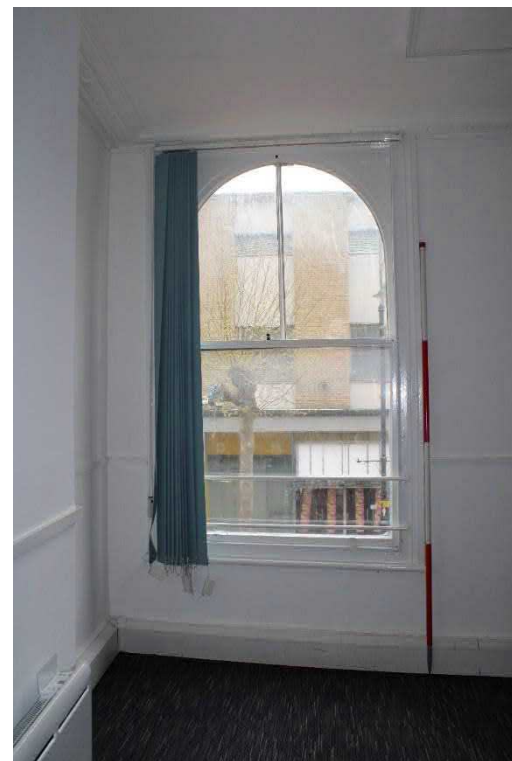
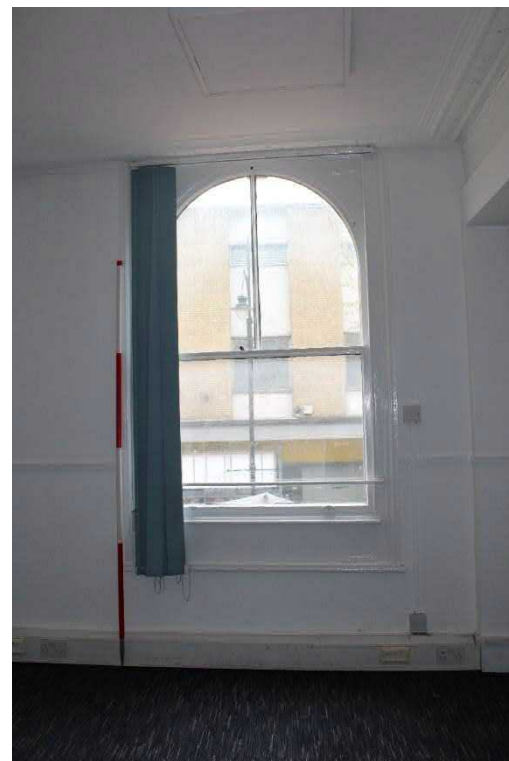
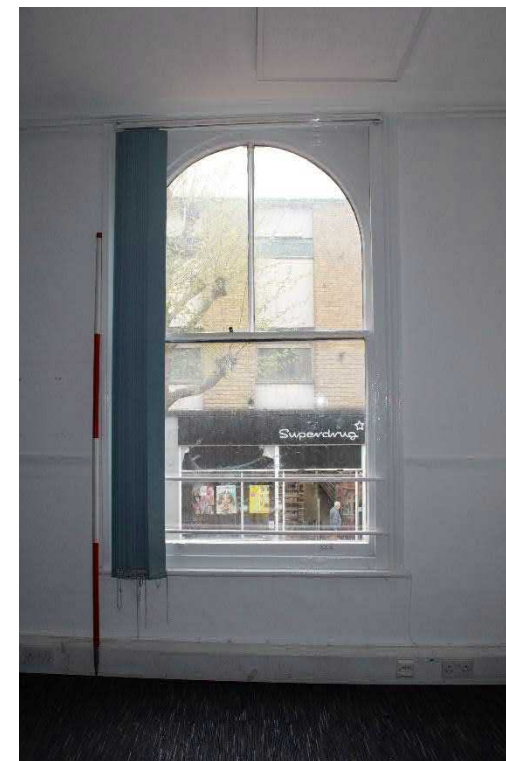
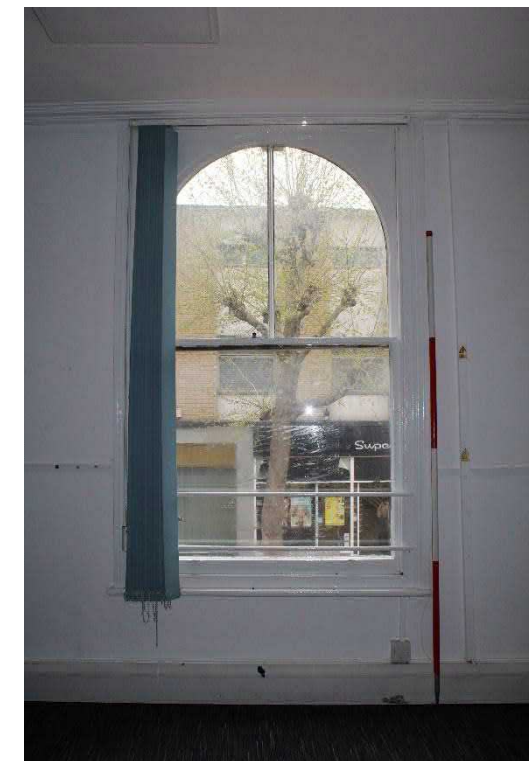
*Photo 26: Western window*

*Photo 27: West of centre window*

*Photo 28: East of centre window*

*Photo 29: Eastern window*

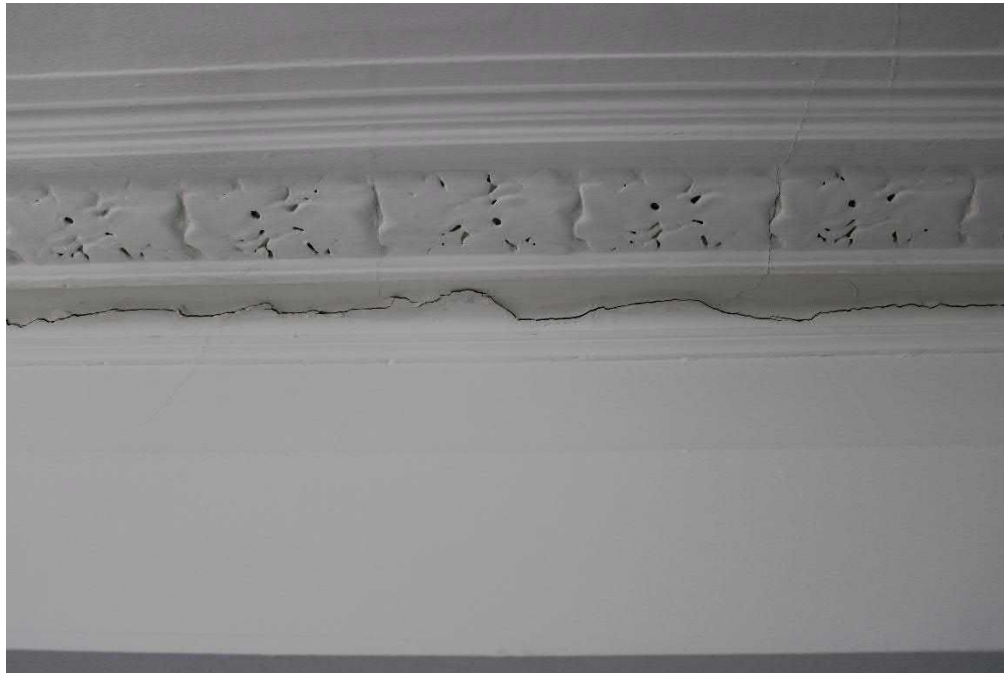
*Photo 30: Surviving element of coving in western half of first floor front room fronting Broad Street*

- 5.12** The doors were a mix of modern flat fire doors and panelled doors with flat boards to the inside of the rooms. Most of these panelled doors were modern replacements. A small amount of decorated coving was visible within the northwestern part of the front room on the first floor, possibly indicating a formal sitting room or reception room. The skirting boards had all been replaced or were originally very plain and square edged.

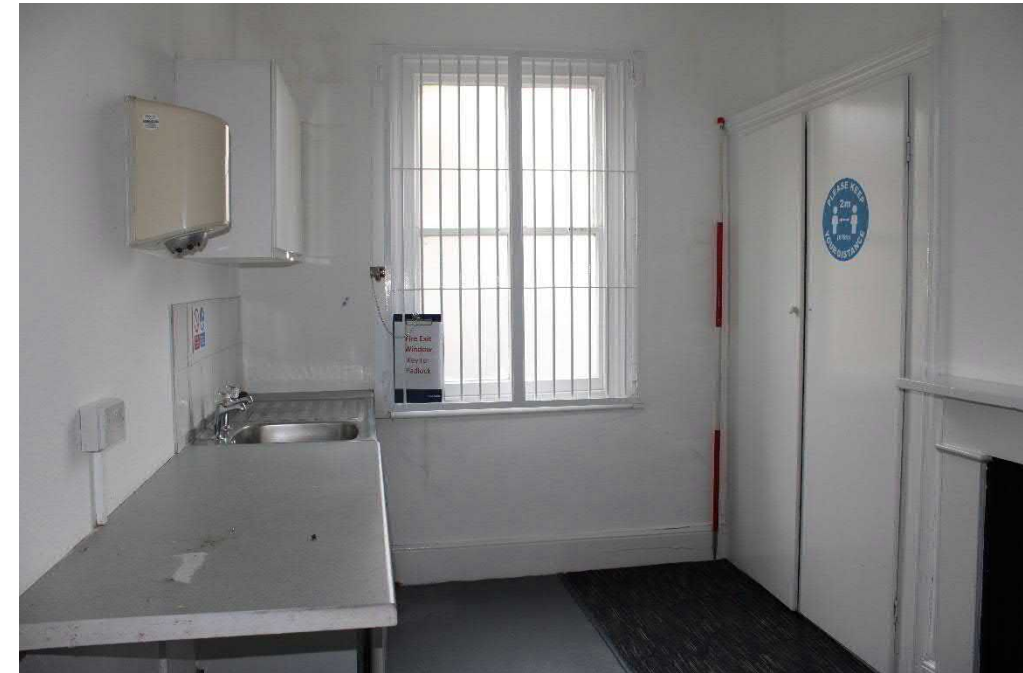
*Photo 33: View south through kitchen area on southwestern side of first floor of No 87 Broad Street showing window to rear and tall cupboard to right*

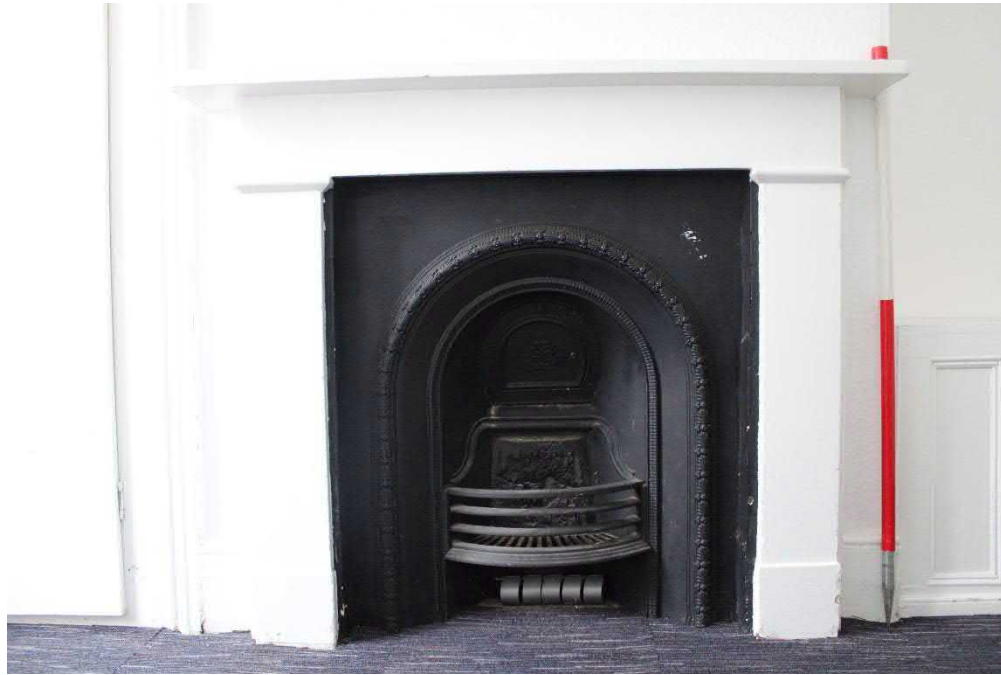
*Photo 35: View west of cast iron fireplace in kitchen area on southwestern side of first floor of No 87 Broad Street*

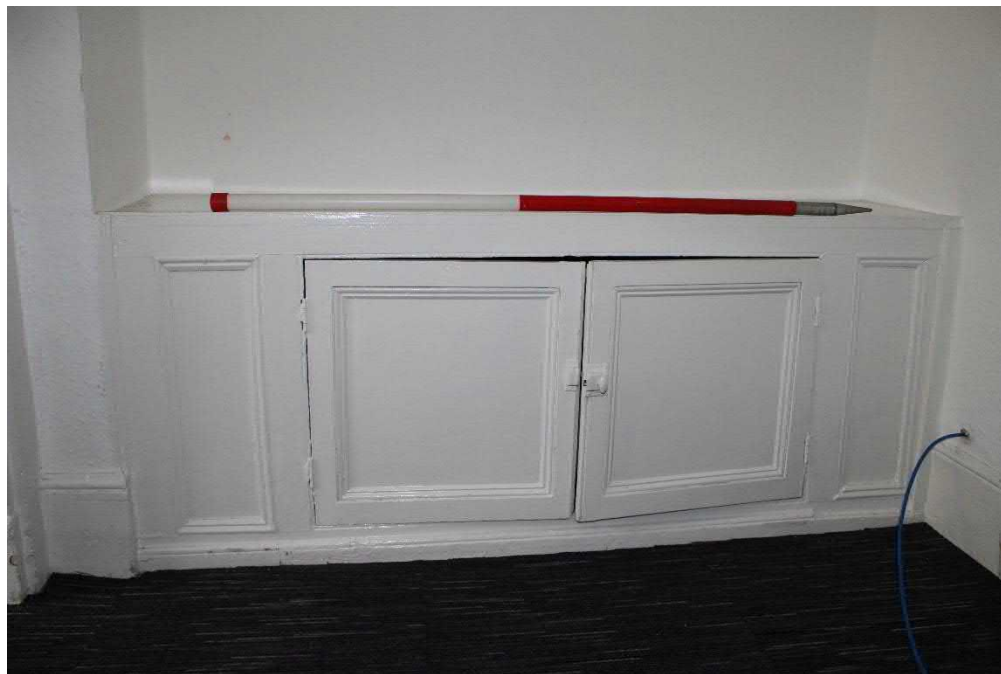
*Photo 36: View west of low cupboard north of chimney breast in kitchen area on southwestern side of first floor of No 87 Broad Street*

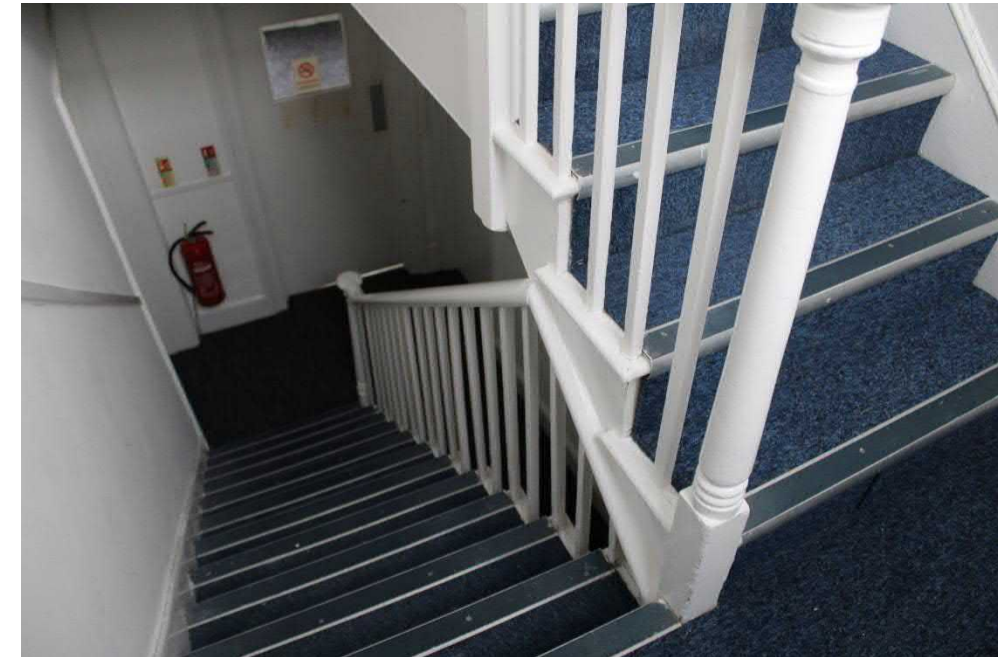
*Photo 38: View north down the stairs to first floor landing*

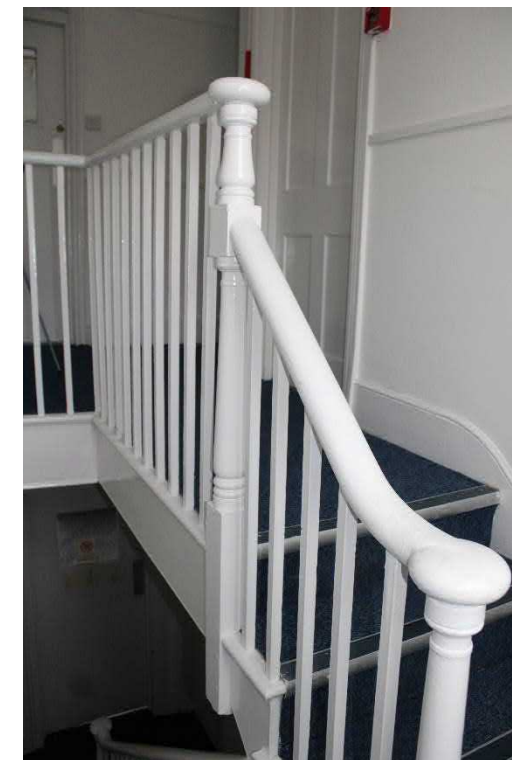
*Photo 39: Detail of banisters at top of staircase leading to second floor*

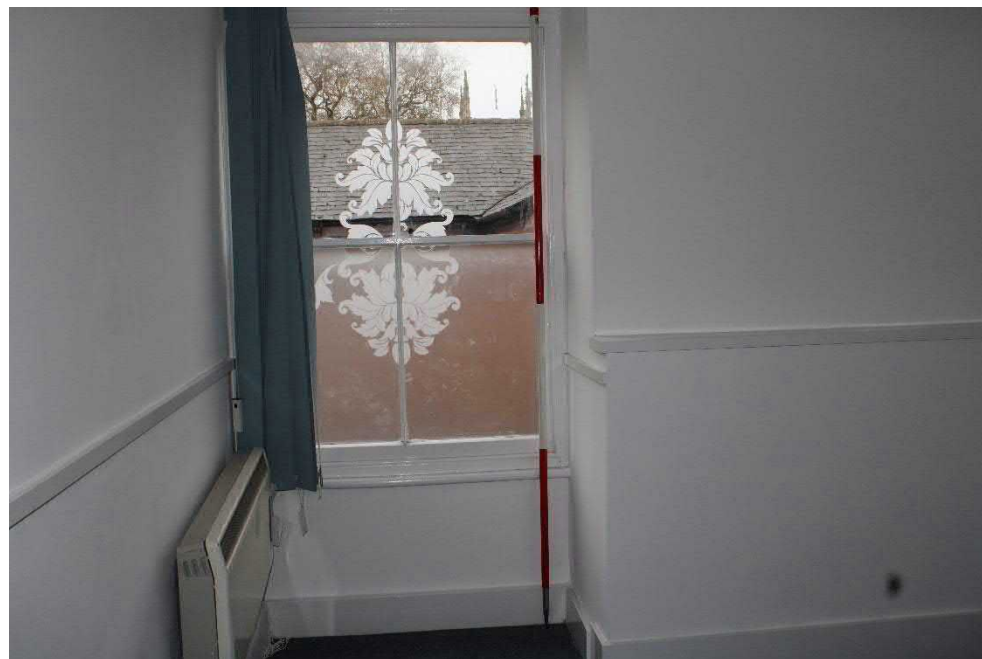
*Photo 40: View south of window and end wall in room adjacent to top of stairs on second floor landing*

- 4.27** The room east of the stairwell was fairly small with window to the south elevation (Photo 40). The window was located adjacent to the partition wall between this room and that to the southeast. The southern wall had a thin projection jutting into the room (Photo 40) which could potentially have been associated with a further fireplace and chimney breast aligned with the projecting brick column seen on the southern elevation (Photos 10 and 11) and gives more credence to it being a chimney stack.

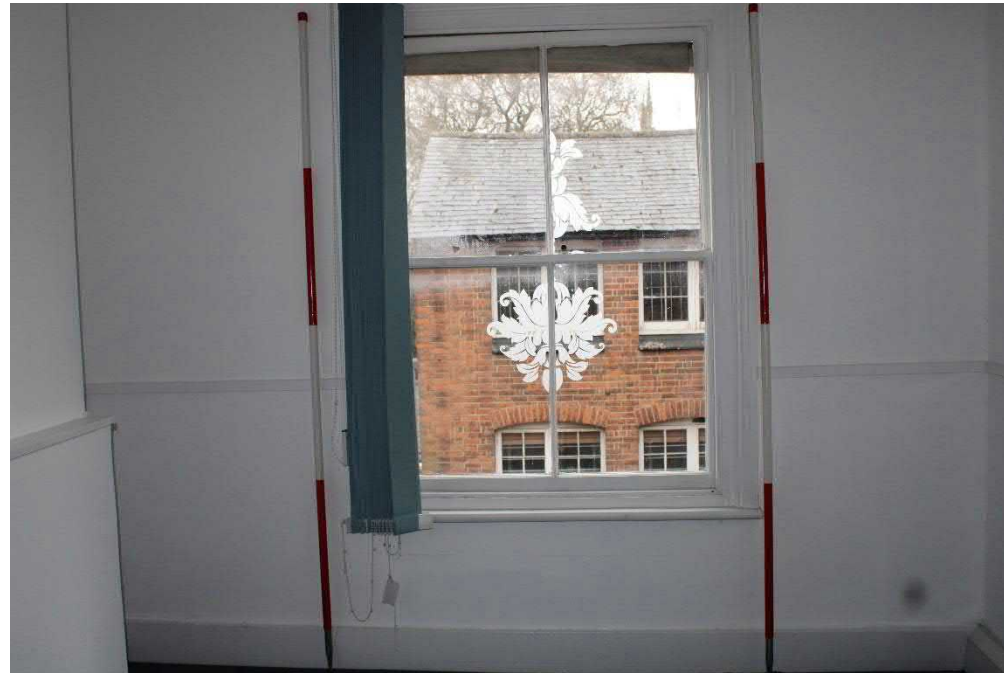
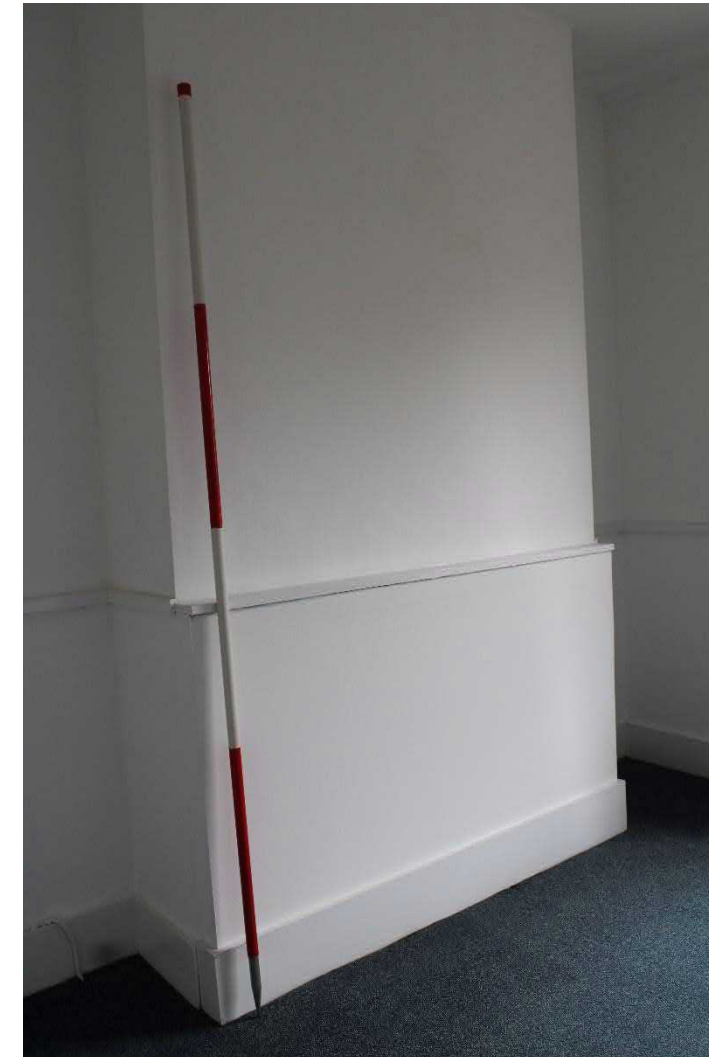
*Photo 44: View south across southeastern room of No 87 Broad Street towards three storey rear building behind*

*Photo 45: View north across southeastern room of No 87 Broad Street towards corridor and doorway into northern room overlooking Broad Street*

*Photo 46: View southeast of chimney breast of southeastern room of No 47 Broad Street*

- 4.30** The southeastern room was accessed via the corridor to the east from the landing. It was again quite a small room with window to the south and chimney breast to the east, with no fireplace surviving (Photos 44, 45 and 46).
- 4.31** The door to the room was panelled on the exterior but had been flat boarded over on the interior (Photo 45) again suggesting some form of fire proofing. The plain appearance of the door suggests it was a modern replacement.

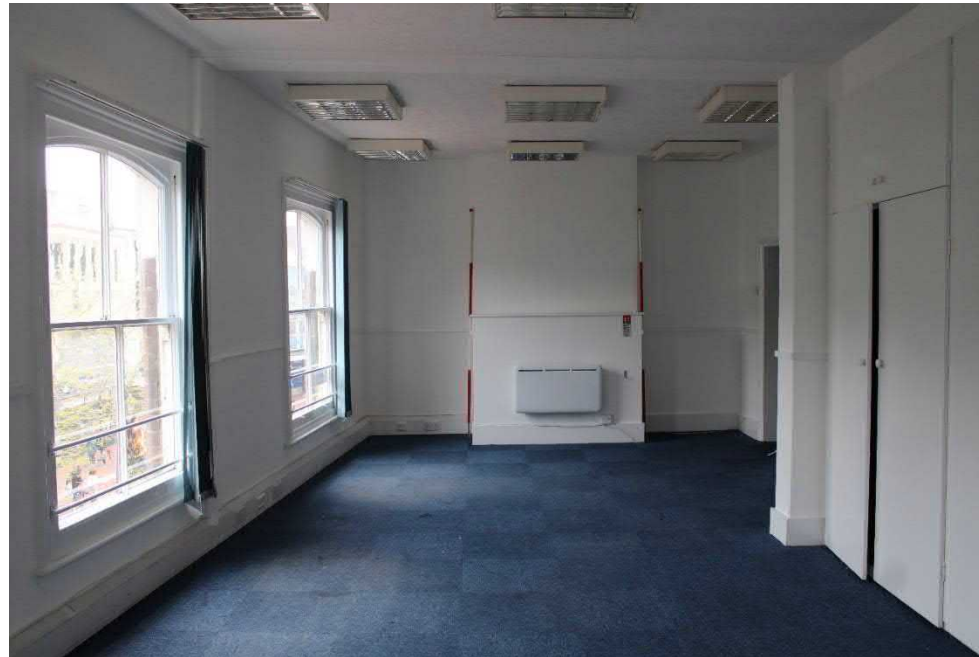
*Photo 49: View east along northern room of second storey of No 87 on the Broad Street frontage*

- 4.33** The northern room was again an open area across the full Broad Street frontage of the building with chimney breasts to east and west but with no fireplaces surviving (Photos 49 and 50).
- 4.34** The four swept head sash windows to the frontage were all of four lights, with stops on the sashes (Photos 51, 52, 53 and 54).
- 4.35** The room had evidently been formerly divided into at least two parts, with walls projecting from its southern wall which had been converted into a cupboard (Photo 55). A small cupboard was also present in the southeastern corner of the room (Photo 56).

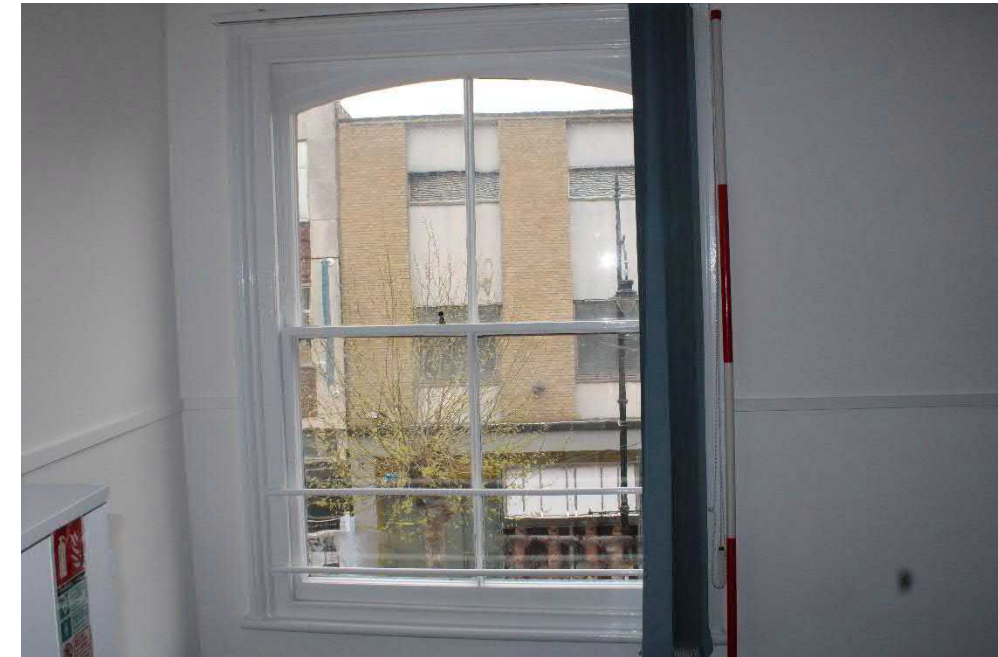
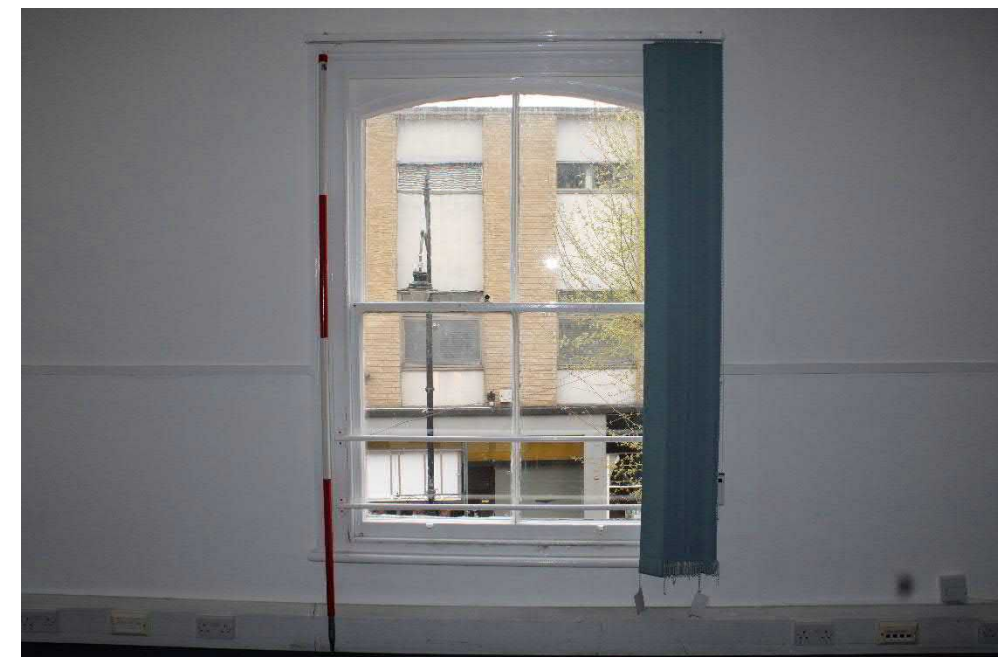
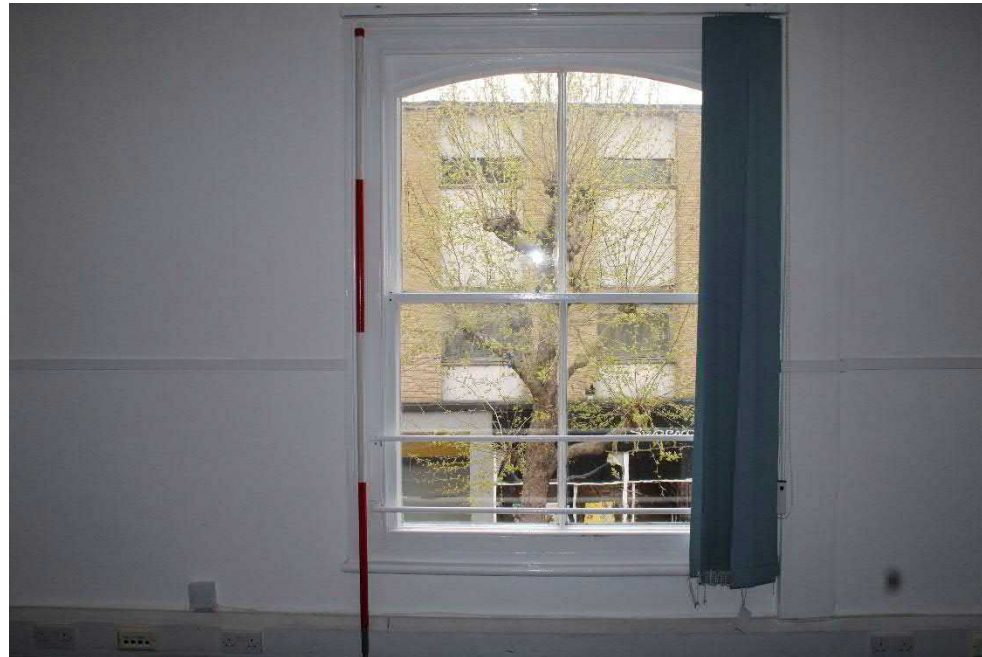
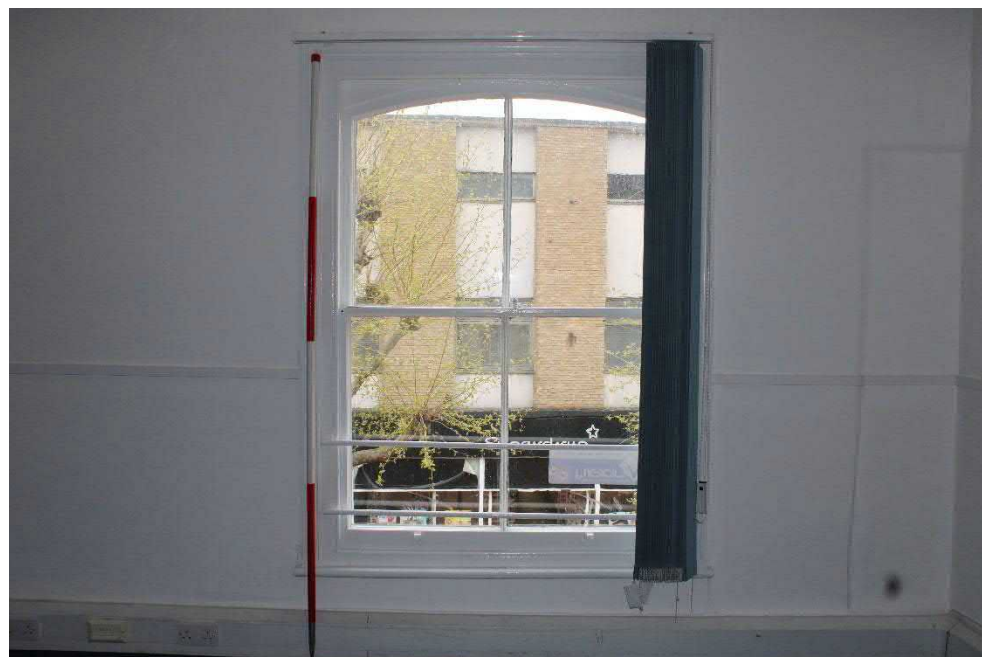
*Photo 51: View north of western window of second storey room overlooking Broad Street frontage*

*Photo 52: View north of west of centre window of second storey room overlooking Broad Street frontage*

*Photo 53: View north of east of centre window of second storey room overlooking Broad Street frontage*

*Photo 54: View north of east window of second storey room overlooking Broad Street frontage*

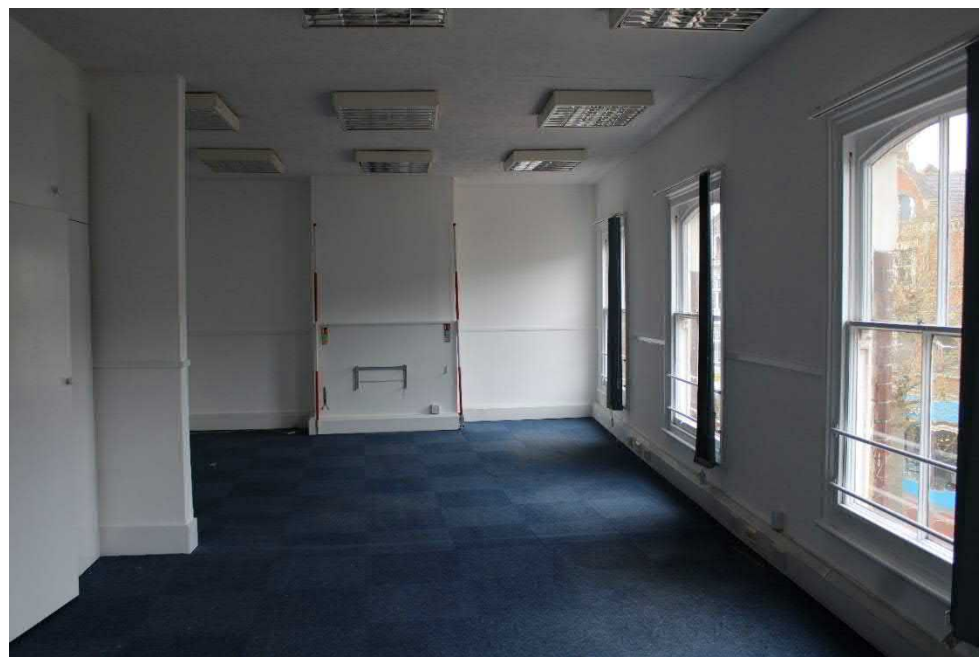
*Photo 50: View west along northern room of second storey of No 87 on the Broad Street frontage*

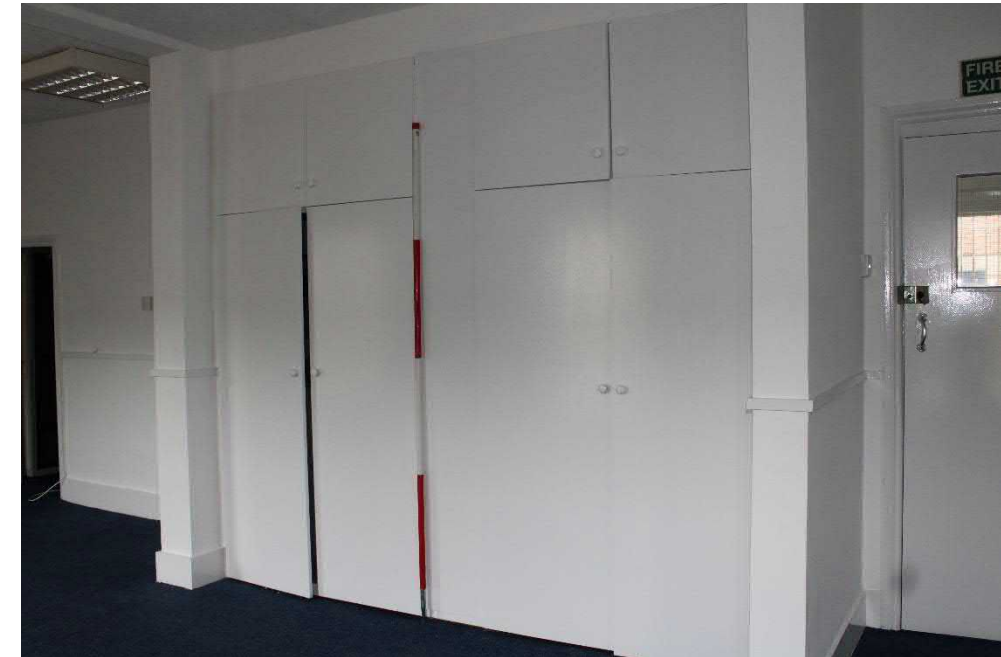
*Photo 55: View southeast across cupboard built between the former dividing walls of second storey room overlooking the Broad Street frontage*

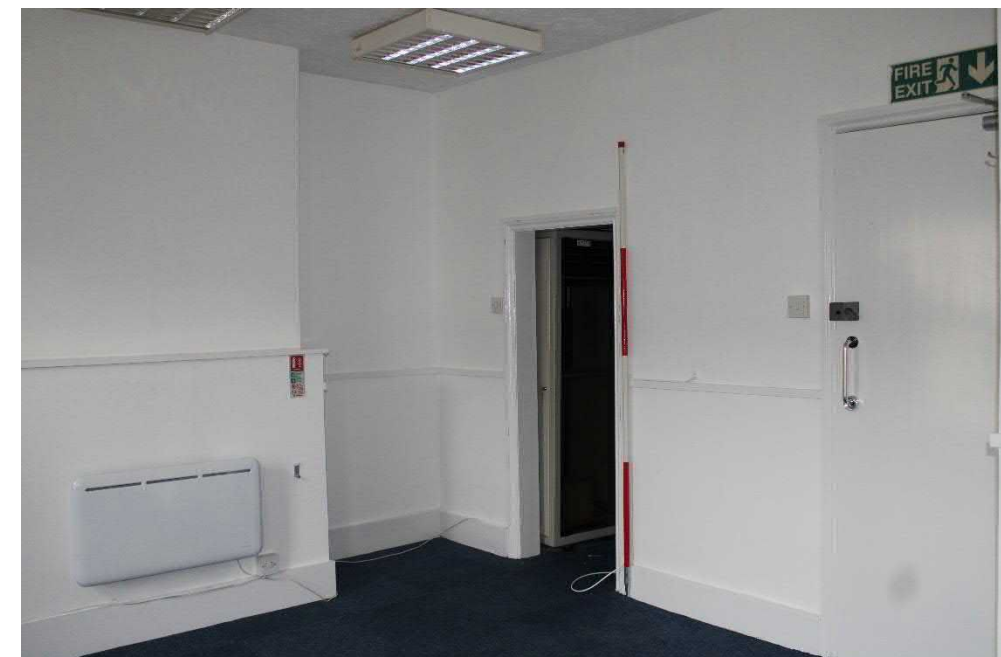
*Photo 56: View southeast across eastern end of second storey room overlooking the Broad Street frontage towards storage cupboard*

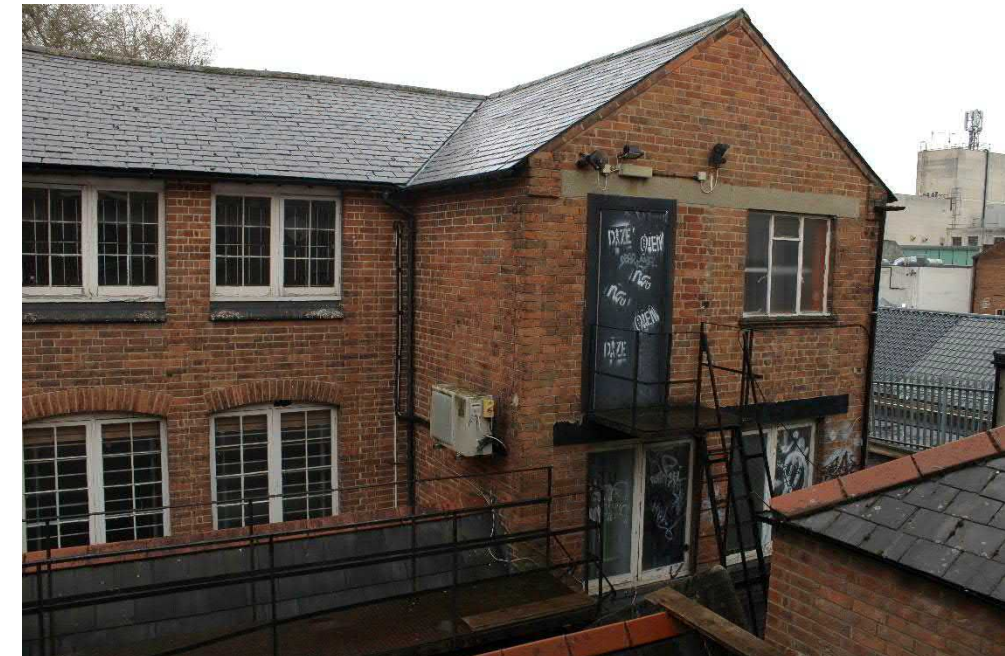
- 4.37** The eastern side of the elevation contained two symmetrically placed windows to both floors, with pairs of 8 light wooden framed casements to first floor and 6 light casements to second (Photo 57 and 58). The brick work on this frontage was neatly bonded with a mix of styles to fit with the window layout, using symmetrical mixes of headers, stretchers and closers. The bonding may have also originally been neat on the north facing gable end but modern alterations had disturbed any such patterning.

*Photo 57: View southwest from second storey rear window of southeastern room of No 87 Broad Street (not shown on a plan)*

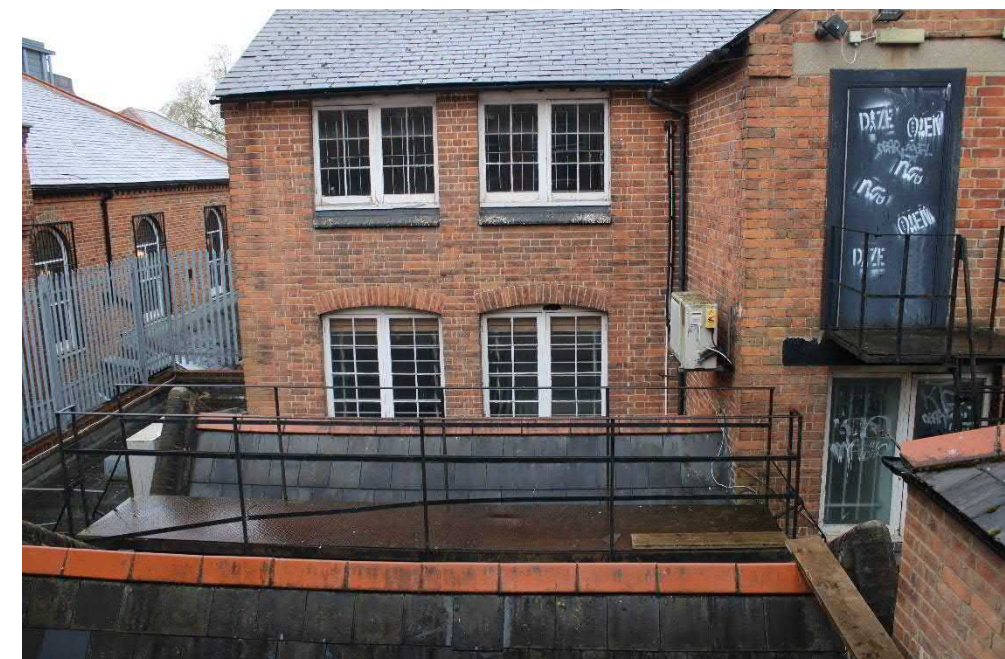
*Photo 58: View south from second storey rear window of southeastern room of No 87 Broad Street (not shown on a plan)*

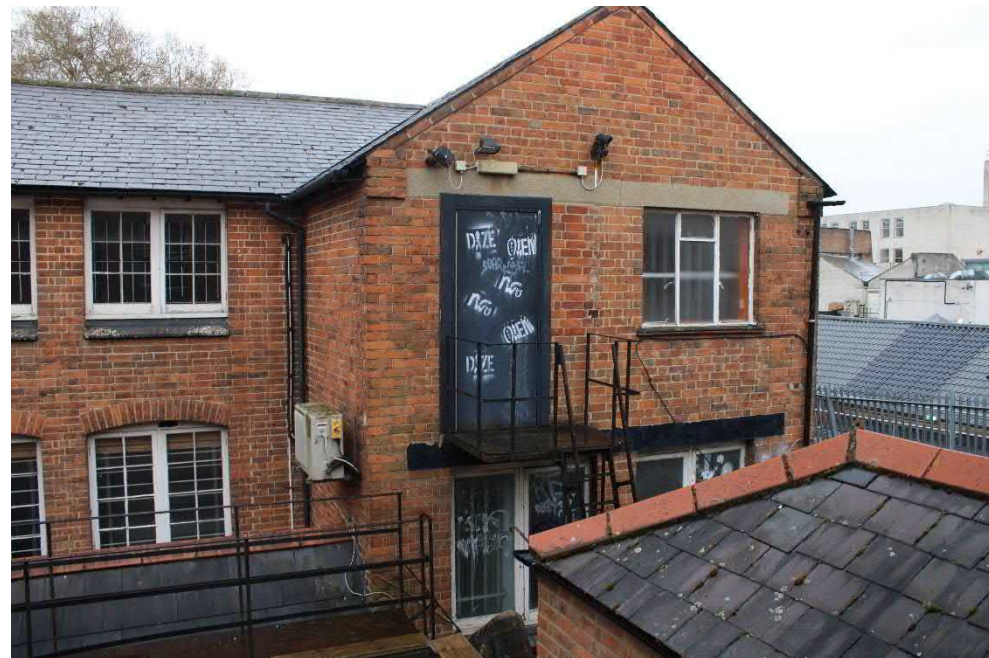
*Photo 59: View south from second storey rear window of room west of stairs of No 87 Broad Street (not shown on a plan)*

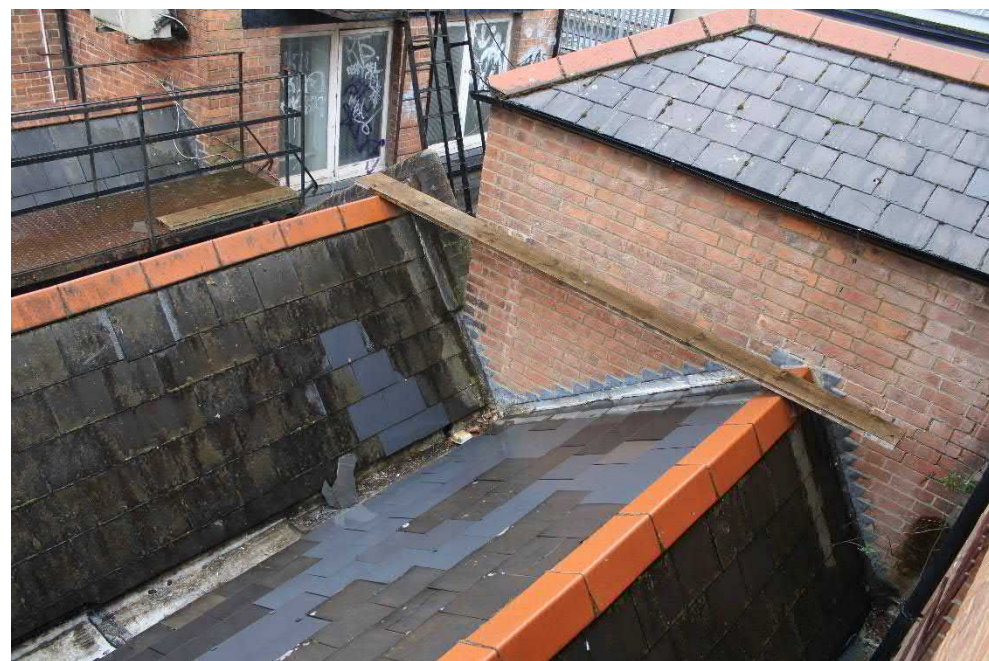
- 4.38** The roof of the three storey building was of slate with grey ceramic ridge tiles.
- 4.39** The first floor of No 87 projecting to the building was covered with a saw tooth roof with two apexes (Photo 60) lying partially adjacent to the toilet extension projecting from the southern façade of No 87 (Photo 60). Both of these structures had grey slate roofs with red ceramic ridge tiles.

*Photo 60: View south from second storey rear window of southeastern room of No 87 Broad Street showing part of saw tooth roof and projecting toilet extension (not shown on a plan)*

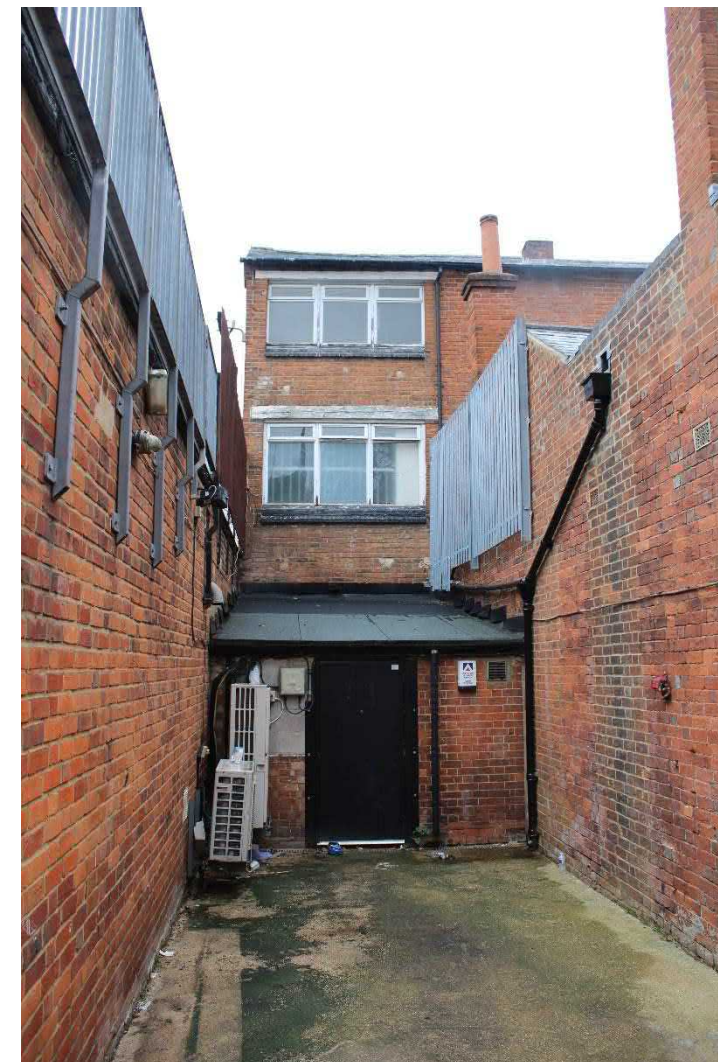
- 4.40** The southern elevation of the building was mostly obscured by the chapel school room and no windows were present in that part of the elevation. On the visible part, seem from the yard area rear of the building accessed from the church, there were large single windows to the two upper floors (Photo 61). These were later insertions with wooden frames and three large panes in each with small top opening lights. Continuous concrete sills lay above these windows. The ground floor was covered by a short modern extension leading to the rear door of No 87.

*Photo 61: View north of rear part of three storey building to rear (not shown on a plan)*

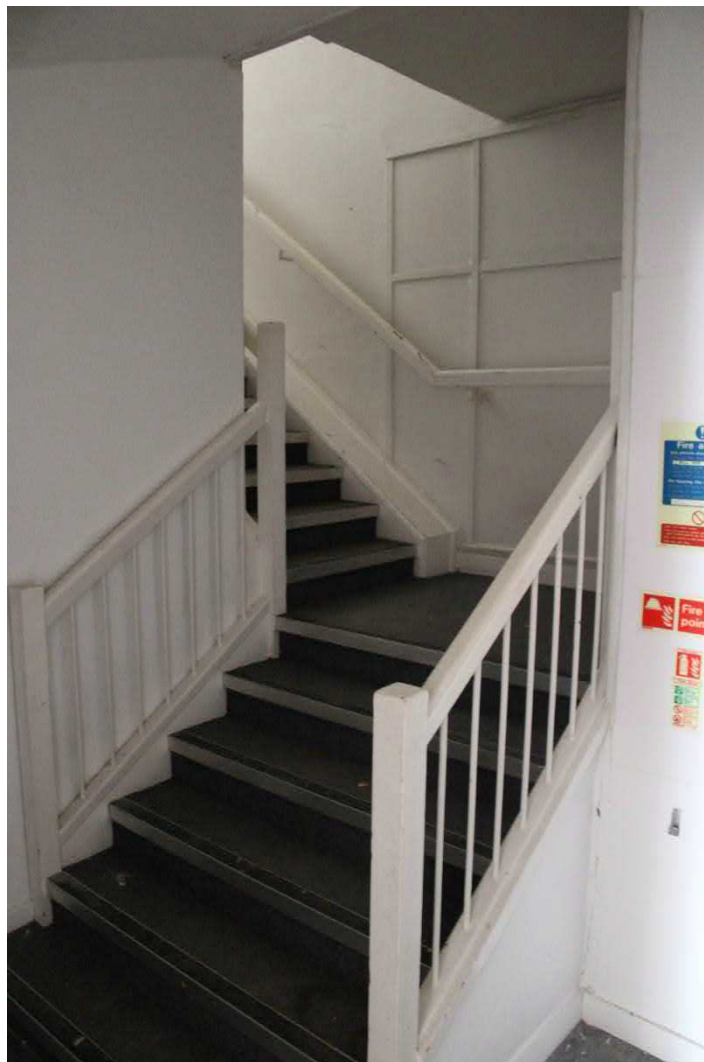
**4.41** The ground floor of the three storey building comprised part of the frontage retail areas of No 87 and are mentioned above. A door led from the shop front into a rear lobby with dog leg stairs leading to the first floor (Photo 62). To the east of the stair was a windowless open area (Photos 63 and 64) leading to a storage cupboard under the stairs (Photo 65). A small hatch was present in the floor leading to a small cellar area. This was viewed into but not accessed.

*Photo 62: View of stairs on ground floor of three storey rear extension looking southeast*

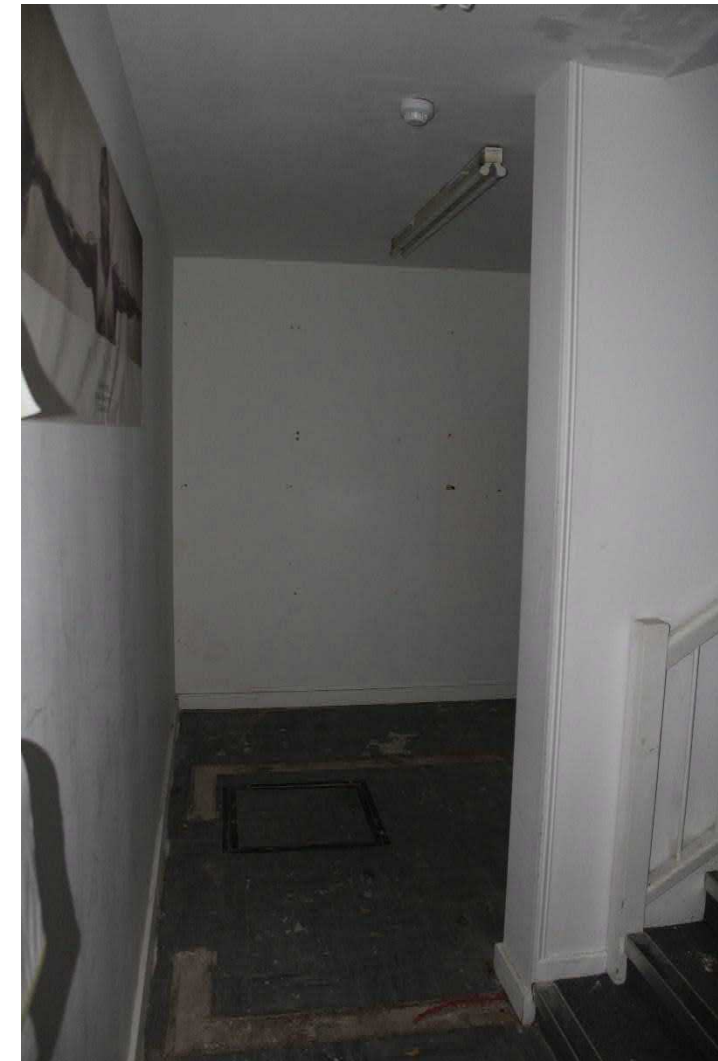
*Photo 63: View east across foot of stairs showing trap door to small cellar area (not accessed)*

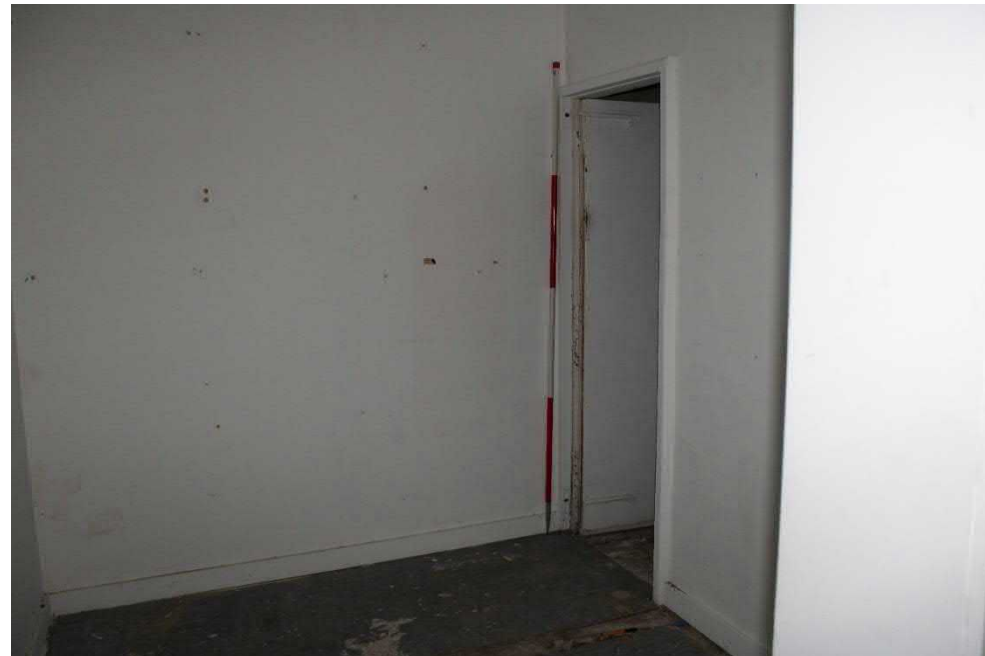
*Photo 64: View southeast of entrance to cupboard below stairs*

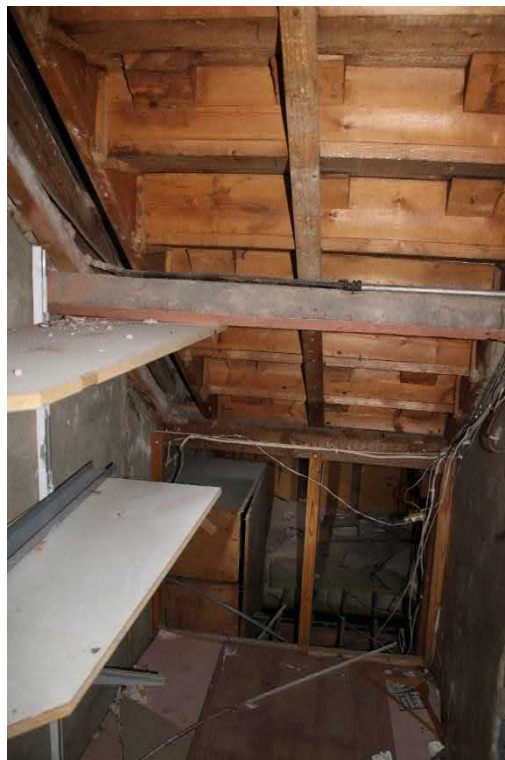
*Photo 65: View west of cupboard under stairs*

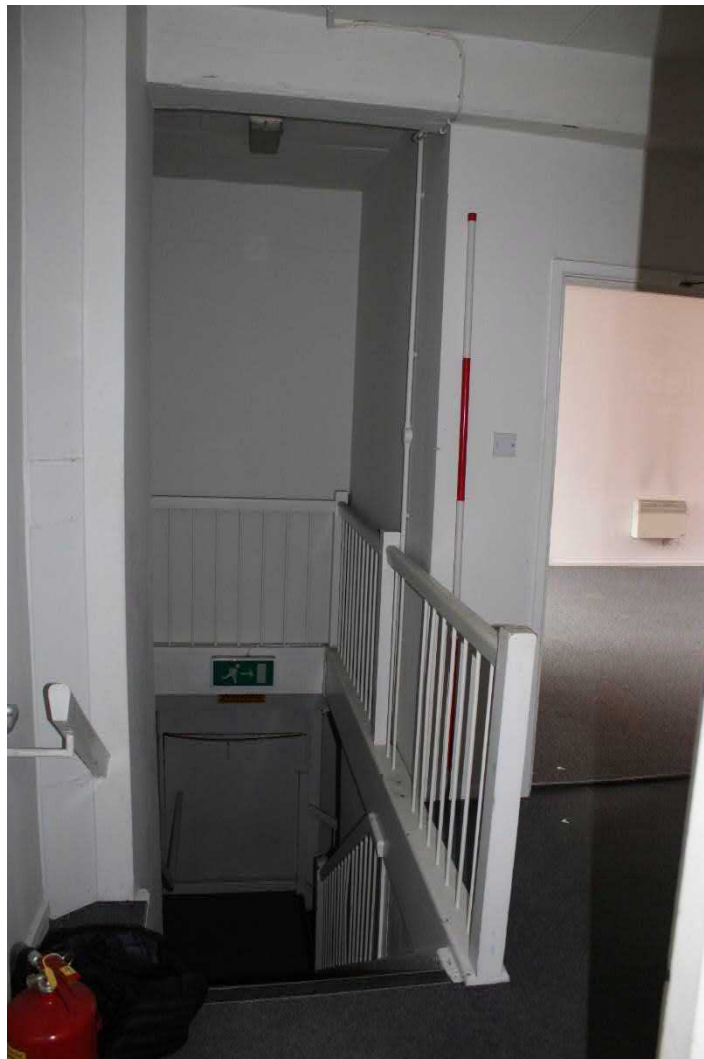
- 4.43** The stairs led to a small landing on the southern side of the building (Photo 67) with doors leading to rooms to the east and west (Photos 67 and 68).
- 4.44** The eastern room had the two eight light casement windows on the northern elevation (Photo 69). The room was L-shaped with shelves to the west (Photo 70) and featureless walls to the south (Photo 71).

*Photo 67: View west across top of stairs at first floor level across landing*
