## Historic Building Record Level 2

86 – 87 Broad Street,  
Reading, RG1 2AP

Sept 2021 | Project Ref 06362B

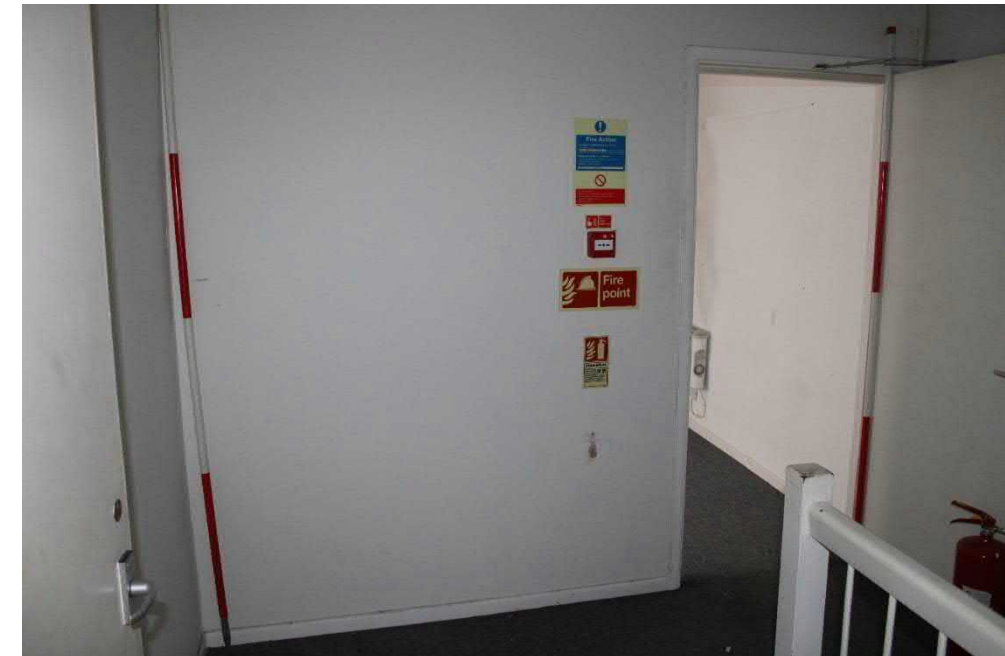
*Photo 68: View east across first floor landing*

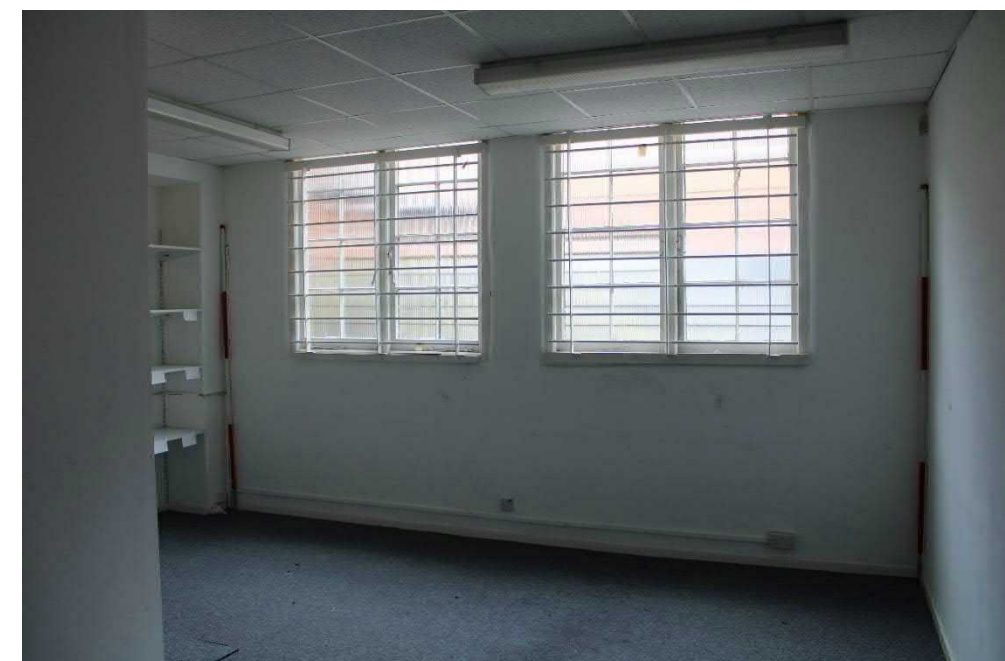
- 4.43** The stairs led to a small landing on the southern side of the building (Photo 67) with doors leading to rooms to the east and west (Photos 67 and 68).
- 4.44** The eastern room had the two eight light casement windows on the northern elevation (Photo 69). The room was L-shaped with shelves to the west (Photo 70) and featureless walls to the south (Photo 71).

*Photo 69: View north across eastern room at first floor level*

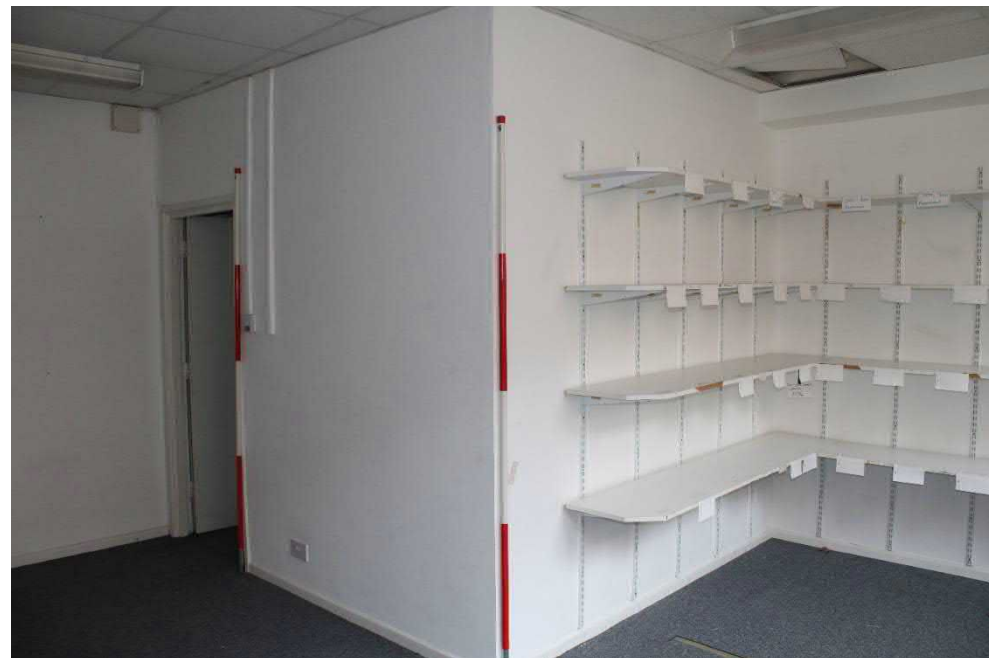
*Photo 70: View southwest across eastern room at first floor level with doorway leading to landing level*

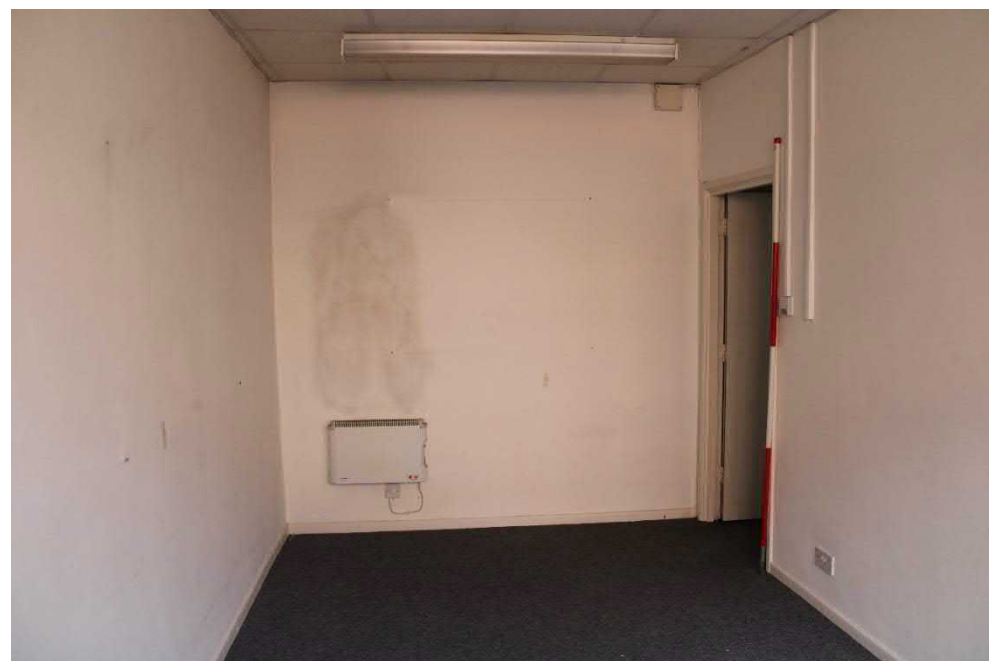
*Photo 71: View south across eastern room at first floor level with doorway leading to landing area*

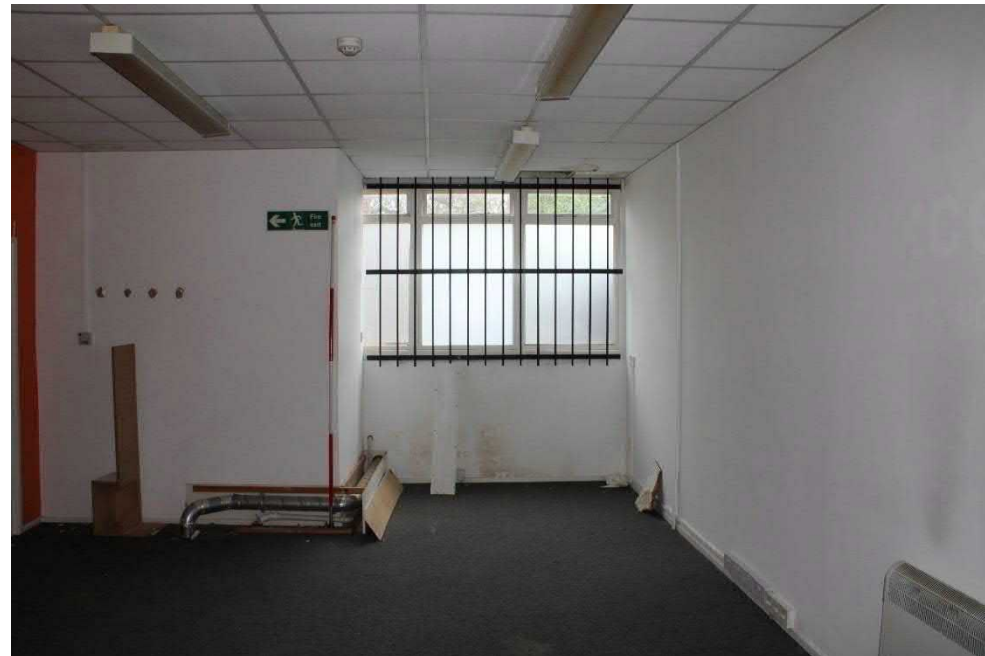
**4.45** The western room was larger running the length of the building with windows to the northern and southern elevations (Photo 72 and 73). The northern windows were the single light modern casements visible on the northern projection gable end although the eastern window was half covered by an inserted wall (Photo 72), and the southern windows were those visible from the yard area (Photo 73). The stairwell from the ground floor projected into the southeastern corner of the room (Photo 74).

*Photo 73: View south across western room of first floor level*

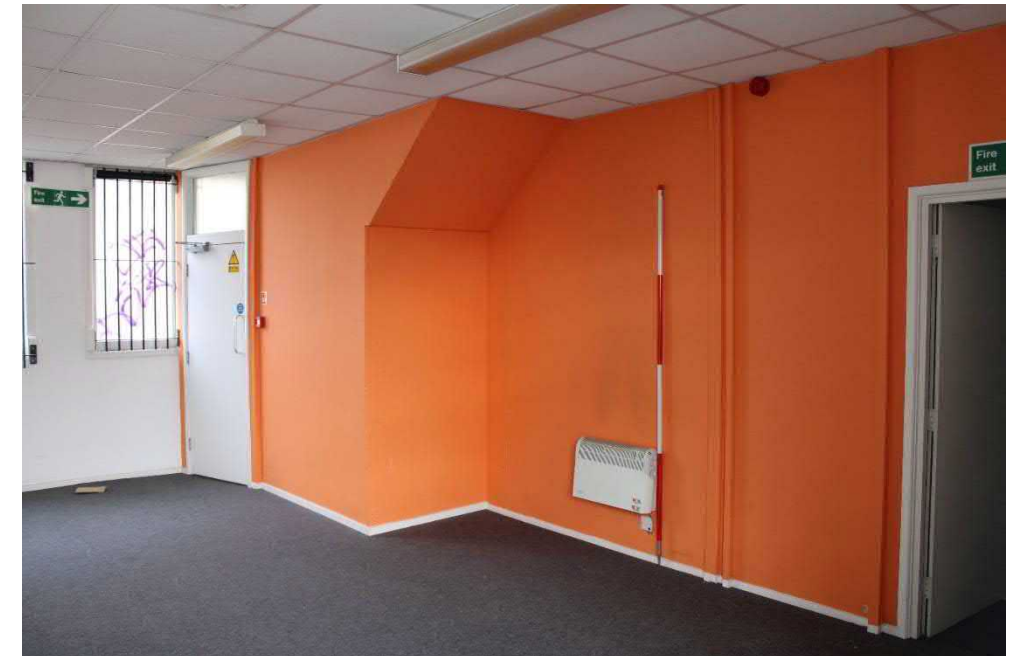
*Photo 75: View northeast across western room at first floor level showing door to stairwell to second floor*

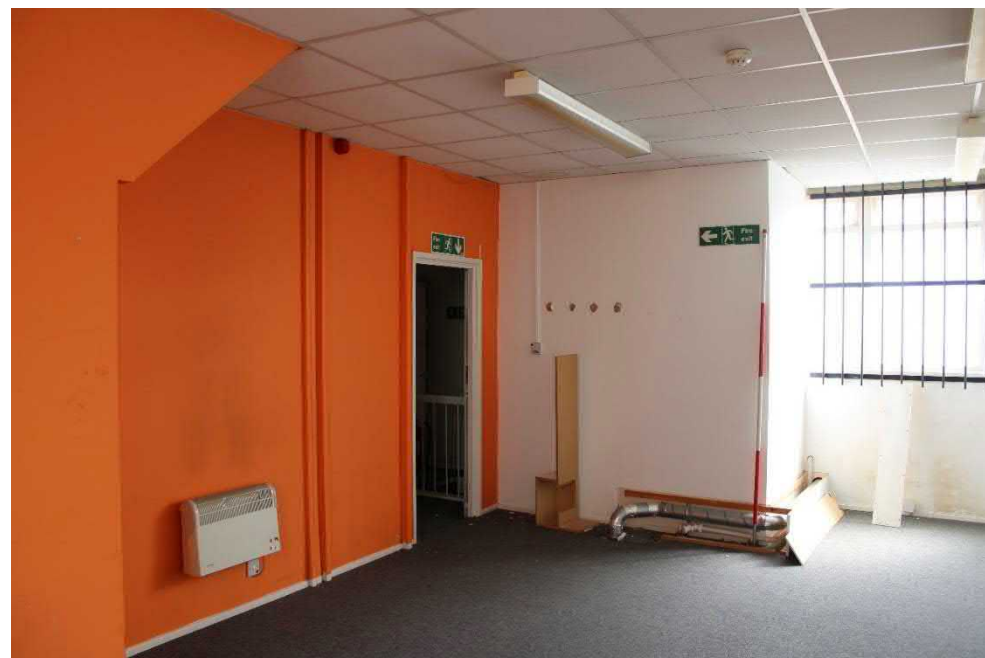
**4.46** On its eastern wall was a doorway leading to a stairwell accessing the second floor (Photos 72 and 74).

*Photo 74: View southeast across western room at first floor level to landing area*

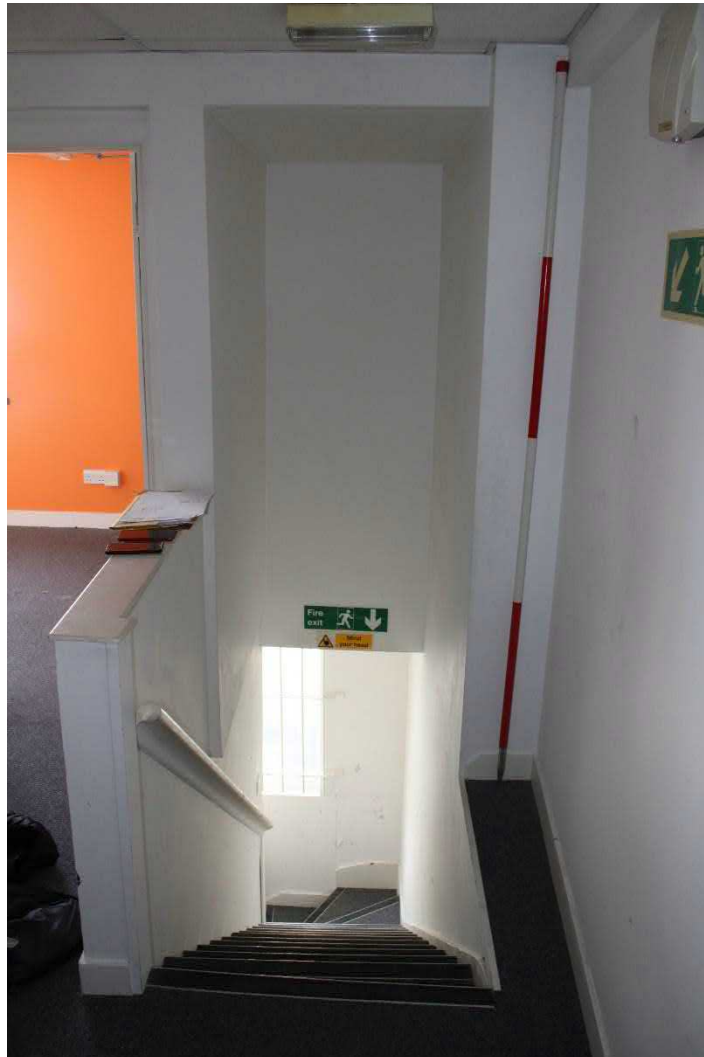
- 4.48** The stairwell led up to the second floor with a light to the north formed by half of the eastern window on the northern projection gable end (Photo 76). This led to a small landing area with doors to four rooms.

Photo 76: View north from second floor landing down the stairwell to first floor level

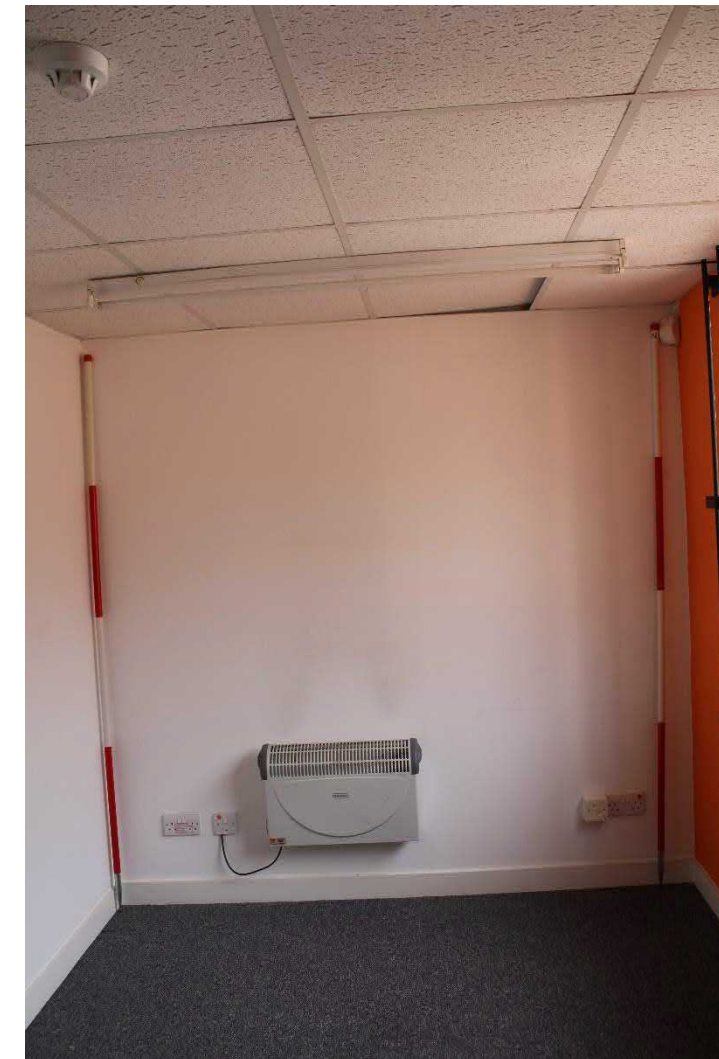
- 4.49** The northwestern room was a small area with the metal framed casement window to the northern elevation and fire escape doorway to the east of that (Photos 77, 78 and 79). A doorway was located to the south opposite the doorway into this room (Photo 80). This accessed a windowless space on the western side of the building, with shelves on the western wall (Photos 82 and 83).

Photo 77: View west of northwestern room at second floor level

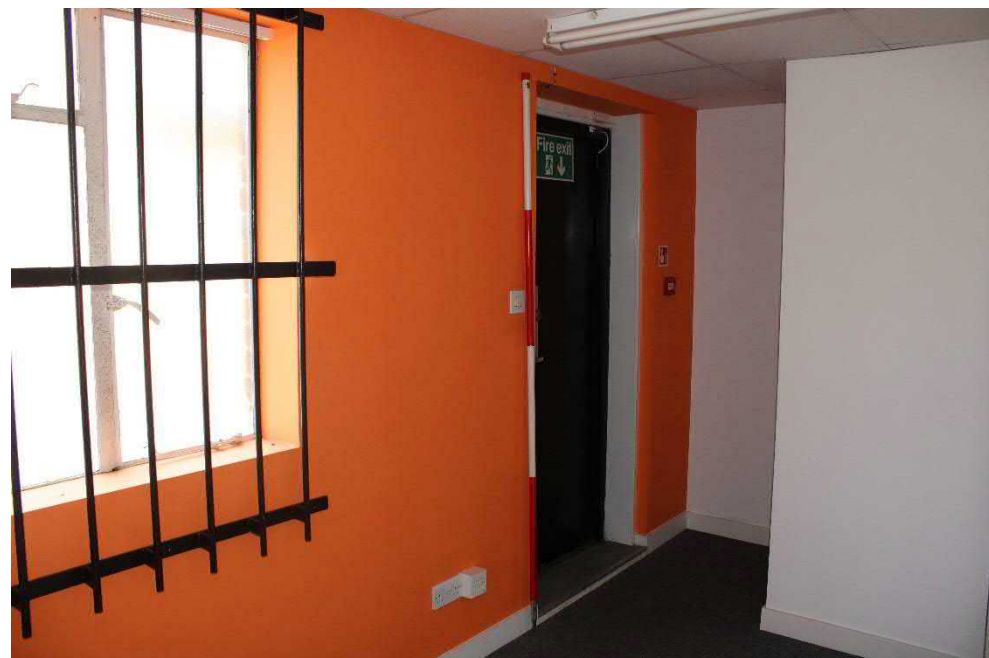
*Photo 79: View northeast across northwestern room at second floor level to fire-escape doorway*

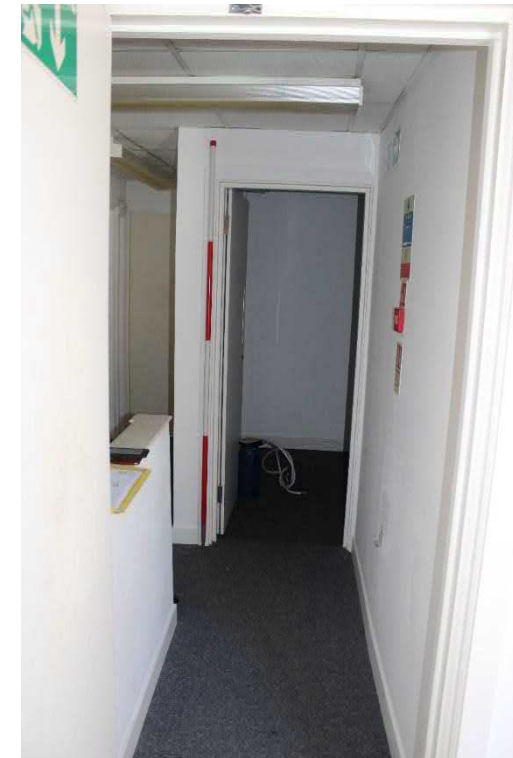
*Photo 80: View south from northwestern room towards western office area of second floor with stairs to left*

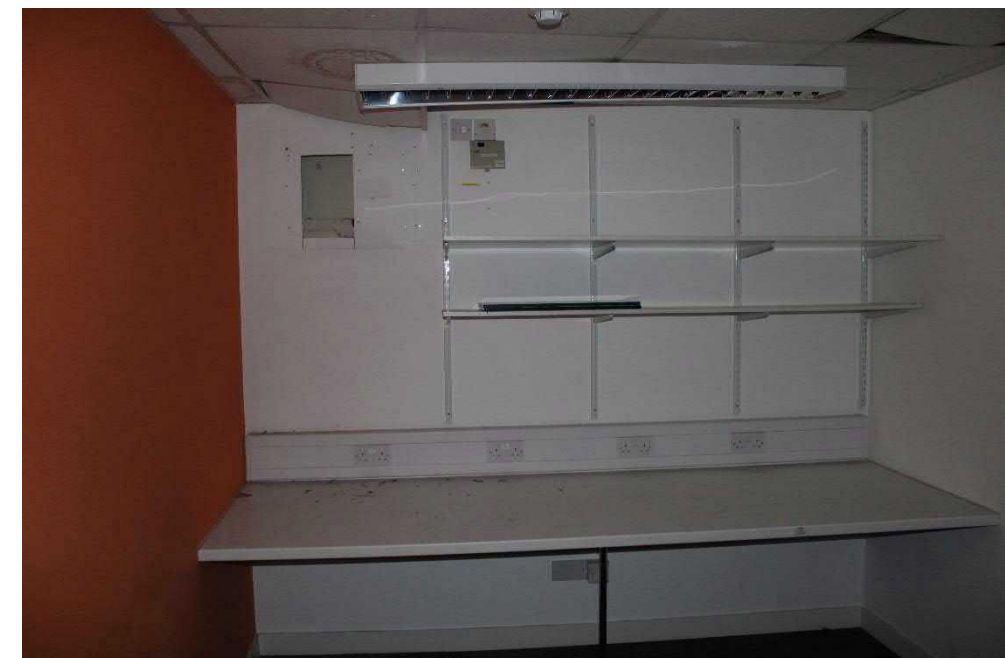
*Photo 81: View north across western office at second floor level*

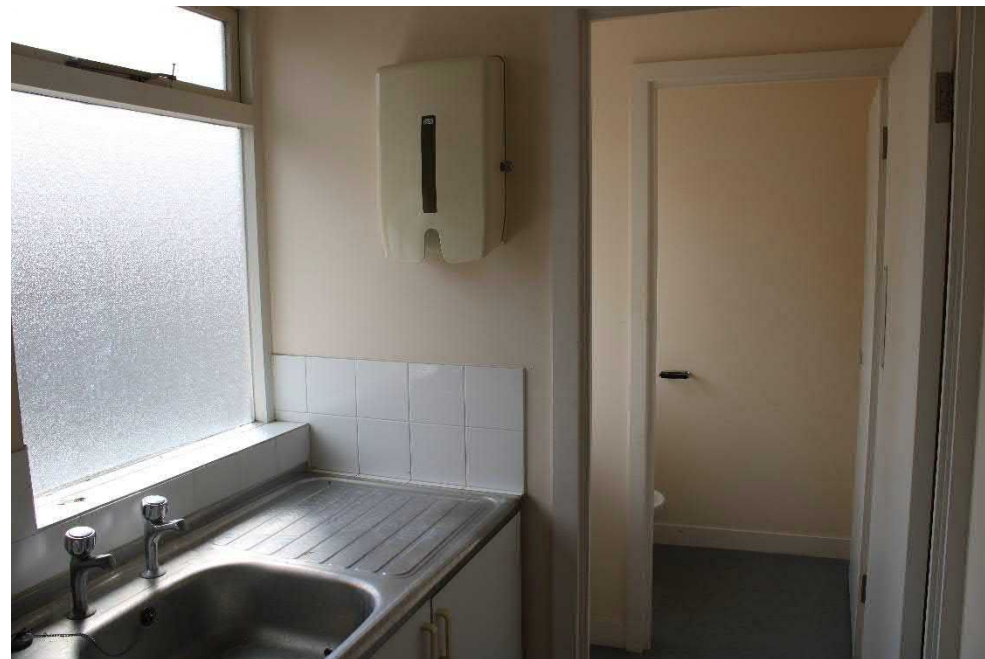
- 4.50** At the southern end of the second floor landing was a small kitchen and bathroom area (Photo 83).

*Photo 83: View west along kitchen and bathroom areas in southwestern part of second floor*

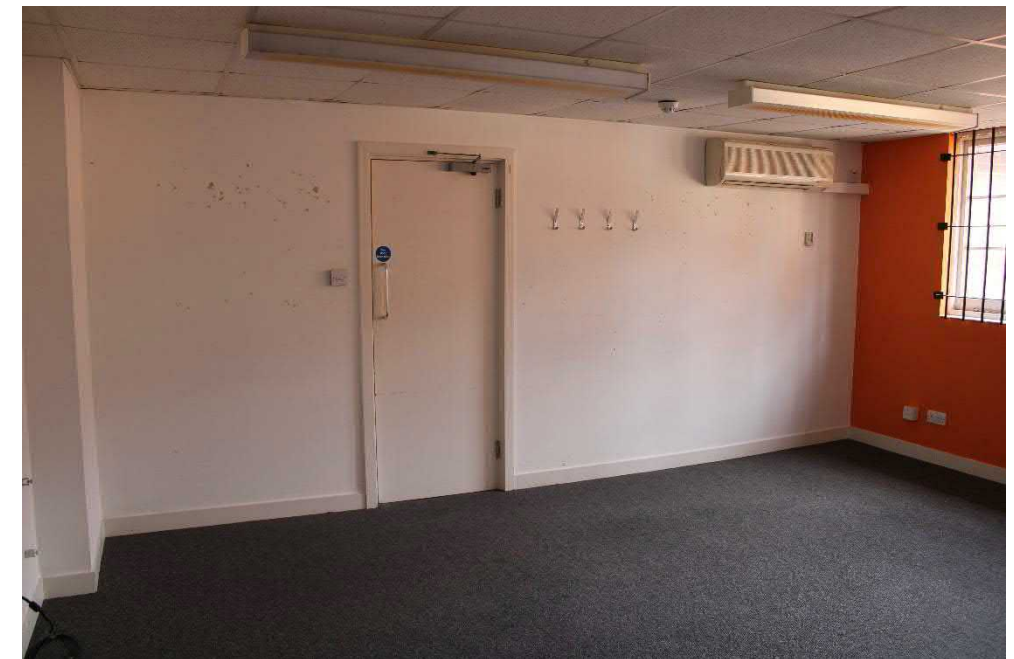
- 4.51** A further room was present to the east containing the two large windows on the northern elevation of the building (Photo 84). The room was otherwise featureless (Photo 85). As with the first floor, there was no evidence for any fireplaces.

*Photo 85: View west through eastern office at second floor level*
