## **2-4 NORTHUMBERLAND AVENUE, READING**

In accordance with your instructions, AA Environmental Limited (AAe) carried out an ecological survey of the above site on Thursday 5 August 2021. The purpose of the survey was to determine the existence and location of any ecologically valuable areas and to record any evidence of protected species, in particular bats. This information will serve to assess the ecological impact of the proposals and identify any ecological constraints and/or mitigation measures that may be required. A series of photographs has been attached for reference.

| Rev. | Details | Drawn<br>Chkd. | Date |
|---|---|---|---|
| Photograph Record Sheet | | | |

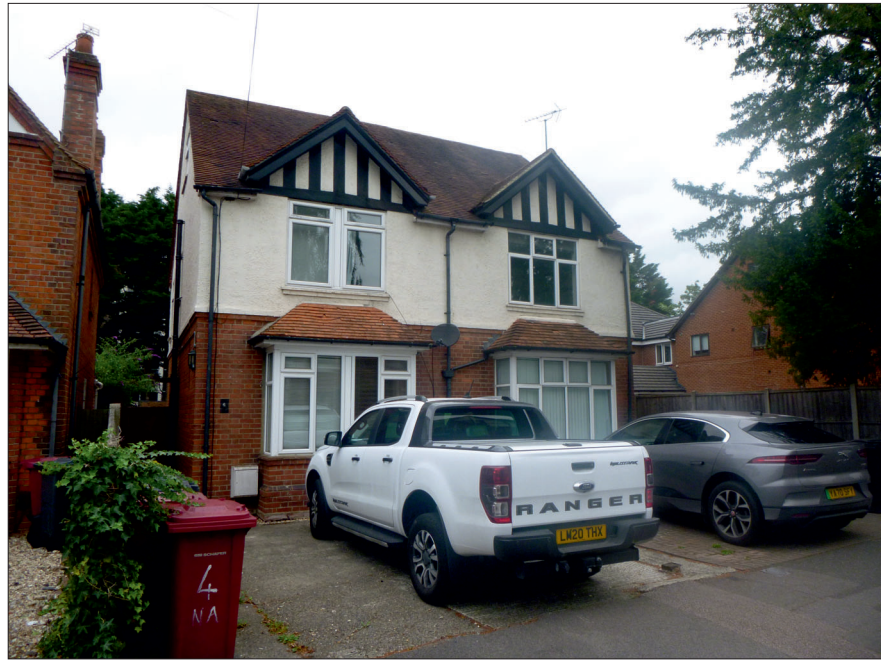
The site is located off Northumberland Avenue in Reading, centred at National Grid Reference: SU 721719 and covers approximately 0.1 of a hectare. The site comprised the existing properties (Nos. 2 and 4), with associated hardstanding and some boundary vegetation. It is bordered by Northumberland Avenue to the east, offices to the west and residential properties and associated gardens to the north and south.

Photograph 1: Showing the front of the properties.

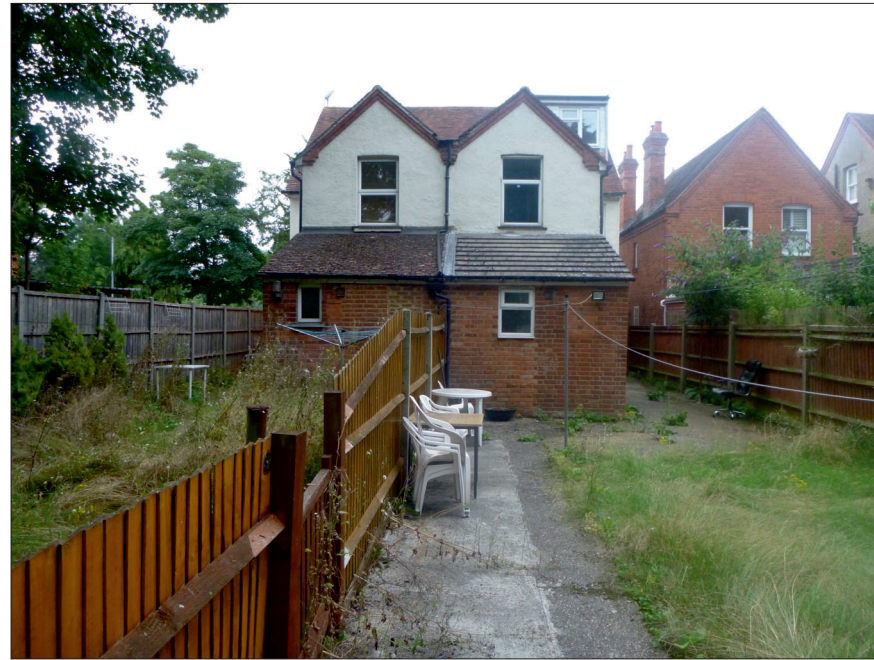
The two semi-detached properties were of masonry construction with a pitched roof of engineered tiles. The upper stories were rendered and painted and the front gables had a mock-tudor timber effect. The timbers, barge boards and soffits/fascias were generally well-maintained and tightly sealed. There were single-storey extensions at the rear with single pitched tiled roofs. There was a single dormer window at the rear of No. 4 with timber cladding and a small section of tile hanging (engineered tiles). Internally, the majority of the roof

Photograph 2: Showing the rear of the properties.

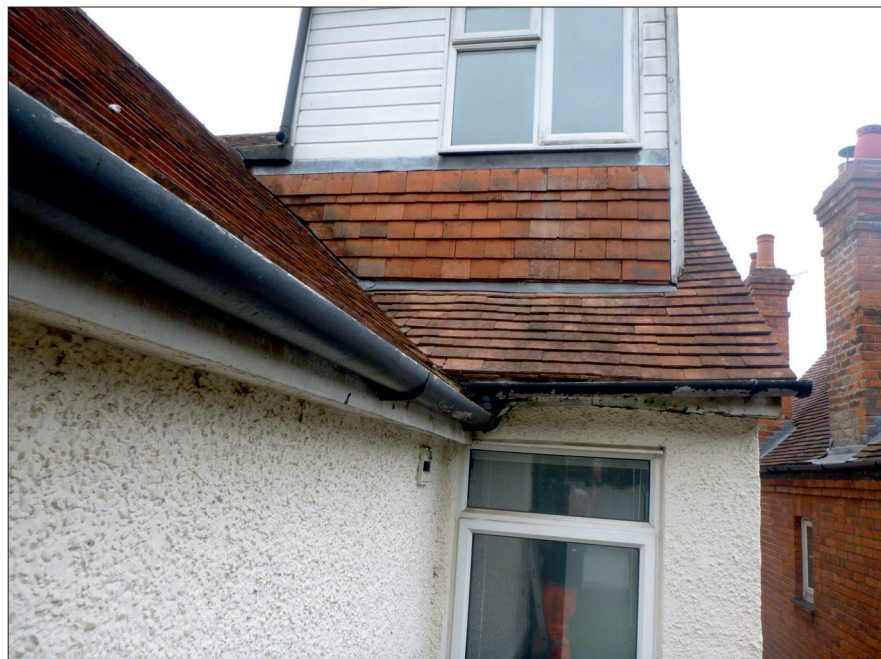
No evidence of bats was recorded during a careful internal and external inspection of each property. The properties were in overall good condition and the roof tiles generally well-aligned and tightly-sealed, with no obvious access points recorded. The areas of engineered tile hanging were carefully inspected, getting up close using ladders and were found to be generally well aligned and sealed. In addition, the timbers and soffits/fascias were generally tightly sealed, with any restricted gaps present found to be covered with cobwebs and/or general debris. Internally, the majority of the roof space had been converted into accommodation leaving only restricted areas of roof and eave spaces. These were fully accessed and found to be unlined, with the tiles attached directly onto the wooden battens, insulated with mineral and dusty and cobwebbed throughout.

Photograph 3: Showing the restricted area of tile hanging on the bottom of the rear dormer.

- all site operatives will be given a toolbox talk on the possibility of encountering bats and the legal protection they and their roosts are afforded (copy of a toolbox talk has been attached for reference);
- initial works will be carried out with great care, with the areas of tile hanging removed by hand, lifting each tile clear with two hands rather than lifting the front and rolling the tile backwards which may crush any bats beneath; and
- tiles will also be checked underneath before being stacked or discarded as bats sometimes cling to the underside of tiles.

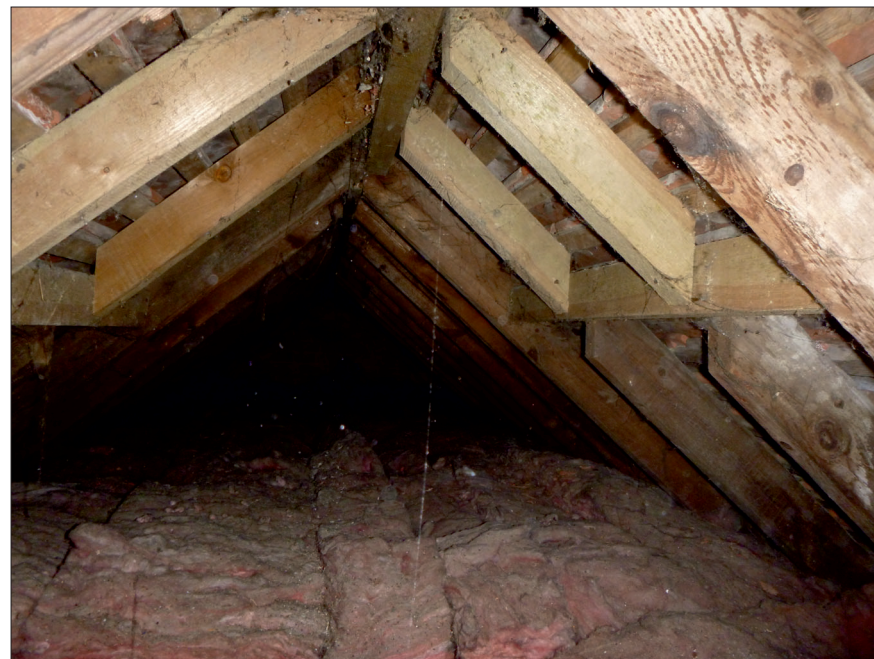
spaces had been converted into accommodation, with restricted roof and eaves spaces present, which were unlined and insulation with mineral wool.

Photograph 4: Showing one of the restricted attic spaces, which was unlined and heavily dusty and cobwebbed throughout.
