PROJECT 27- 33 Christchurch Road  
Reading

TITLE Existing Window Schedule  
For Lower Ground Floor

| DRG NO<br>A-1600 | REV<br>A |

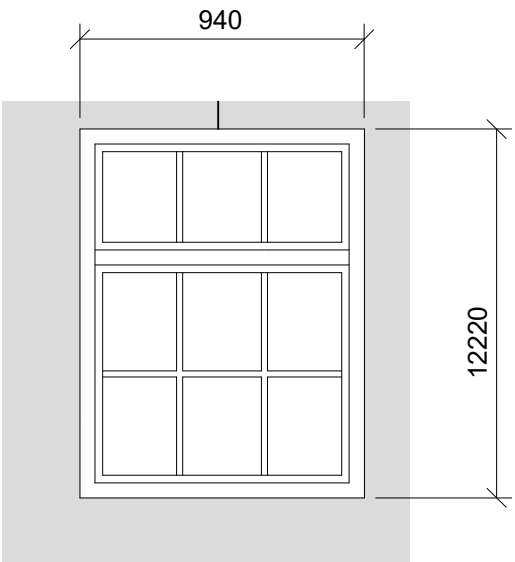
Window A Scale 1:25

Window A  
Floor: Lower Ground Floor  
Zone : Bedroom  
Material : PVC  
Condition : Good

Sill  
Material: Painted Concrete  
Condition: Satisfactory

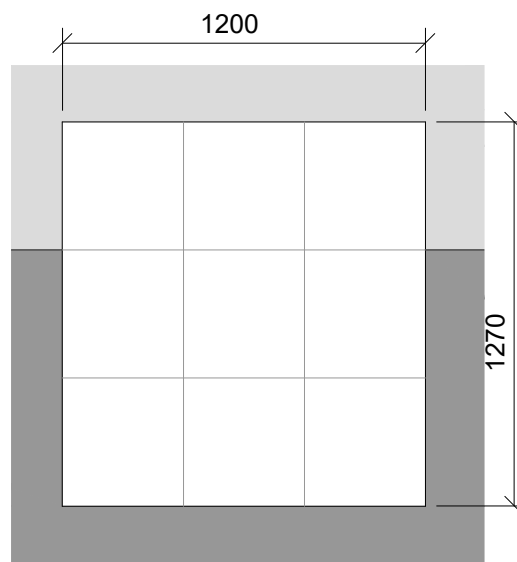
Window B Scale 1:25

Window B  
Floor: Lower Ground Floor  
Zone : Bedroom  
Material : Timber  
Condition : Poor  
Glazing : Require new Putty  
Frame: Rotten  
Pulley System: Broken

Sill  
Material: Painted Concrete  
Condition: Needs Painting

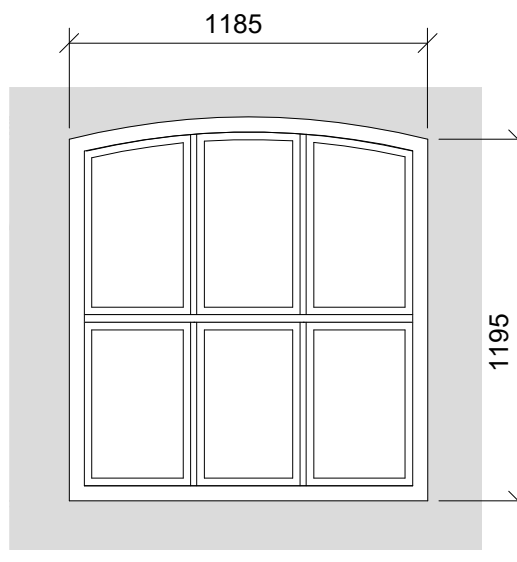
Window C Scale 1:25

Window C  
Floor: Lower Ground Floor  
Zone : Bedroom  
Material : Timber  
Condition : Poor  
Glazing : Require new Putty  
Frame: Rotten  
Pulley System: Broken

Sill  
Material: Painted Concrete  
Condition: Needs Painting

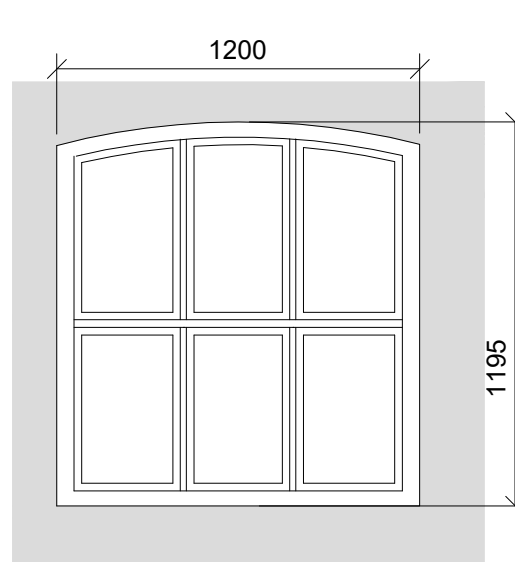
Window D Scale 1:25

Window D  
Floor: Lower Ground Floor  
Zone : Bedroom  
Material : Timber  
Condition : Poor  
Glazing : Require new Putty  
Frame: Rotten  
Pulley System: Broken

Sill  
Material: Painted Concrete  
Condition: Needs Painting
