# Ecological Appraisal of 205-213 Henley Road, Caversham, Reading

Client Mr L Anthony

Reference A1144.002

Date 29 October 2020

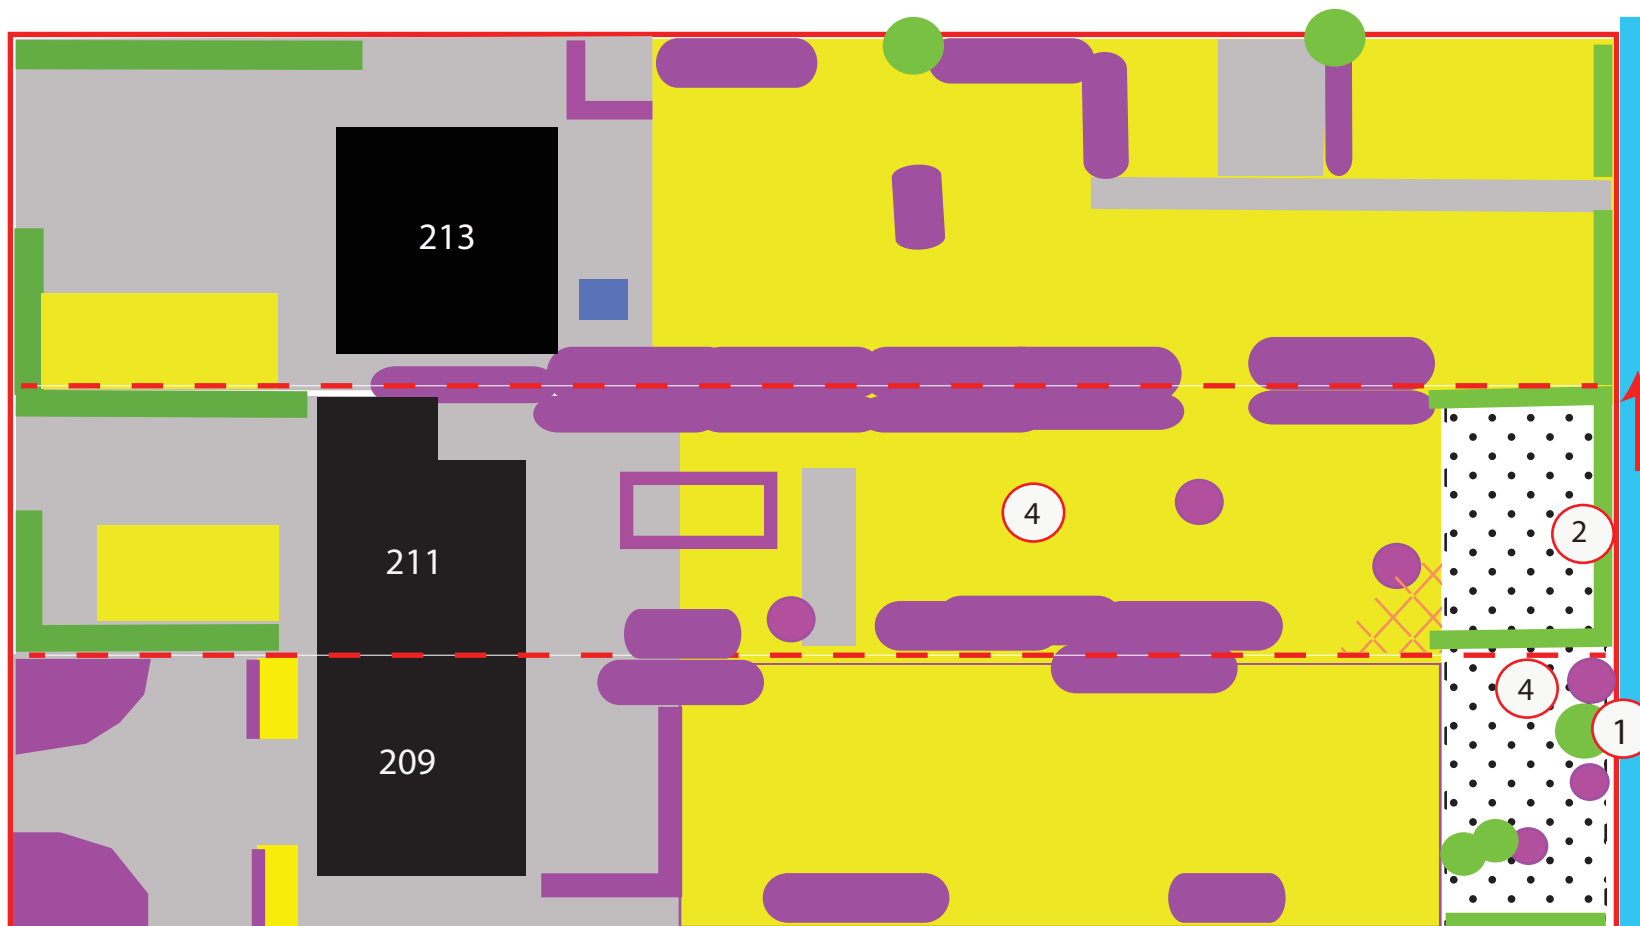
3.6. The habitats on site are described in the paragraphs below and are mapped on Figure 1, Appendix I. Photographic reference can be found within Appendix II.

Client Mr A Lloyd  
Title Habitat Map  
Site 209, 211 & 213 Henley Rd  
Figure 2  
Date 15 October 2020  
Scale Indicative

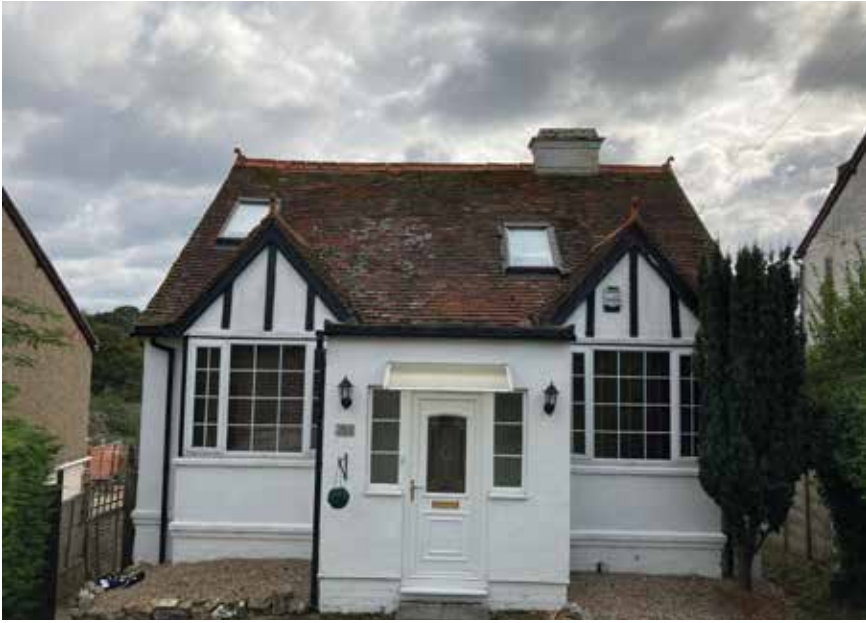
Photograph 1:

No 213; front northern elevation

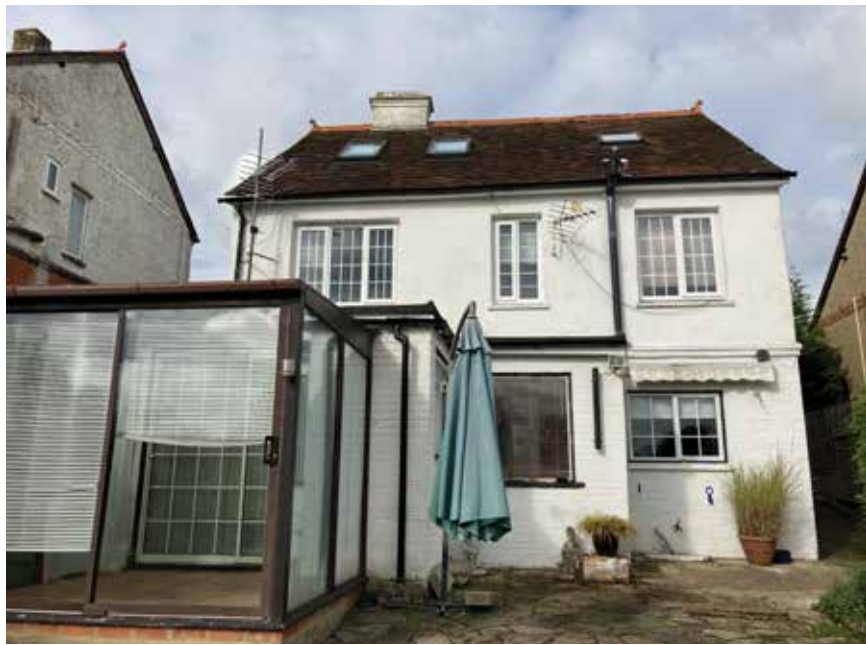
Photograph 2:

No 213; rear; southern elevation

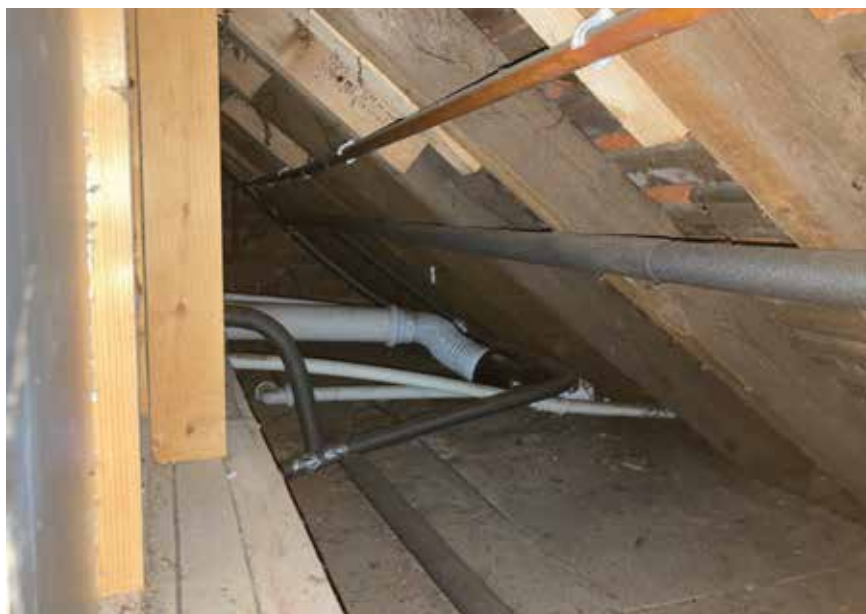
Photograph 3:

No 213: the dwelling has eaves crawl spaces.

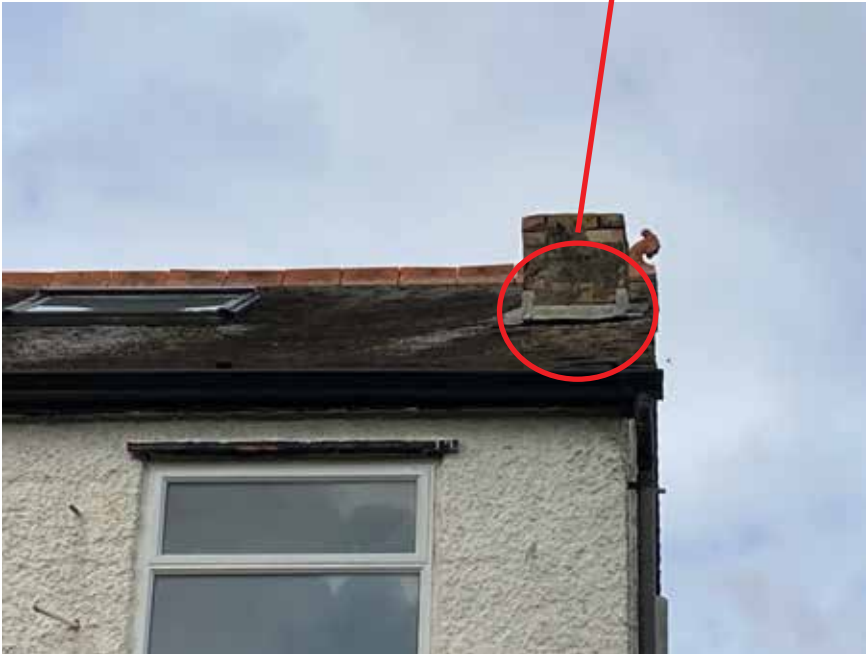
Photograph 11:

Loose lead flashing around chimney base

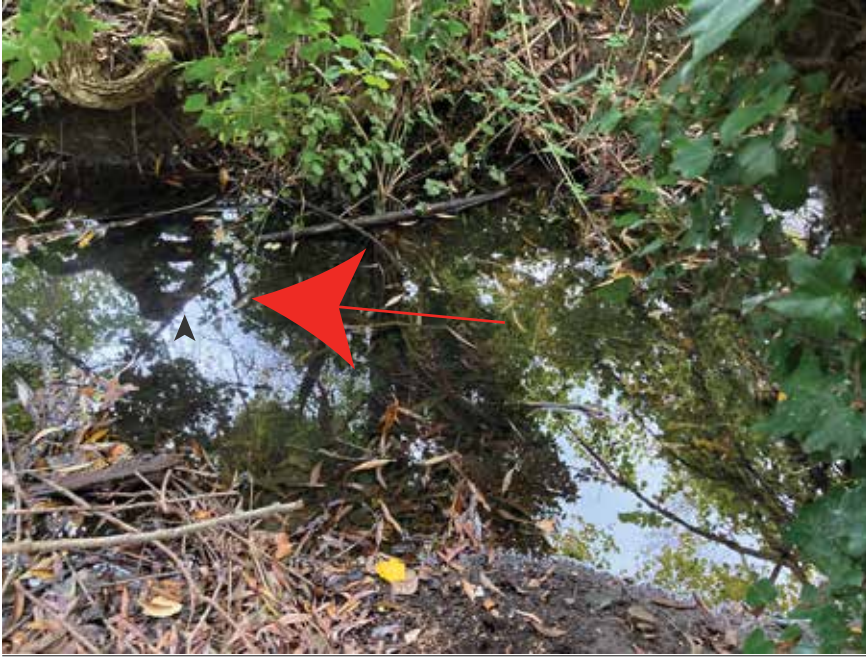
Photograph 22:

Detail; showing the stream that flows past the southern boundary of all 3 properties. The stream is approximately 2 m wide with 1.2 m high banks. A depth of approximately 150 mm was recorded and no aquatic vegetation was present.
