# **Preliminary Bat Roost Assessment & Nesting Bird Survey Report**

305 Peppard Road, Emmer Green,  
Reading, RG4 8TQ

| Reference | 2021-062 |

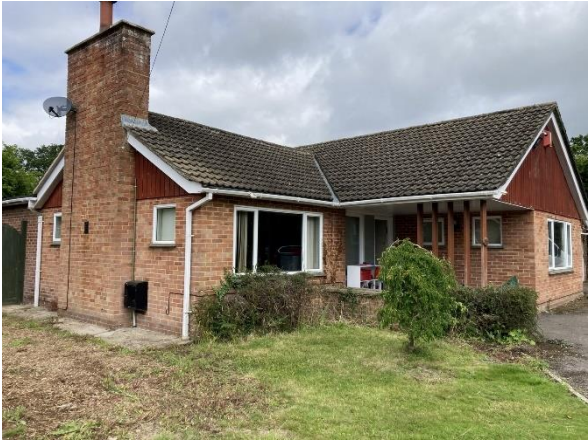
| General Photographs | |
|---|---|
| Eastern and southern elevations | Northern elevation |

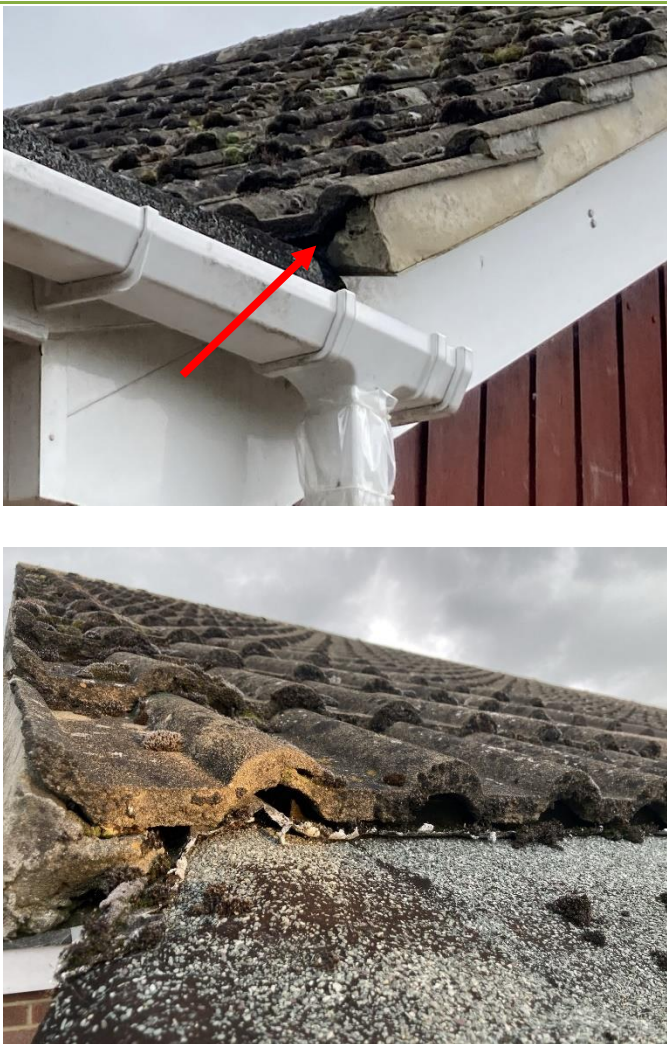
| Number | Description | Photograph |
|---|---|---|
| P1 | Examples of the gaps present at the end of roof tiles which could permit bats access to areas between tiles and bitumen felt. | |

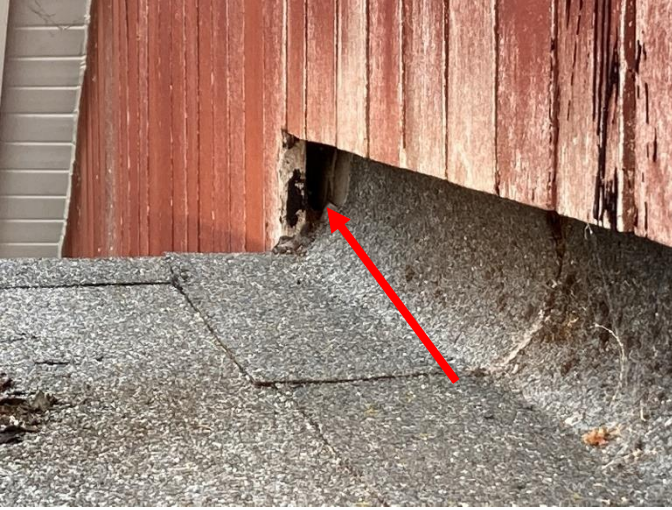
| Number | Description | Photograph |
|---|---|---|
| P3 | <p>Gap at the northern side of timber cladding on the western gable which extended back approximately 30 cm. The entrance to this feature was covered by dense cobweb, which indicated no recent use by bats, and the feature was fully inspected and no bats, or evidence of use by bats, were identified.</p> | |

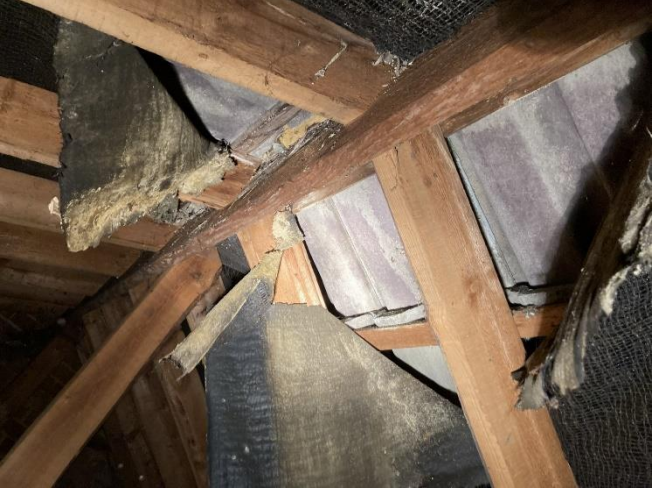
| Number | Description | Photograph |
|---|---|---|
| P5 | <p>Examples of the holes and gaps present in the bitumen felt, providing access to gaps between tiles and the felt.</p> | |

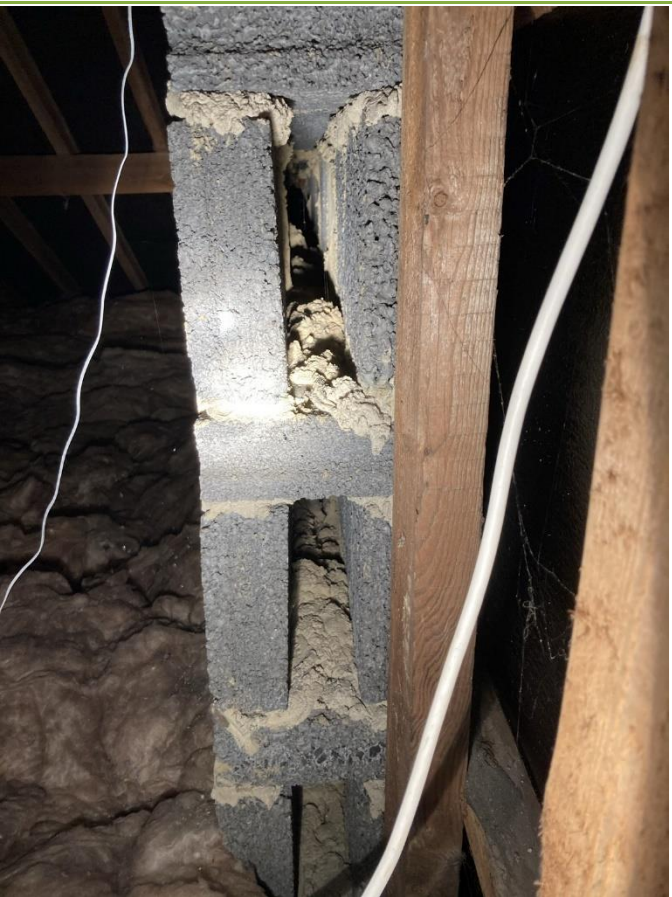
| Number | Description | Photograph |
|---|---|---|
| P6 | <p>Example of the cavities present within the blockwork wall at the eastern end of the larger roof space. Light to moderate coverage of cobweb was present within these features, which indicated no recent use by bats, and visual inspection showed that no bats were present.</p> | |

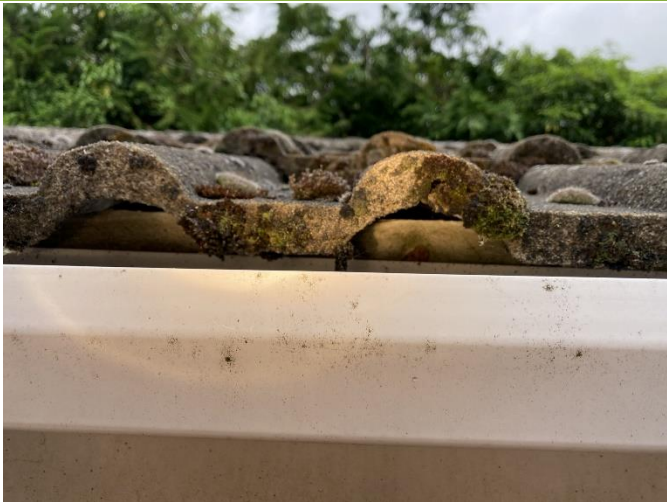
| Number | Description | Photograph |
|---|---|---|
| P7 | Example of the gaps present at the end of roof tiles which could permit bats access to areas between tiles and bitumen felt. | |
