## **PHASE IV –VALIDATION REPORT**

***Land Adjacent to  
94 George Street,  
Reading  
RG1 7NT***

***August 2021  
Report No. 16550***

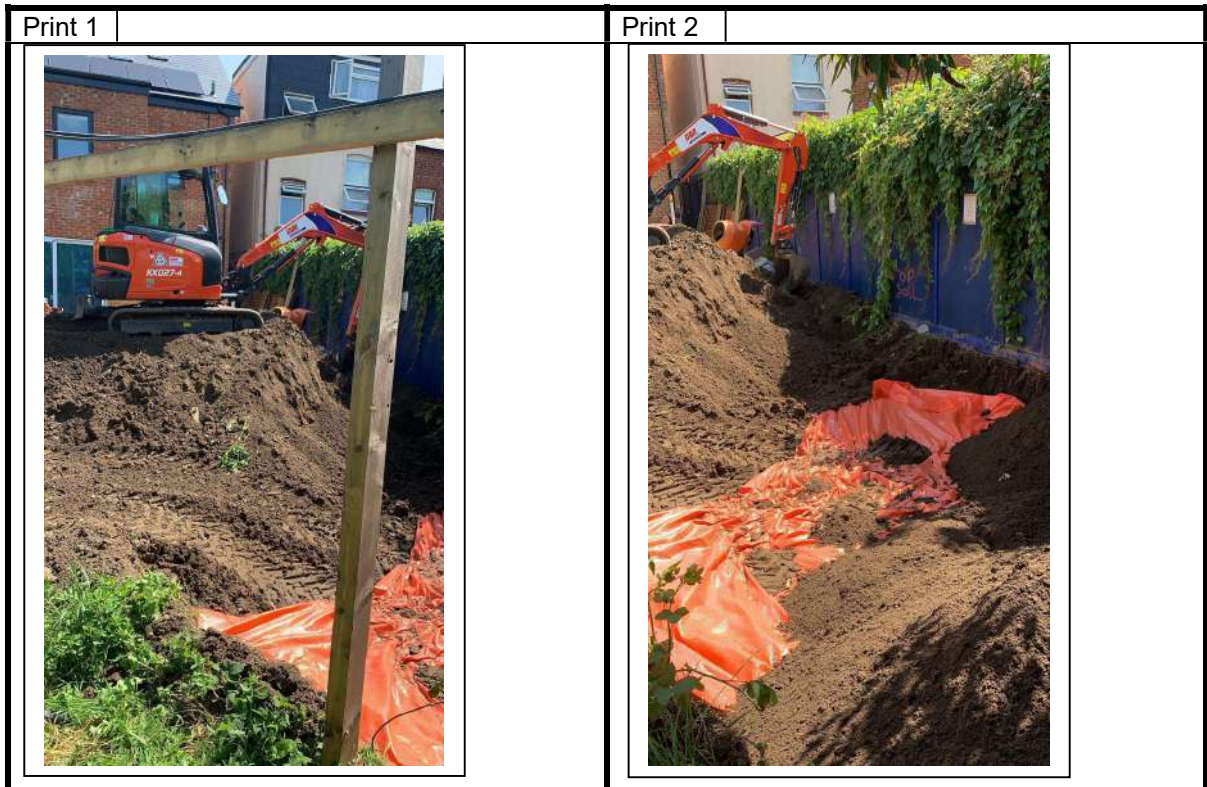
Within the area of Remediation Cell removal of a strip of a minimum of 0.60 meters was completed. As shown by the photos provided by the client:-

Based on the above, the client has confirmed that the garden areas have been excavated and removed at least 0.60 metres of subsoil to develop at least a replacement 0.60 metres of replacement soils. A demarcation barrier has been installed at the site below all proposed soft landscaping which has been identified as a 609 geotextile orange, (details of which have been provided within appendices of this report).
