## **PRELIMINARY ECOLOGICAL APPRAISAL (BATS) AT 31 & 33 HILLTOP ROAD CAVERSHAM**

**1 July 2021**

**Ref: BP/PEA-21/28.06**

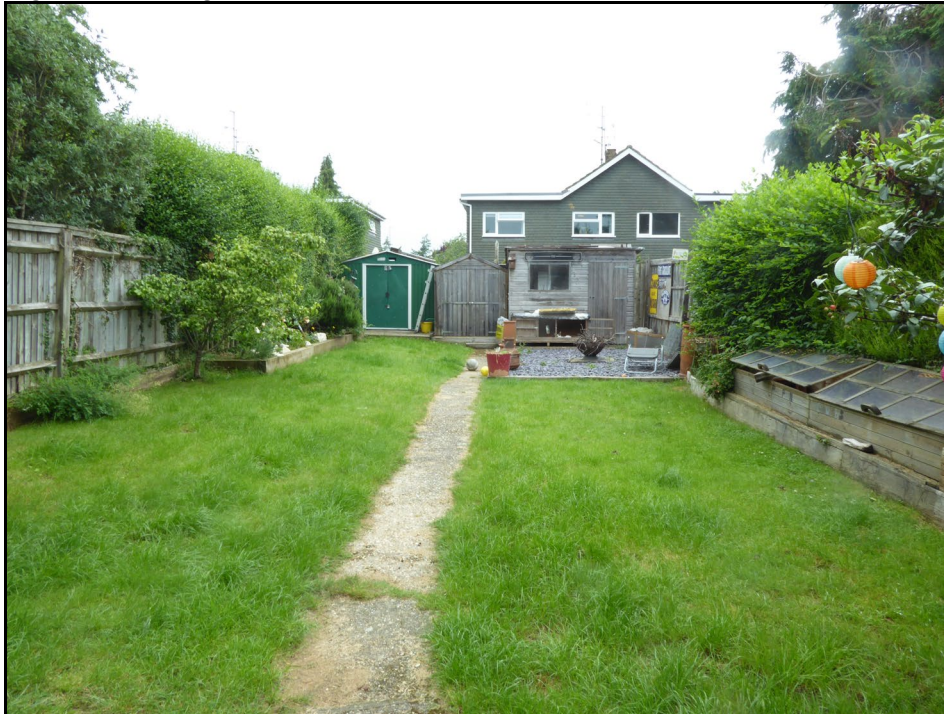
Figure 3. Rear garden. 31 Hilltop Road, Caversham. 28.06.21

The application site comprises a pair of semi-detached houses with concrete parking in the front of number 31 and gravelled parking in the front of number 33. The rear gardens of both houses have a small, paved patio and a lawn with mature trees and shrubs all around, see Figure 3 and 4 below. The site itself offers limited foraging habitat for bats.

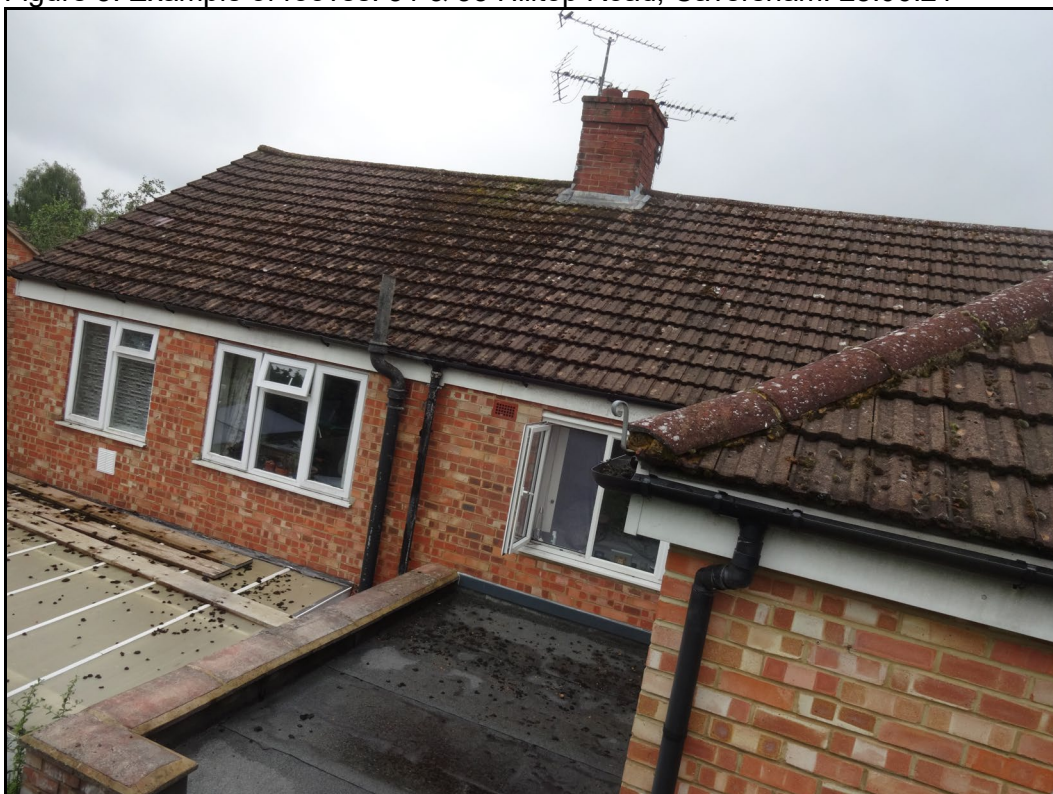
Figure 5. Example of rooves. 31 & 33 Hilltop Road, Caversham. 28.06.21

The properties are a pair of semi-detached, brick-built houses that are in a good condition externally. The pitched rooves are covered in composite tiles that are all in a good condition with no broken or missing tiles, and the ridge tiles are well cemented in, see Figure 5 below. The uPVC windows and doors throughout the properties are all well sealed with no gaps, as are the fascias and soffits (see Figure 6 on page 9). There are no gaps in the verges at the gable ends, see Figure 7 on page 10. The lead flashing around the chimney is well sealed and provides no opportunity for bats to access the building, see Figure 8 on page 10.

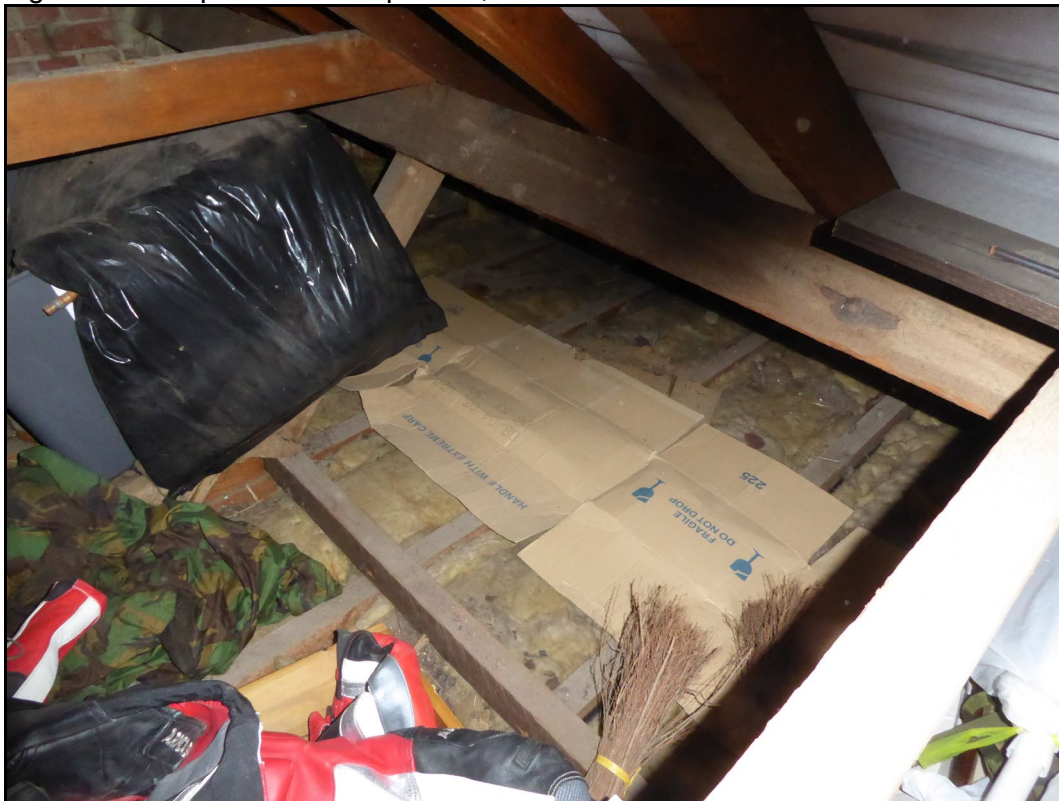
Figure 9. Loft space. 31 Hilltop Road, Caversham. 28.06.21

The loft space of the number 31 was accessed from the first floor, via my ladder. The loft is unlit, insulated and not boarded, see Figure 9 below. The roof tiles were lined with breathable membrane, which is in a good condition, see Figure 10 on page 12.

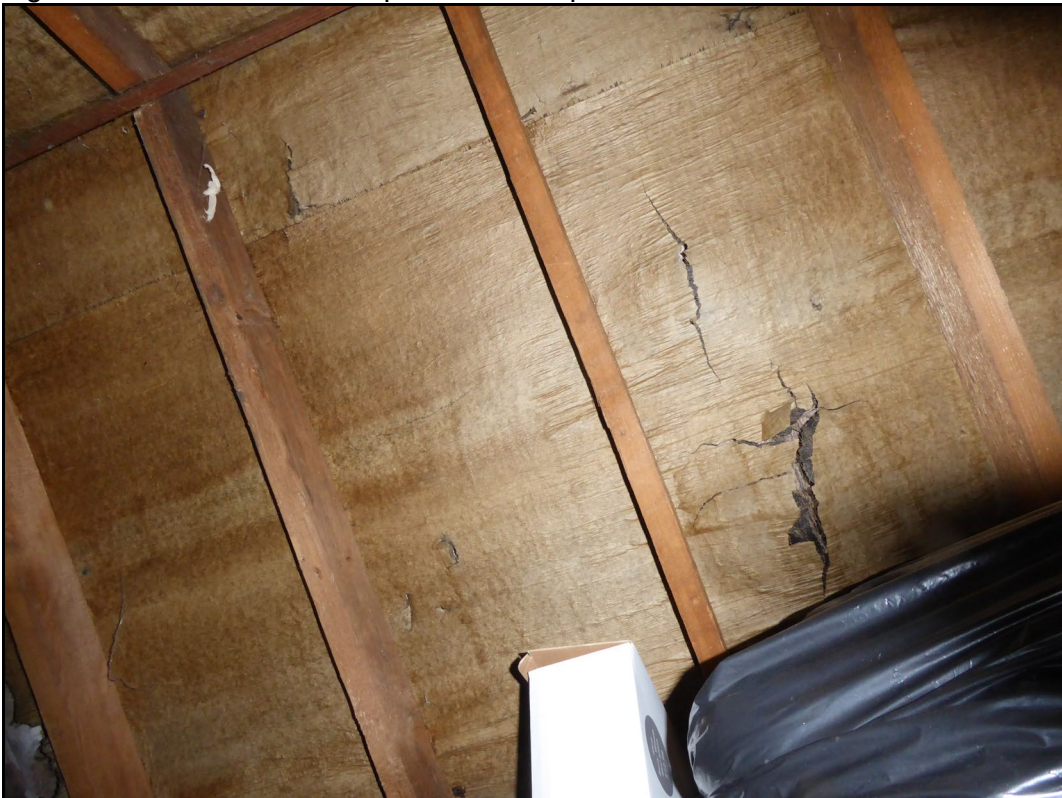
Figure 11. Membrane in loft space. 33 Hilltop Road, Caversham. 28.06.21

The loft space of number 33 was accessed by a fixed loft ladder. This loft was insulated and not boarded, there was a loft light, but the bulb had blown. The tiles are lined with tar paper, which was in a warn condition, see Figure 11 on page 12. The floor of the loft was fully visible, with the stored items being on shelves above, see Figure 12 on page 13.
