## **124 CARDIFF ROAD**

### **Preliminary Bat Roost Assessment Report**

**PROJECT NO. 70063683**

**DATE: JUNE 2020**

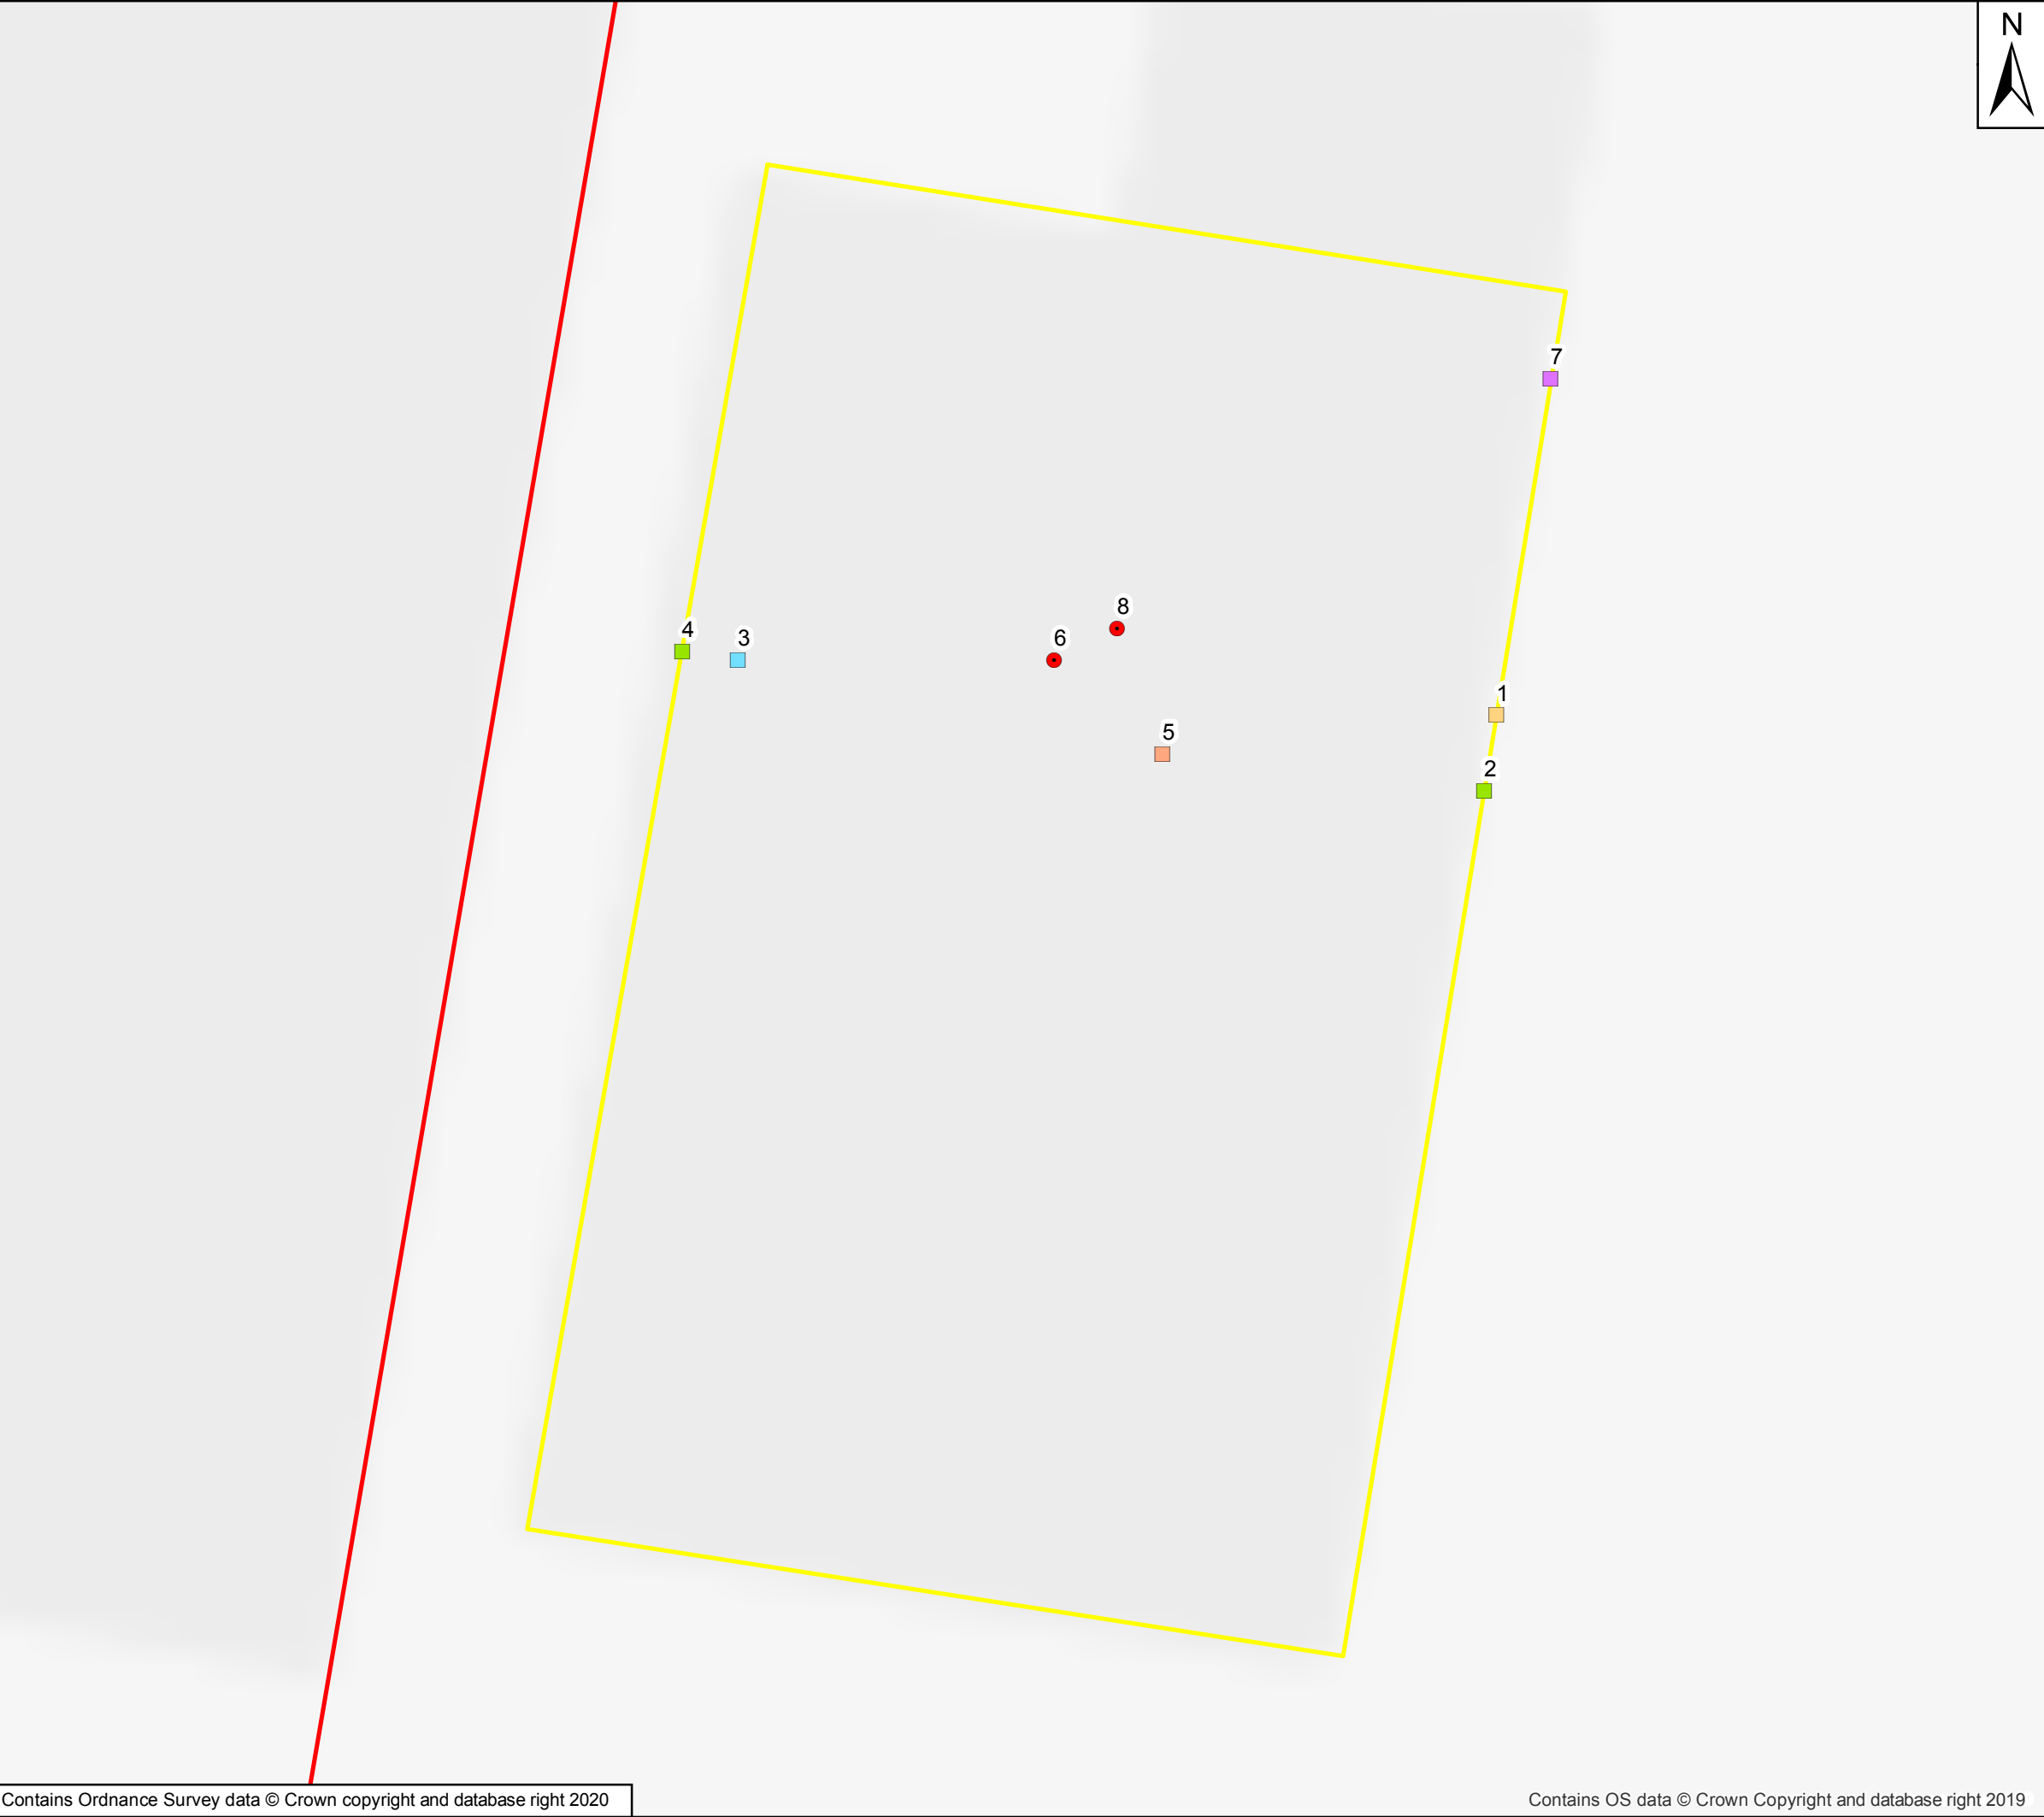
**Figure 3 – Preliminary Bat Roost Assessment Results**

- 3.1.5. Further detail is included in Table 2 below and shown on Figure 3. Photographs of the features and access/egress points are given in Appendix A.

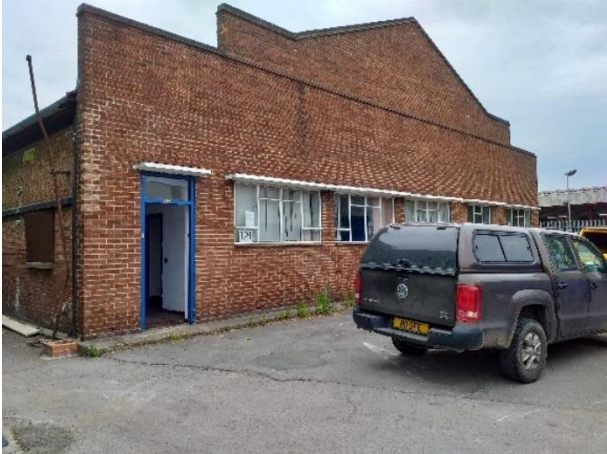
| 1 - Southern aspect of the Site | 2 - Eastern aspect of the Site | 3 - Western aspect of the Site | 4 - Large warehouse space |

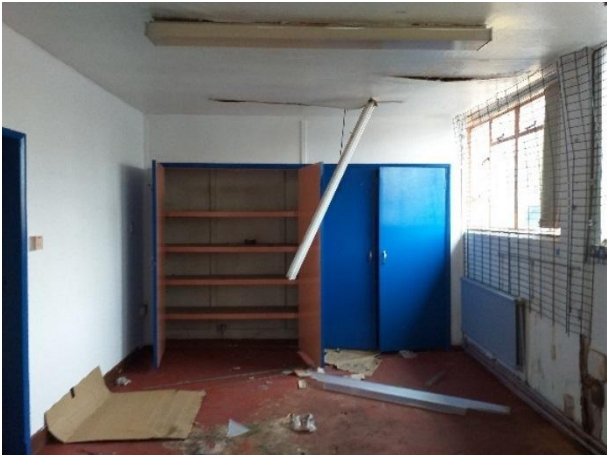
| 5 - Office space with false ceiling | 6 - Small segregated warehouse | 7 - Access points in brickwork (Feature 1 and 2) | 8 - Access points in doorways and roof (Feature 3 and 4) from the building external |

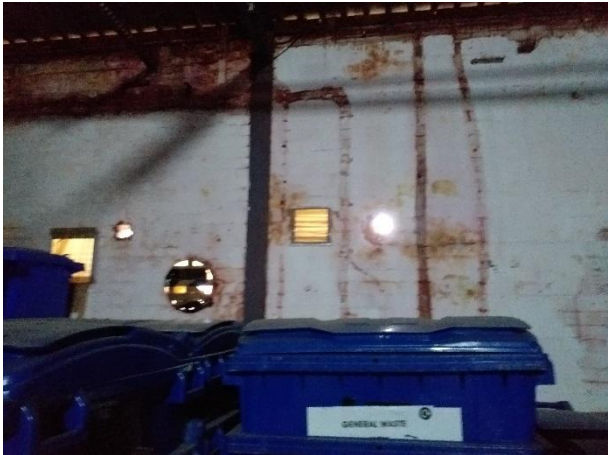
| Feature No. as shown on Figure 3 | Photograph Number (Appendix A) | Description <sup>2</sup> | Location of Features | | Evidence of roosting bats recorded? | Overall Assessment of Suitability to Support Bat Roosts | Suitability for different roost types <sup>3</sup> | | |
|---|---|---|---|---|---|---|---|---|---|
| 1 | 7 | Brickwork access/egress point– three gaps within the brickwork providing internal access into the warehouse. | Y | - | N | - | - | - | - |
| 2 | 7 | Roof access/egress point – gaps between the corrugated roof and wall providing internal access into the warehouse. | Y | - | N | - | - | - | - |

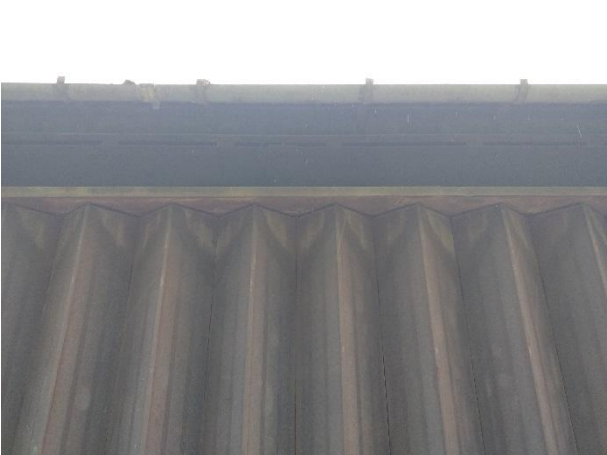
| Feature No. as shown on Figure 3 | Photograph Number (Appendix A) | Description <sup>2</sup> | Location of Features | | Evidence of roosting bats recorded? | Overall Assessment of Suitability to Support Bat Roosts | Suitability for different roost types <sup>3</sup> | | |
|---|---|---|---|---|---|---|---|---|---|
| 3 | 8 & 9 | Doorway access/egress point – gap above sliding door providing internal access into the warehouse. | Y | - | N | - | - | - | - |
| 4 | 8 & 9 | Roof access/egress point – gaps between the corrugated roof and wall providing internal access into the warehouse. | Y | - | N | - | - | - | - |

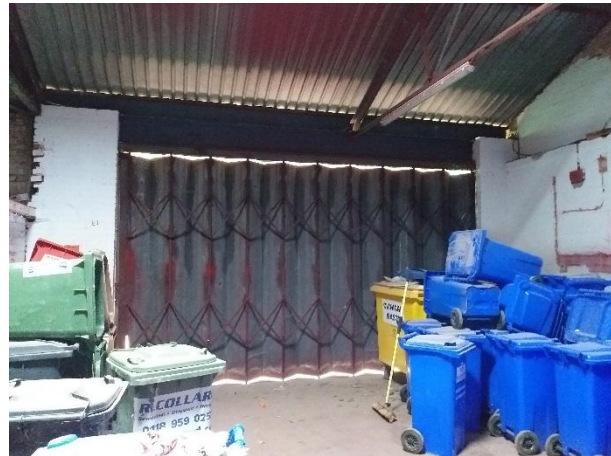
9 - Access points in doorways and roof (Feature 3 and 4) from the building internal

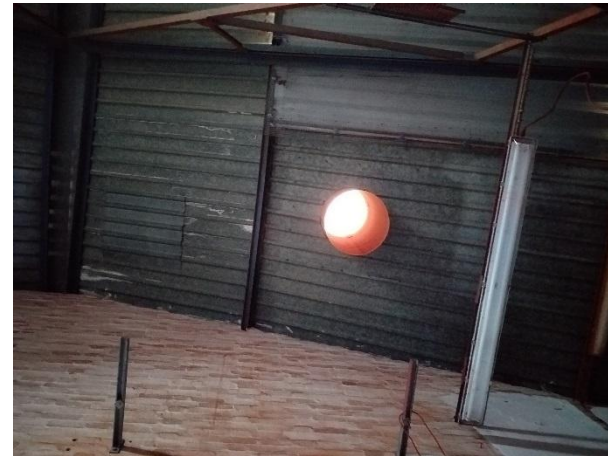
| Feature No. as shown on Figure 3 | Photograph Number (Appendix A) | Description <sup>2</sup> | Location of Features | | Evidence of roosting bats recorded? | Overall Assessment of Suitability to Support Bat Roosts | Suitability for different roost types <sup>3</sup> | | |
|---|---|---|---|---|---|---|---|---|---|
| 5 | 10 | Vent access/egress point – open metal vent in roof providing internal access into the warehouse. | Y | - | N | - | - | - | - |

10 - Access point from vent (Feature 5)

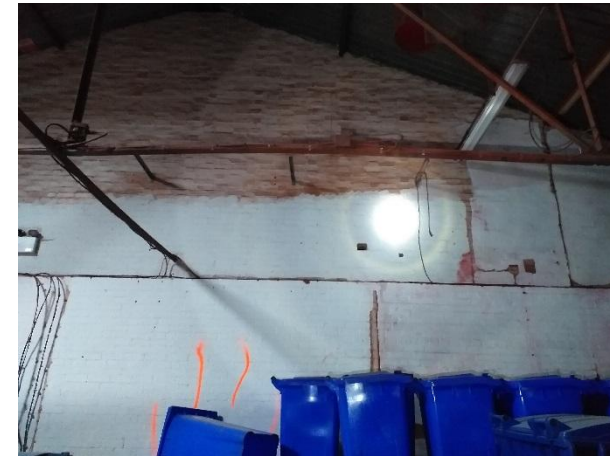
- 3.1.3. The two internal features are gaps in brickwork which may lead to cavity spaces within internal brick walls. The features are at a height of approximately 3-4m from the ground.

| Feature No. as shown on Figure 3 | Photograph Number (Appendix A) | Description <sup>2</sup> | Location of Features | | Evidence of roosting bats recorded? | Overall Assessment of Suitability to Support Bat Roosts | Suitability for different roost types <sup>3</sup> | | |
|---|---|---|---|---|---|---|---|---|---|
| 6 | 11 | PRF 1 – three gaps in the internal brick wall within warehouse. These may extend into a cavity wall. These are approximately 3-4m above ground level. | - | Y | N | Low | - | Y | - |

11 - PRF 1- gaps in the brickwork leading to cavity space.

- 5.1.1. Building 1 has a low suitability to support roosting bats. It is therefore recommended that following good practice guidelines (Collins 2016), further dusk emergence/dawn re-entry survey is undertaken to identify the presence or likely absence of bat roosts.

- 5.1.2. Following good practice guidance, one survey visit is required. This is to comprise one emergence or one re-entry survey to be completed between May and August inclusively in suitable weather conditions (sunset temperature 10°C or above, no rain, no strong wind).

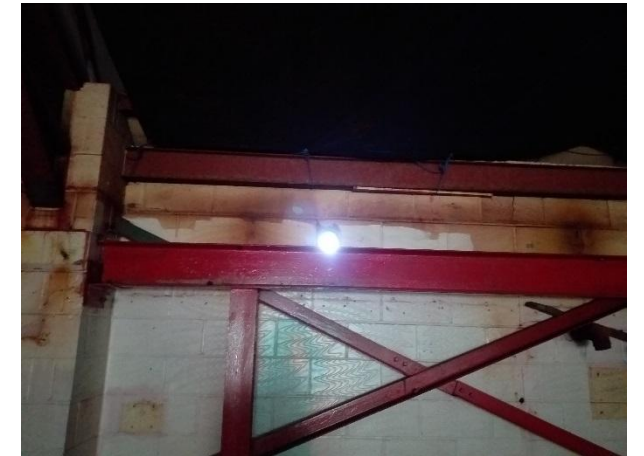
| Feature No. as shown on Figure 3 | Photograph Number (Appendix A) | Description <sup>2</sup> | Location of Features | | Evidence of roosting bats recorded? | Overall Assessment of Suitability to Support Bat Roosts | Suitability for different roost types <sup>3</sup> | | |
|---|---|---|---|---|---|---|---|---|---|
| 7 | 12 | Pipe access/egress point – open pipe providing internal access into the segregated warehouse. | Y | - | N | - | - | - | - |

12 - Access point via wall pipe (Feature 7)

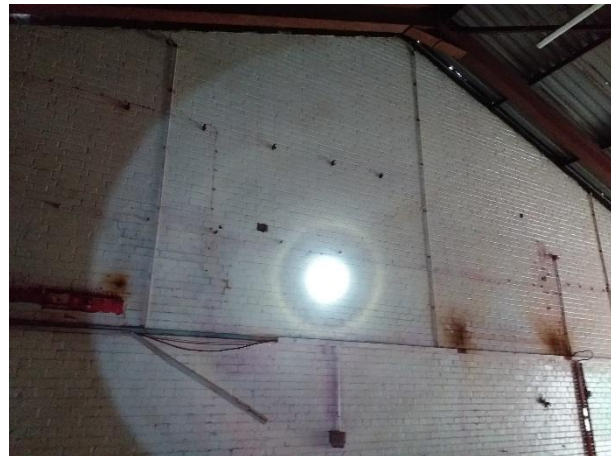
| Feature No. as shown on Figure 3 | Photograph Number (Appendix A) | Description <sup>2</sup> | Location of Features | | Evidence of roosting bats recorded? | Overall Assessment of Suitability to Support Bat Roosts | Suitability for different roost types <sup>3</sup> | | |
|---|---|---|---|---|---|---|---|---|---|
| 8 | 13 | PRF 2 – three gaps in the internal brick wall within the segregated warehouse. These may extend into a cavity wall. These are approximately 3-4m above ground level. | - | Y | N | Low | - | Y | - |

13 - PRF 2 gaps in the brickwork leading to cavity space.
