LAND AT ATTERBURY GARDENS - READING

PHASE 1 DESK STUDY

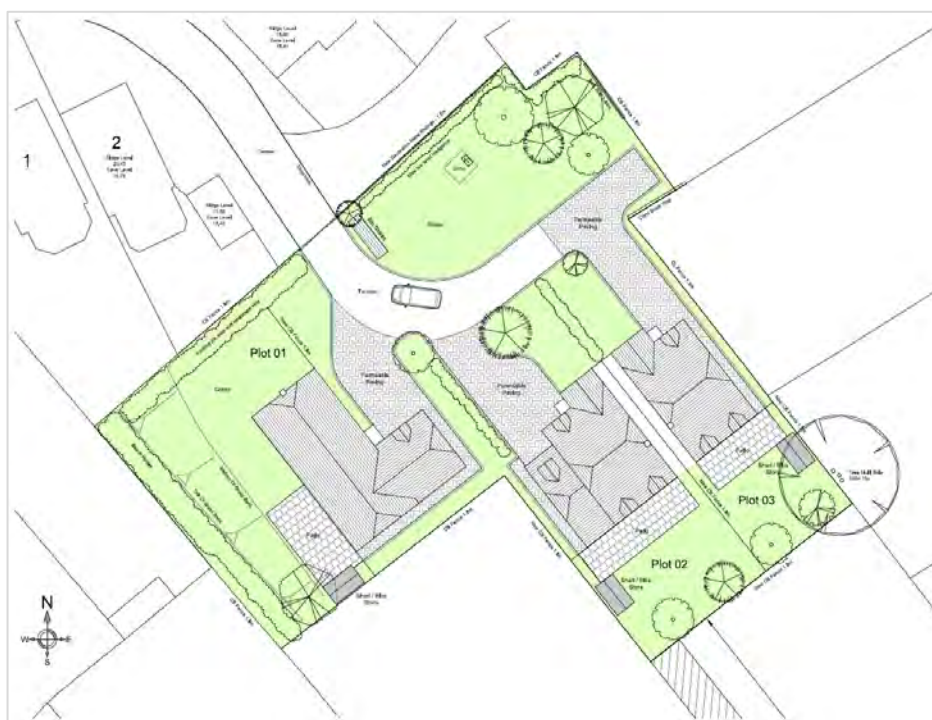
Figure 2: Proposed Site Layout

- 1.2 The site, L-shaped in plan, is centered at National Grid Reference 470360, 175940, and occupies an approximate area of 0.17 ha as shown in Figure 1. The site currently comprises the large rear garden of residential property No. 23 Richmond Road and is located within a residential area of Caversham. The site is located within the suburbs of Reading and lies approximately 3km to the north of Reading Town Centre. Barafundle Whenua Ltd require this Phase 1 Desk Study to support the proposed development scheme for the site which relates to the clearance of the site and subsequent construction of 3 No. low-rise residential properties with associated private gardens, access infrastructure, driveways and adjacent garage structures. Figure 2 illustrates the proposed development scheme.

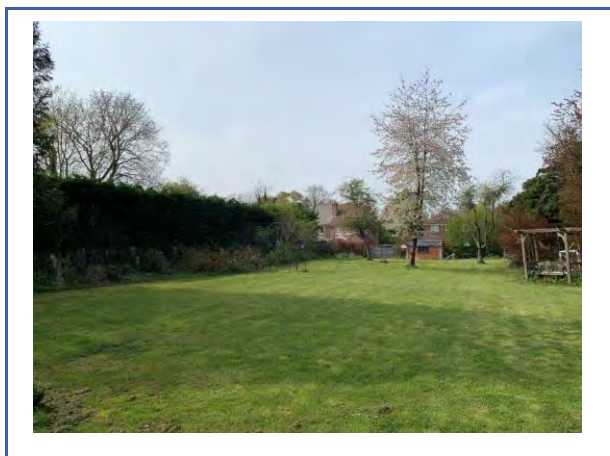
- 2.3 The site is a residential lawned garden bound by adjoining residential properties. The site is generally flat, although a grassed soil mound approximately 2m high was present along the western site boundary. Towards the north-east of the site were three garden sheds containing various domestic items. Two of the sheds were of wooden construction, with rooves of corrugated metal (corroded) and asphalt sheeting respectively. The third shed was of brick construction, with an asphalt roof. Two concrete slabs were also present in this area which may have previously housed small sheds or outbuildings.

*View north along the site*

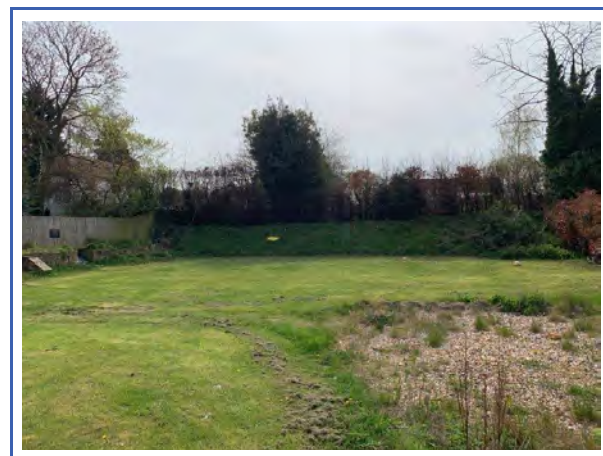
*Soil mound along western boundary*

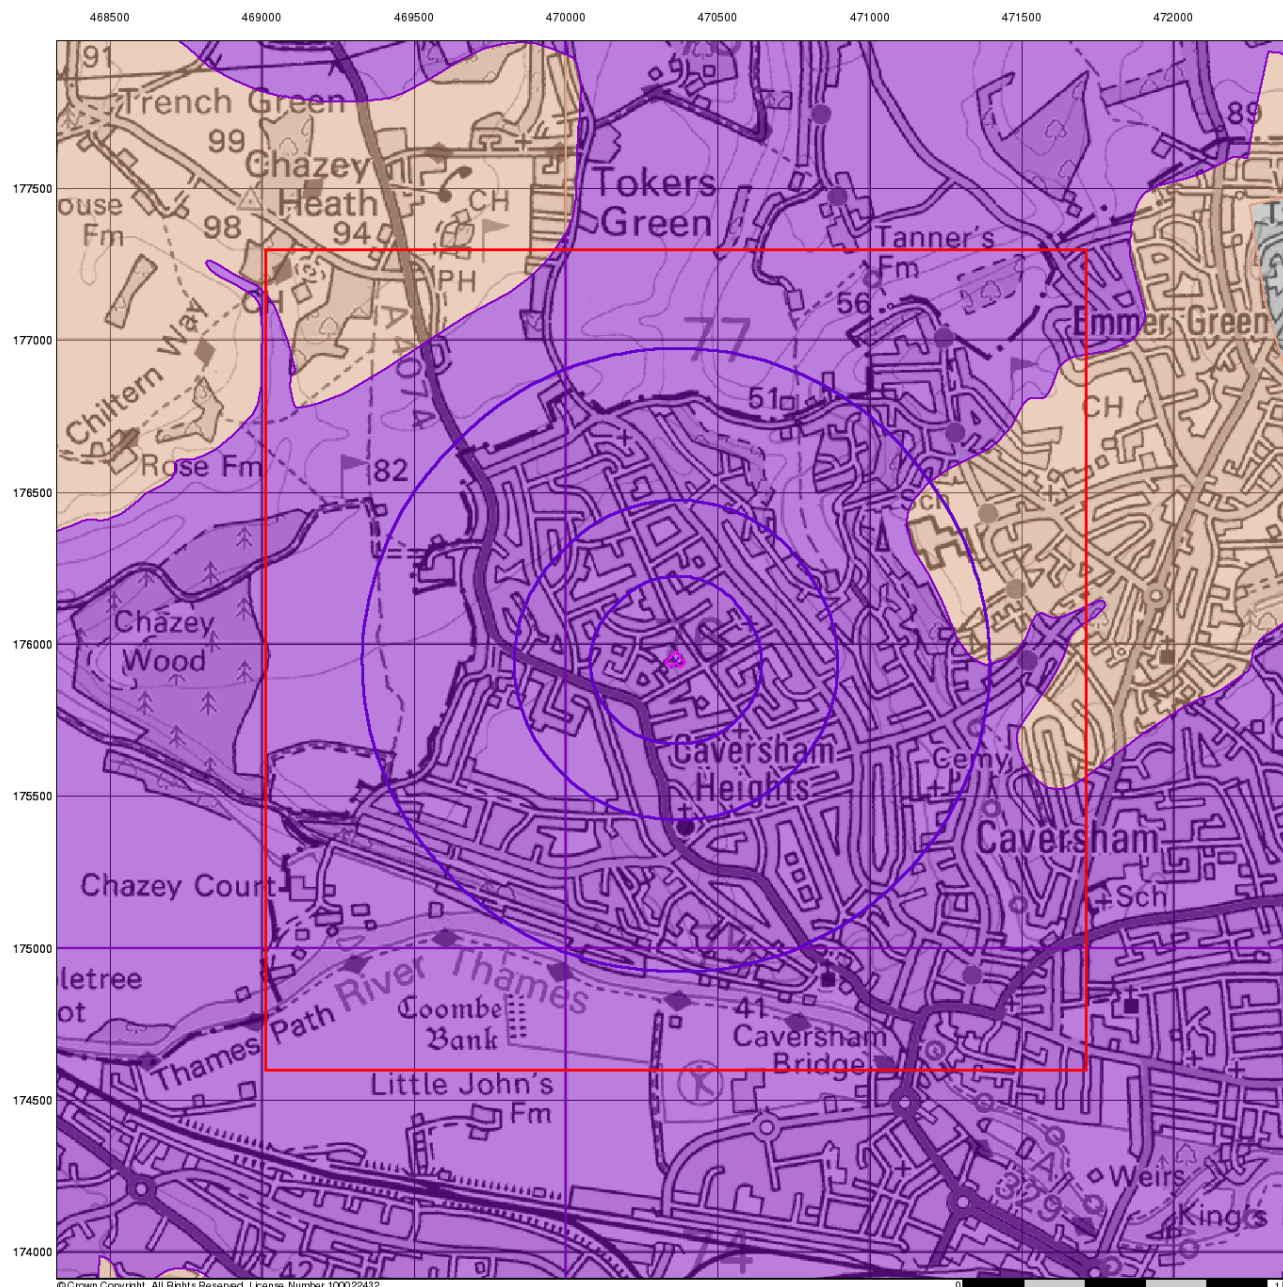
## Groundwater Vulnerability

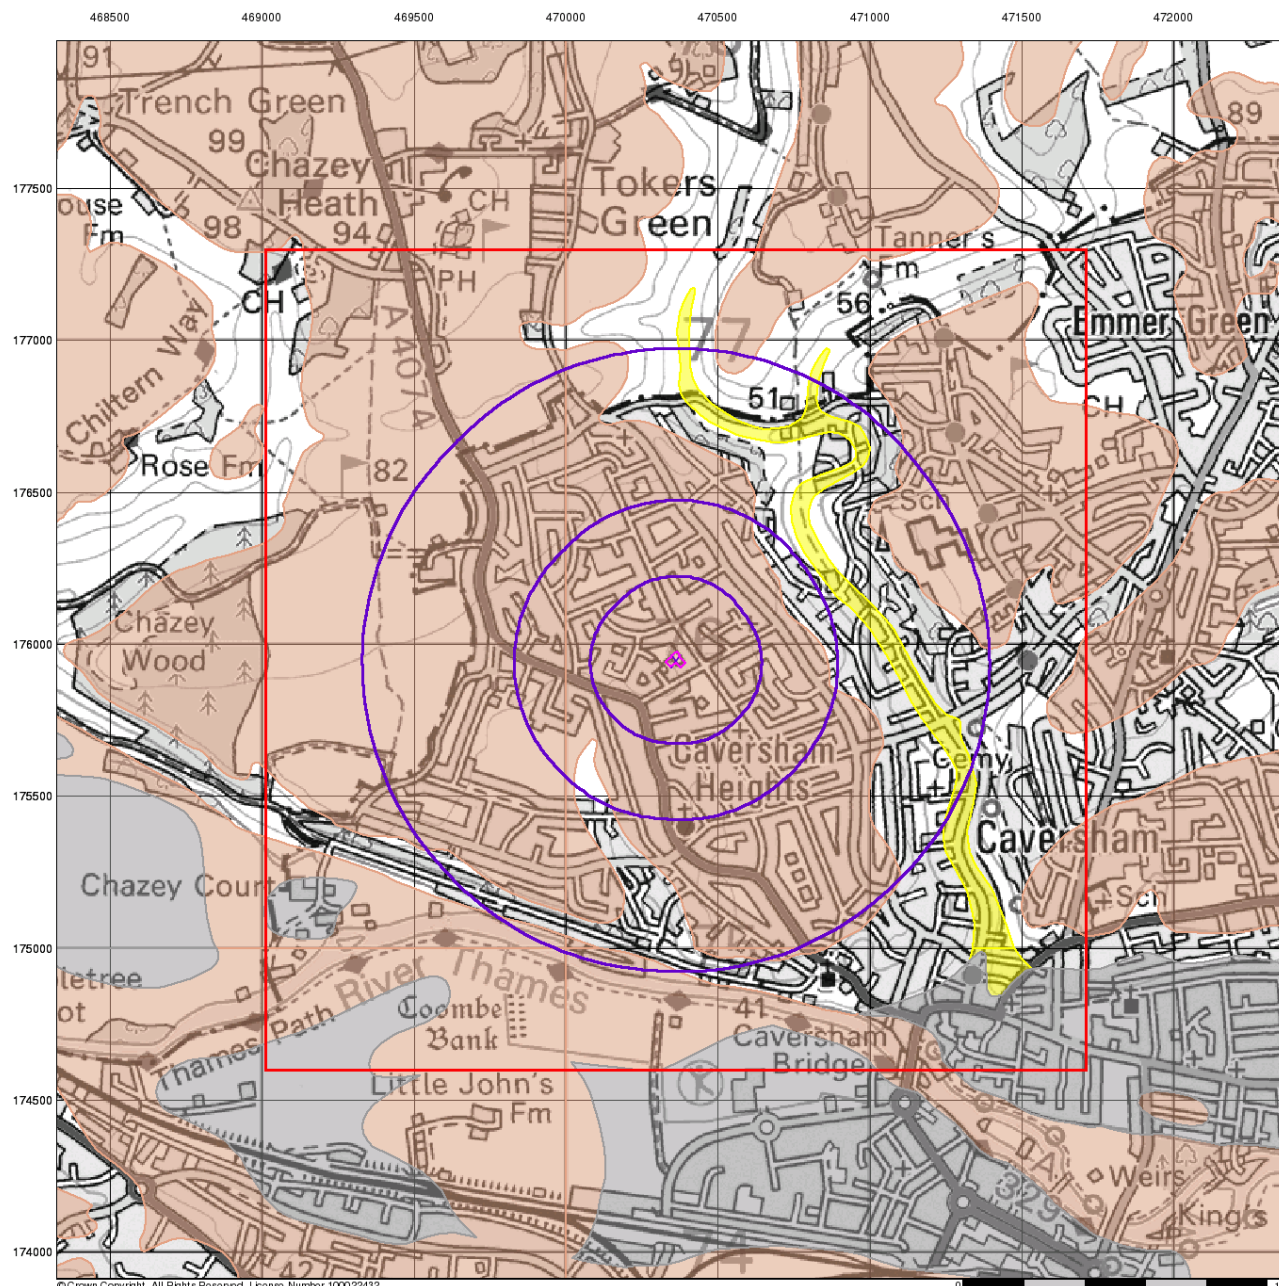
## Bedrock Aquifer Designation

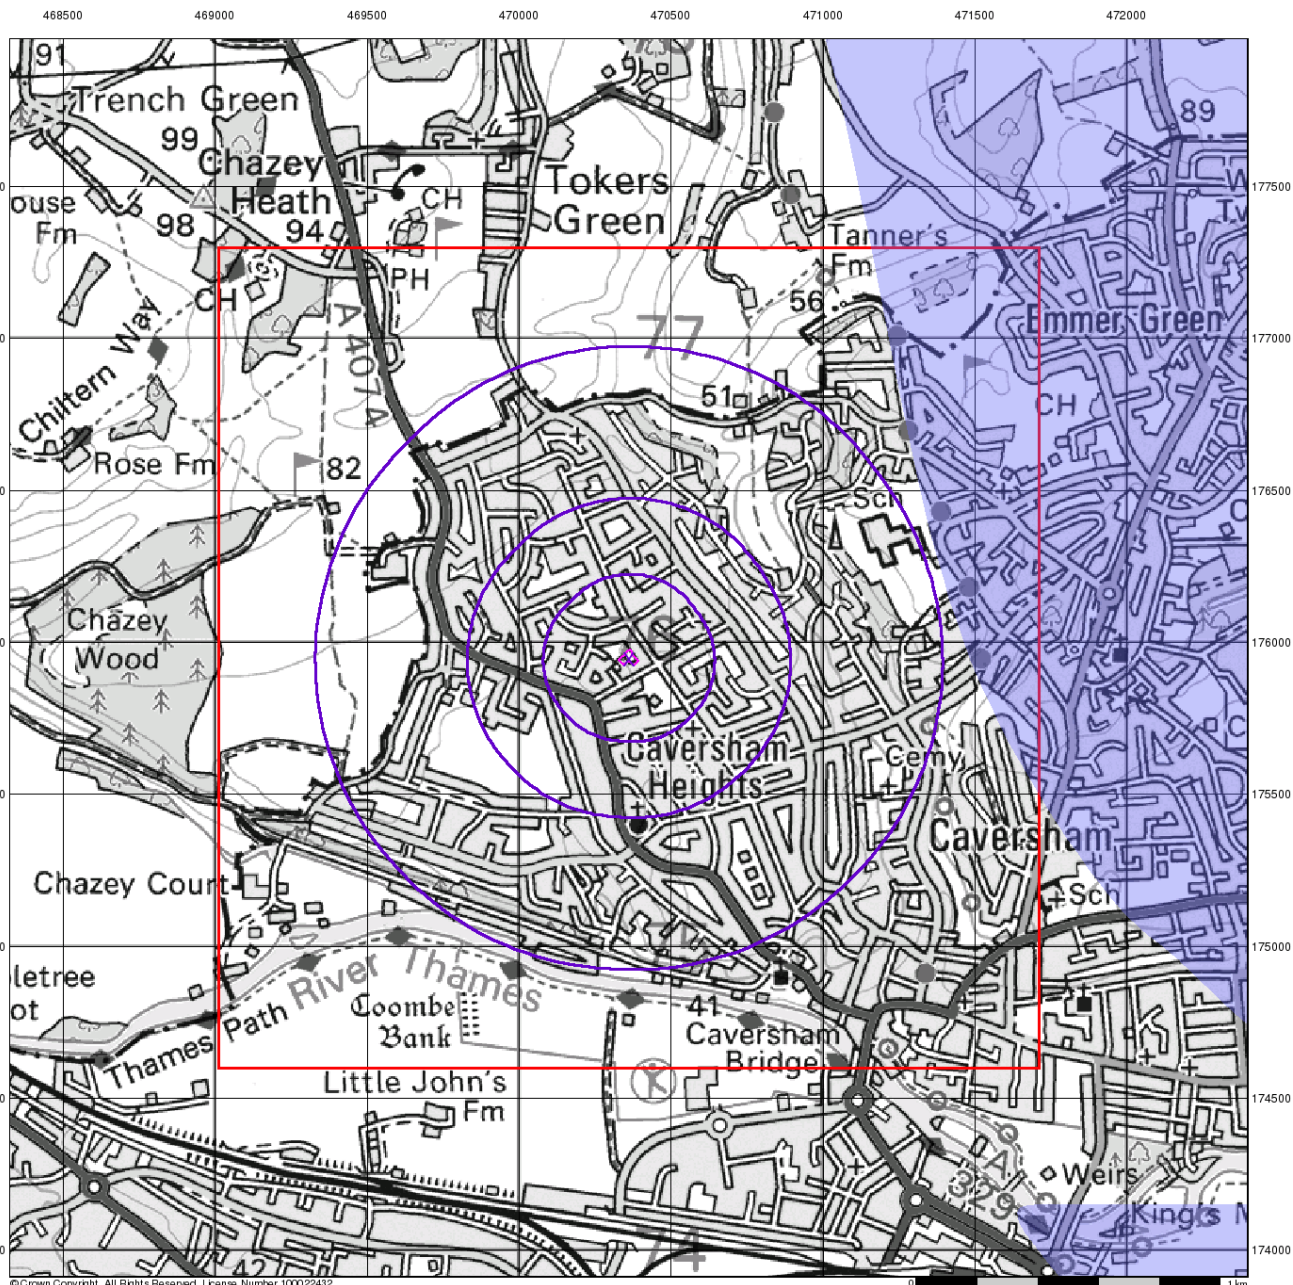
## Superficial Aquifer Designation

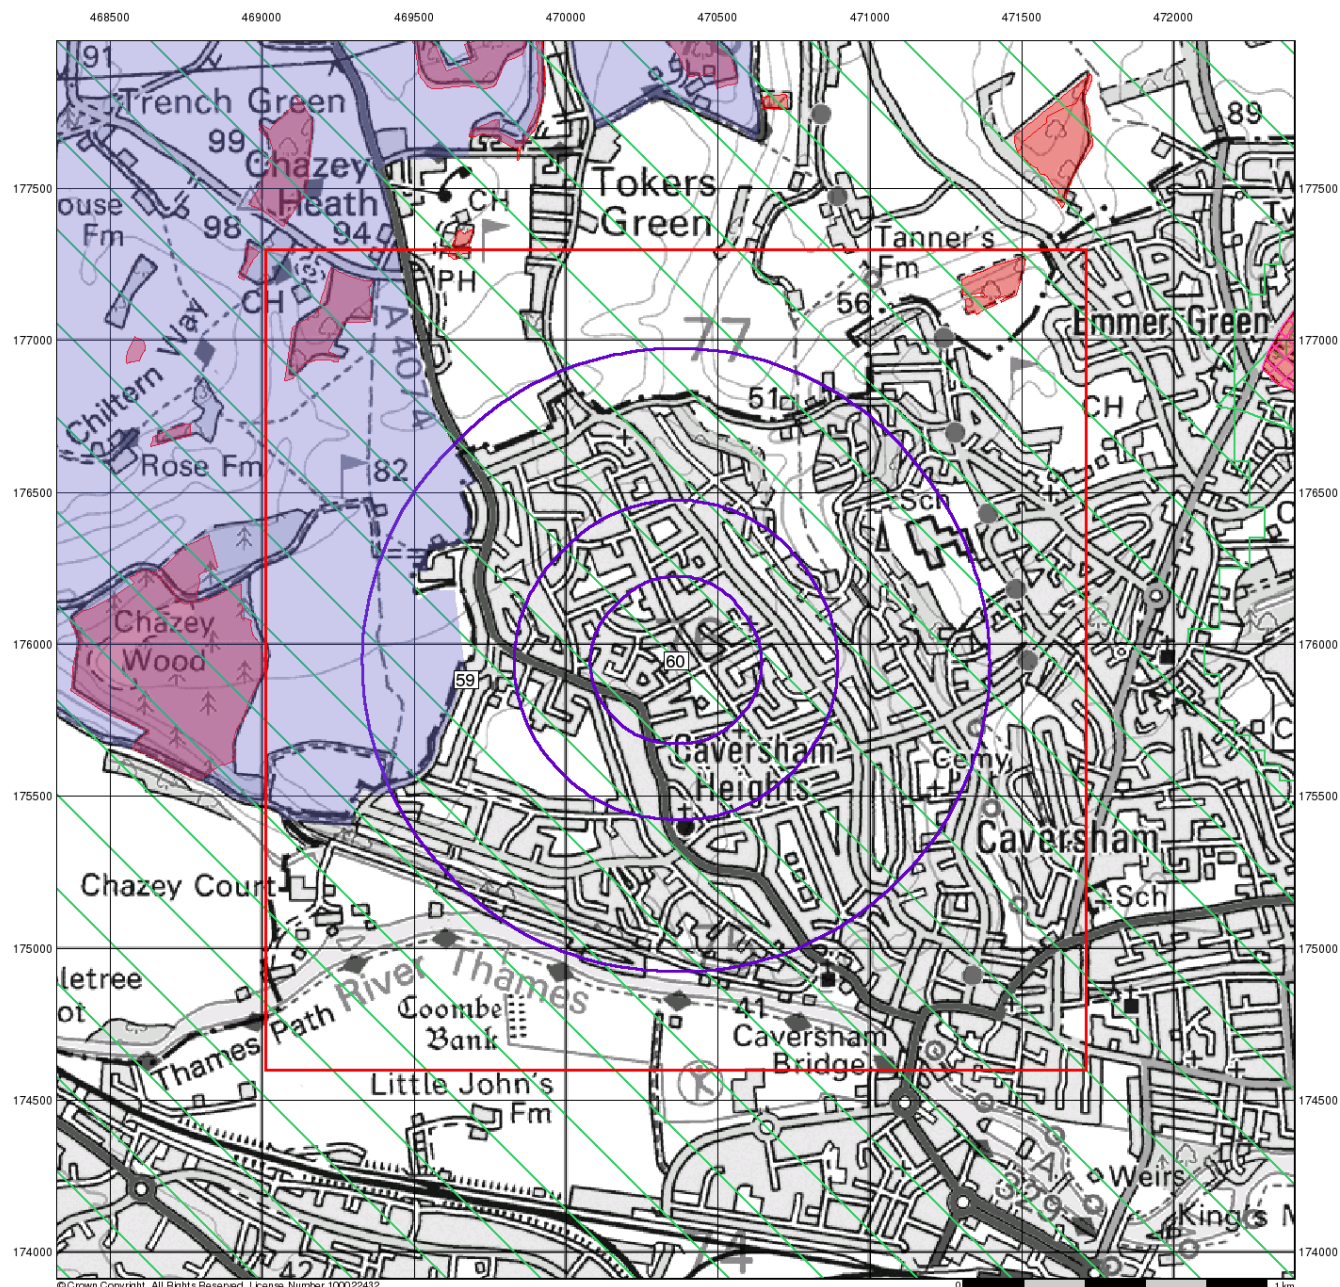
## Source Protection Zones
