# CRACK MONITORING

## for Subsidence Management Services

**81 Baker Street, Reading, RG1 7XY**

| Our Ref: | M15099 |

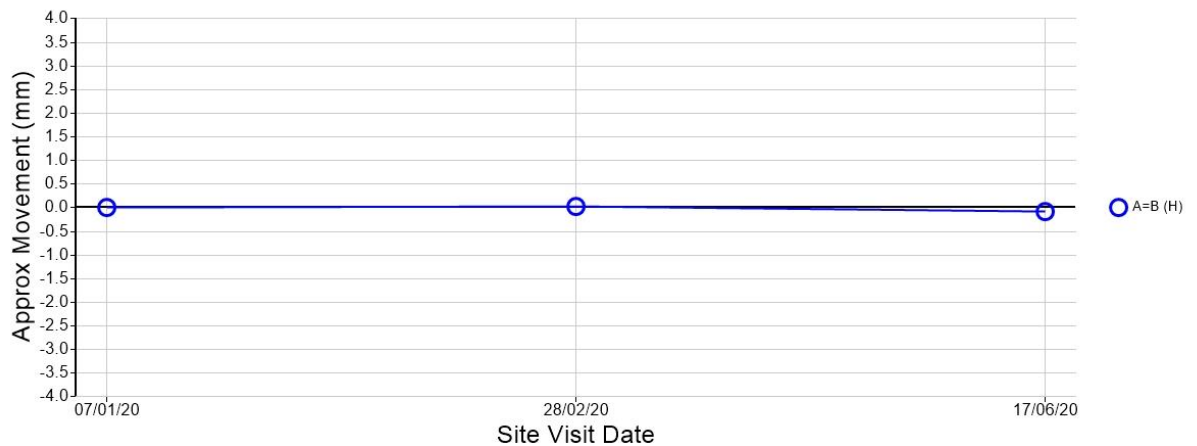
C1 - INT- Church Hall RH Wall

| Date | A=B (H) | B=C (D) | A=C (V) | Crack Width |
|---|---|---|---|---|
| <b>C1 - INT- Church Hall RH Wall</b> | | | | |
| 7 January 2020 | 61.64 | | | 1.10 |
| 28 February 2020 | 61.68 | | | |
| 17 June 2020 | 61.57 | | | |

The following graphs display the progressive movement that each Crack Monitoring Station recorded at each separate site visit date to give an overall look at how much the property is moving.

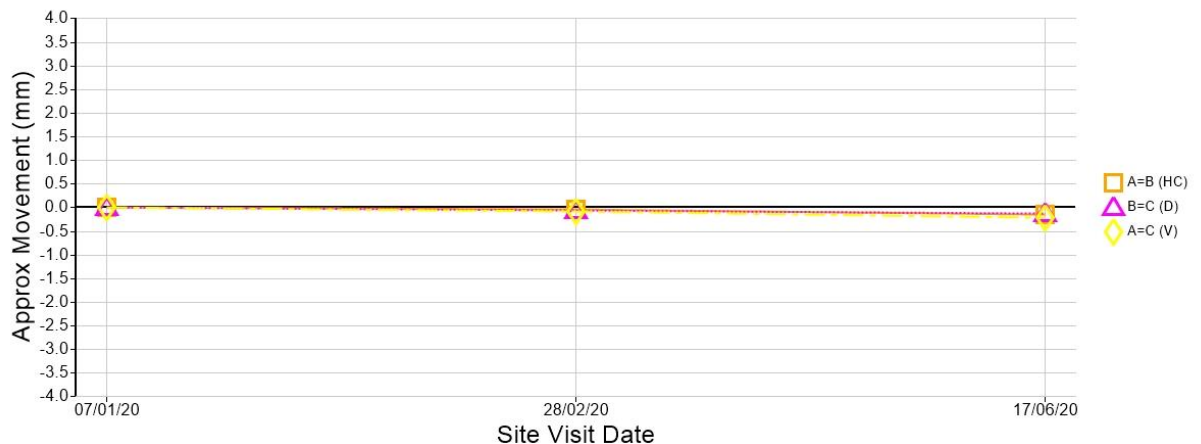
C2 - INT- Church Hall Front Wall LHS of Double Doors (Steps)

| Date | A=B (H) | B=C (D) | A=C (V) | Crack Width |
|---|---|---|---|---|
| <b>C2 - INT- Church Hall Front Wall LHS of Double Doors (Steps)</b> | | | | |
| 7 January 2020 | 72.66 | 121.12 | 91.18 | 16.60 - 12.00 |
| 28 February 2020 | 72.63 | 121.06 | 91.10 | |
| 17 June 2020 | 72.53 | 121.01 | 90.98 | |
