# Bat Survey Report – Preliminary Roost Assessment

126 Tilehurst Road, Reading RG30 2LX

July 2020

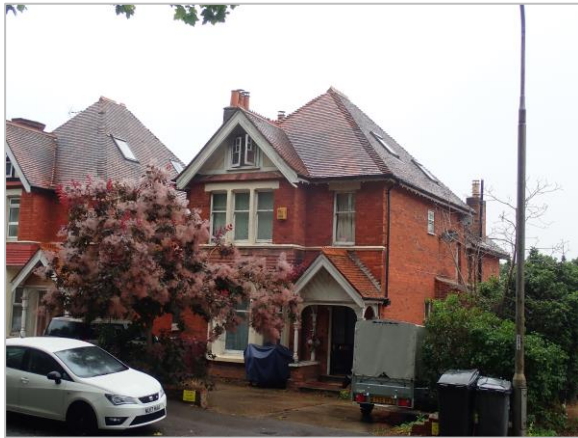
*Photo 1 Front (south) elevation*

- 1.6. There are exposed eaves with timber sarking, and no soffit boxes. Windows are modern white uPVC and rainwater goods are modern black plastic.
- 1.7. There is a small garden laid largely to lawn to the rear of the property.
- 1.8. Photos 1 and 2 in Appendix 1 show the front and rear elevations of the house.

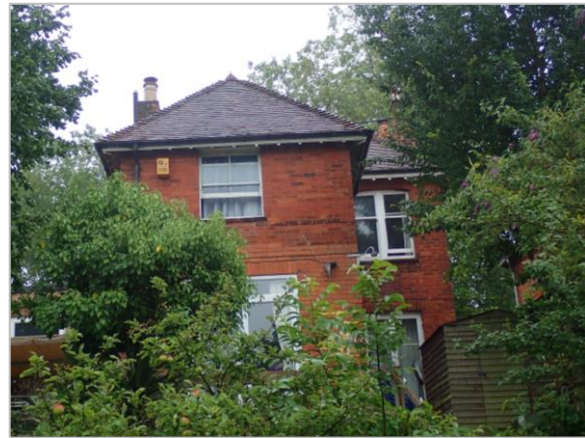
*Photo 2 Rear (north) elevation*

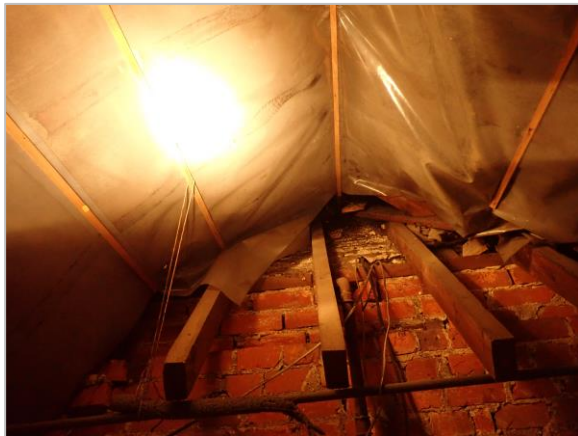
- 3.6. Internally, the small loft was inspected from the loft hatch. Photos 3 and 4 show the conditions in the loft. Examination of all surfaces, including internal timbers, floor, walls, and domestic services was carried out. Particular attention was paid to features such as the ridge apex at either end of the loft and joints in the timber work.
- 3.7. No droppings were seen on the floor (Photo 5) or the internal timbers or brickwork (Photo 6). The plastic sheeting around the underside of the rafters was seen to be tightly fitting and with no gaps around it or areas of damage.
- 3.8. No evidence of recent or historic bat roosting activity was seen in any areas.

*Photo 3 General conditions in loft*

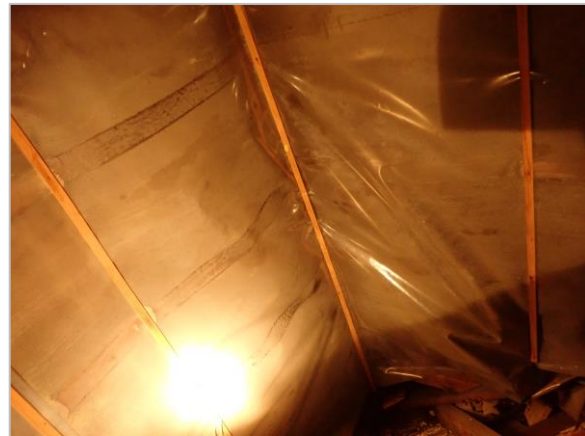
- 4.6. Internally, the small loft space does not present a suitable roosting location due to extensive sheer plastic sheeting fixed to the rafters. There are also no apparent points that would allow bats to gain access into the loft. No evidence of historic or recent bat use was seen in any areas of the loft.

*Photo 4 Ridge and internal plastic sheeting*

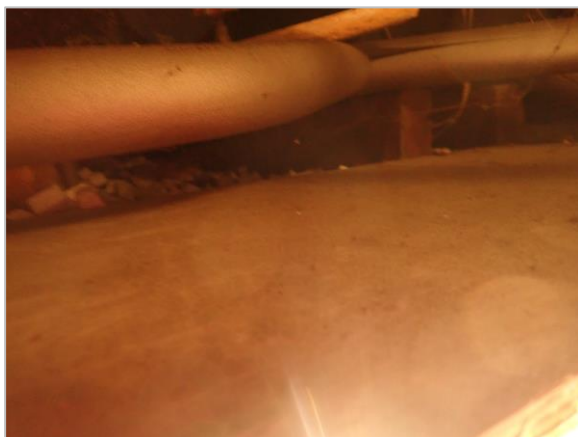
*Photo 5 Loft floor*

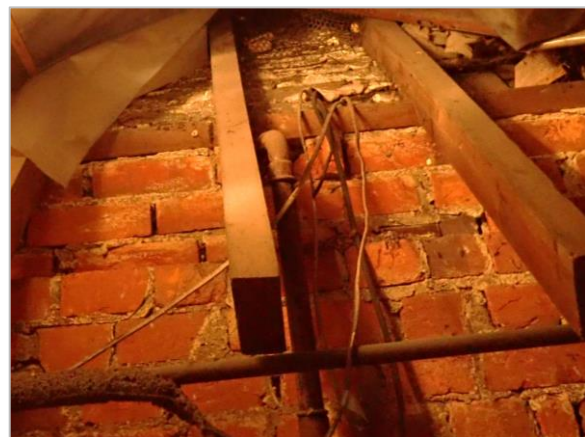
*Photo 6 Internal brickwork and timbers*

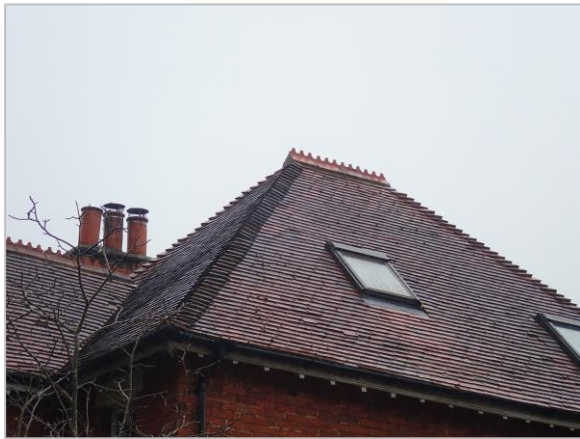
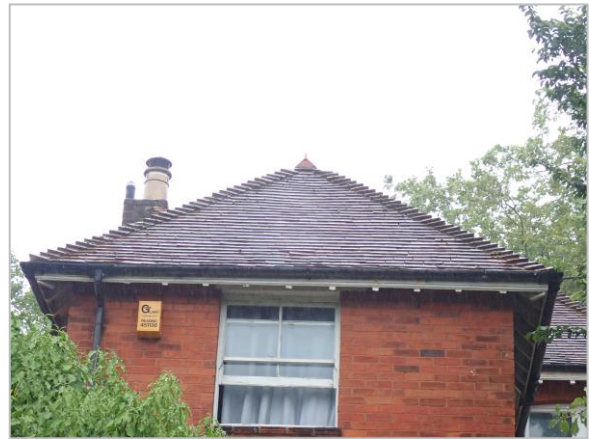
- 3.9. Externally, the roof tiles are of flat machine-pressed clay and were generally found to be well-fitting over the majority of the roof (see Photos 7 and 8). Some areas of slight slippage were noted where the tiles had started to come loose, but these areas had not resulted in gaps between the tiles due to the flat construction of the tiles unlike the bowed nature of more traditional clay tiles.

*Photo 7 Roof tiles*

*Photo 8 Roof tiles*

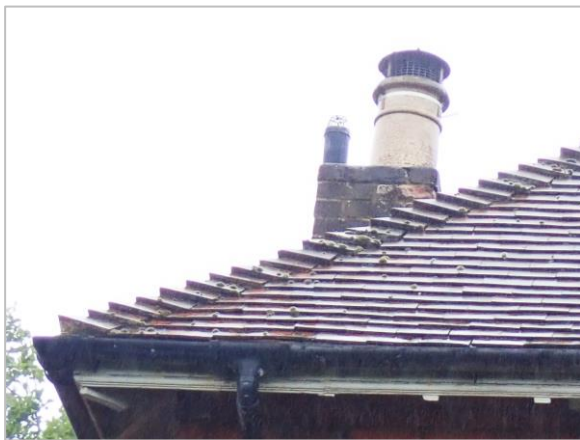
- 3.10. The ridge tiles and hip bonnets were undamaged, and the bedding mortar was in place with no apparent significant areas of deterioration that resulted in gaps suitable for allowing bat access (Photos 9 and 10).

*Photo 9 Hip bonnets*

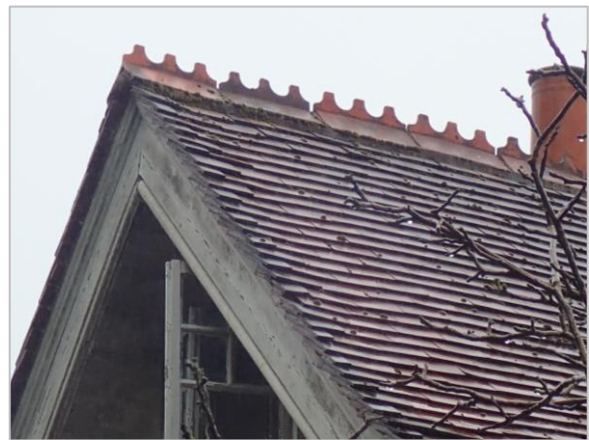
- 3.11. The front bay gable verge mortar was sound with no gaps between the tiles and the front fascia (Photo 10).
- 3.12. The eaves were closely examined with binoculars and a torch. There is timber sarking to the underside of the roof tiles around the exposed eaves, and the sarking is generally tight to the external brickwork with no apparent gaps for bats to access the tops of the external walls – see Photos 11 to 13. Initially it appears that there is a gap between the timber sarking and the wall; however, as can be seen in Photo 12, this is due to the white paintwork not extending up to the brickwork along the edge.

*Photo 10 Ridge and bay gable verge*

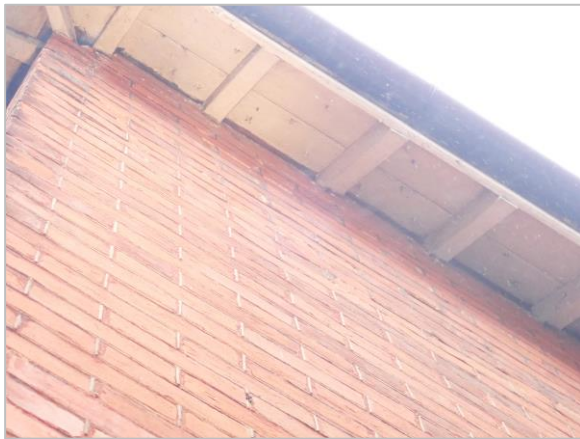
*Photo 11 Exposed eaves*

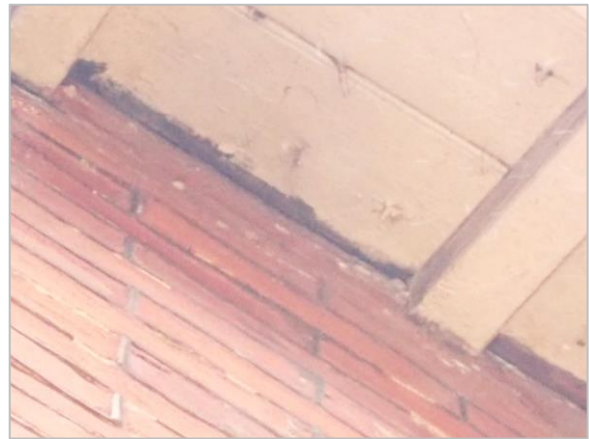
*Photo 12 Exposed eaves*

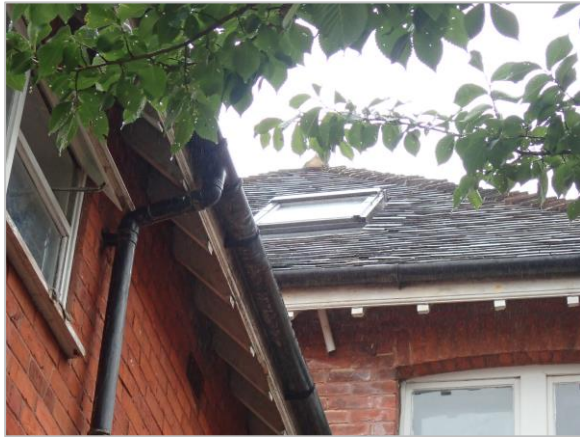
*Photo 13 Exposed eaves*

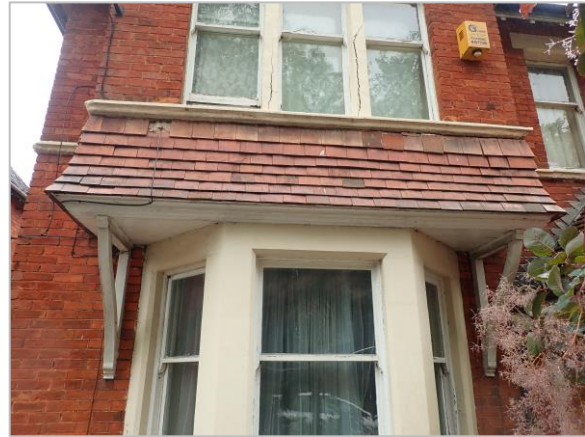
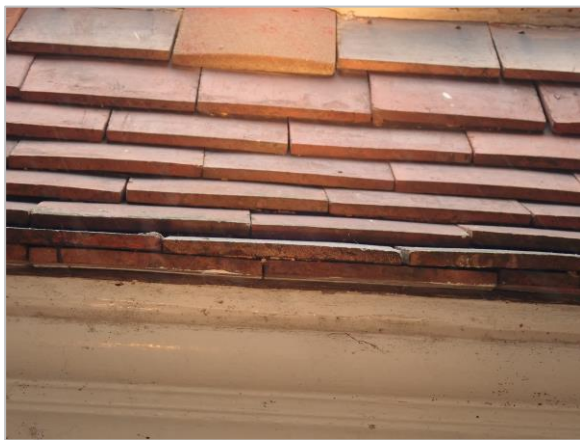
- 3.13. There is a small area of hanging tile around the front bay, between ground and first-floor level. These were inspected and although (as with the roof tiles) there was some minor slippage, there were no gaps between the overlapping tiles sufficient to allow bats access (Photos 14 and 15).
- 3.14. There is a timber fascia around the edge of the single-storey flat-roofed extension. There is no gap between this and the external wall sufficient to allow bats to access (Photo 16).

*Photo 14 Hanging tiles to front bay*

*Photo 15 Hanging tiles*

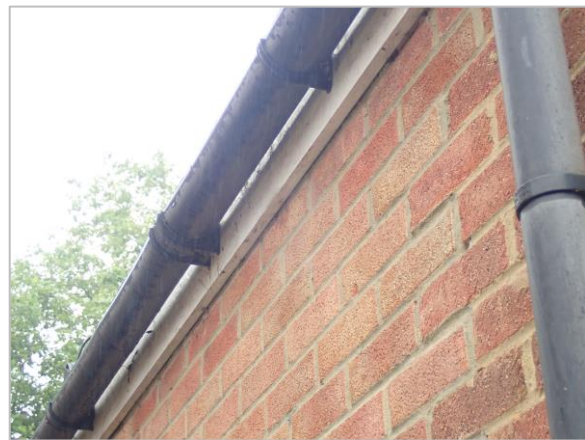
*Photo 16 Fascia around flat roofed extension*
