## Preliminary Contamination Risk Assessment

PROPOSED RESIDENTIAL DEVELOPMENT AT  
NO. 6 NORFOLK ROAD,  
READING,  
RG30 2EE

Report Ref: 19CLR4615CW

**Report Date: 28<sup>th</sup> November 2019**

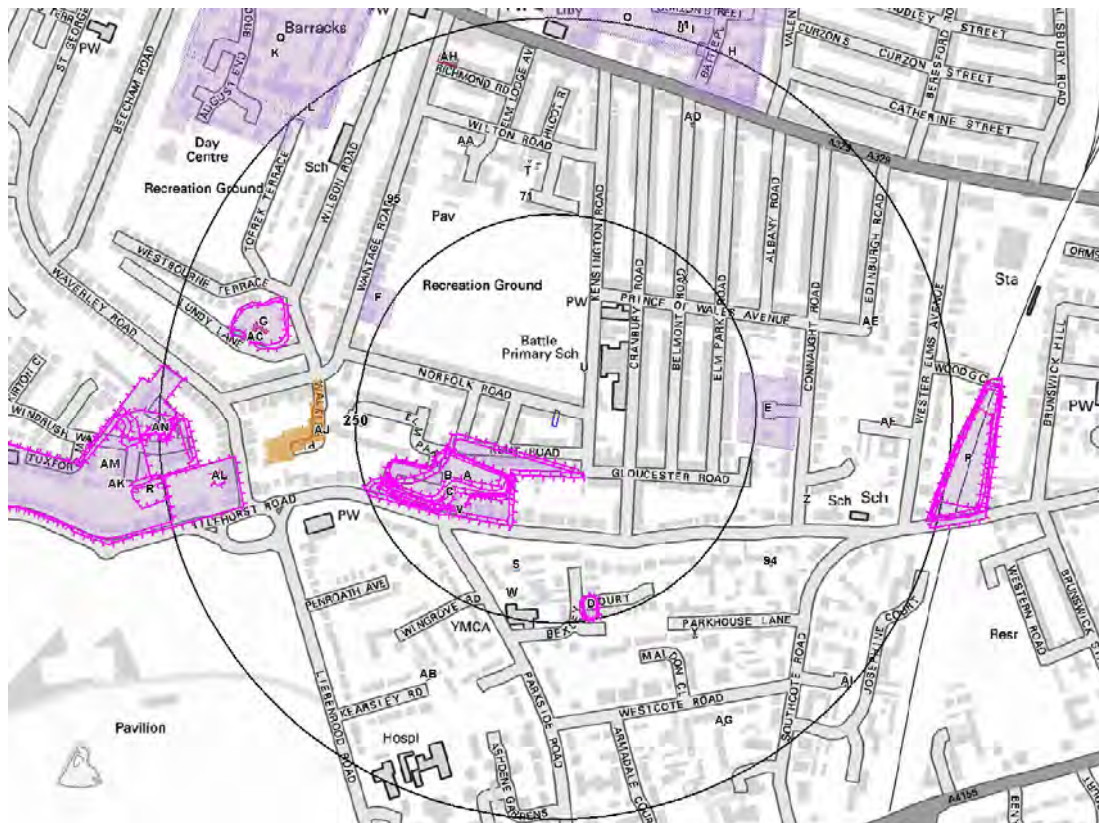
The following records of potentially contaminative historical land uses within 250m of the site are shown:

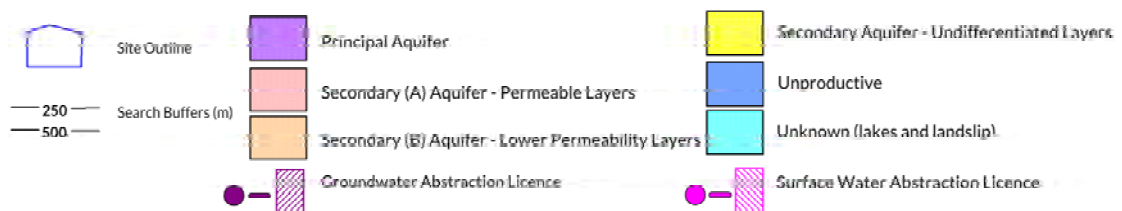
The aquifer within the bedrock at the site is classed as a principal aquifer which is a geology of a high intergranular and/or fracture permeability, usually providing a high level of water storage and may support water supply/river base flow on a strategic scale. The major aquifer has a high leaching potential which is often assumed for sites located in urban areas.

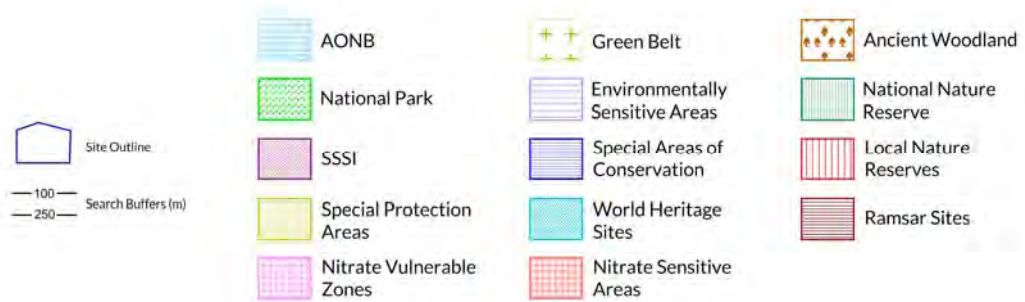
The following designated environmentally sensitive sites are located within 250m of the sites:
