# Verification Report

13-21 Crown Street and 22 Silver Street Reading RG1 2SE

Project Ref. 28957-R03 (00)

**DECEMBER 2020**

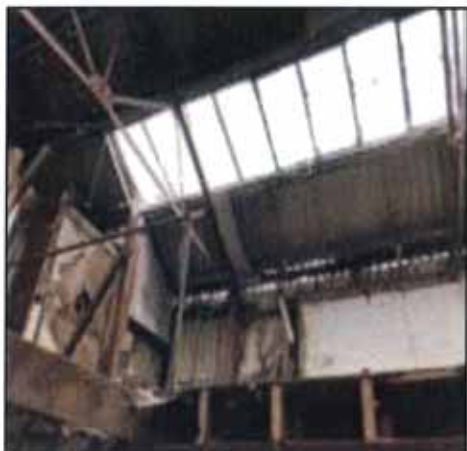
Sample Ref: B01

Location: Wall sheets and flue pipe

Material Sampled: Cement wall sheets and flues

Analysis Result: **Crocidolite (blue) Asbestos**

Condition: **Low Damage**

Remarks / Recommendations: **Remove prior to demolition**

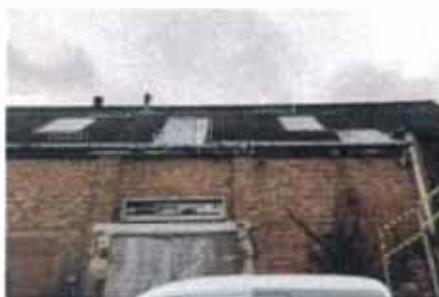
Sample Ref: B02

Location: Roof sheets

Material Sampled: Roof sheets to both units

Analysis Result: **Chrysotile (white) Asbestos**

Condition: **Low Damage**

Remarks / Recommendations: **Remove**

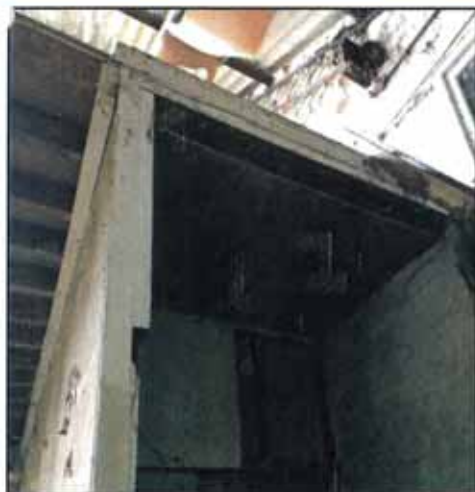
Sample Ref: B03

Location: Boiler room left hand building

Material Sampled: Insulation board lining

Analysis Result: **Amosite (brown) Asbestos**

Condition: **Low Damage**

Remarks / Recommendations: **Remove**

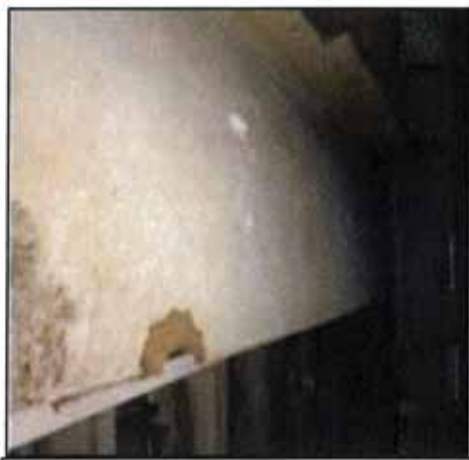
Sample Ref: B04

Location: Throughout warehouses

Material Sampled: Fibreboard

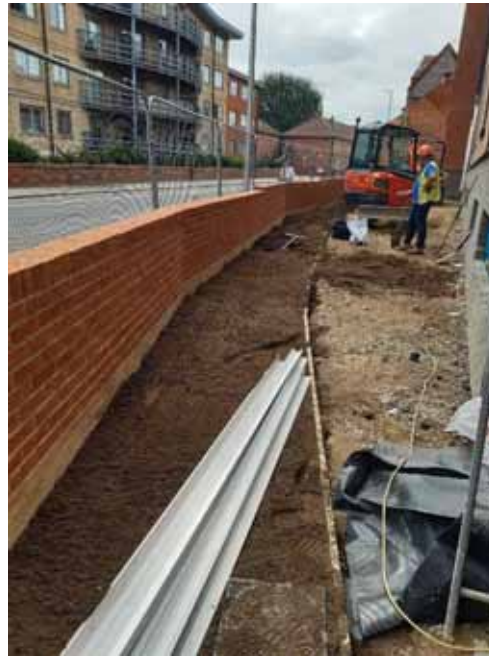
**Direction Photo Taken:**  
South

**Description:**  
Topsoil Planting Bed  
(eastern boundary planter)

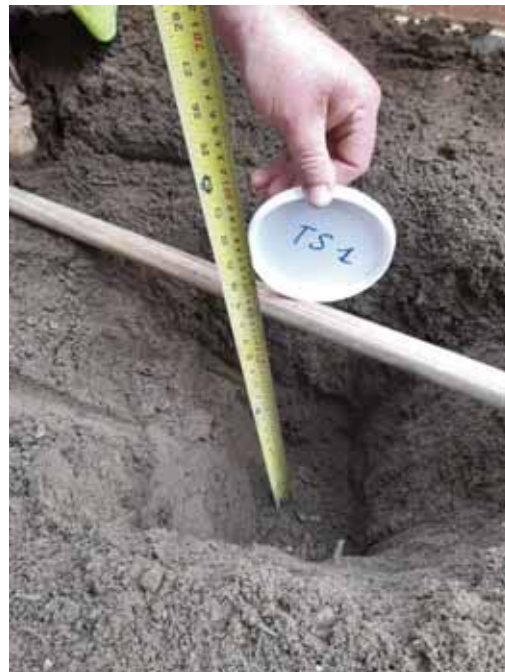
**Photo No.**  
2

**Description:**  
Inspection pit TS1

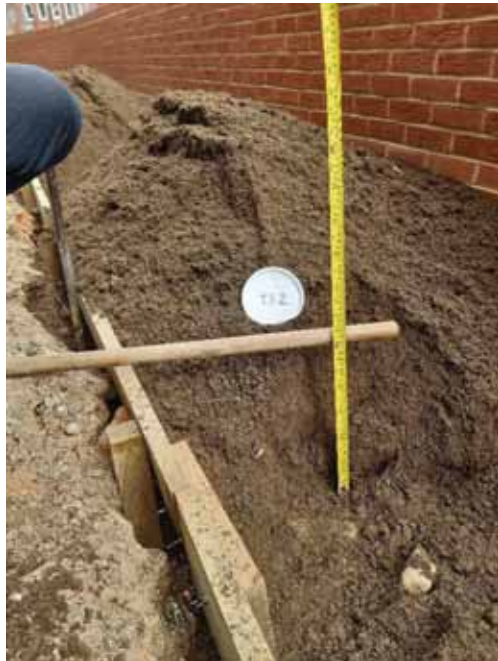
| <b>Photo No.</b><br>3 | <b>Date:</b><br>08/09/20 | |
| <b>Description:</b><br>Topsoil sample TS2 location | | |

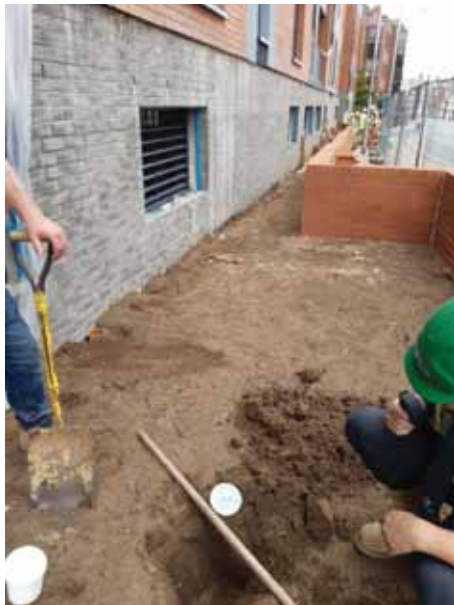
| <b>Photo No.</b><br>4 | <b>Date:</b><br>08/09/20 | |
| <b>Description:</b><br>Topsoil Planting Bed<br>(northern boundary planter) | | |

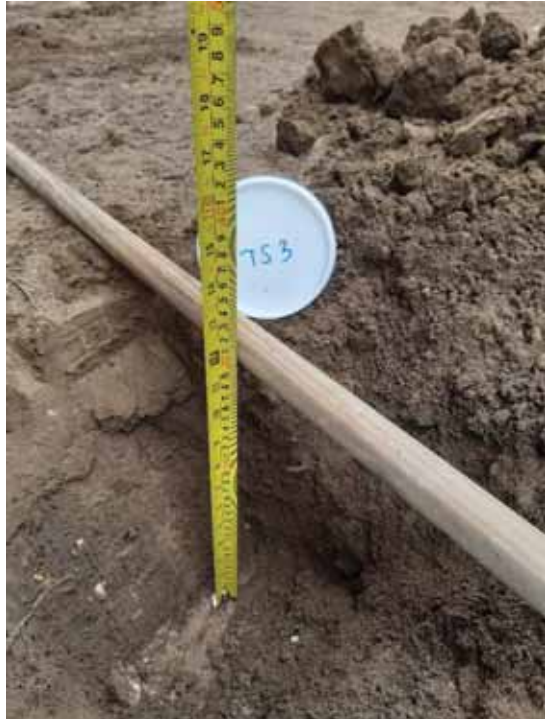
| <b>Photo No.</b><br>5 | <b>Date:</b><br>08/09/20 | |
| <b>Description:</b><br>Inspection pit TS3 | | |

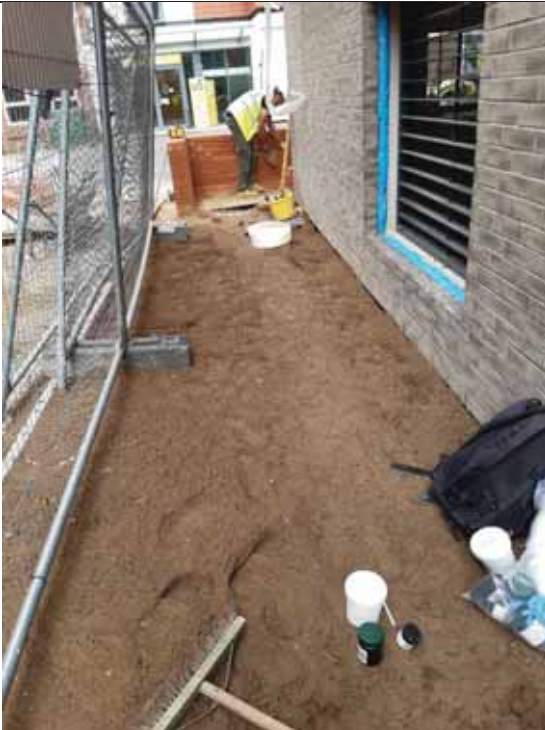
| <b>Photo No.</b><br>6 | <b>Date:</b><br>08/09/20 | |
| <b>Description:</b><br>Topsoil Planting Bed<br>(The Western Wall) | | |

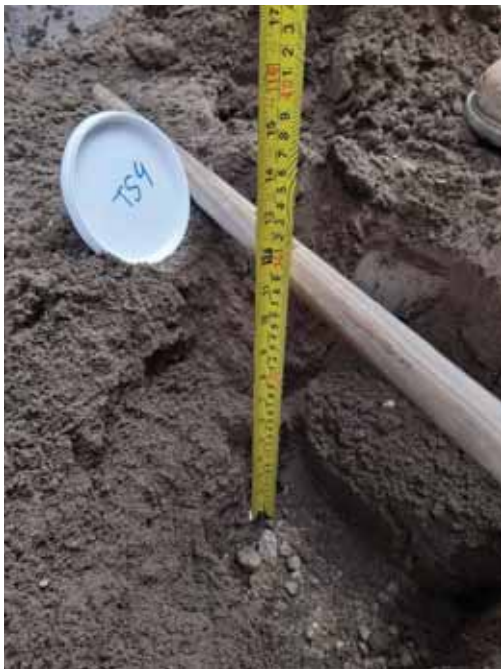
| Photo No.<br>7 | Date:<br>08/09/20 | |
| Description:<br>Inspection pit TS4 | | |

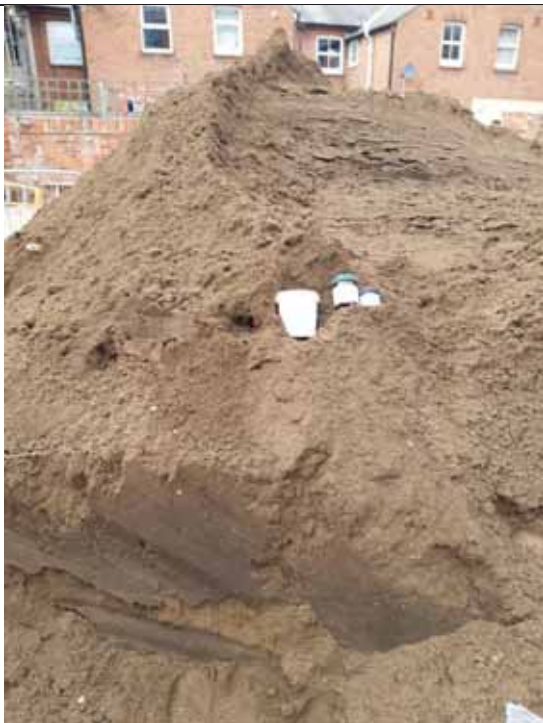
| <b>Photo No.</b><br>8 | <b>Date:</b><br>08/09/20 | |
| <b>Description:</b><br>Topsoil sample TS5 location, obtained from<br><br>Topsoil stockpile located to the south-west of the building | | |

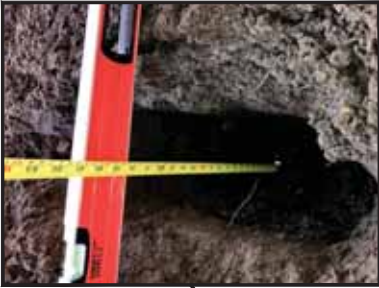
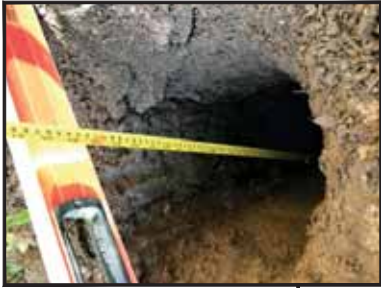
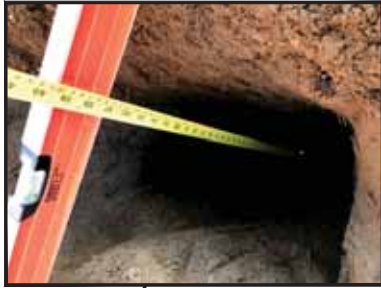
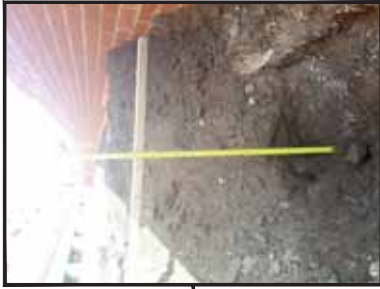
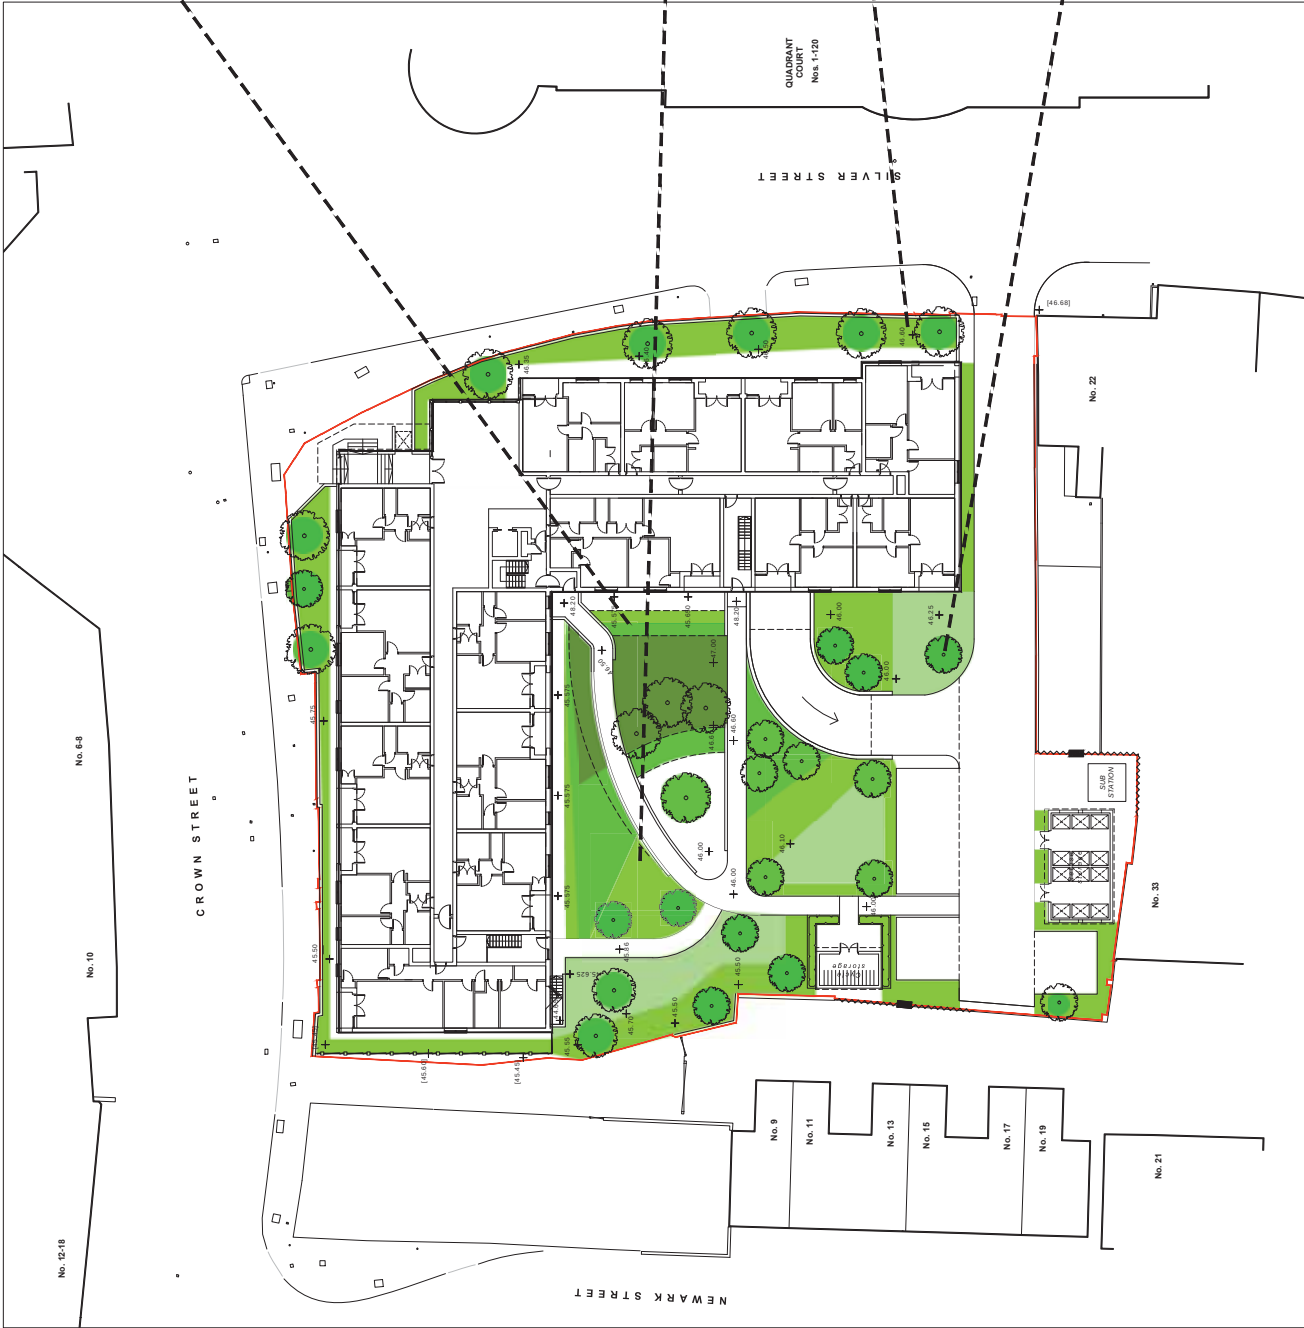
Overall Soil Depths between 1000mm+

When located under tree locations, soil depth to be minimum 900mm. Refer to landscape architect's drawing for soil outline.
