173-175 Friar St &  
27-32 Market Place,  
Reading

## Bat Survey Report

Prepared by  
CSA Environmental

Report No: CSA/3517/04

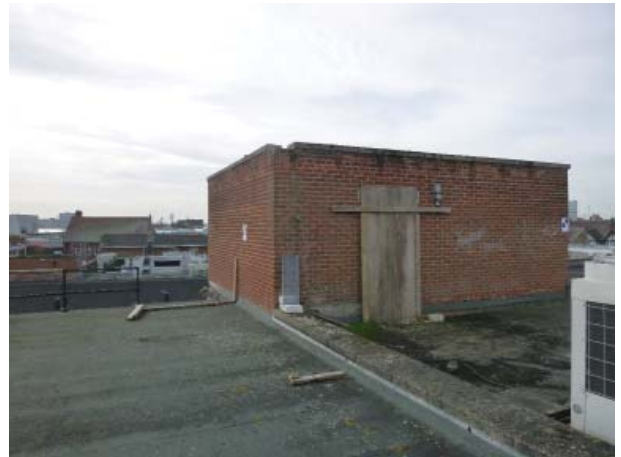
Plate 4. Roof and small external structure/room of 173-175 Friar Street - 'Bristol and West Arcade'

- 3.7 The basement of 173-175 Friar Street was not accessible at the time of surveys due to the presence of asbestos. A small structure/room located on the roof of the building was not accessible via the loft hatch on the third floor or from the roof due to access points being blocked off. The exterior of this structure/room was well sealed with a flat bitumen felt roof

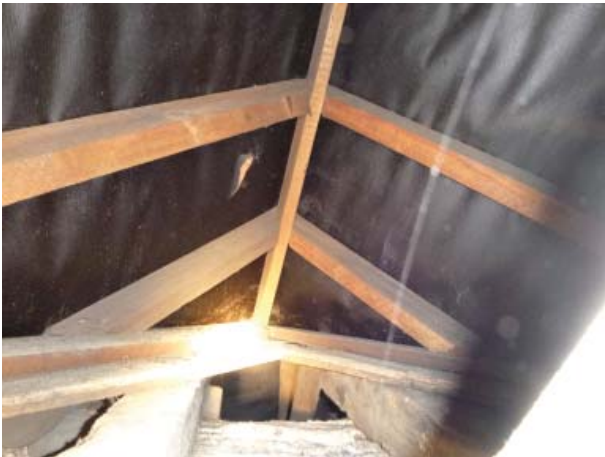
Plate 9. Roof void above dormer window on third floor of of 27-28 Market Place - 'Kik Sports'. Small tear in bitument felt lining. Visible via hole in ceiling.

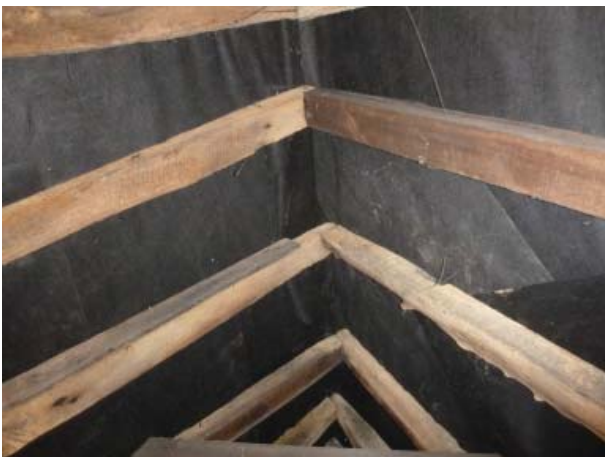
Plate 17. Bitumen lining of roof void of 29-31 Market Place 'Coopers Arms'

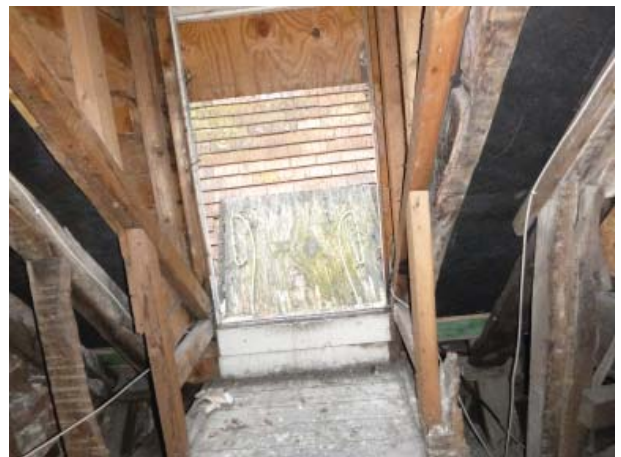
Plate 18. Chicken wire over window in roof void of 29-31 Market Place 'Coopers Arms'

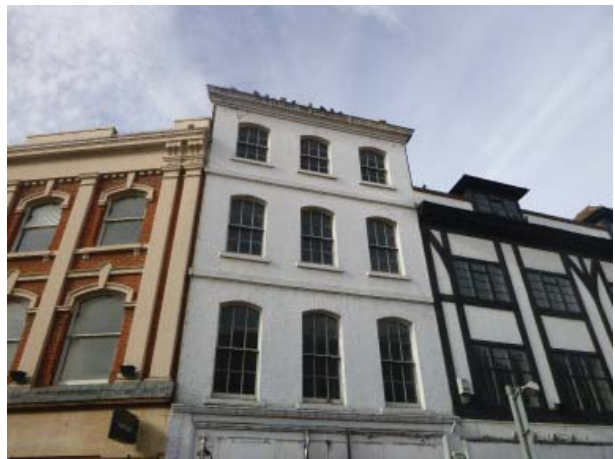
Plate 20. Exterior of 32 Market Place (upper levels, not accessed during survey)

- 3.8 The first, second and third floors and the roof void of 32 Market Place were not accessible at the time of surveys due to access points being blocked off. However, the ground floor was inspected internally and the building was accessed from the exterior for inspection. Given the suitability of the rest of the building it is not considered that a lack of access to these areas would severely impact the outcome of the survey.
- 3.9 Prior to the survey, evidence of bats may have been removed/obscured as pigeons and associated guano had recently been cleared from the roof void of 29-31 Market Place with chicken wire placed on windows to exclude pigeons. Further survey recommendations have been made on the basis of the suitability of this building for bats rather the presence/absence of bat evidence (which may or may not have resulted from recent pigeon removal).

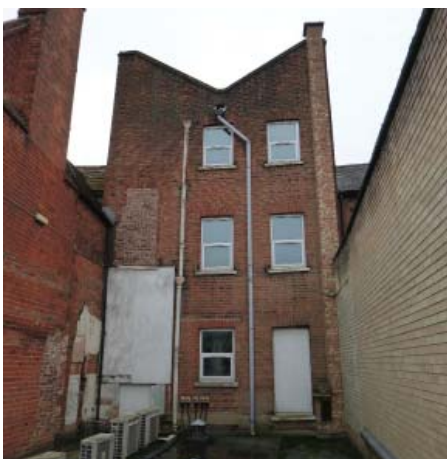
Plate 23. Rear exterior of 32 Market Place (interior of these levels not accessed during survey)

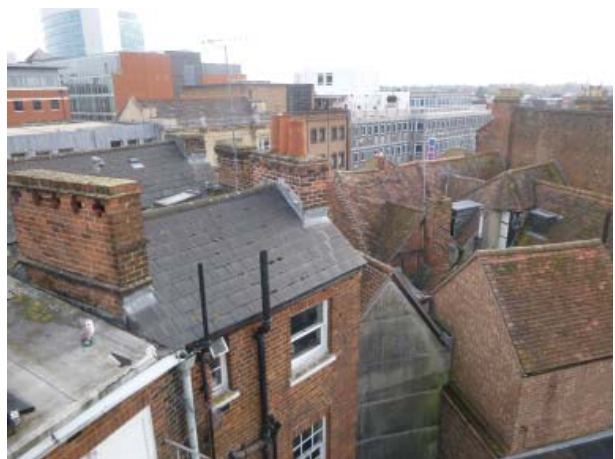
Plate 24. Roof structure of 27-32 Market Place

- 5.1 The survey work undertaken in 2018 and 2020 to date has confirmed the presence of up to seven minor common pipistrelle day roosts within the roof structure of 27-32 Market Place. In line with the methodology set out in Wray *et al* (2010), these roosts are all considered to be of '**Local**' importance. Structures at 173-175 Friar Street have 'Negligible' potential to support roosting bats with no bat roosts recorded and are therefore not of importance in respect of bats.

- 5.4 Works are proposed for to the rear of the roof of 27-32 Market Place, in addition to four rooflights. The majority of the roof and its structure is understood to remain intact with only a limited number of tiles having to be removed to allow for the new structures.

- 5.8 To compensate for the anticipated loss of a single common pipistrelle roost a minimum of two bat access tiles will be provided within the new roof, once works are complete. This access tile will continue to allow pipistrelle bats to make use of the crevice formed between the tiles and roofing felt. No modern 'breathable' roofing membranes will be used within any of the roof voids, with traditional bitumastic felt to be used, allowing bats to use crevice roosting features safely.
