# TENDER

## Demolition Method Statement

**Project:** Reading Gasholder Dismantling

**Location:** Alexander Turner Close, Reading

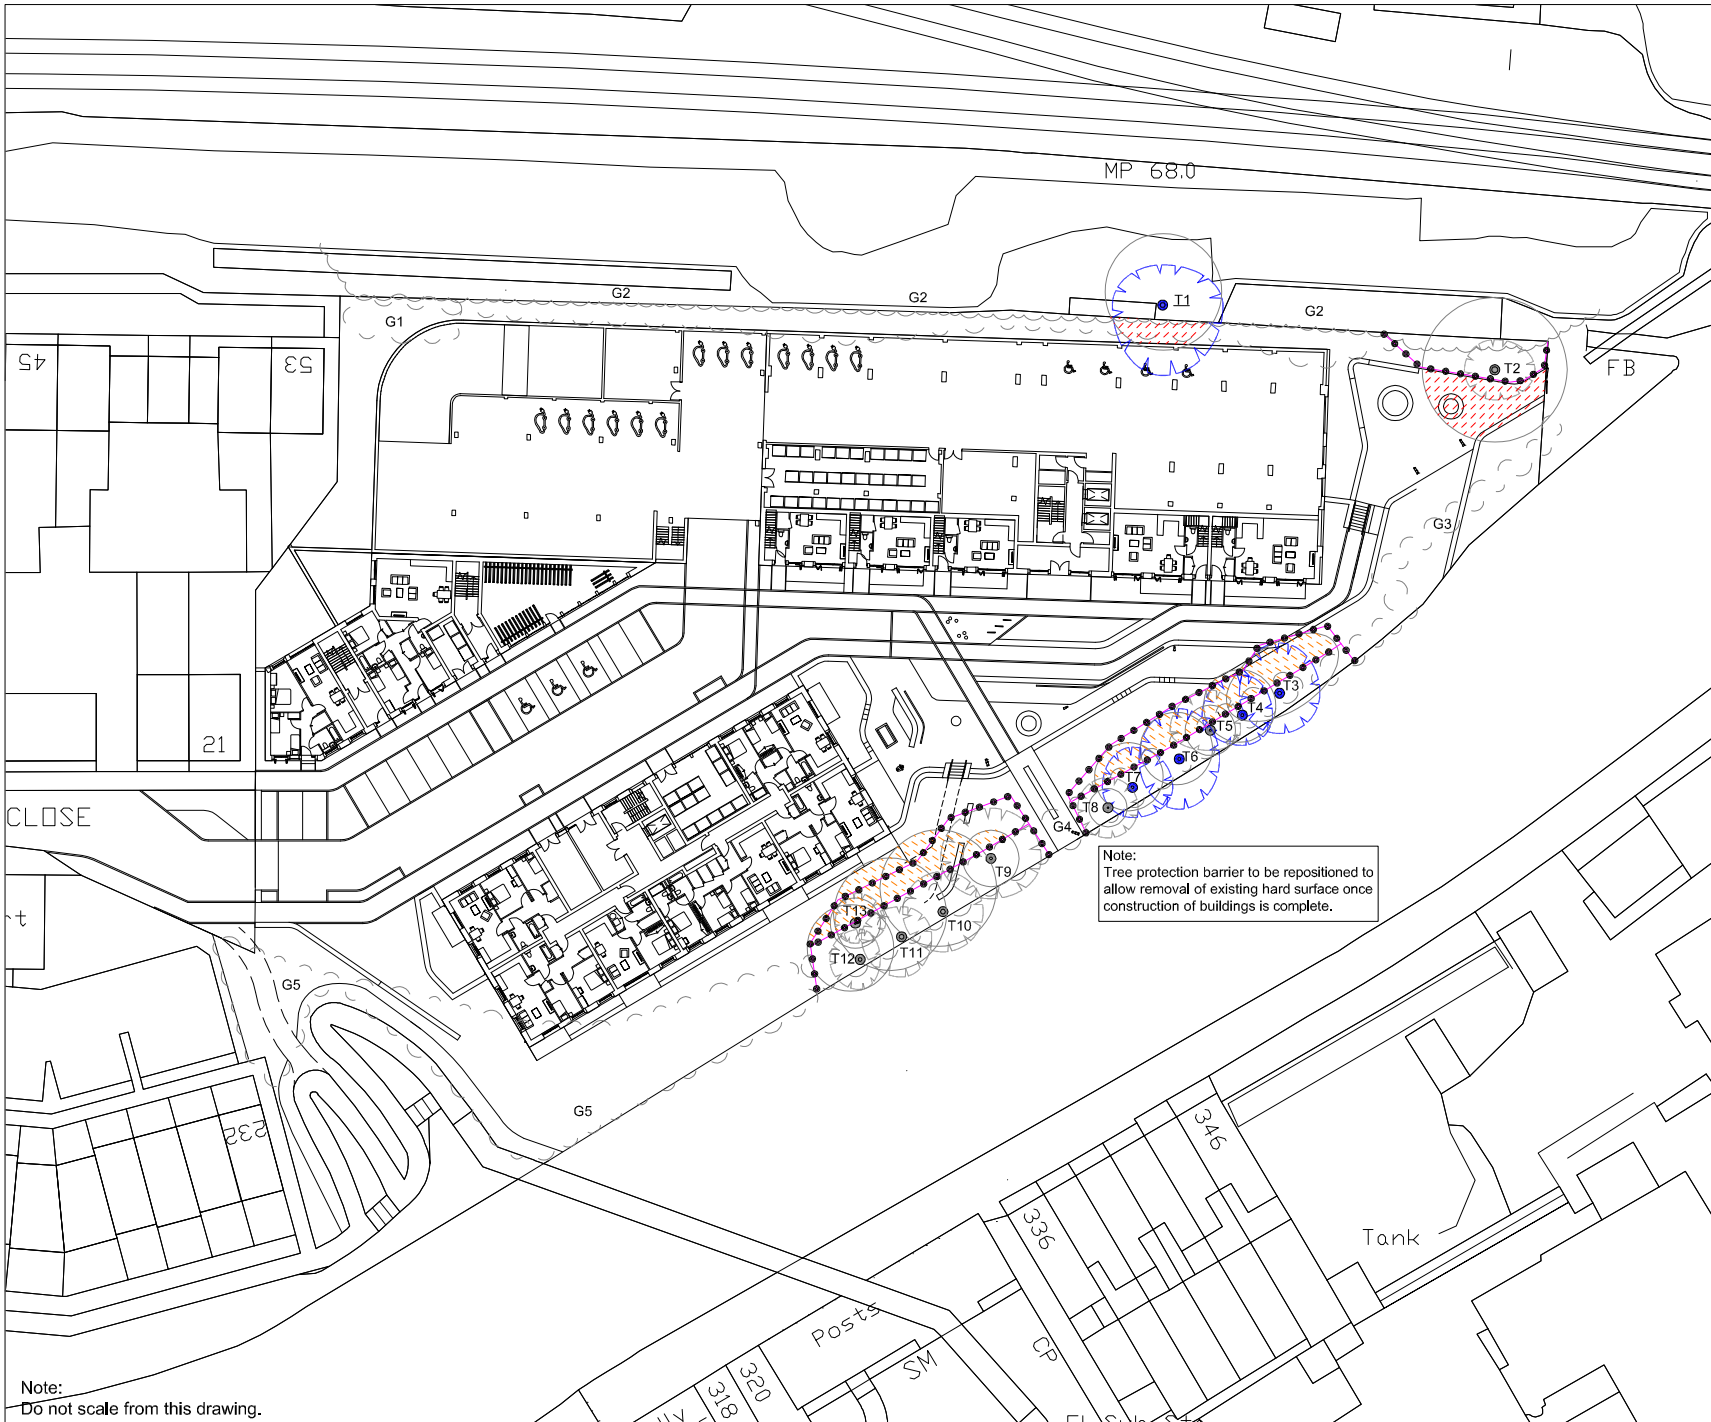
## Tree Categories

- Root protection area (RPA)
  - Diameter of trunk
  - Tree number as recorded on Survey Schedule
  - Tree canopy
  - Coloured symbol indicating BS category as shown below
- Category A tree  
BS5837 2012
  - Category B tree  
BS5837 2012
  - Category C tree  
BS5837 2012
  - Category U tree  
BS5837 2012

5.1.2 The quality and relative importance of each tree is illustrated as a coloured polygon. The colour used relates to the BS categories as follows: A - green, B - blue, C - grey and R - red (see accompanying drawing reference J20563\_TPP). In general the design process will try to retain A and B category trees. Proposed construction will therefore normally be excluded from the RPA of A and B category trees. Red trees are discounted as they are recommended for removal.

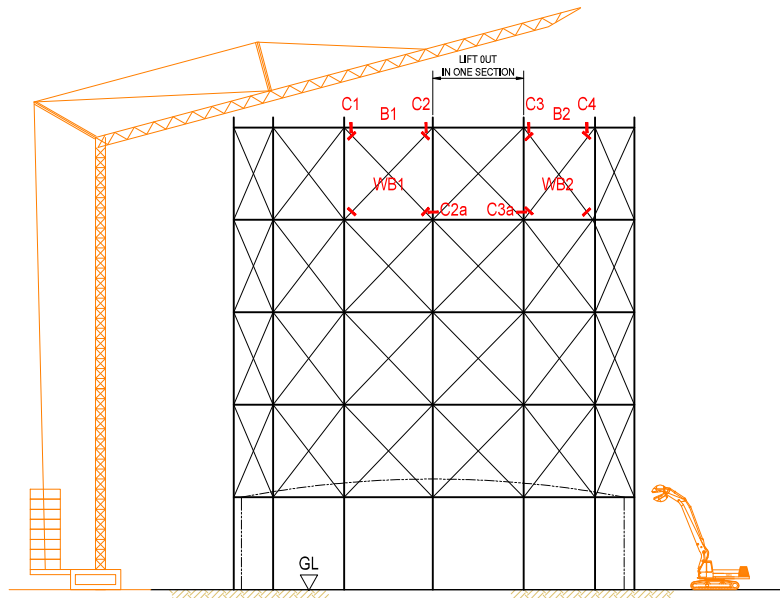
ELEVATION ON GAS HOLDER No.4  
SHOWING COLUMN DISMANTLING SEQUENCE 1.

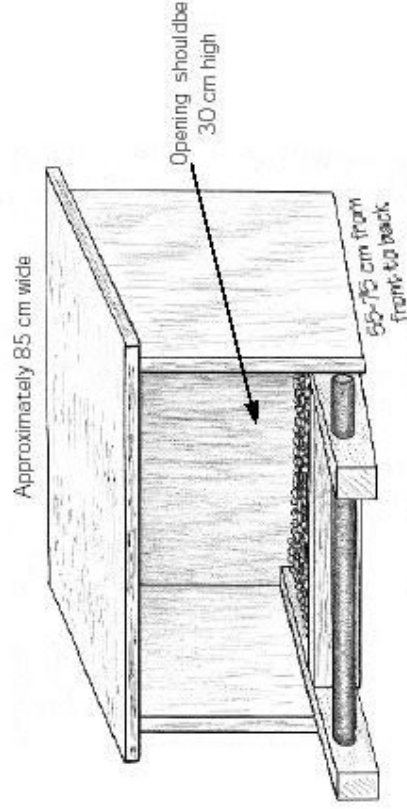
## 3 PERCH DETAILS

An indicative detail of the perch box is provided in the sketch below which includes dimensions. The Tenderer is to provide exact details and dimensions of the proposed perch for approval by Greenspace Ecology.

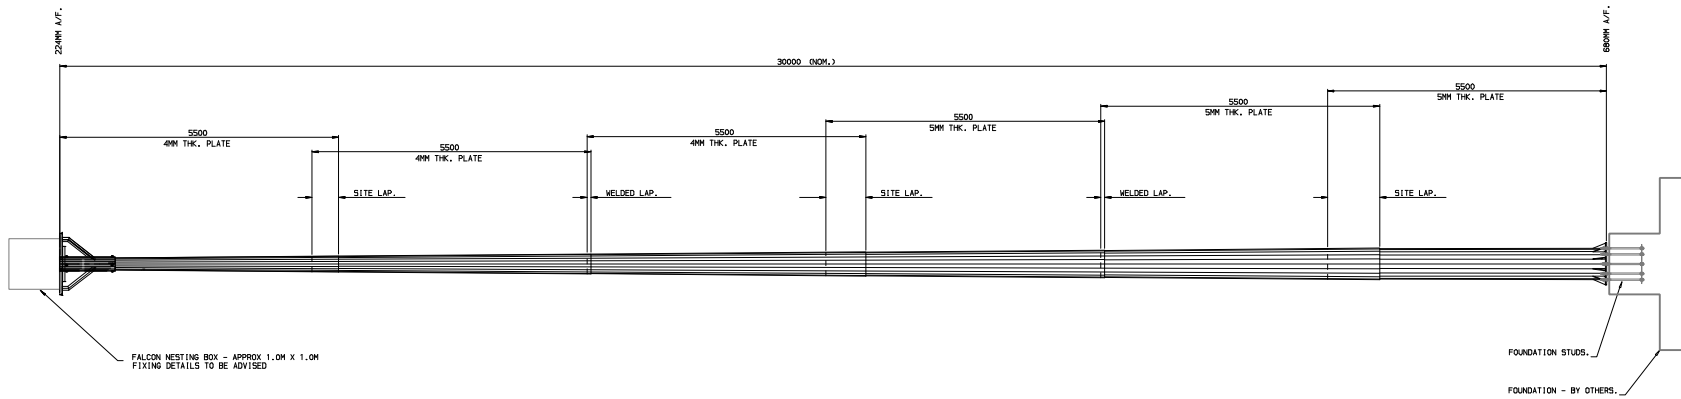
ALL DIMENSIONS IN MM.  
ALL PLATE TO BS EN 10025; MAST SHAFT - GRADE S355JR, FLANGEPLATE - GRADE S275J2.  
ALL WELDING TO BS EN 1011.  
FABRICATION OF STEELWORK TO BS EN 1090-2 FOR EXC2.  
FINISH: H.D.G. TO BS EN ISO 1461  
SCALE 1:35 (A0 SHEET) - UNLESS STATED OTHERWISE.

DETAIL OF FLANGEPLATE.

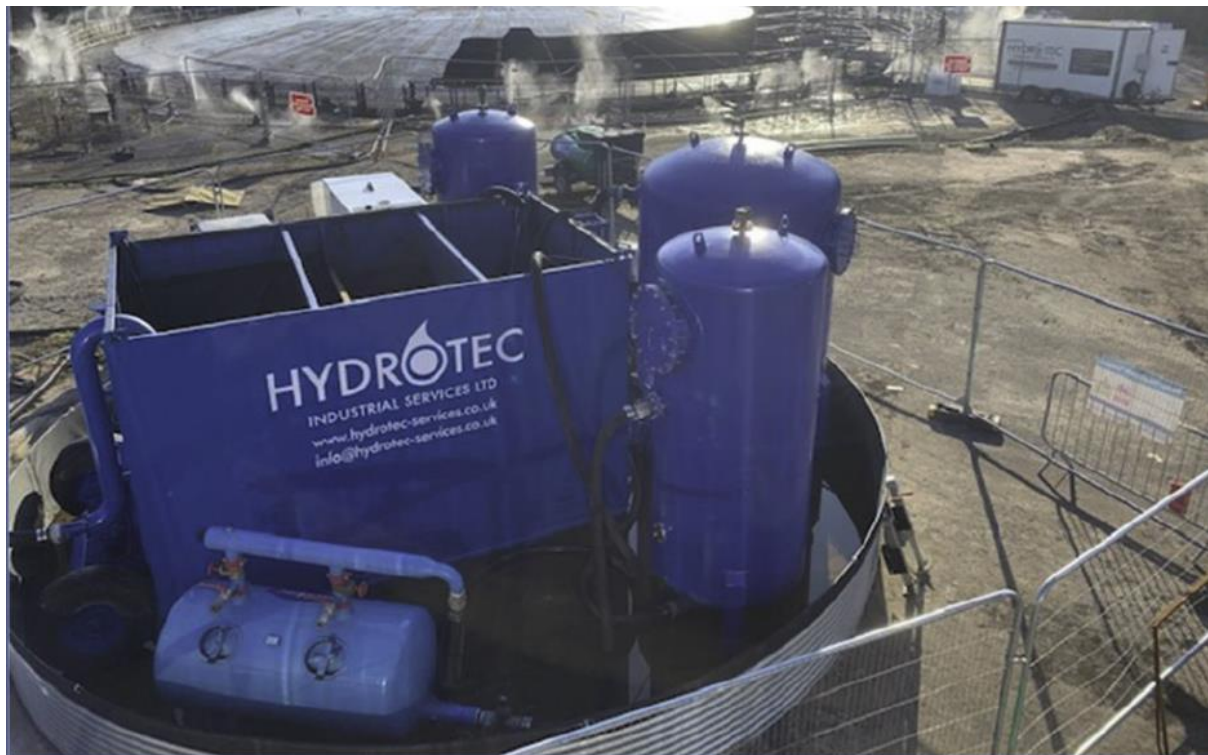
Works starts with the Dewatering of the Gasholder which is undertaken under Discharge Consent License from Thames Water. This was applied for by SGN. This specifies the rate of water which can pump into the Foul Sewer as well as the Chemical Content contained within the water. The water is sampled weekly by us to confirm that it meets the requirements of the Discharge Consent set by Thames Water. Thames Water as come to Site to make spot checks and take their own Water Samples. The majority of the Gasholder Water has already been Discharged by SGN's Contractor. The remaining water is still to be Discharged with a rate for this project at 5L/s. This is going to take a further 1.5 weeks to Dewater the remaining 2500 cubic meters of water. The water is pumped out of the Gasholder through continuous Hoses through a series of Filters and Scrubbers finishing off passing through a Carbon Filter before entering the Foul Sewer. Note the entire equipment set up to undertake this task is located with a Bund, the Bund has a level Float System for any leaks will be contained, if the Level gets to the Level Float the Pumps are automatically switched off preventing a loss of containment.

During the Dewatering Process as the water passes through the Methane Stripper this can cause odours similar to Gas, during this phase the Contractor will deploy its Odour Suppressant System. This comprises of a 100m Line featuring 50 Dispersant Nozzles spraying a fine mist dosed with Odour Surfactant which will help mitigate and eliminate nuisance odours. An Odour Scoring System will be used throughout the Works, please see the Odour Monitoring Record Documents. If odours become problematic throughout other Hydrotec Operations, the Odour System will be installed.

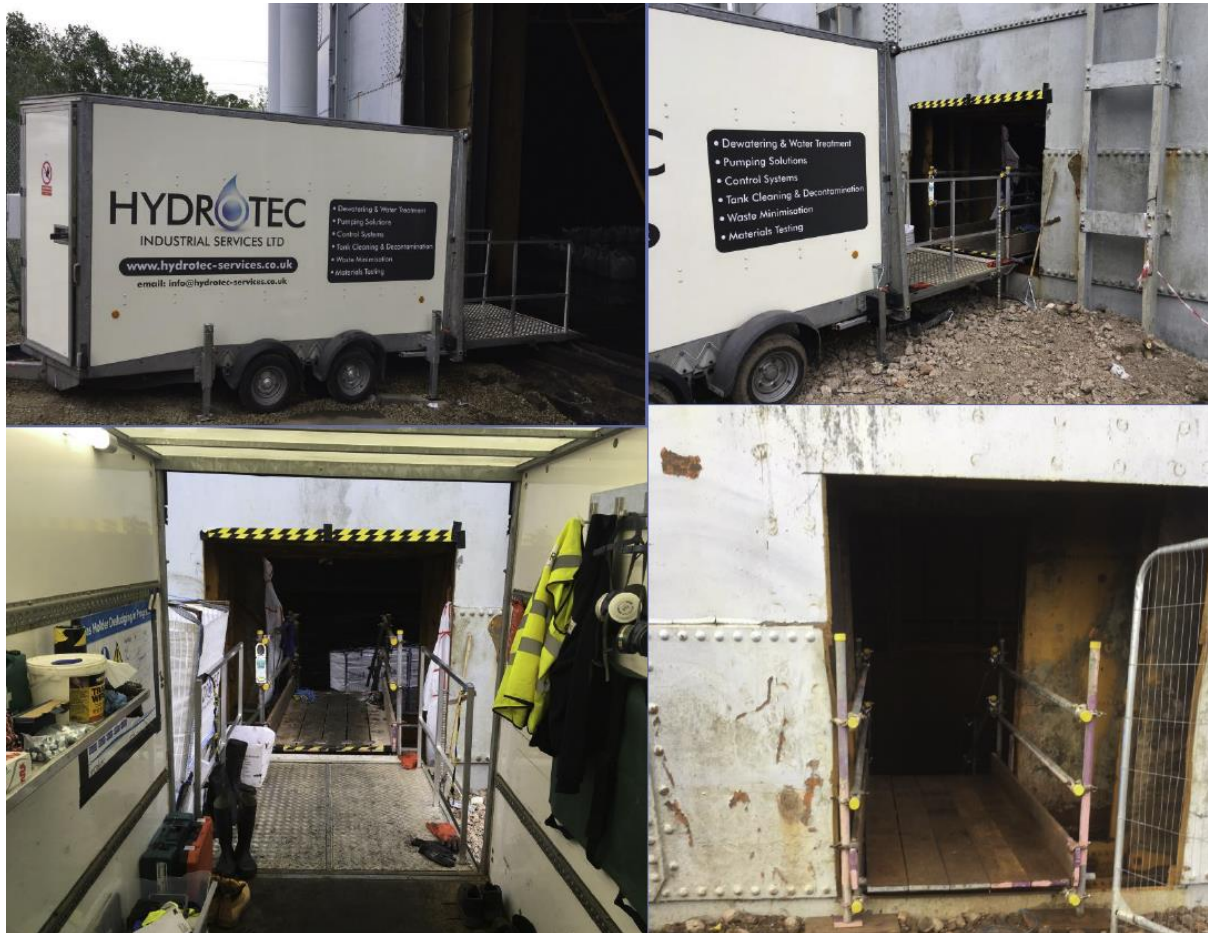
Access into and out of the Gasholder is controlled through a Decontamination Unit to ensure that we don't bring out the Sludge and contaminate the ground around the Gasholder.

This run off water will be pumped through a Filter Vessel inside the Gasholder and Discharged through the Thames Water Discharge Consent License. The remaining “treated” wet Sludge will be transferred into Filter Dewatering Bags for draining. Note this process is still undertaken from with the Gasholder which minimise the risk of ground contamination.

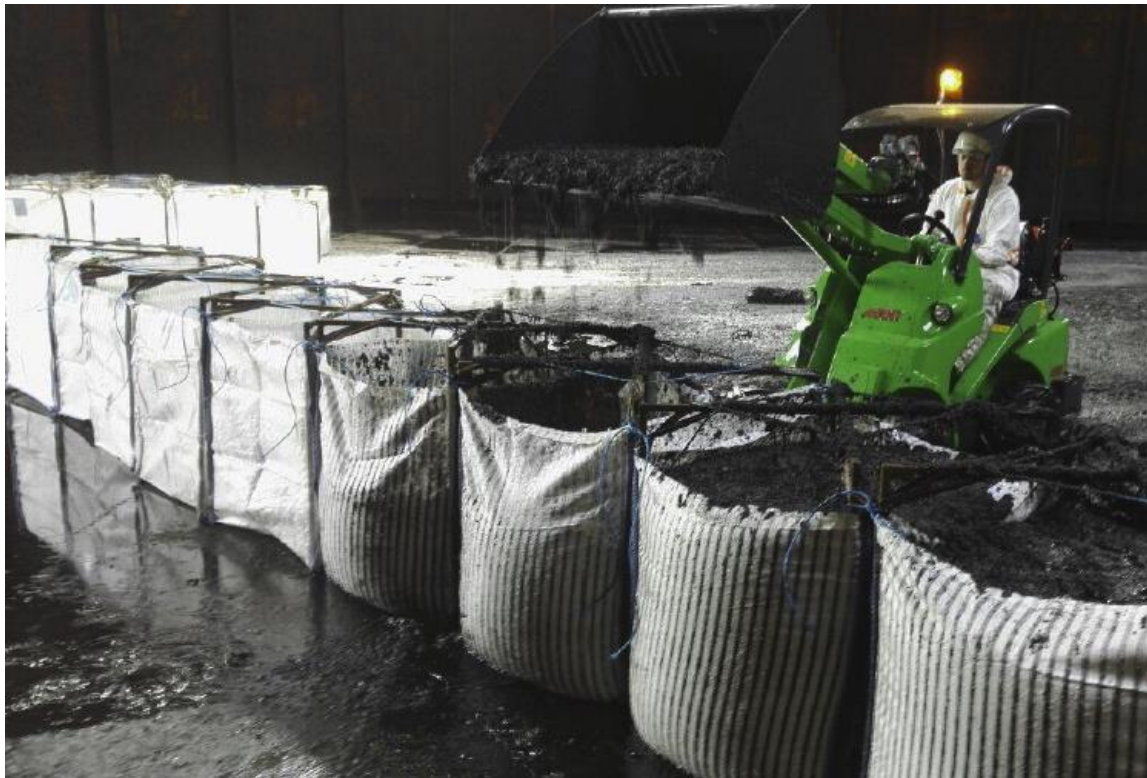
The Sludge is removed in two phases, the first being the longest at approximately 5 - 7 days, the second phase Sludge clean can only be undertaken following a significant amount of Gasholder Deconstruction. The second phase typically takes 3-4 days. Again, like the Dewatering, both Phases can create a Gaseous Odour and so we will again deploy our Odour Suppressant System.

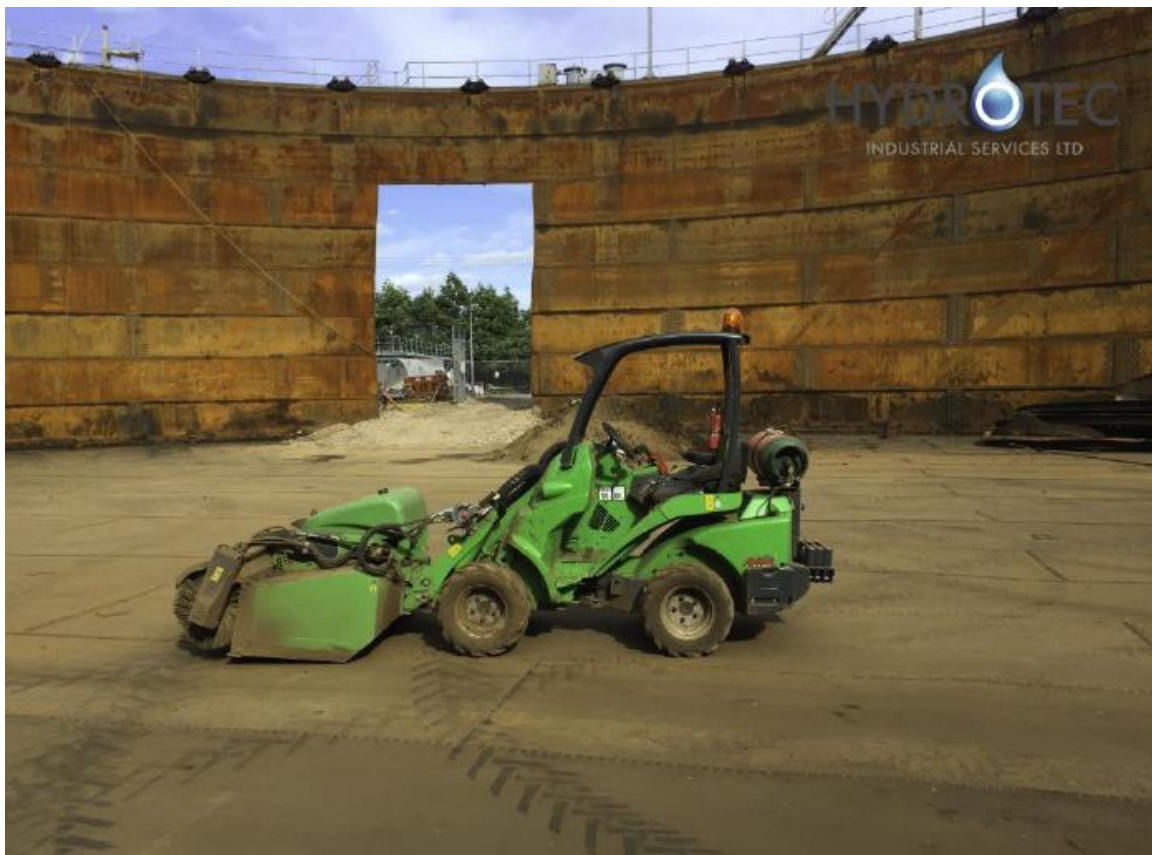
This how the Gasholder looks following both Phases of Sludge removal;

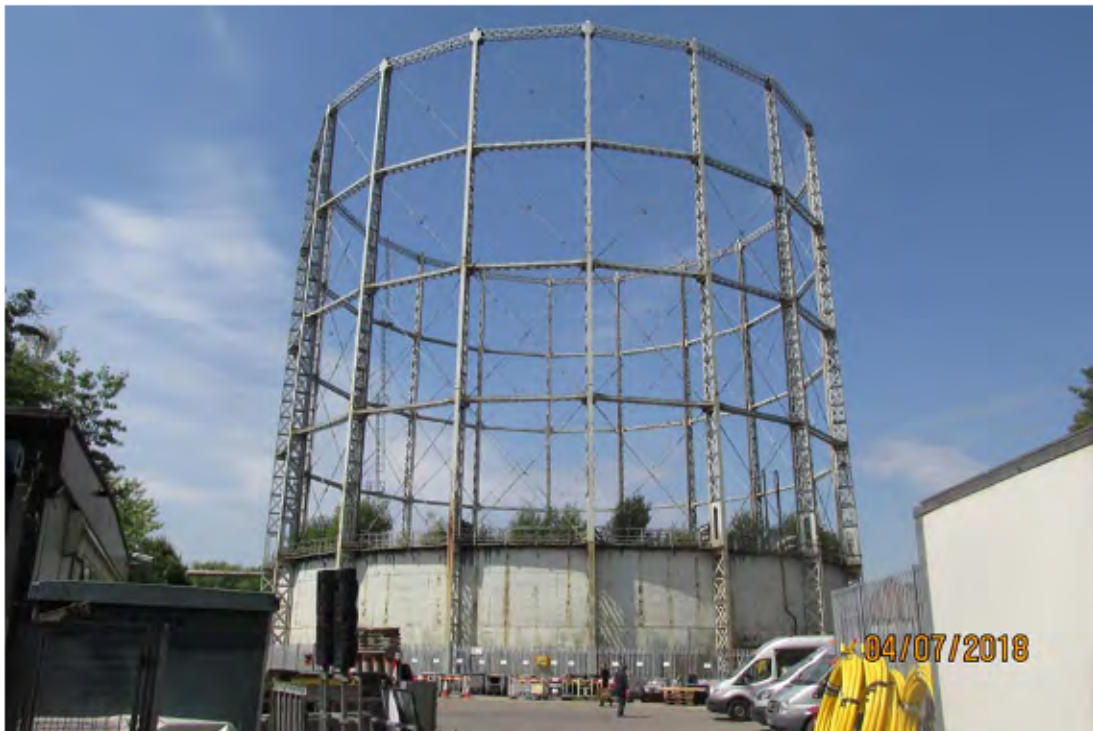
Plate 2. Gasholder located within the site

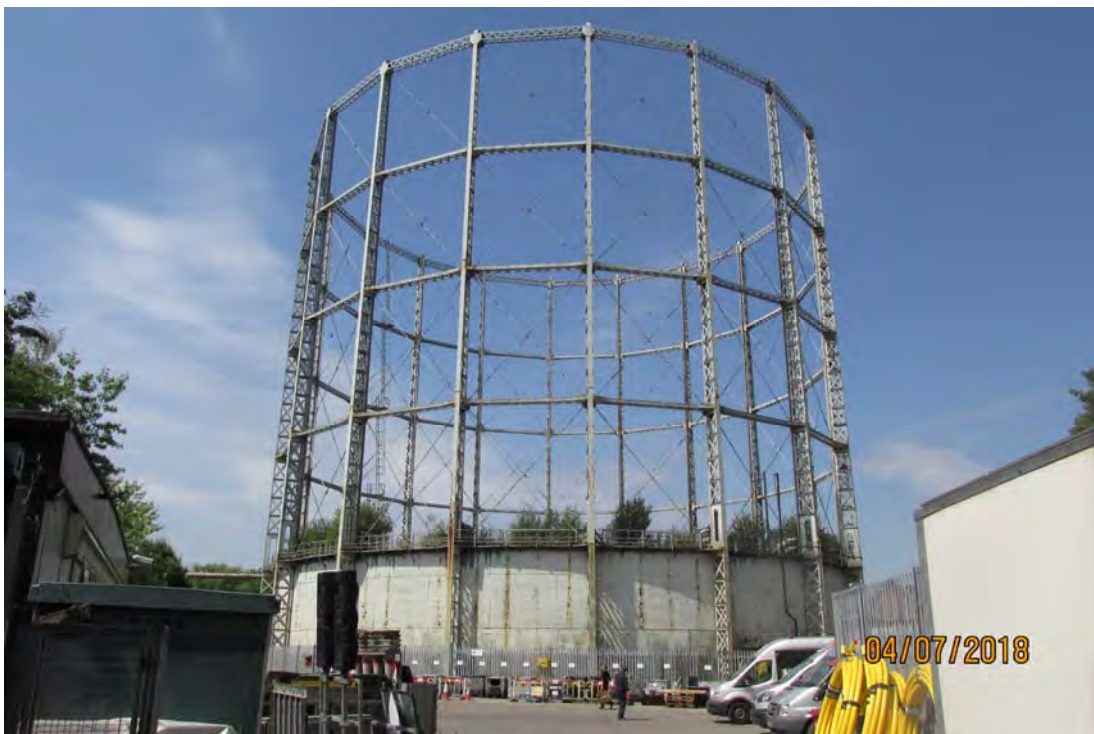
Plate 2. Gasholder located within the site
