**Dellwood Hospital, Liebenrood Road, Reading,  
Berkshire RG30 2DX**

**Bat Survey Report  
& Mitigation Strategy**

**September 2020**

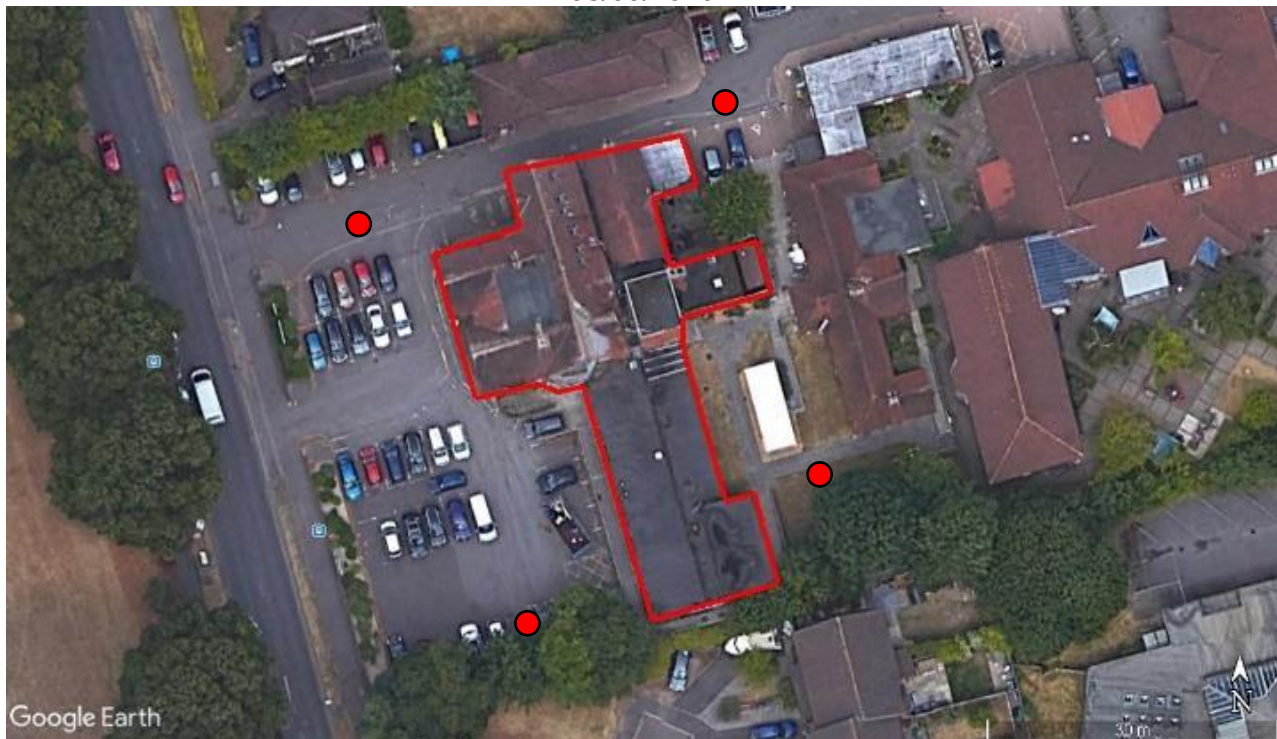
Figure 1. The position of the surveyors at Dellwood Hospital during the bat activity surveys undertaken in 2020. The positions of the surveyors (and infrared camera on one occasion) are shown as red circles. The study building is shown by the red outline.

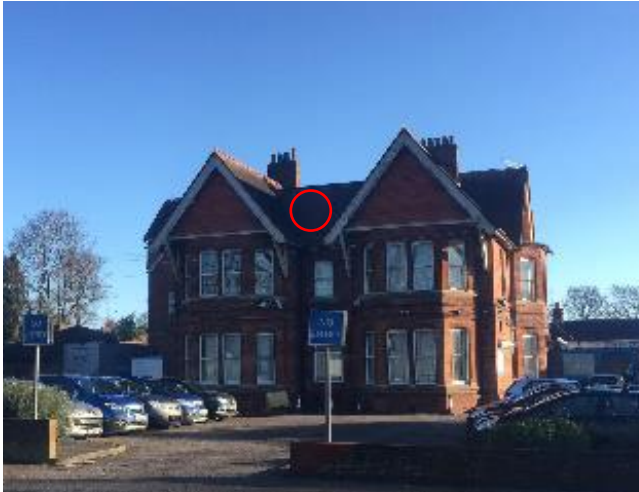
| Time | Species | Emergence (Y/N) | Observation |
|---|---|---|---|
| 21:51 | Common pipistrelle | Y | Emerged from under a tile in the gap between the two western wings (roost access A). |

Roost access A (one common pipistrelle)

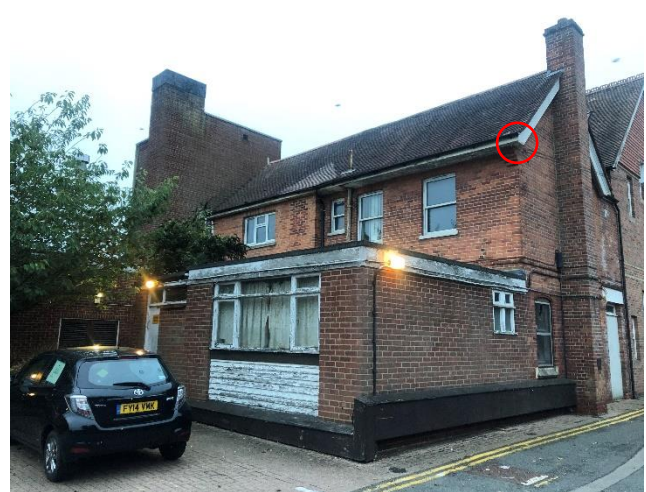
| Time | Species | Emergence (Y/N) | Observation |
|---|---|---|---|
| 22:14 | Brown long-eared bat | Y | Emerged from a gap in the soffit eaves on the north east corner (roost access B). |

Roost access B (one brown long-eared bat)

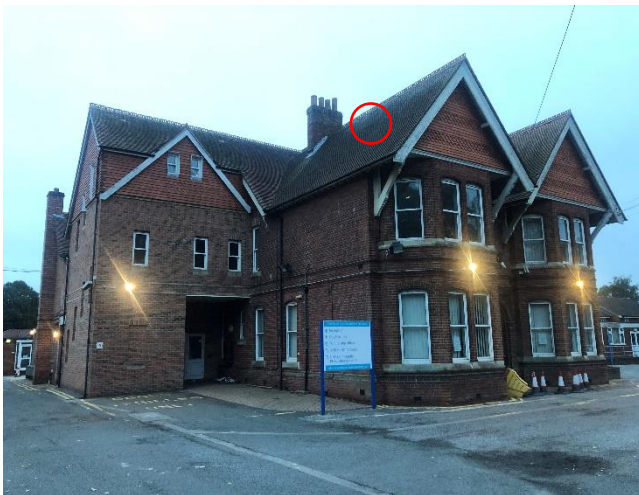
| Time | Species | Emergence (Y/N) | Observation |
|---|---|---|---|
| 21:07 | Common pipistrelle | Y | Emerged from under a roof tile on the northern aspect of the western elevation and flew NW towards the row of trees (roost access C). |

Roost access C (one common pipistrelle)

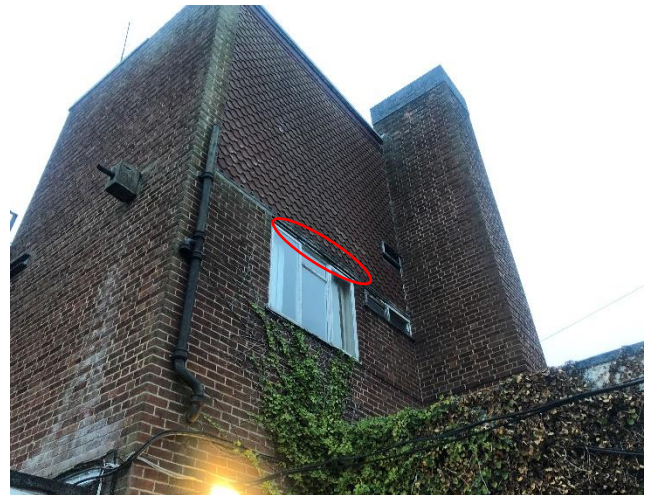
| Time | Species | Emergence (Y/N) | Observation |
|---|---|---|---|
| 06:02 | Brown long-eared bat | Y | Re-entered into gap at the join between the window and hanging tiles on the south eastern elevation (roost access D). |

Roost access D (one brown long-eared bat)
