## **PRELIMINARY ECOLOGICAL APPRAISAL (BATS) AT 34, 36 AND 36A MILL ROAD CAVERSHAM**

**Prepared for:  
Mr E Jennings  
34, 36 and 36A Mill Road  
Caversham  
Reading  
RG4 8DP**

**28 August 2020**

**Ref: SPH/ET/PEA-20/19.08**

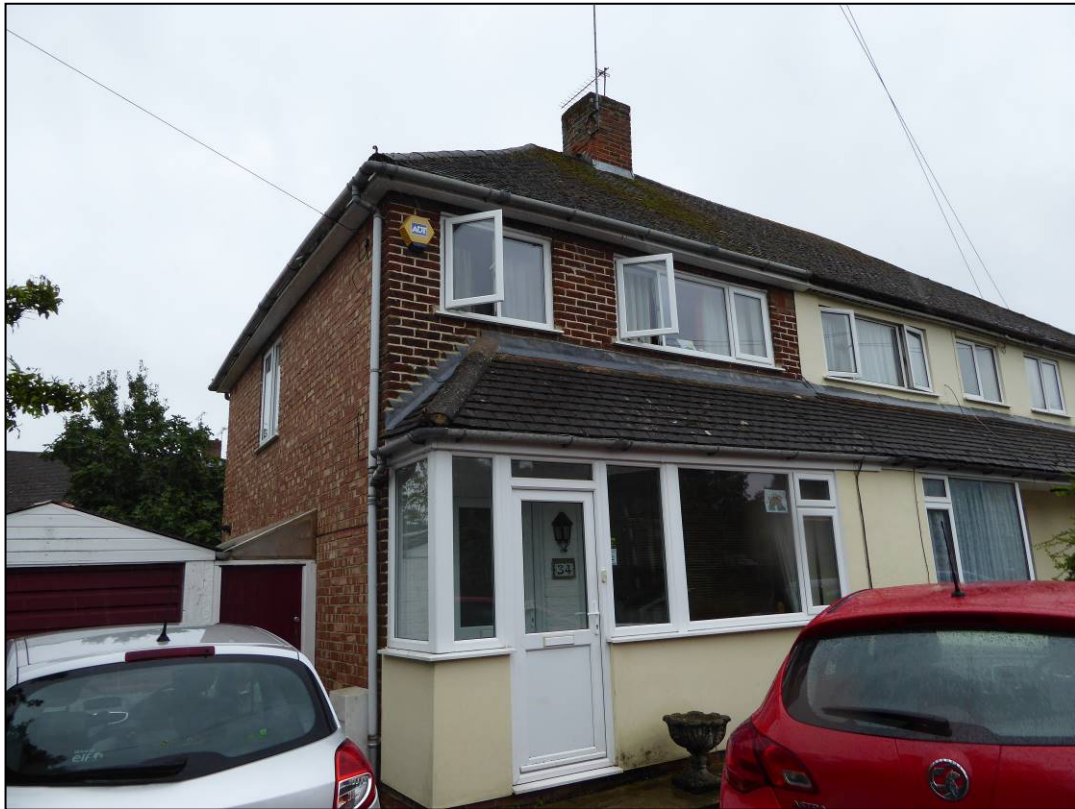
Figure 6. 34 Mill Road, Caversham. 19.08.20

34 Mill Road is an end of terrace building, which is in a fair condition externally, see Figure 6 on page 10. The roof of this property is pitched and covered in close fitting tiles, none of which are missing or broken, see Figure 7 on page 10. The ridge and hip tiles are all close fitting with no gaps in which roosting bats could exploit and the soffits and fascia's are tight to the wall and there were no splits or cracks which could be used by roosting bats, see Figure 8 on page 11. The detached garage at 34 Mill Road was of a concrete and wooden structure and was in a poor condition, see Figure 9 on page 11. The roof had a slight pitch and was covered in asbestos sheets which was tightly fitted, with no gaps in which roosting bats could utilise.

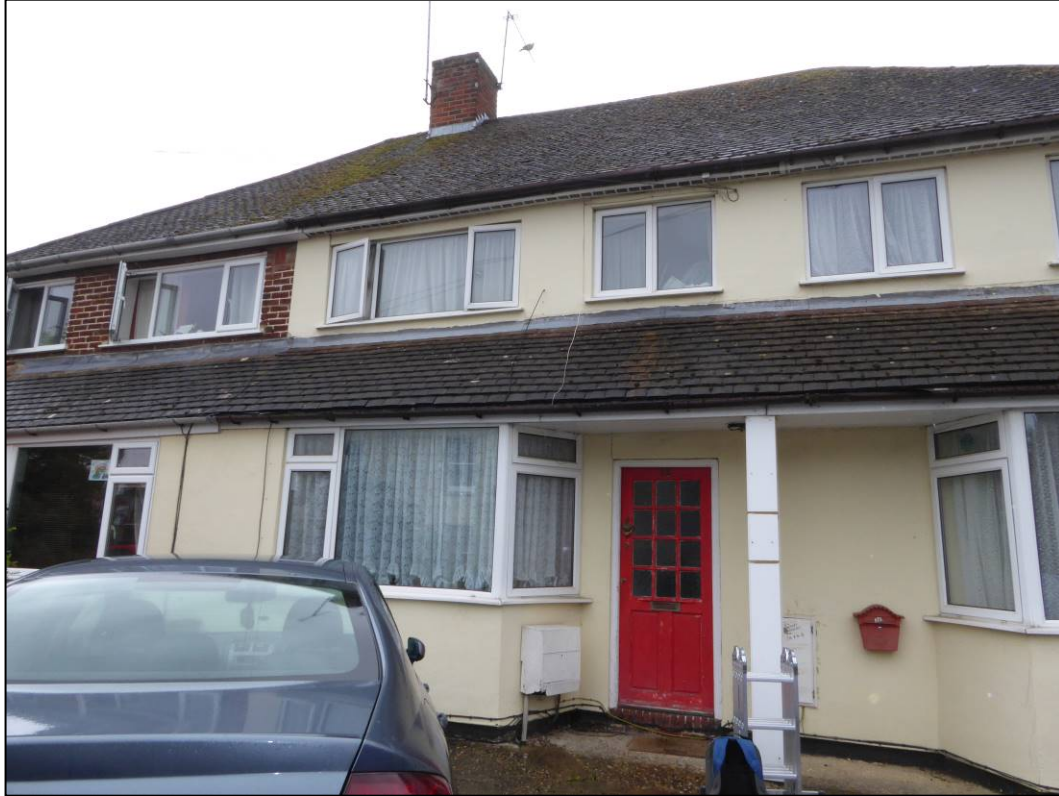
Figure 10. 36 Mill Road, Caversham. 19.08.20

36 Mill Road is the middle terrace property, which is also in a fair condition externally, see Figure 10 on page 12. The roof of this house is pitched and covered in close fitting tiles, none of which are missing or broken, see Figure 11 on page 12. The ridge tiles are all in a good condition with no gaps and the soffits and fascia's are all tightly fitting with no roosting opportunities for bats.

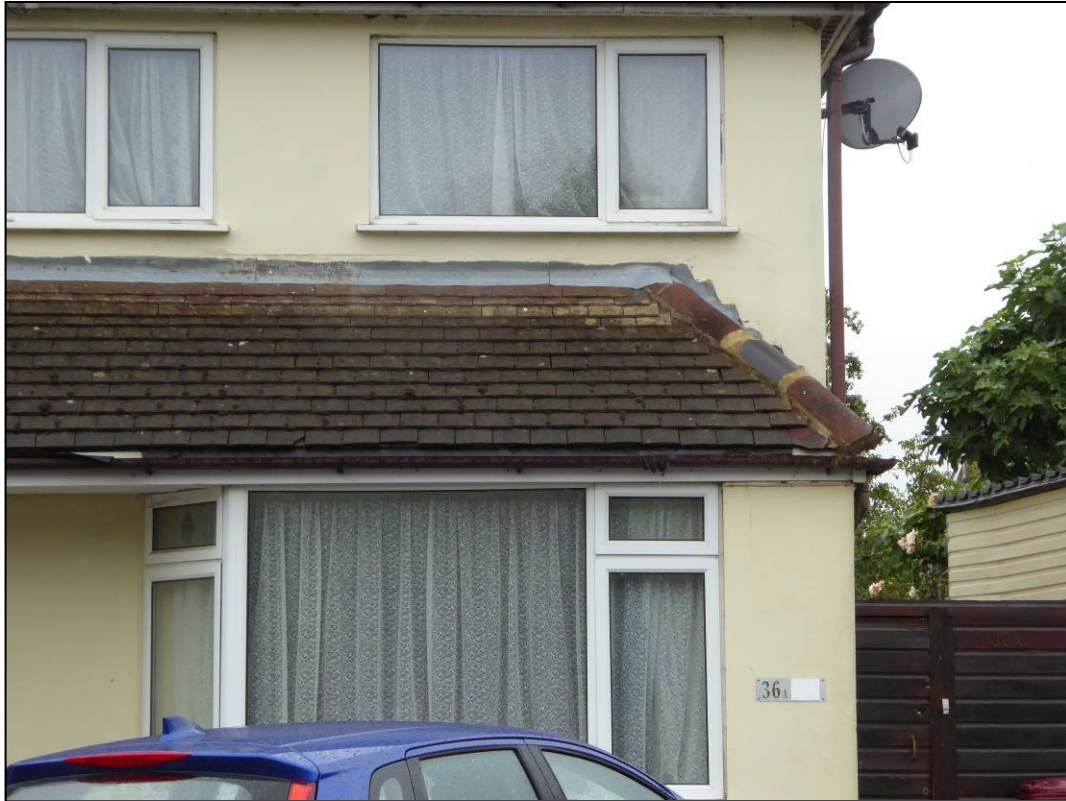
Figure 12. 36A Mill Road, Caversham. 19.08.20

36A is the other end of row terrace house and is also in a fair condition externally, see Figure 12 on page 13. The roof of this property is pitched and covered in close fitting tiles, all of which are in a good condition with no gaps in which roosting bats could exploit, see Figure 13 on page 13. The ground floor roof on the front elevation is joined to the main building with lead flashing, which is tight to the wall, with no gaps in which roosting bats could utilise, see Figure 14 on page 14.

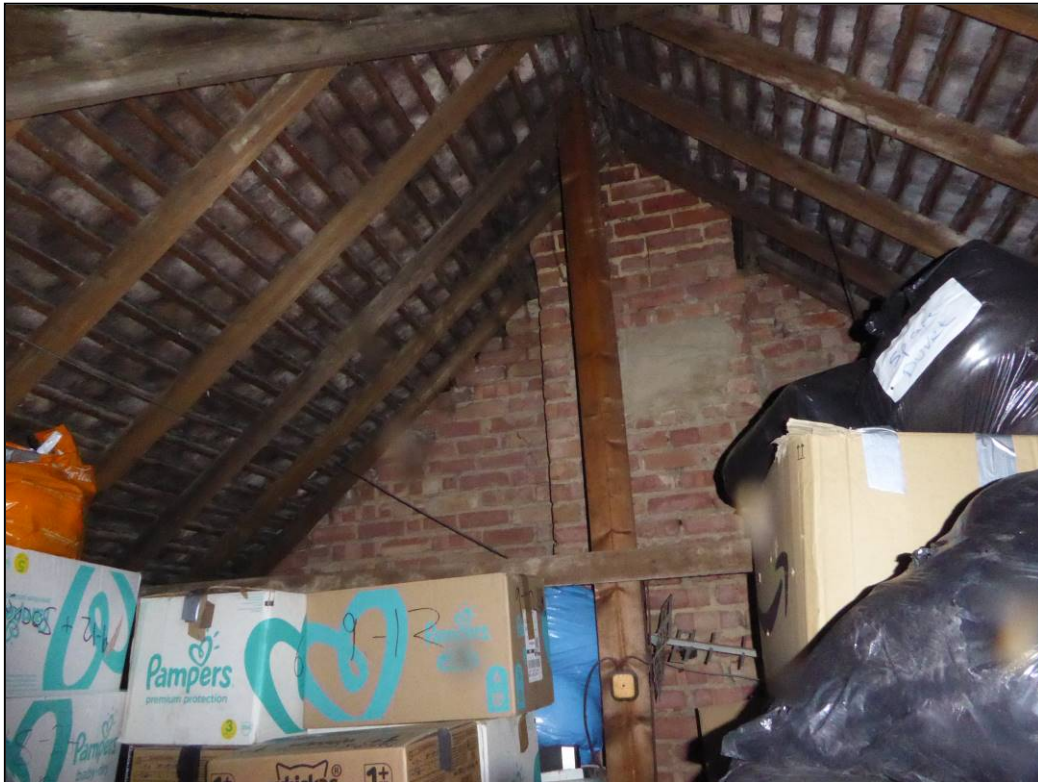
Figure 15. Loft space of 34 Mill Road, Caversham. 19.08.20

The loft space of 34 Mill Road was inspected and was in a fair condition internally. The loft was accessed from the first floor via ladders. The loft was cluttered, was not illuminated, partially boarded and partially insulated, see Figure 15 on page 15. The roof tiles were not lined and were exposed, although they were all tightly fitted with no obvious gaps in which roosting bats could enter the building, see Figure 16 on page 15. The garage at 34 Mill Road was also inspected for roosting bats. The garage was cluttered and in a poor condition internally, see Figure 17 on page 16. There was no loft space within the garage, and the asbestos roofing is exposed, although there are no obvious roosting opportunities for roosting bats, see Figure 18 on page 16.

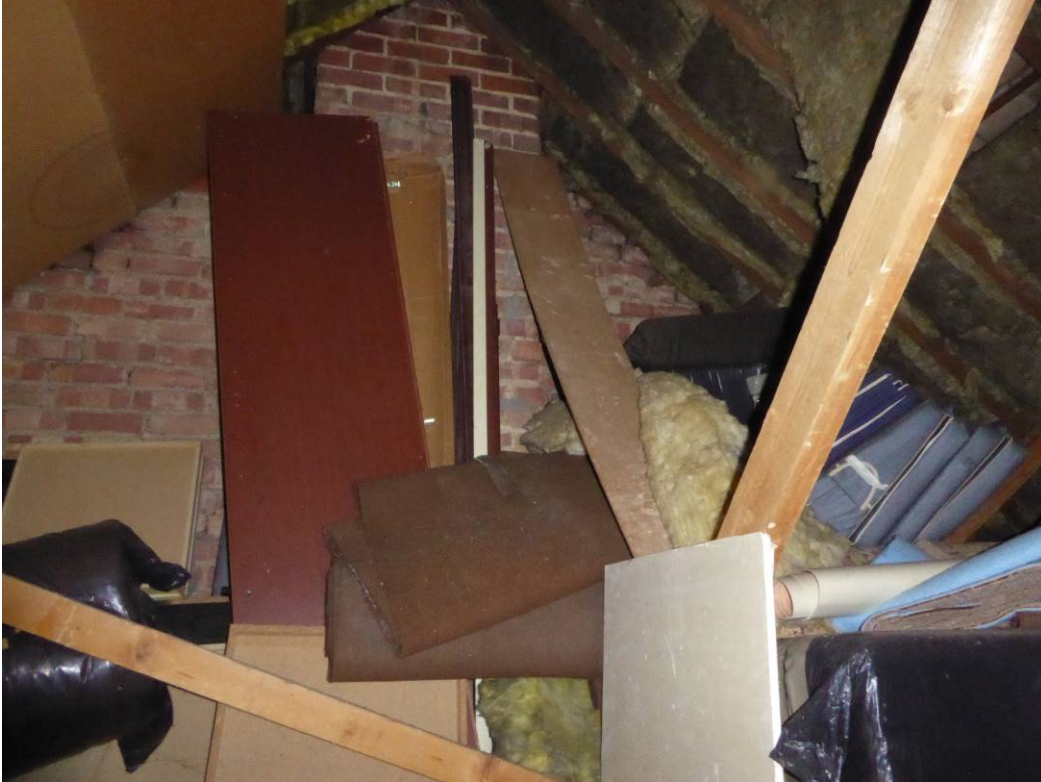
Figure 19. Loft space of 36 Mill Road, Caversham. 19.08.20

The loft space of 36 Mill Road was also examined and accessed from the first floor via ladders. The loft was cluttered, partially boarded, partially insulated and not illuminated, see Figure 19 on page 17. The loft was partially lined with wooden boards (see Figure 20 on page 17) and partially with bitumen felt (see Figure 21 on page 18), all of which is in a good condition with no splits or tears in which roosting bats could exploit.

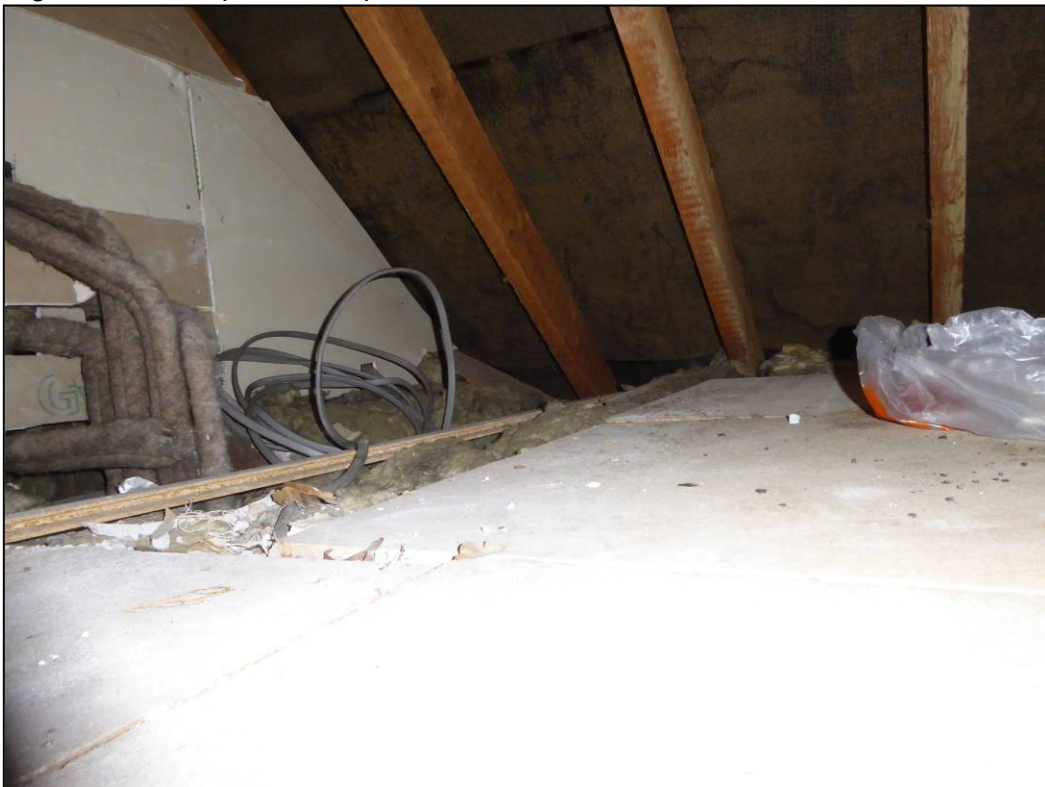
Figure 22. Example of loft space. 36A Mill Road, Caversham. 19.08.20

The loft space of 36A was also inspected and it too is in a fair condition. The loft was accessed by ladders from the first floor. The loft was uncluttered, partially illuminated, boarded and insulated, see Figure 22 on page 18. The roof tiles were lined with bitumen felt, all of which was in a good condition with no rips or tears that roosting bats could utilise, see Figure 23 on page 19.
