## **PRELIMINARY ECOLOGICAL APPRAISAL (BATS) AT 132 COCKNEY HILL TILEHURST**

**Prepared for:  
Mrs J Brown  
132 Cockney Hill  
Tilehurst  
Reading  
RG30 4EX**

**30 November 2020**

**Ref: SPH/ET/PEA-20/24.11**

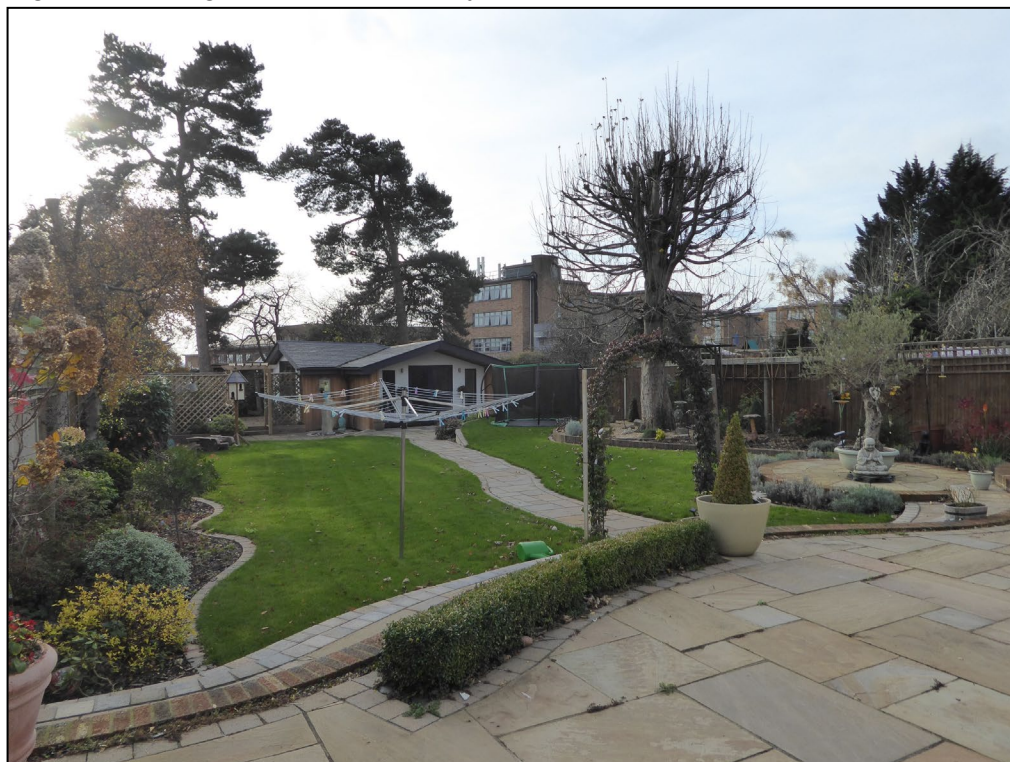
Figure 3. Rear garden. 132 Cockney Hill, Tilehurst. 24.11.20

The proposed planning application site comprises a detached, brick-built and painted bungalow with a detached wooden garage. The remainder of the site comprises a graveled front parking area and a rear garden which is mainly laid to lawn with a large patio area, garden building and some small trees and shrubs throughout, see Figure 3 below. The site itself offers limited foraging and commuting habitat for bats.

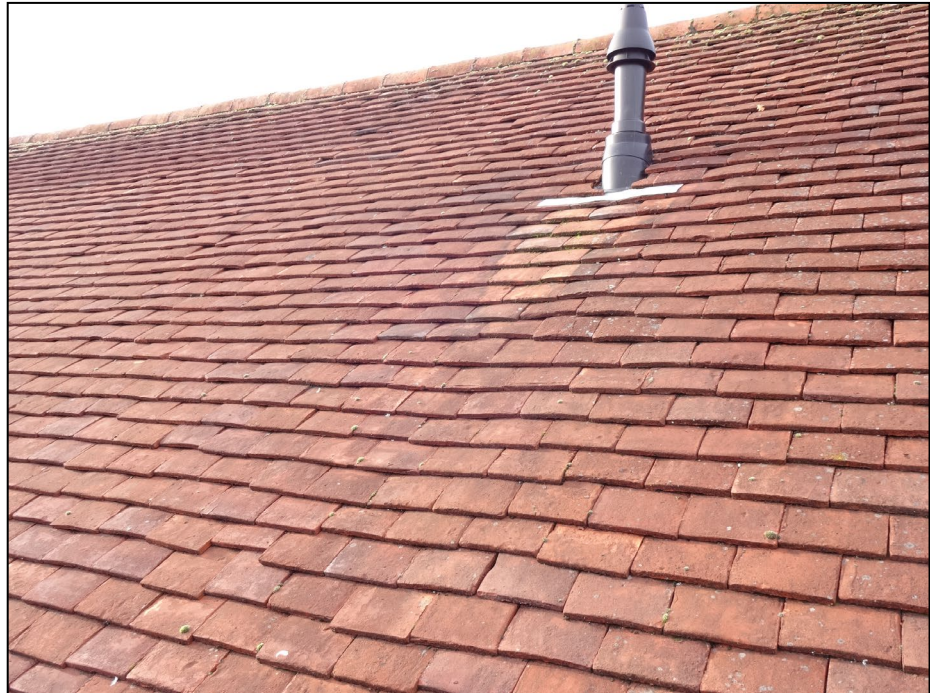
Figure 4.  
Example roof  
tiles. 132  
Cockney Hill,  
Tilehurst.  
24.11.20

The property is a detached, brick-built building which is in a good condition externally. The cross-hipped roof is covered in close fitting tiles, none of which are missing or broken, see Figure 4 on page 8. The ridge tiles and valleys are all in a good condition with no gaps (see Figure 5 on page 8) and the verges are well sealed, see Figure 6 on page 9.

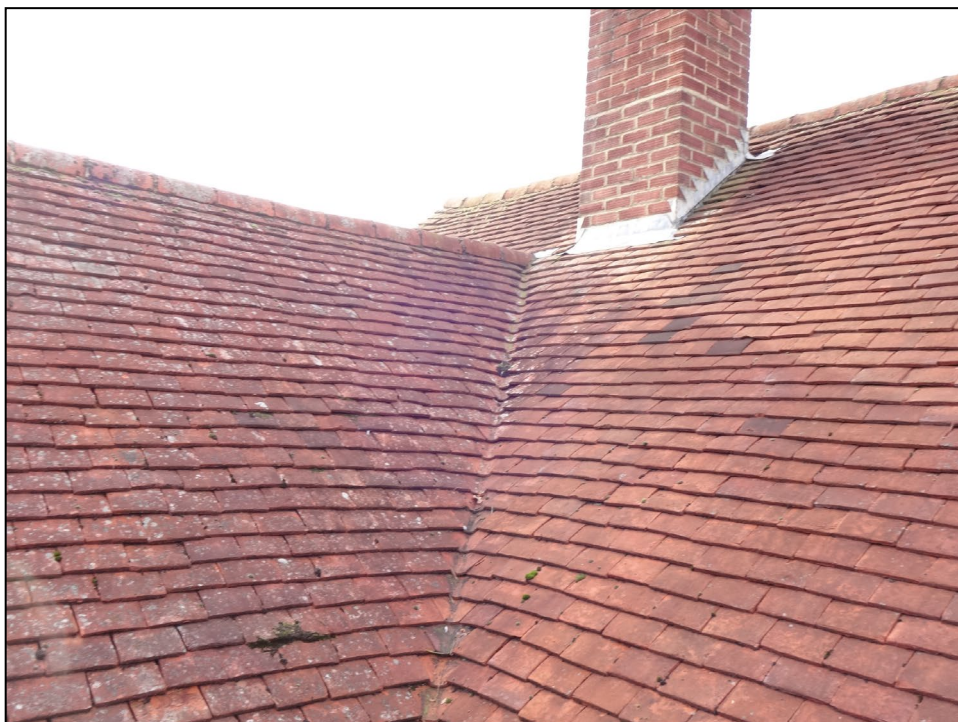
Figure 5. Sealed ridges, valleys and lead flashing. 132 Cockney Hill, Tilehurst.  
24.11.20

The lead flashing is well sealed with no gaps (see Figure 5) and the uPVC windows, soffits and fascia's are all tightly fitted to the wall with no gaps in which roosting bats could exploit, see Figure 7 on page 9.

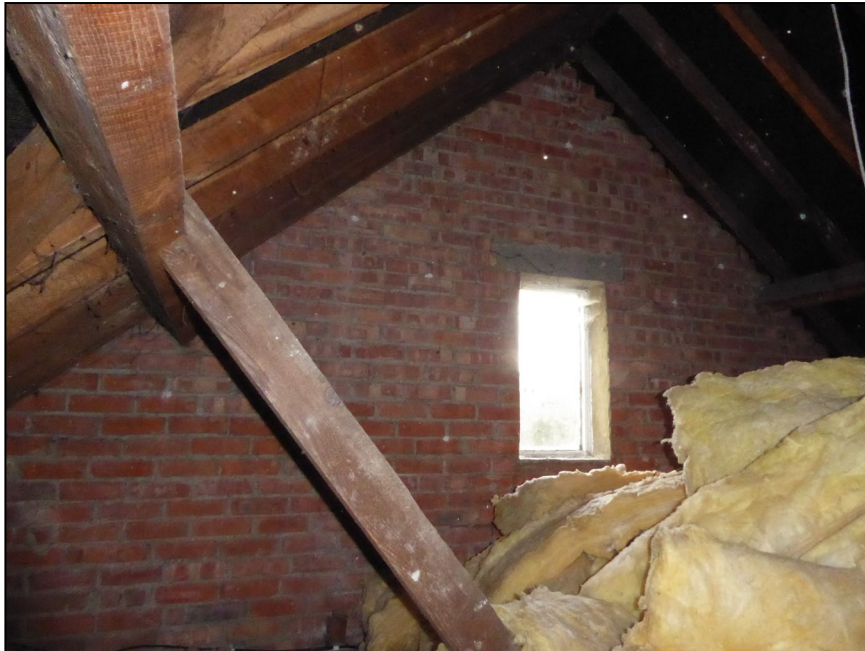
Figure 8. Windows at gable ends. 132 Cockney Hill, Tilehurst. 24.11.20

The loft space of the property was accessed via a ladder. The loft has a window at each gable end which illuminate the loft, see Figure 8 below. It is being used for some personal storage, but this did not hinder the inspection and it is in a good condition internally. The loft is partially boarded, not illuminated and insulated, see Figure 9 on page 11. The roof tiles were lined with bitumen which was in a good condition with no rips or tears, see Figure 10 on page 11.
