# Heritage Design and Access Statement 36 Albion Terrace

**April 2 2020**

Structural Repairs and Specialist Services Ltd.

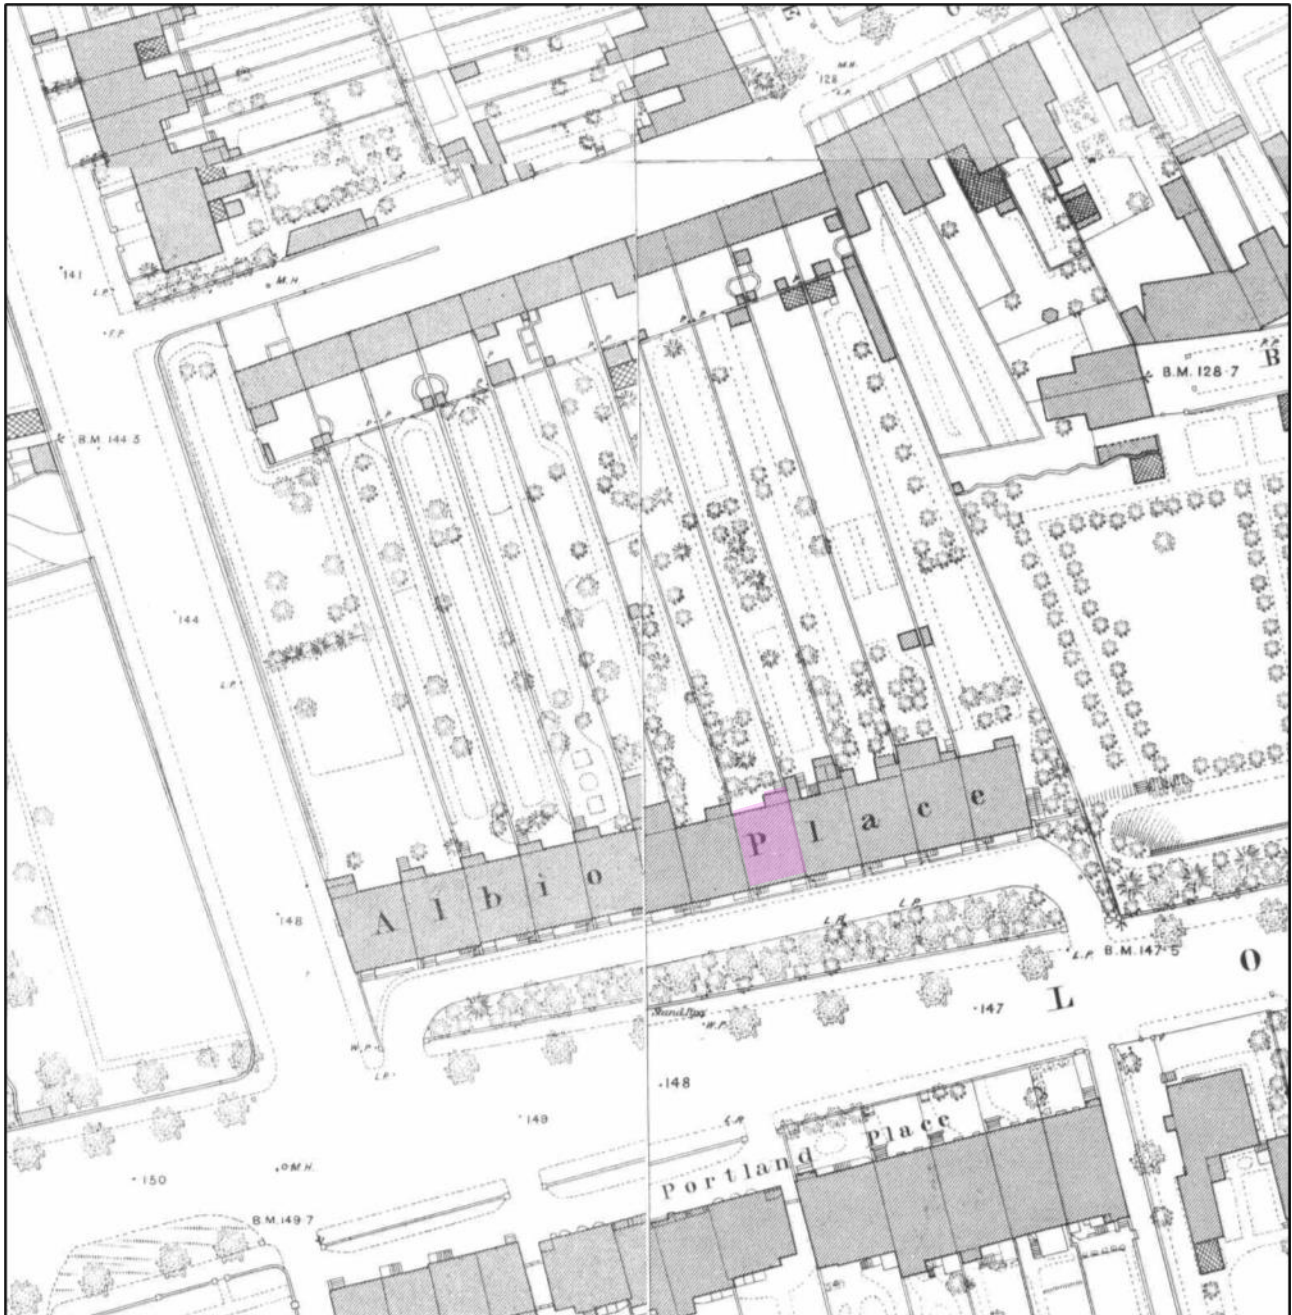
FIGURE 2 - ALBION TERRACE 1879 - COUNTY SERIES 1:2500 (BLACKWELL'S MAPPING SERVICES, 2020)

The Terrace was originally constructed as a row of individual dwellings each with its own entrance on London Road with garden plot extending to the rear. The mews road to the rear housed coach houses and stabling for the individual properties. The mapping indicates 12 dwellings although documentary descriptions of the Terrace describe it as being 11 dwellings.
