# Bat Survey Report

17 Thicket Road

On behalf of Timothy Rooke

May 2020

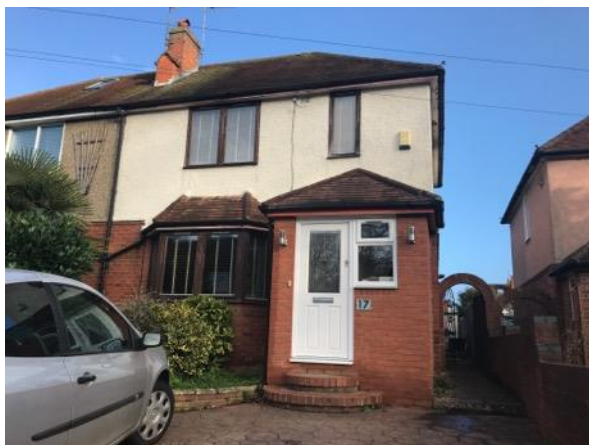
**Photo 1: Southern elevation of the house**

To the north of the property is a single storey extension with a flat bitumen roof and a conservatory of glass and PVC construction (see Photos 1 and 2 in Appendix 1).

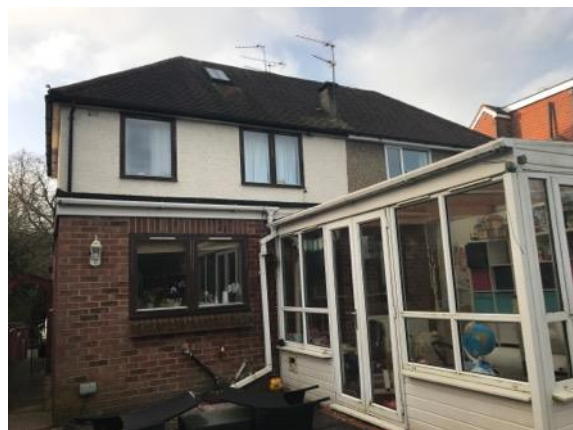
**Photo 2: Northern elevation of the house**

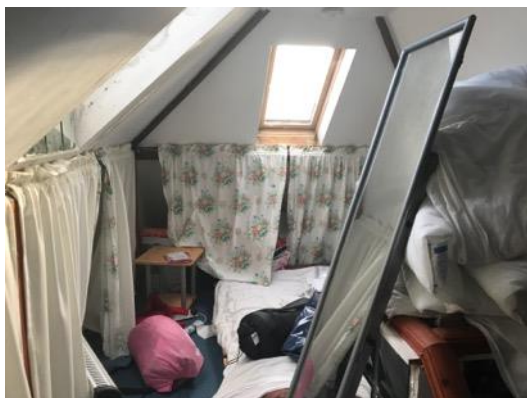
**Photo 3: Internal loft space convert into living space**

Internally, the loft has been converted for use as a store room and play area and is well sealed. The walls and ceiling are boarded and there are two roof windows (see Photo 3 in Appendix 1).

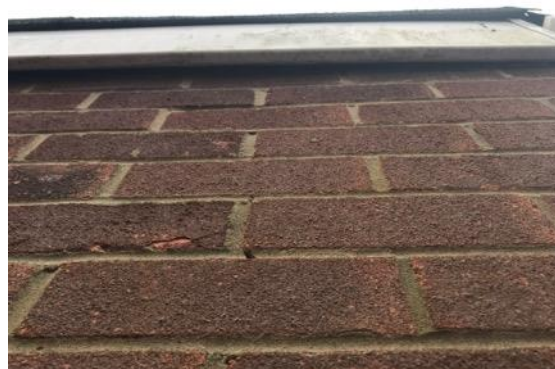
There is mortar missing from under ridge tiles to the south of the building and a lifted tile at the apex of the porch to the south. There was a further raised tile behind the chimney to the south and around the roof window to the east (see Photos 5 & 6). The A gap was noted under the PVC fascia board on the east of the single storey extension which was fairly cobwebbed (see Photo 4 in Appendix 1). The gap was inspected with an endoscope and it was found to allow access into the roof void of the flat roof single-storey extension. No evidence of bats was noted within or around the feature however, due to the depth of the void it was not possible to view all areas. An external light was noted adjacent to the gap.

**Photo 4: Gap under fascia board on single storey extension to the north**

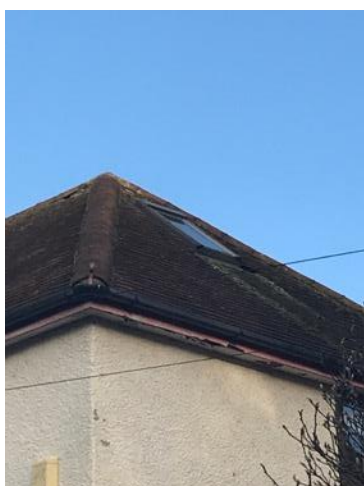
**Photo 5: Missing mortar under ridge tiles and lifted tiles around roof window**

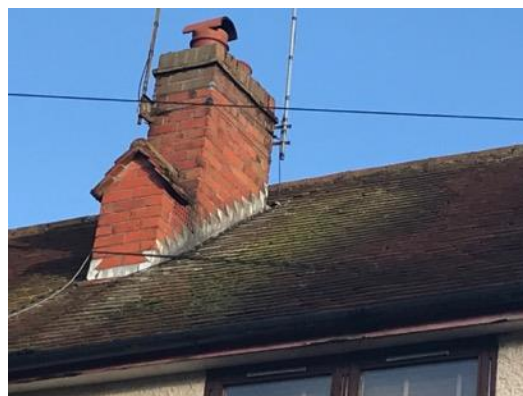
**Photo 6: Lifted tile behind chimney**
