## Katesgrove School – Heritage Statement

July 2020

Revision P1

This document has been prepared by the Historic Buildings Group in Hampshire County Council Property Services to accompany a Listed Building Application for works involving a new boiler flue and new structural buttresses to the south retaining wall at the Henry Building, Katesgrove School, Reading.

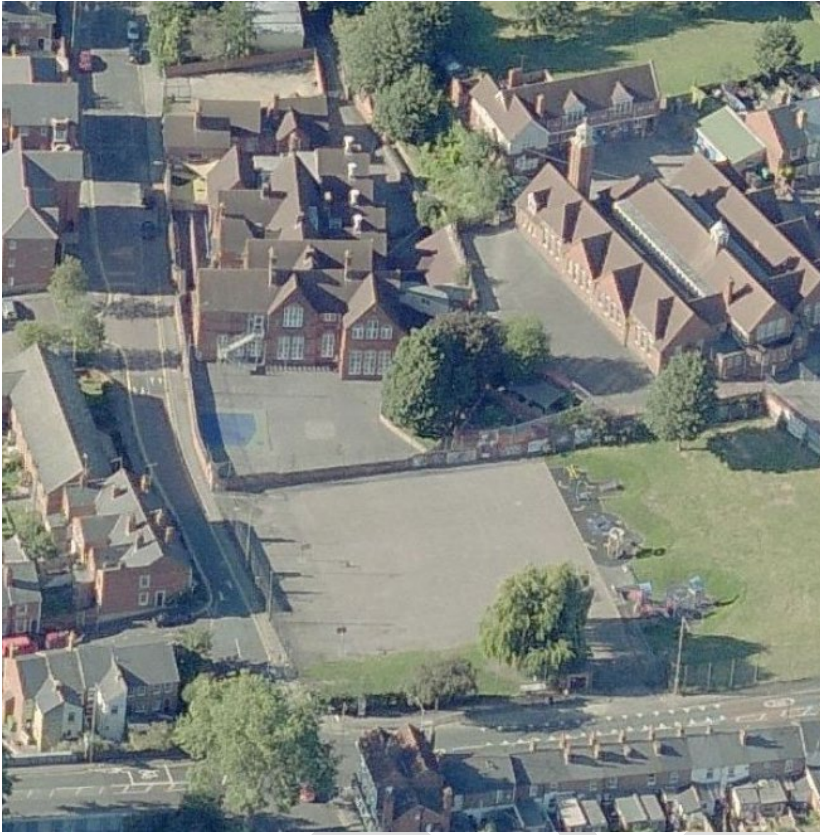
Fig 1: Aerial view of South elevation of Henry Building with retaining wall in the foreground

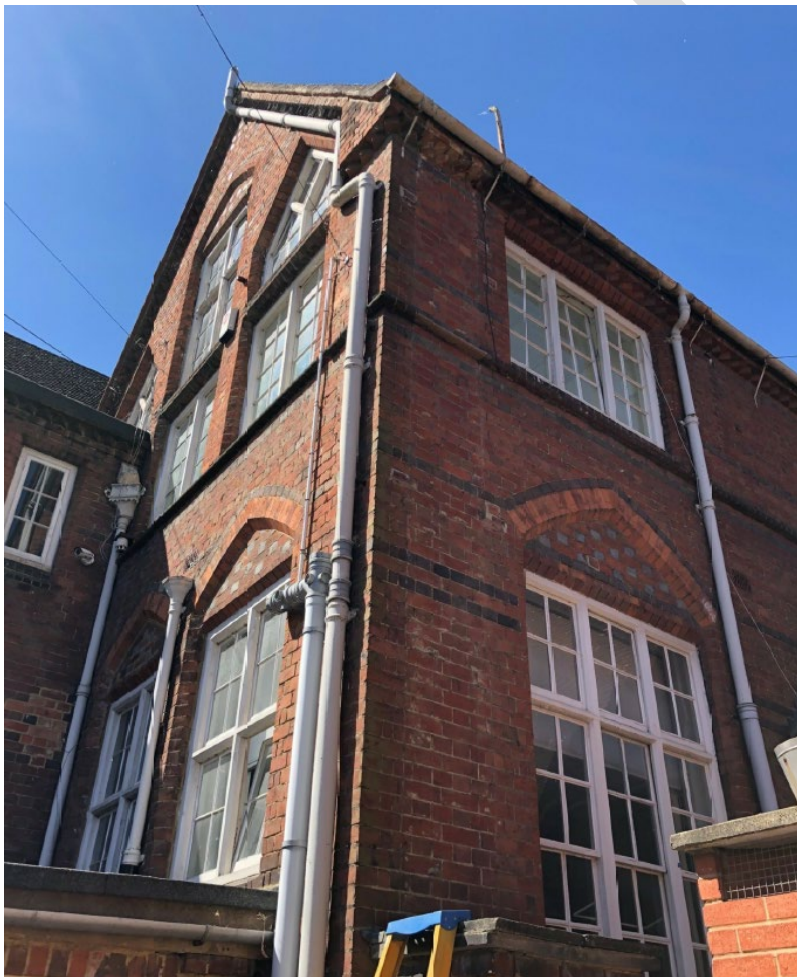
Fig 4: East Facing Gable, line of former flue visible on north facing return brickwork

Following a compliance assessment by the clients appointed mechanical engineers it was concluded that the existing flue is not in compliance with current gas regulations and there are some elements of the flue system which are missing. It is therefore proposing to install a new flue to ensure compliance with current regulations. The new arrangement will ensure appropriate distance from the outlet to opening windows located adjacent to the boiler room, preventing any opportunity for flue gasses to enter the building. It is proposed that the new flue will follow the route of the old chimney which was at some point removed.

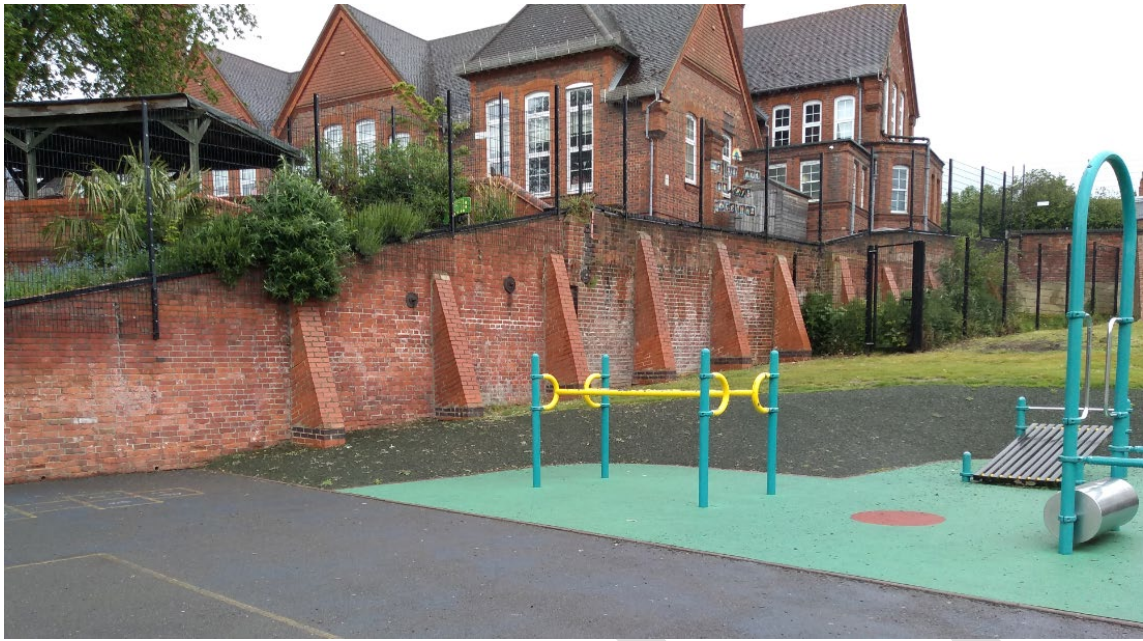
Fig 5: South facing elevation of retaining wall showing modern buttresses.

The existing buttresses are not original, and it is assumed were added due to movement of the wall. The bedding plain at the base of the brick buttresses is not structurally acceptable, and as such repair of the existing buttresses is not viable as the bed plains should be perpendicular to the line of thrust, as indicated on the propose drawing S-03.

| Description of proposed works | Impact | | | Extent of impact | Justification |
|---|---|---|---|---|---|
| Removal of 11No. Existing Buttresses | Low. Existing buttresses are modern additions. Any residual damage caused by removal of modern buttresses will be made good as part of the general wall repair works. | Low. Existing buttresses are modern additions. | Low. | Low. | Existing modern buttresses have failed and are not repairable. |

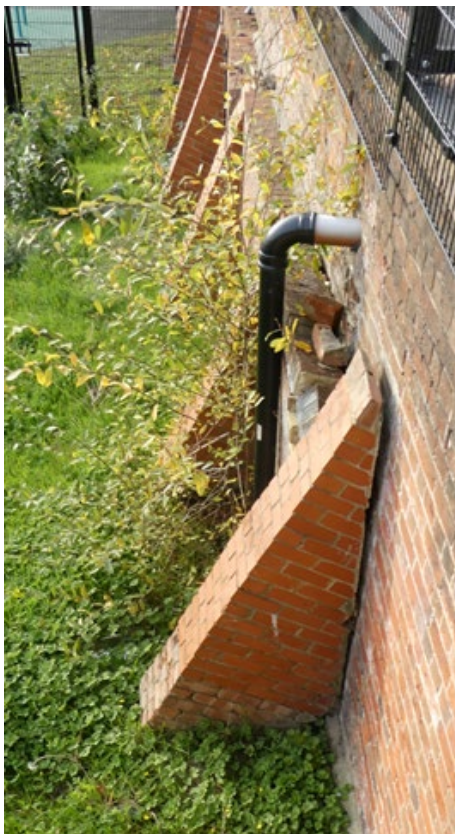
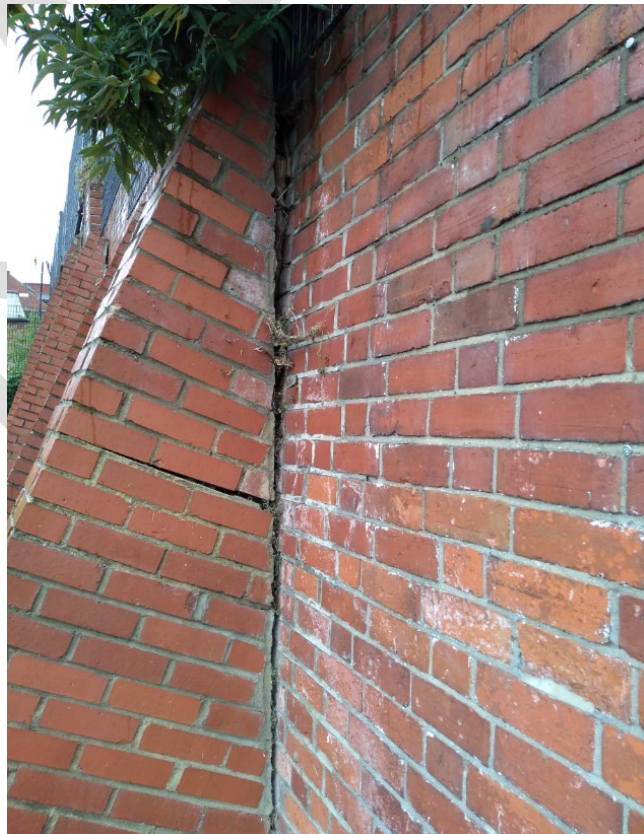
Fig 6 & 7 : Detail of detached moderns buttresses to south facing retaining wall.

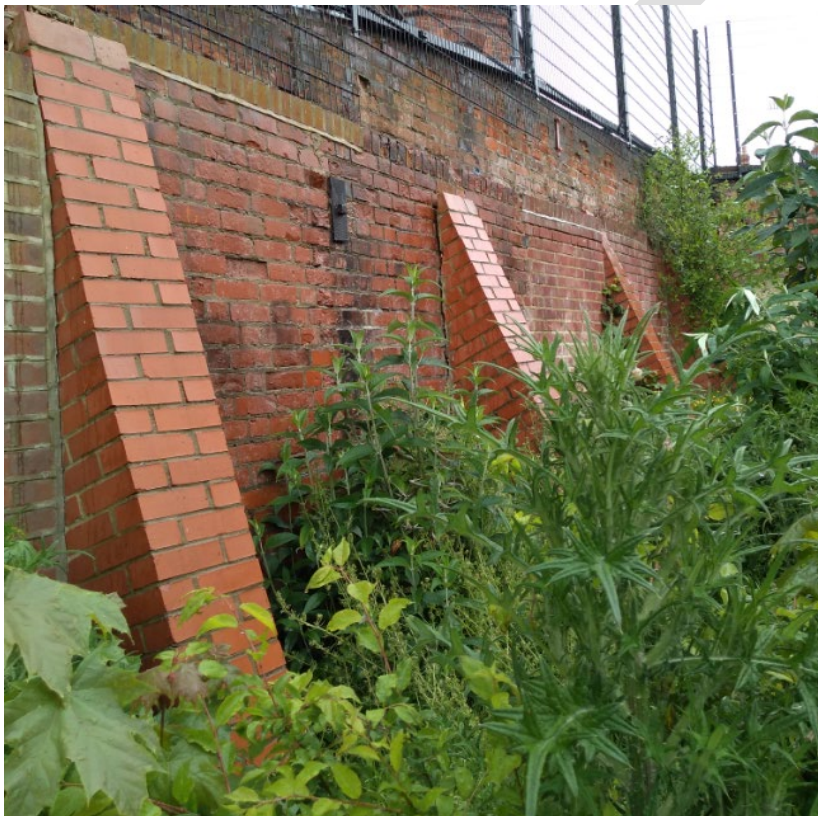
Fig 9: East end of south facing wall, showing modern single leaf facing brick to right hand side.

| Description of proposed works | Impact | | | Extent of impact | Justification |
|---|---|---|---|---|---|
| Removal of single skin brickwork (East end of South facing section of wall) | Low. Existing brickwork single leaf is modern addition. Any residual damage caused by removal of modern buttresses will be made good as part of the general wall repair works. | Low. Existing brickwork single leaf is modern addition. It's removal will expose the original historic brickwork of the wall. | Low | Low. | Modern facing brickwork is in poor state of repair and with the new buttresses is not required structurally. |

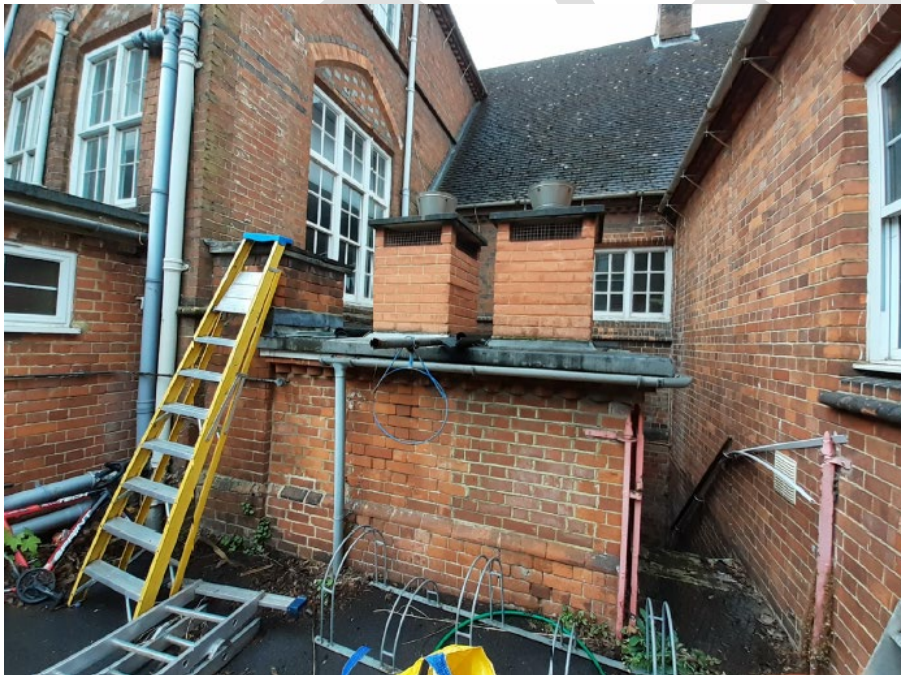
Fig 10 : Existing plant room area (East facing)

The Henry Building boiler room currently uses a balanced compartment flue system. This system enables open flued boilers to be installed in a sealed compartment but relies upon the component parts of the system being sized to match the installed boilers. As a result, if a boiler upgrade is required, the flue components need to change as well.

The new flue will be colour coated to match the existing plethora of pipework around the plant room area (SVP,s RWP's) The flue will be fixed to the building through the mortar joints, ensuring damage to original facing brickwork is minimised.

The old flues are to be reduced in height and have new cowls added to enable them to function as air intake for the plant room below.

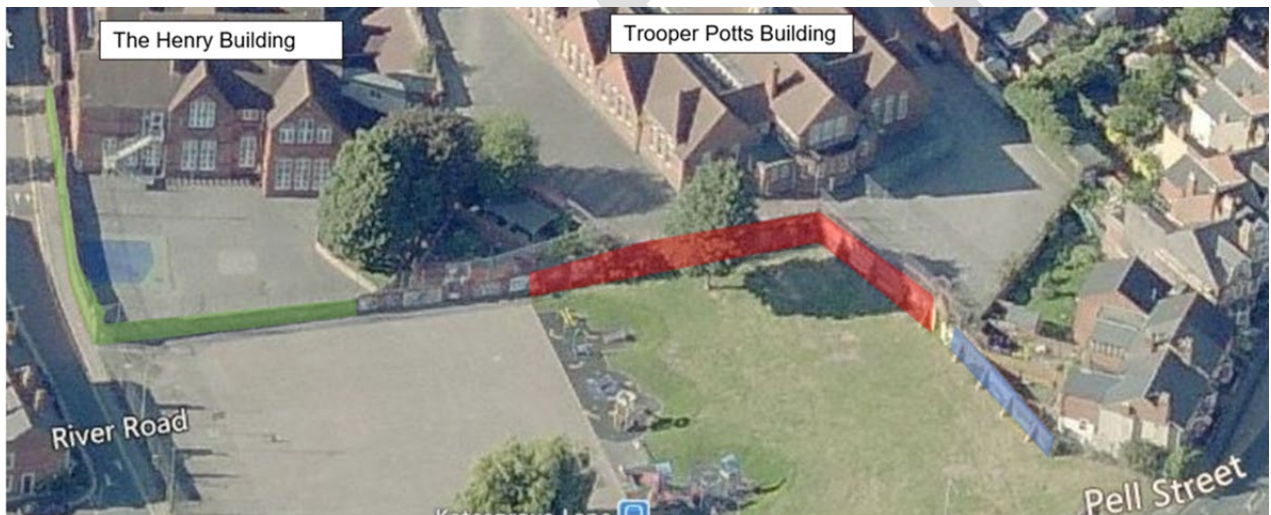
The Henry Building wall comprises both retaining and free standing elements. The freestanding section of wall is highlighted green on Fig 11. The retaining section of wall, proposed to be repaired, is highlighted in red. The wall highlighted in blue, adjacent to the housing is excluded from works. Between the green and red walls is a part retaining/part freestanding (ground drops behind) which is also not included in the proposed works.

1. The removal of modern one-brick thick walls between buttresses
2. The removal of 11No. modern brick buttresses.
3. Construction of 12No. new buttresses, connected to the retaining wall, including new foundations, broken into existing as necessary.
4. Repairs and making good to brickwork and render.
