**GEOENVIRONMENTAL  
REPORT ON  
GROUND INVESTIGATION  
AT  
HENLEY ROAD,  
CAVERSHAM**

| <b>Report Title:</b> | Geoenvironmental Report on Ground Investigation at Henley Road, Caversham |
| <b>Report Number:</b> | AG3094-19-AJ69 |

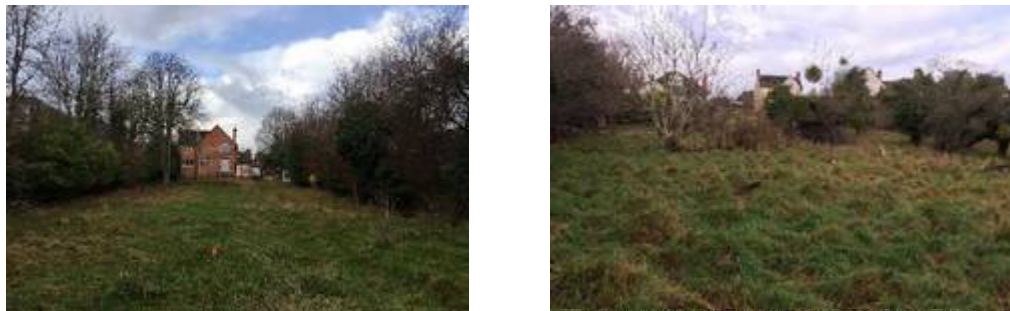
Photo showing the rear gardens of plots 199, 201 and 203 showing the natural topography of the site (facing north).

Areas of hardstanding (asphalt/ concrete/ compacted gravel) were generally limited to the small driveways noted at the front of the properties, whilst paving patio areas were noted in the rear gardens of the plots. All hardstanding was noted to be of poor condition. The ground surface across the remaining areas of the site comprised rough grass and vegetation which appeared to have undergone some localised terracing in plots 201, 203 and 205.

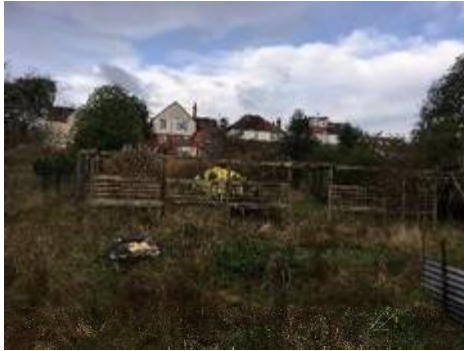
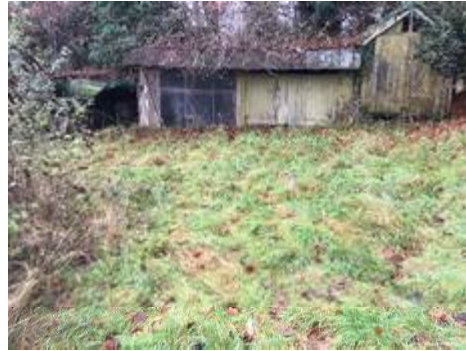
Photo showing the rear gardens of plots 205 and 207 and a photo of a series of existing onsite sheds.

Two small man-made ponds were recorded in the rear gardens of plots 205 and 207 and two separate badger sets were identified in the rear gardens of plots 199 and 201. Mature, semi-mature trees and hedgerows were noted around the periphery of the existing plots and between 199 and 201. A tree survey was previously undertaken by Tracey Clark Tree Consultancy dated February 2019 (ref; TCTC-17327-PL-01) on behalf of the Client.

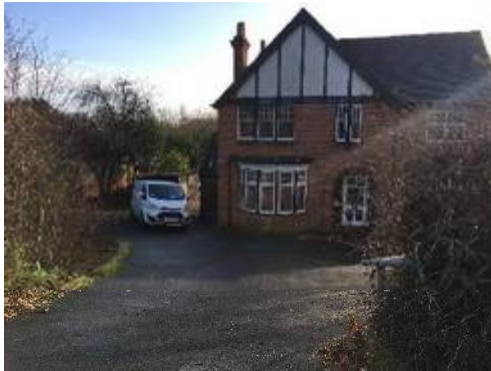
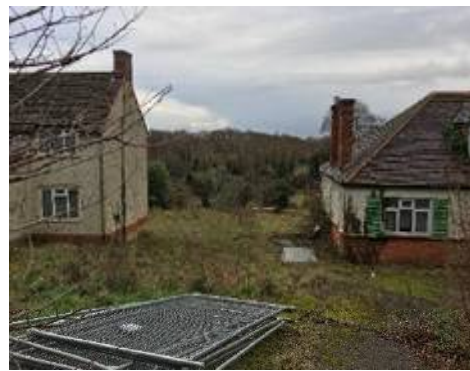
Photo showing the front gardens of plots 199, 201 and 203.
