Reference: TT2999-34 Sherwood Street, Reading-L02-Bat Survey Report-Rev00

### **Results of Preliminary Roost Appraisal on 34 Sherwood Road, Reading.**

This letter report presents the results of a Preliminary Roost Appraisal (PRA) for bats carried out at 34 Sherwood Street, Reading, RG30 1LJ. The survey was carried out in connection with proposed loft conversion of the building to increase the available living space.

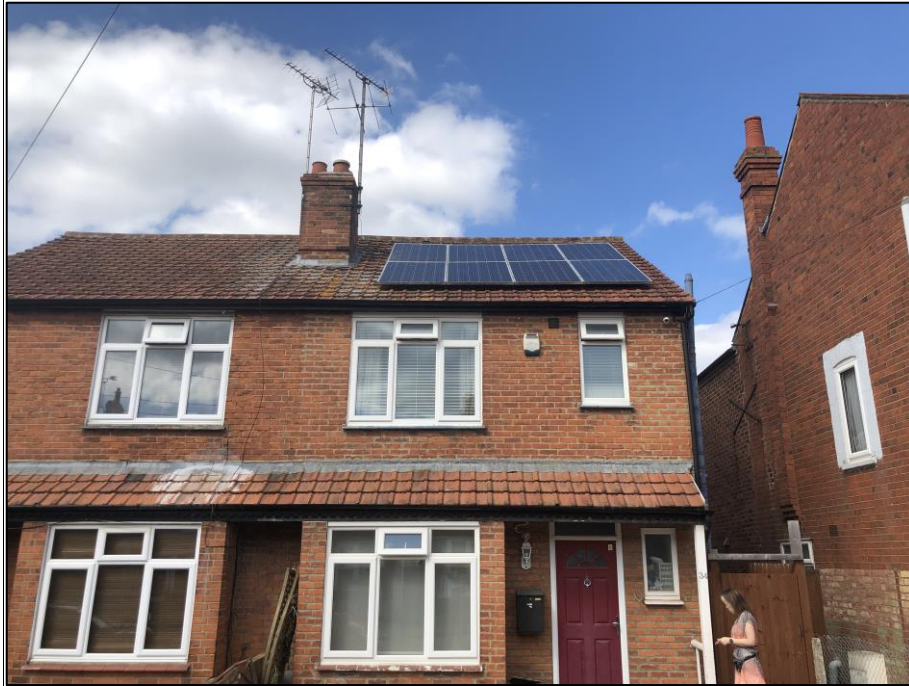
*Plate 1 – Front view of 34 Sherwood Street*

The surveyed building is approximately 110-120 years old and is a semi-detached two storey residential house constructed of brick. To the front the building has a bay window and an overhanging porch area. The building has cavity walls and internally has an open loft with a ridge height of approximately 2.4m.

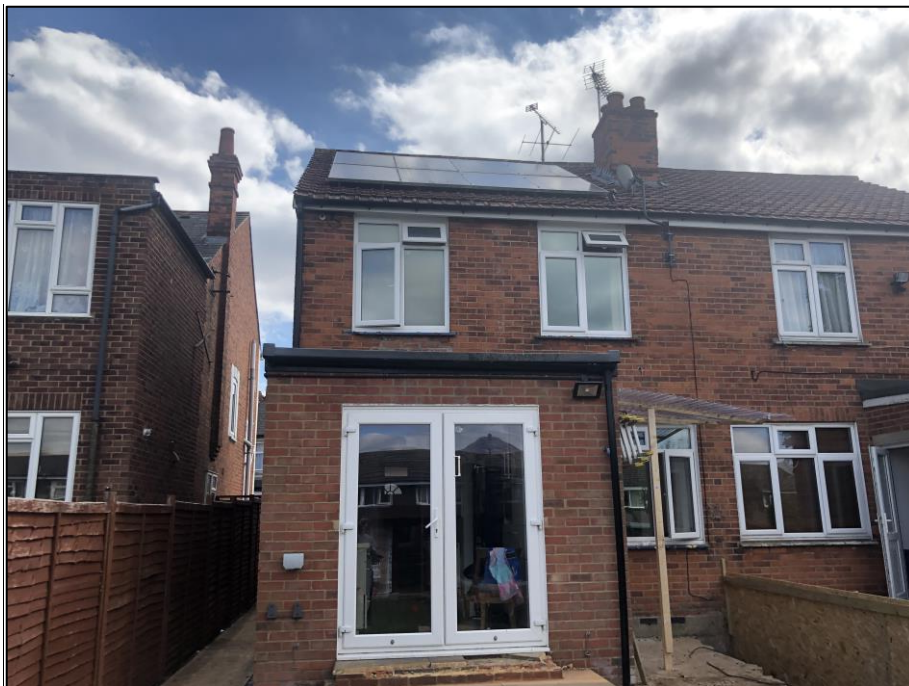
*Plate 2 – Rear View of 34 Sherwood Street*

Externally the building has a roof covered with interlocking clay tiles which fit tight and well across the visible areas of the roof. The majority of the roof is covered with solar panels, with eight cells on each slope of the roof. The ridge is tight with no obvious mortar gaps and the same is true to the pointing at the verge. There are two chimneys, both with lead flashing around. The rear chimney flashing has a small gap which may offer potential roosting opportunities for bats, though this is outside the proposed working area. No other potential for bats was noted.

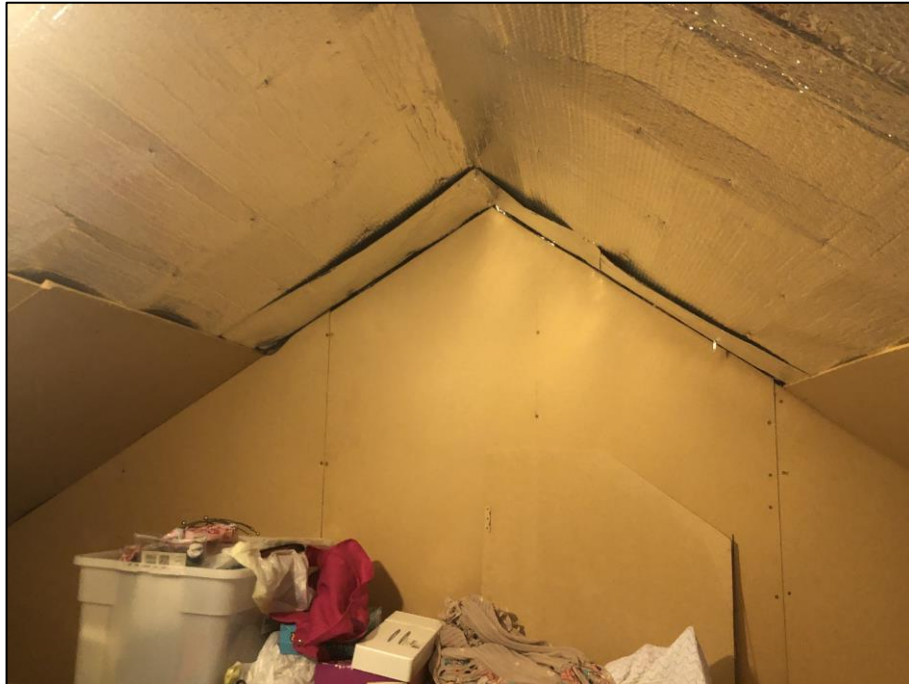
*Plate 3 – Internal view of loft space*

Internally the roof is constructed with an untrussed frame and has been insulated and lined with boarding on the floor and at the rafters. The loft is currently used as a storage room. *Plate 3* shows the interior of the loft.

No bats or evidence of bats was identified in the interior of the loft and all areas could be checked during the survey.
