Intended for  
**Lincoln MGT**

Project no.  
**1620004716**

Date  
**August 2019**

# STATION HILL, NORTH SITE, READING **GROUND INVESTIGATION REPORT**

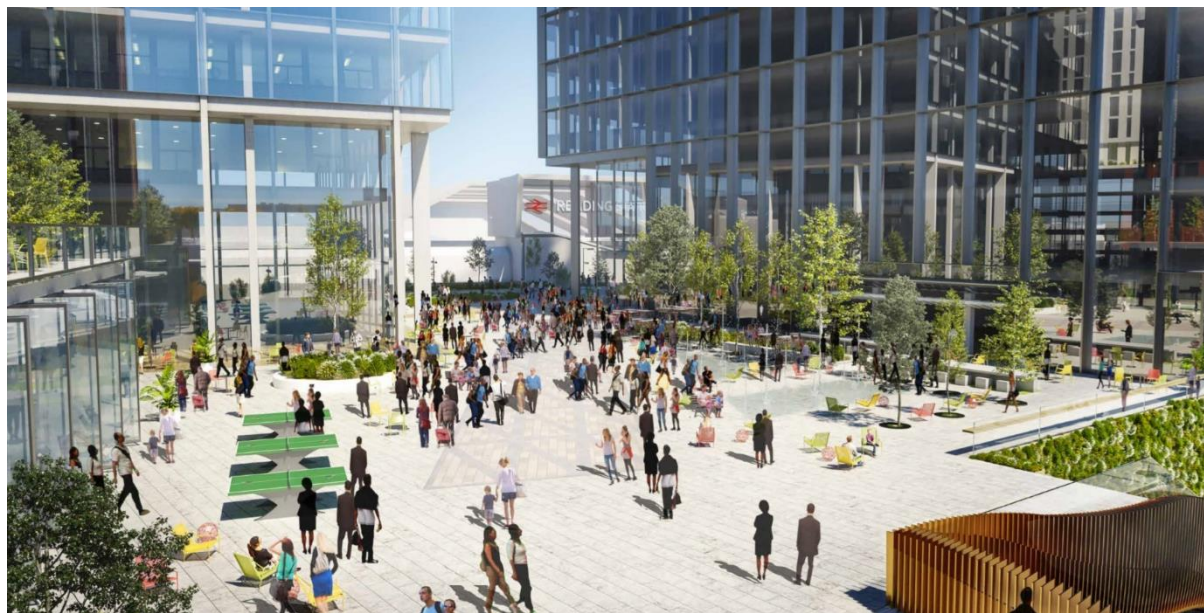
**Figure 3: A CGI of the North Site (Source: MGT)**

A basement for car parking and plant rooms is currently proposed to the north of the Thames Water Main in Phase 3 of the development (the west of the site). The exact design details of the basement are still to be finalised but there are no proposals for basement to be constructed beneath Phase 2 of the development (the east of the site).

The proposed substructure is anticipated to comprise piled foundations and a retaining wall. The retaining wall type is still to be finalised.

The Station Hill Site is a combined office and residential development, located directly opposite Reading train station and occupying 2.6 hectares (six and a half acres). An image representing the proposed development is shown below in Figure 3.

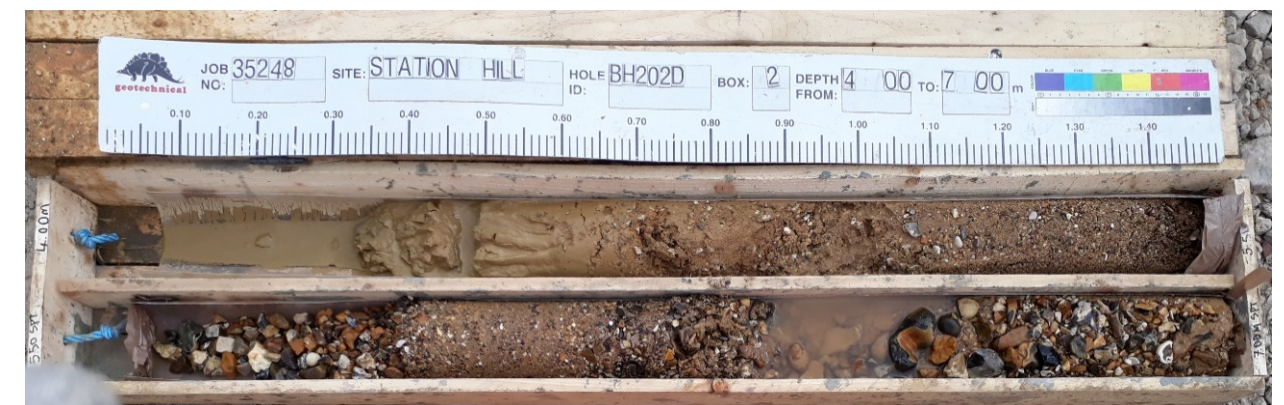
Photograph 1: Alluvium and Taplow Gravel in BH202D (Source: GEL Factual Report 35248)

The Taplow Gravel is described as orangish brown clayey gravelly sand or sandy gravel. Gravel comprises subangular and subrounded fine to coarse flint and chalk gravel.

4no. particle size distribution tests were carried out on the Taplow Gravel as given in Data Plot A1.5. The results indicate that the samples contained predominately gravel (65-82%), a smaller portion of sand (10-30%) and a minor portion of silt/ clay (1 to 5%).

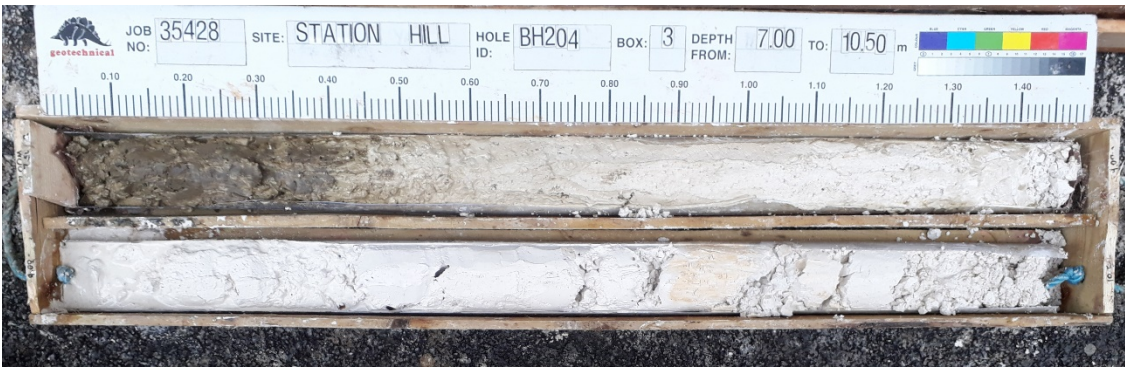
Photograph 2: Structureless Chalk in BH204 (Source: GEL Factual Report 35248)

The Structureless Chalk has a CIRIA grade of Dm or Dc. The typical description comprises Structureless Chalk composed of white slightly gravelly silt. Gravel is subangular and rounded fine to coarse very weak low to medium density white with frequent black specks chalk, rarely angular fine to coarse flint.

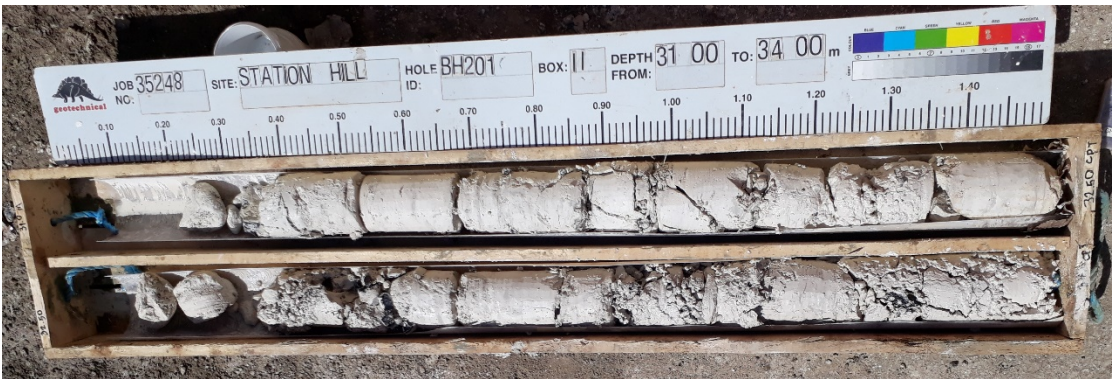
The typical description consists of very weak medium density white CHALK with frequent black specks and yellowish orange staining.

Photograph 3: Structured Chalk in BH201 (Source: GEL Factual Report 35248)
