## 40 - 68 SILVER STREET READING

SILVER STREET DEVELOPMENTS LTD.

## COMBINED PHASE 1 & PHASE 2 GROUND INVESTIGATION REPORT

Report Reference: 1227-003-002

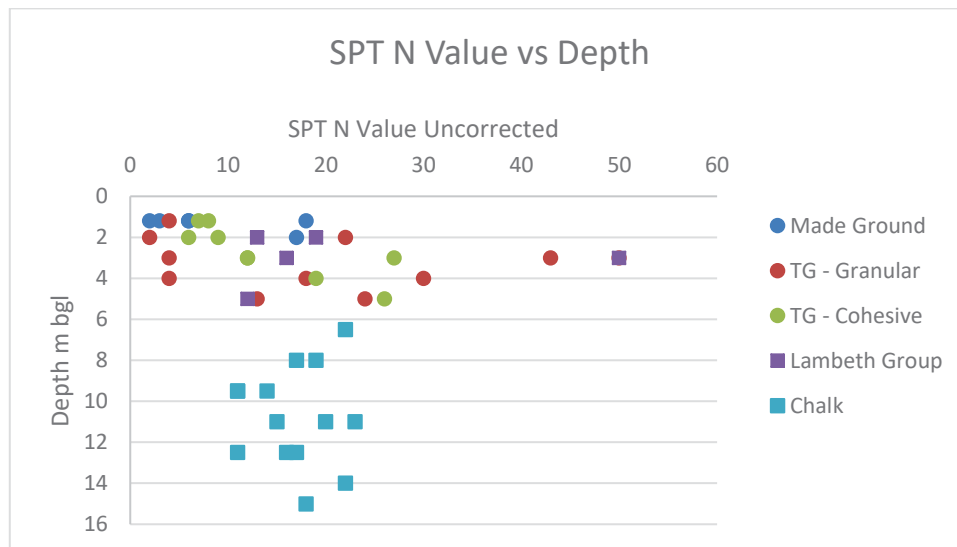
SPTs were undertaken in all the boreholes except BH4, and the N value results are plotted against depth. The SPT results are distinguished based on ground type, and there is no clear increase in strength with depth.

Eleven SPT's were undertaken in these granular deposits and results varied from 2 to 50 with the average value of 19. The highest result may have been influenced by the presence of coarse gravels and should therefore be interpreted with caution. The deposits were found to be range from very loose to medium dense through to dense. The results are plotted in Section 6.7.

At 3.5m bgl natural ground is expected to be encountered; comprising intermixed cohesive and granular Taplow Gravel deposits. SPT N values have shown a large variation in ground strength during the GI at around 3m to 4m bgl. In general, an allowable bearing capacity in the order of 100kN/m<sup>2</sup> (for a 2m wide strip footing founded circa 3.75m bgl) is assigned to the Taplow Gravels at this site. In the area of WS5 the ground is noted to be loose or very loose.

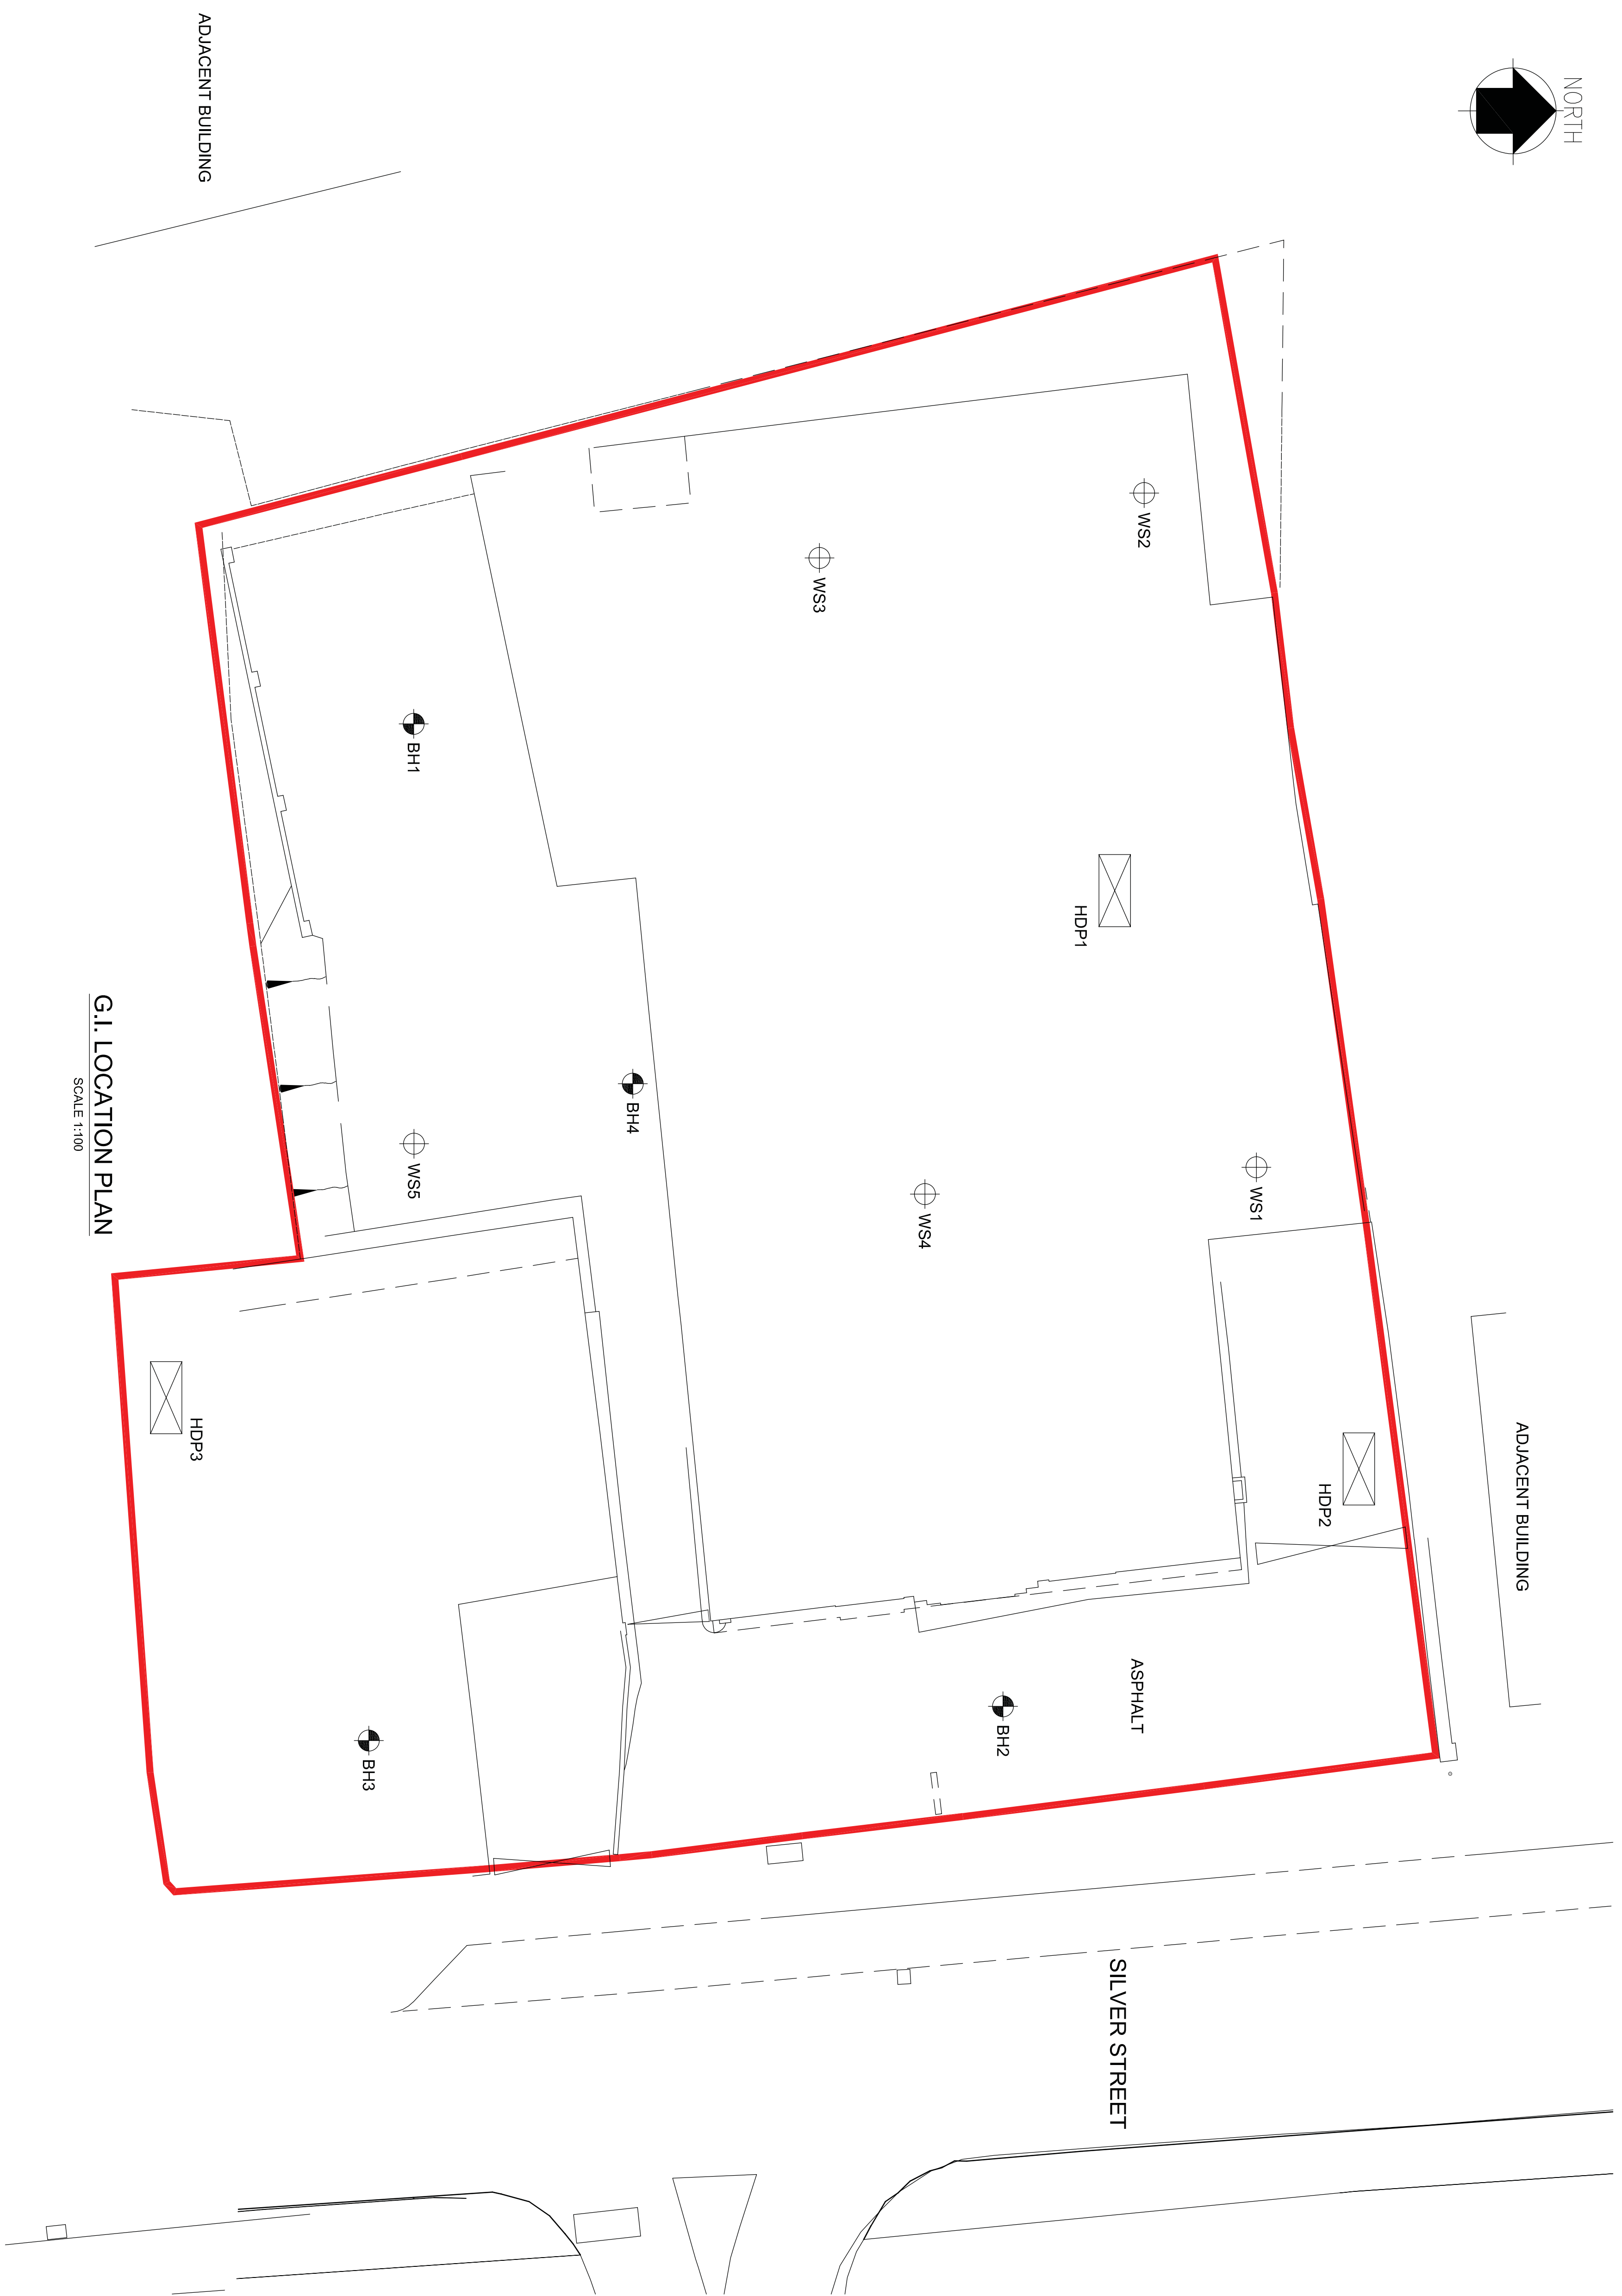
G.I. LOCATION PLAN  
SCALE 1:100

## **Drawing – GI Location Plan including Current Site Layout**

The GI at 40 Silver Street was undertaken between 29<sup>th</sup> and 30<sup>th</sup> January 2018 and comprised drilling two cable percussive boreholes (BH1 and BH2) and five window sampling boreholes (WS1 to WS5) across the site. Weather conditions were dry during the GI.

The GI at 62 to 68 Silver Street was undertaken on 19<sup>th</sup> and 20<sup>th</sup> January 2018, and comprised drilling two cable percussive boreholes (BH3 and BH4), and the excavation of three hand-dug pits (HDP1 to HDP3) across both sites to allow shallow soil sampling for supplementary contamination testing. Weather conditions were warm and dry during the GI.

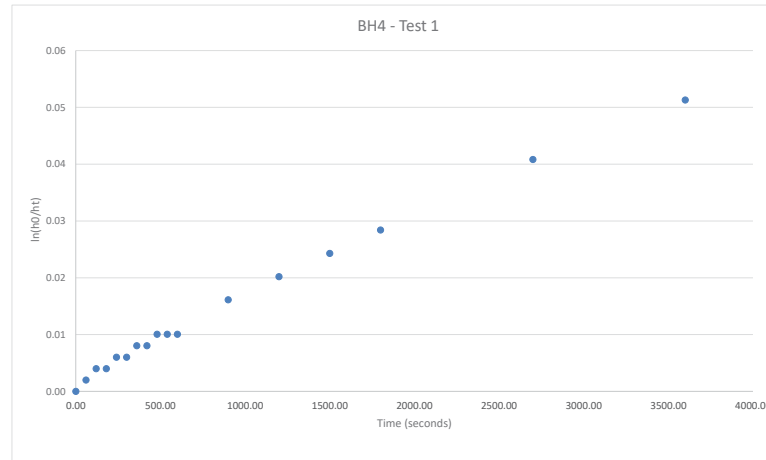
Case 1  
L 0.5  
D 0.15  
L/D 3.33

For Case 1, Lambeth Group (see log)

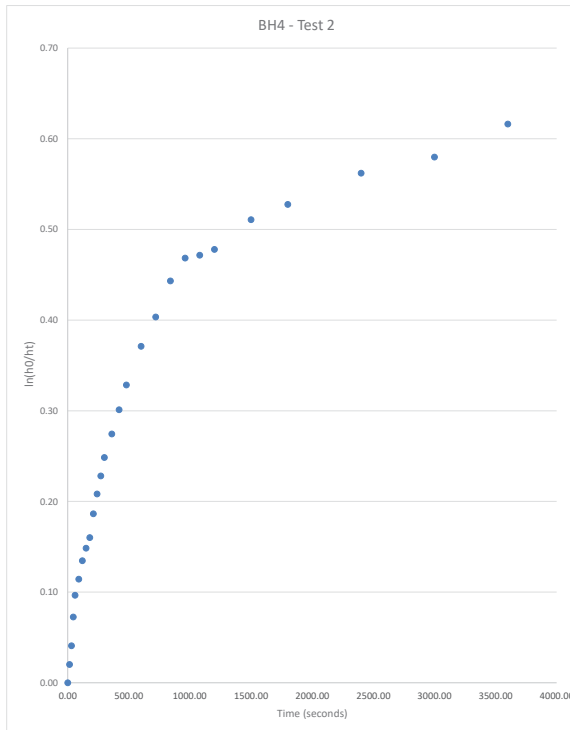
Case 2  
L 1.5  
D 0.15  
L/D 10.00

For Case 2, Taplow Gravel and Lambeth Group (see loc)

K=  $\alpha \cdot S / F$   
Slope  $\alpha = 1.71E-04$  All Test  
Slope  $\alpha = 5.60E-05$  Taken over slope 960to3600seconds  
Slope  $\alpha = 4.88E-04$  Taken over slope 0 to 960

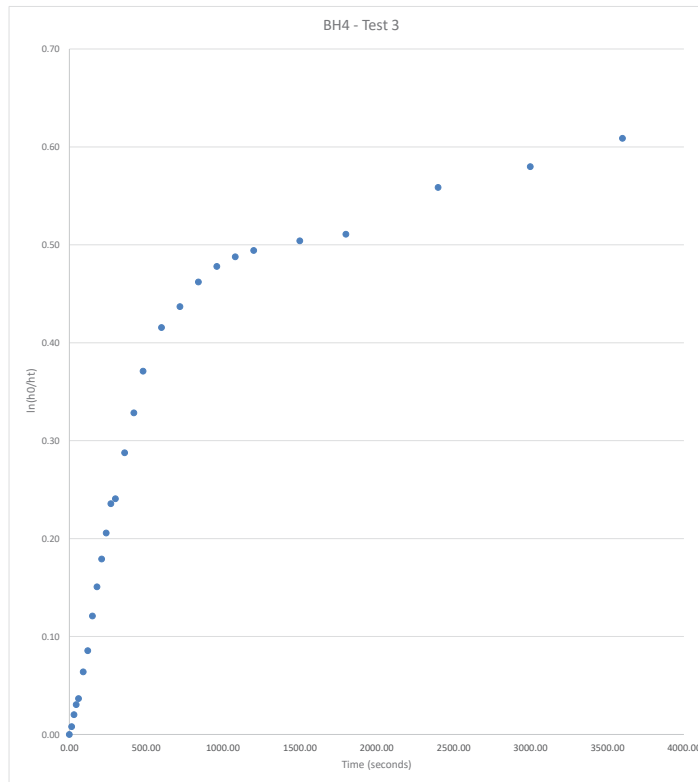
The plotting of  $\ln[h_0/h(t)]$  versus elapsed time gives a straight line of slope  $\alpha$  equal to  $k/S$  (Figure B.3).  $k$  is calculated directly by Equation (B.5).

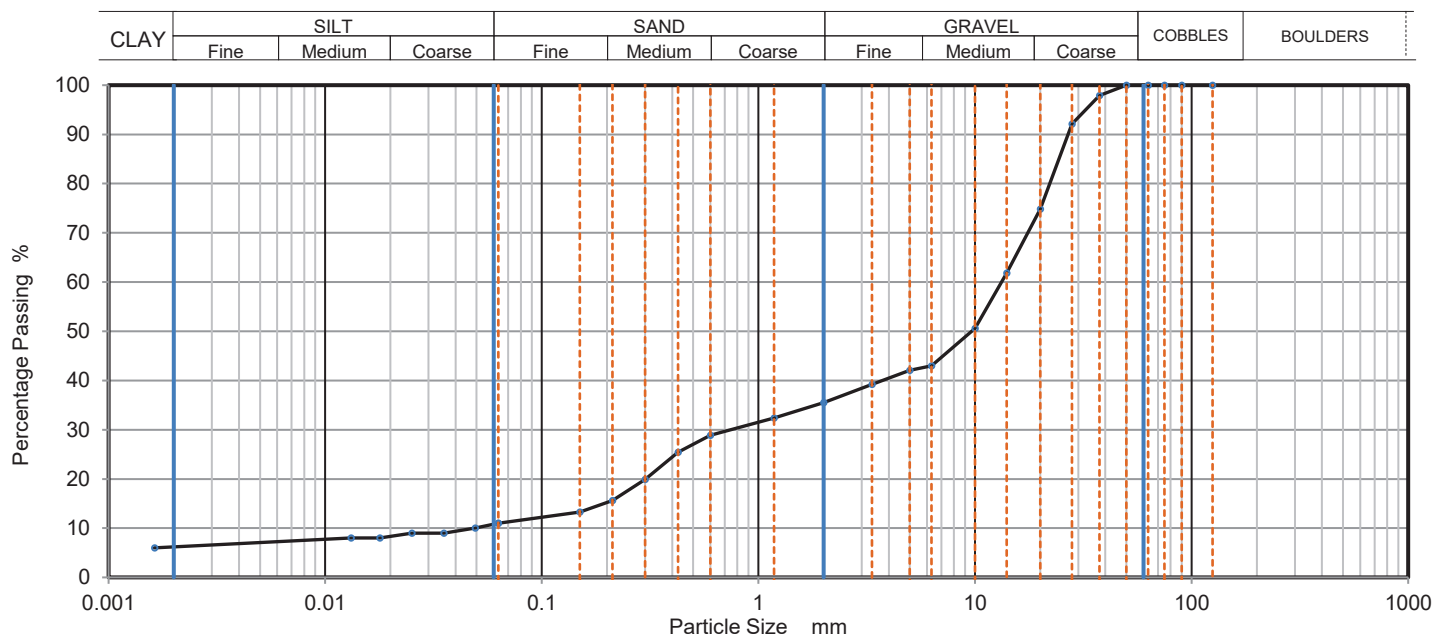
Laboratory Reference: 1298248  
Hole No.: BH3  
Sample Reference: Not Given  
Sample Description: Brown slightly silty slightly clayey sandy GRAVEL

Depth Top [m]: 4.00  
Depth Base [m]: 4.50  
Sample Type: B

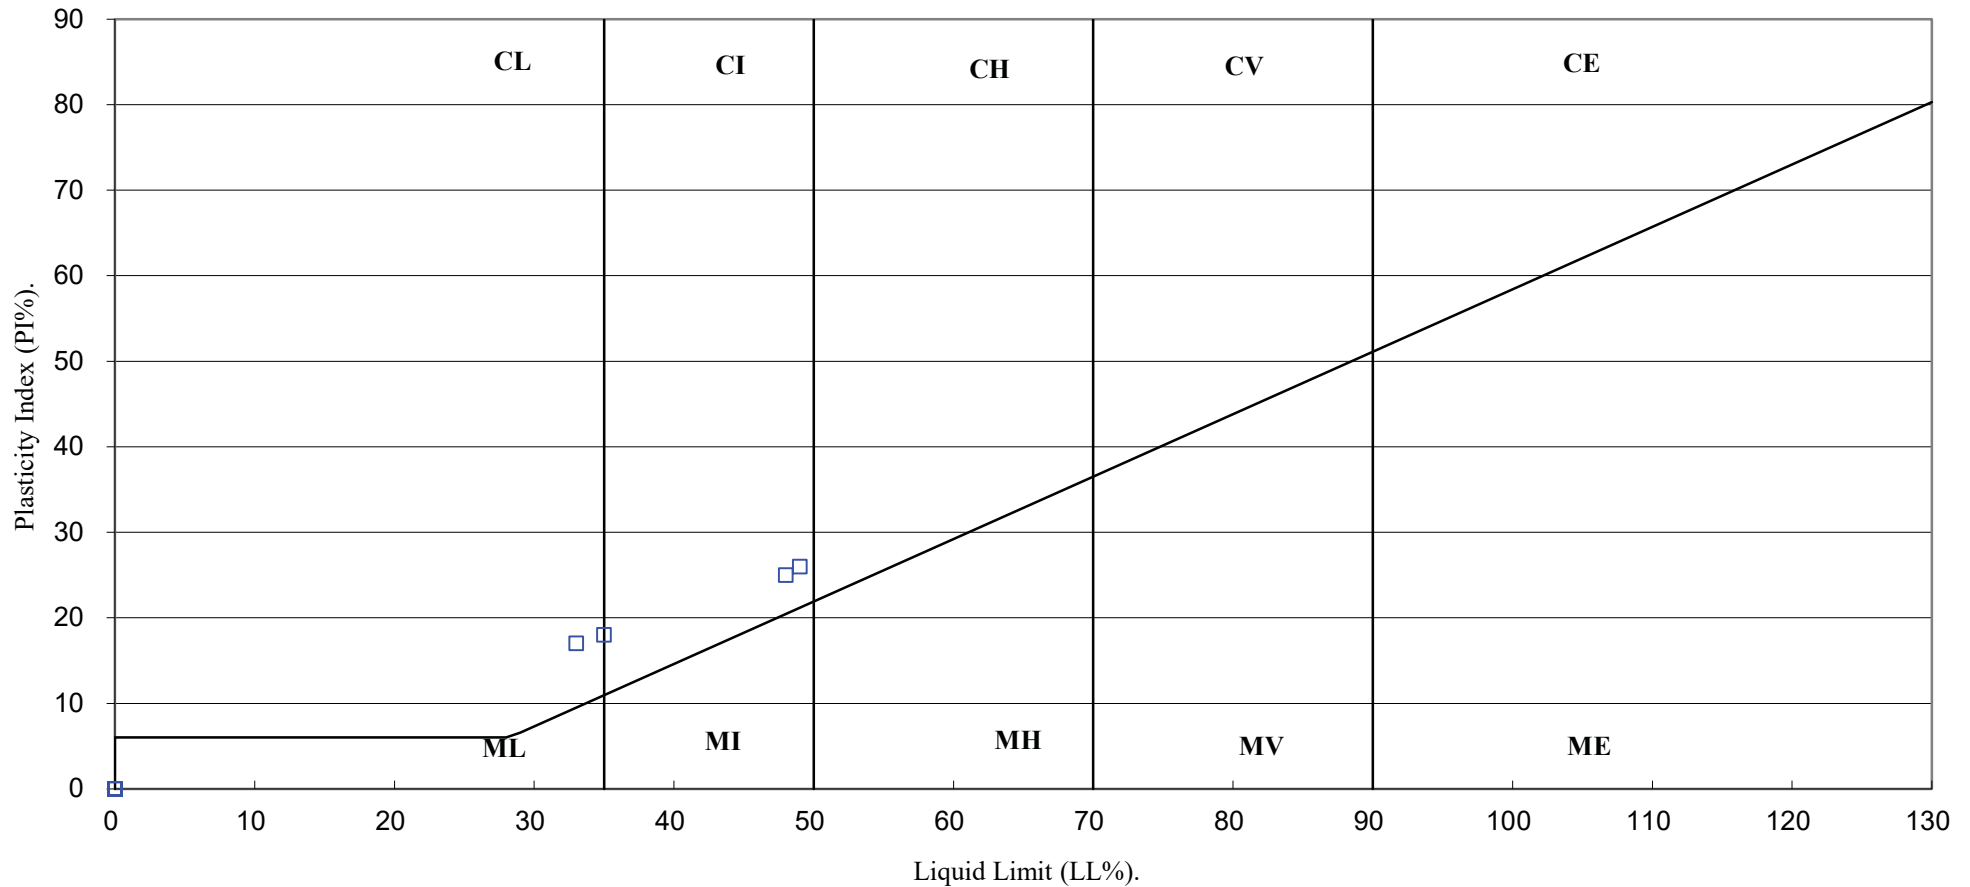
# PLASTICITY CHART FOR CASAGRANDE CLASSIFICATION.

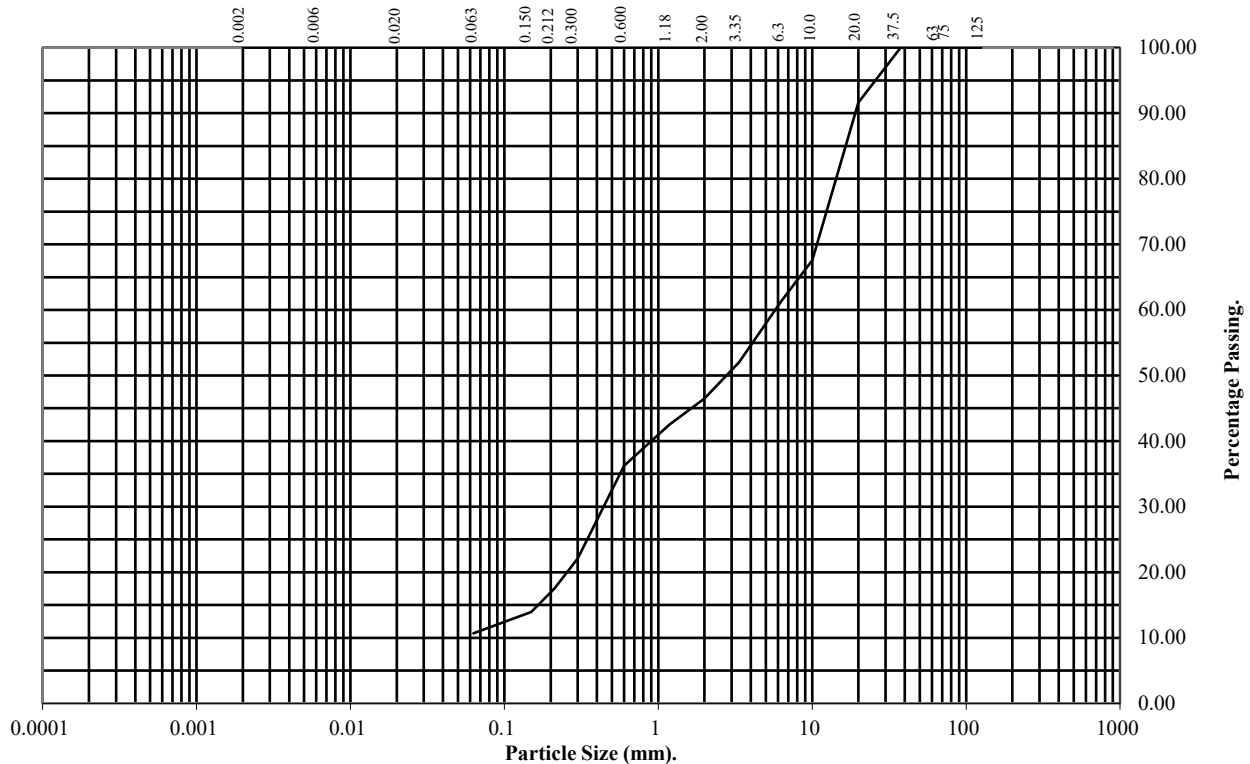
Sample Number: Base Depth(m): 5.00

Sample Type: Bulk

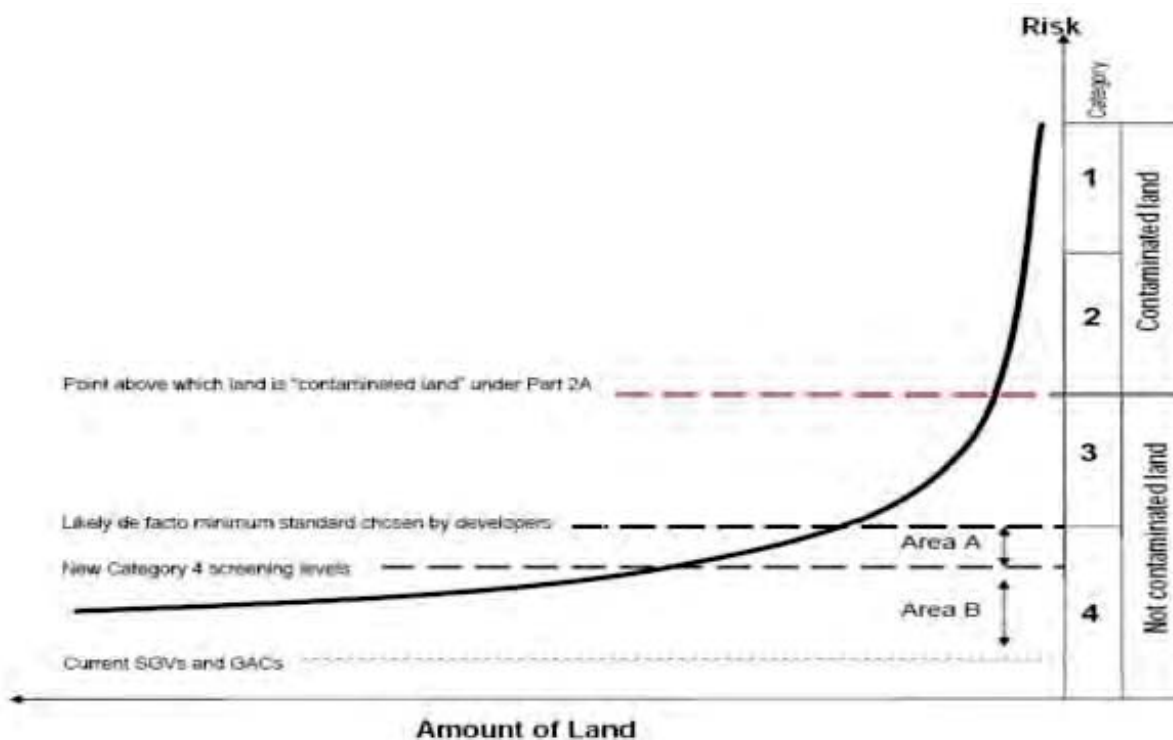
However revised Statutory Guidance to support Part 2A of the Environmental Protection Act 1990 was published by Defra in April 2012 which introduced a new four-category system for classifying land under Part 2A. This new four-category system is displayed graphically below:

Category 1 includes land where the level of risk is clearly unacceptable and Category 4 includes land where the level of risk posed is acceptably low. Land is determined as 'contaminated land' under Part 2A if it falls within Categories 1 or 2, such that the Category 2/3 border defines the point at which land is determined under the legislation.

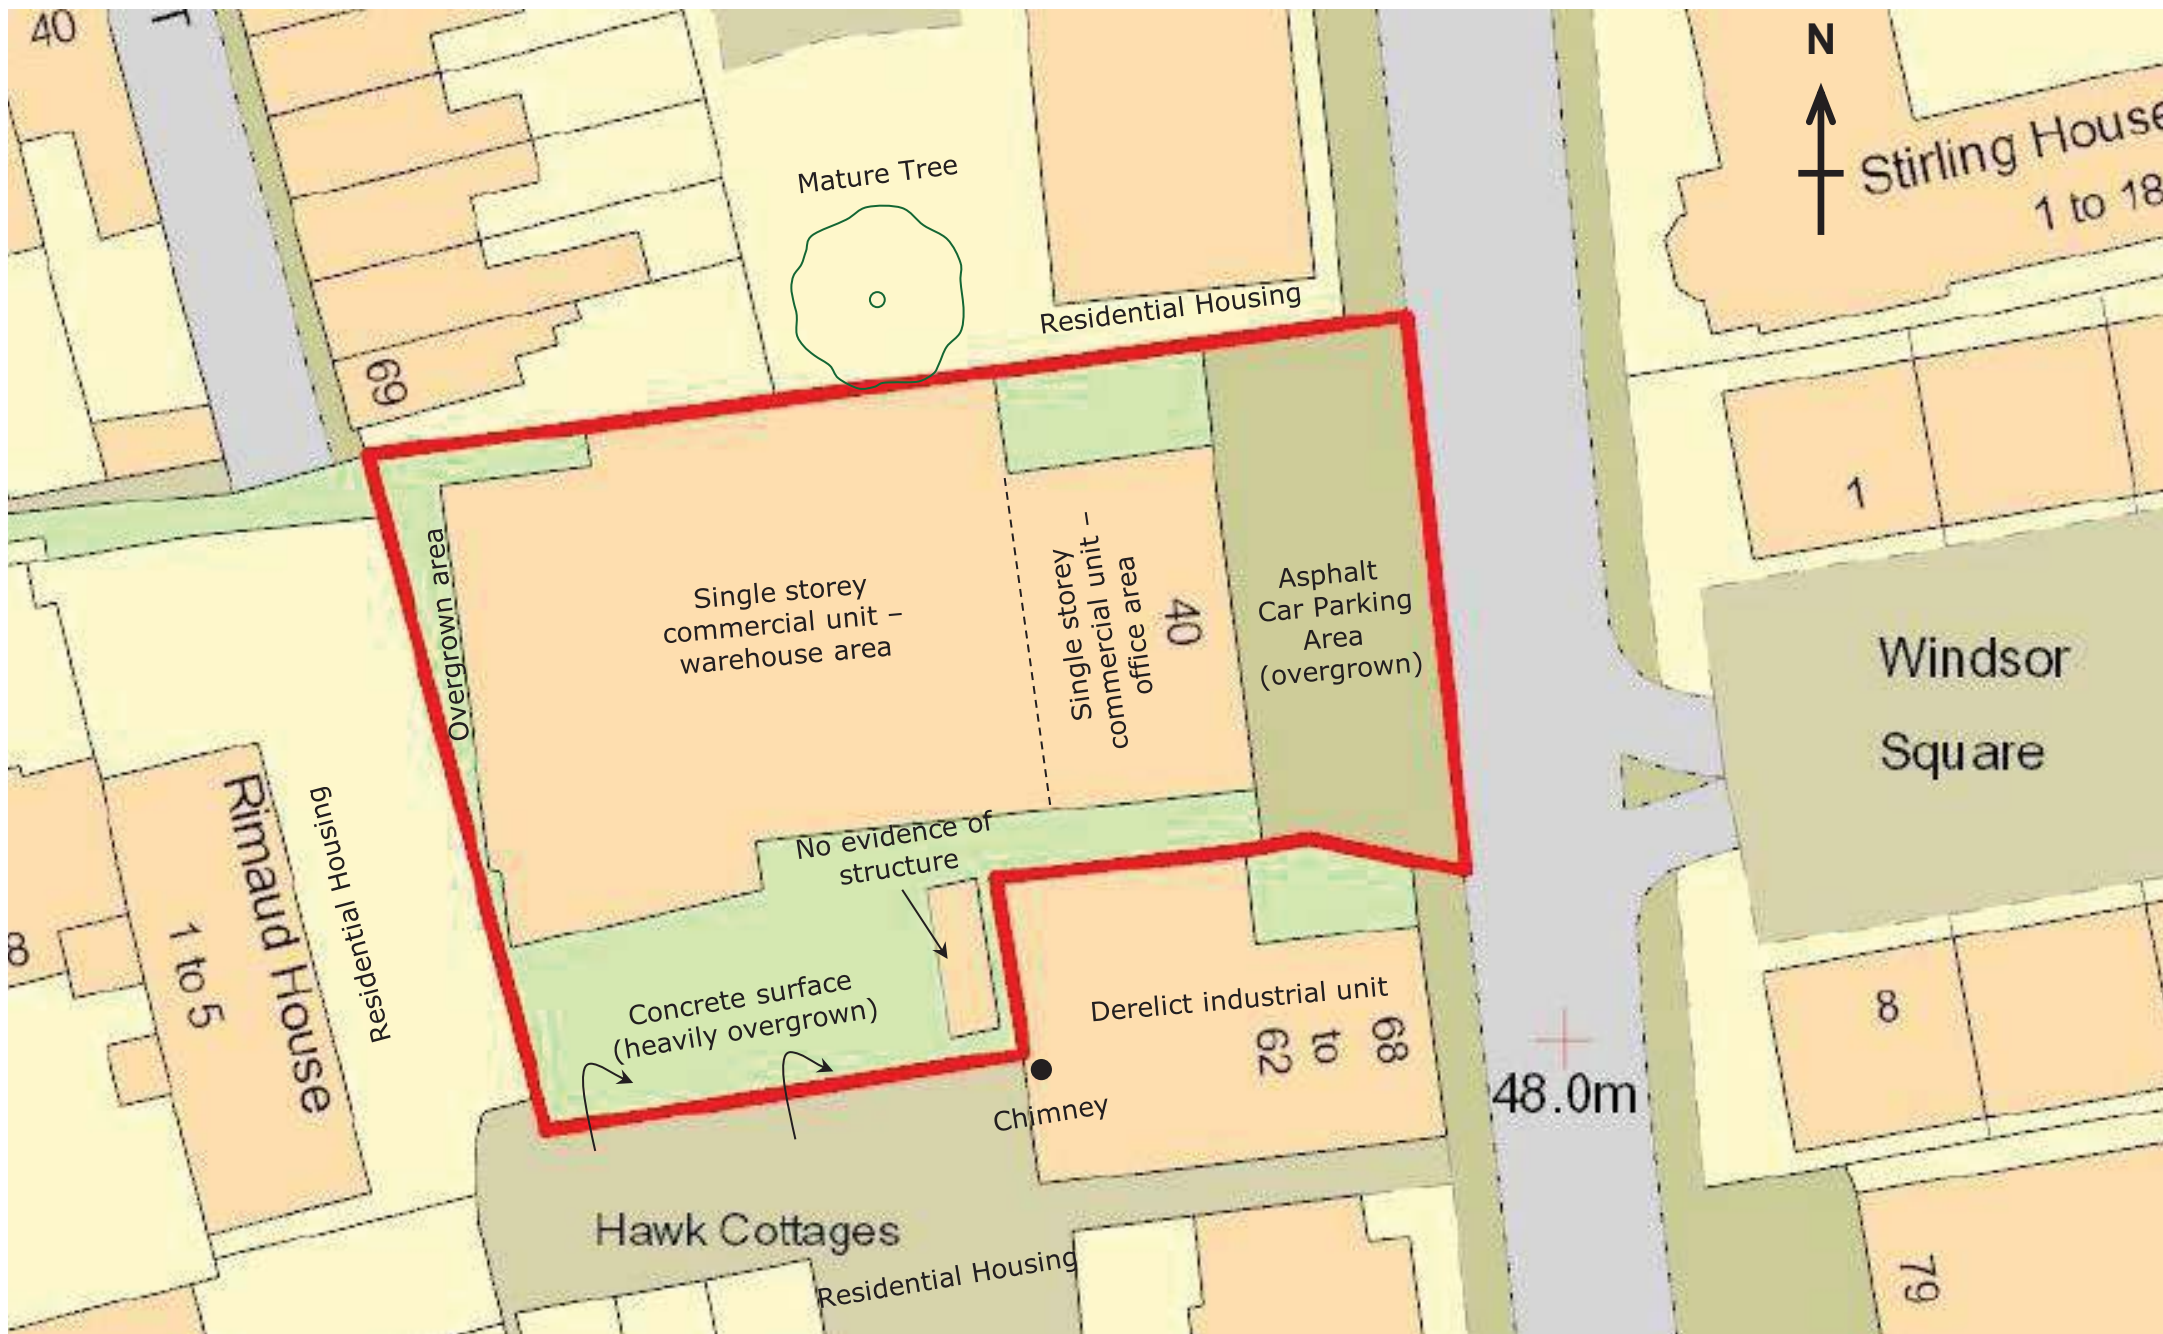
The site comprises an approximately rectangular shaped plot of land located at 40 Silver Street, Reading, Berkshire and is centred on the approximate Ordnance Survey national grid reference SU 7189 7273. A site location plan and site plan are presented as Figure 1 and Figure 2, respectively. Photographs taken during the walkover survey are included in Appendix A.

During the walkover survey there was no evidence of a small outbuilding in the south east of the site that was shown on the planning boundary map for the site (See Figure 2).

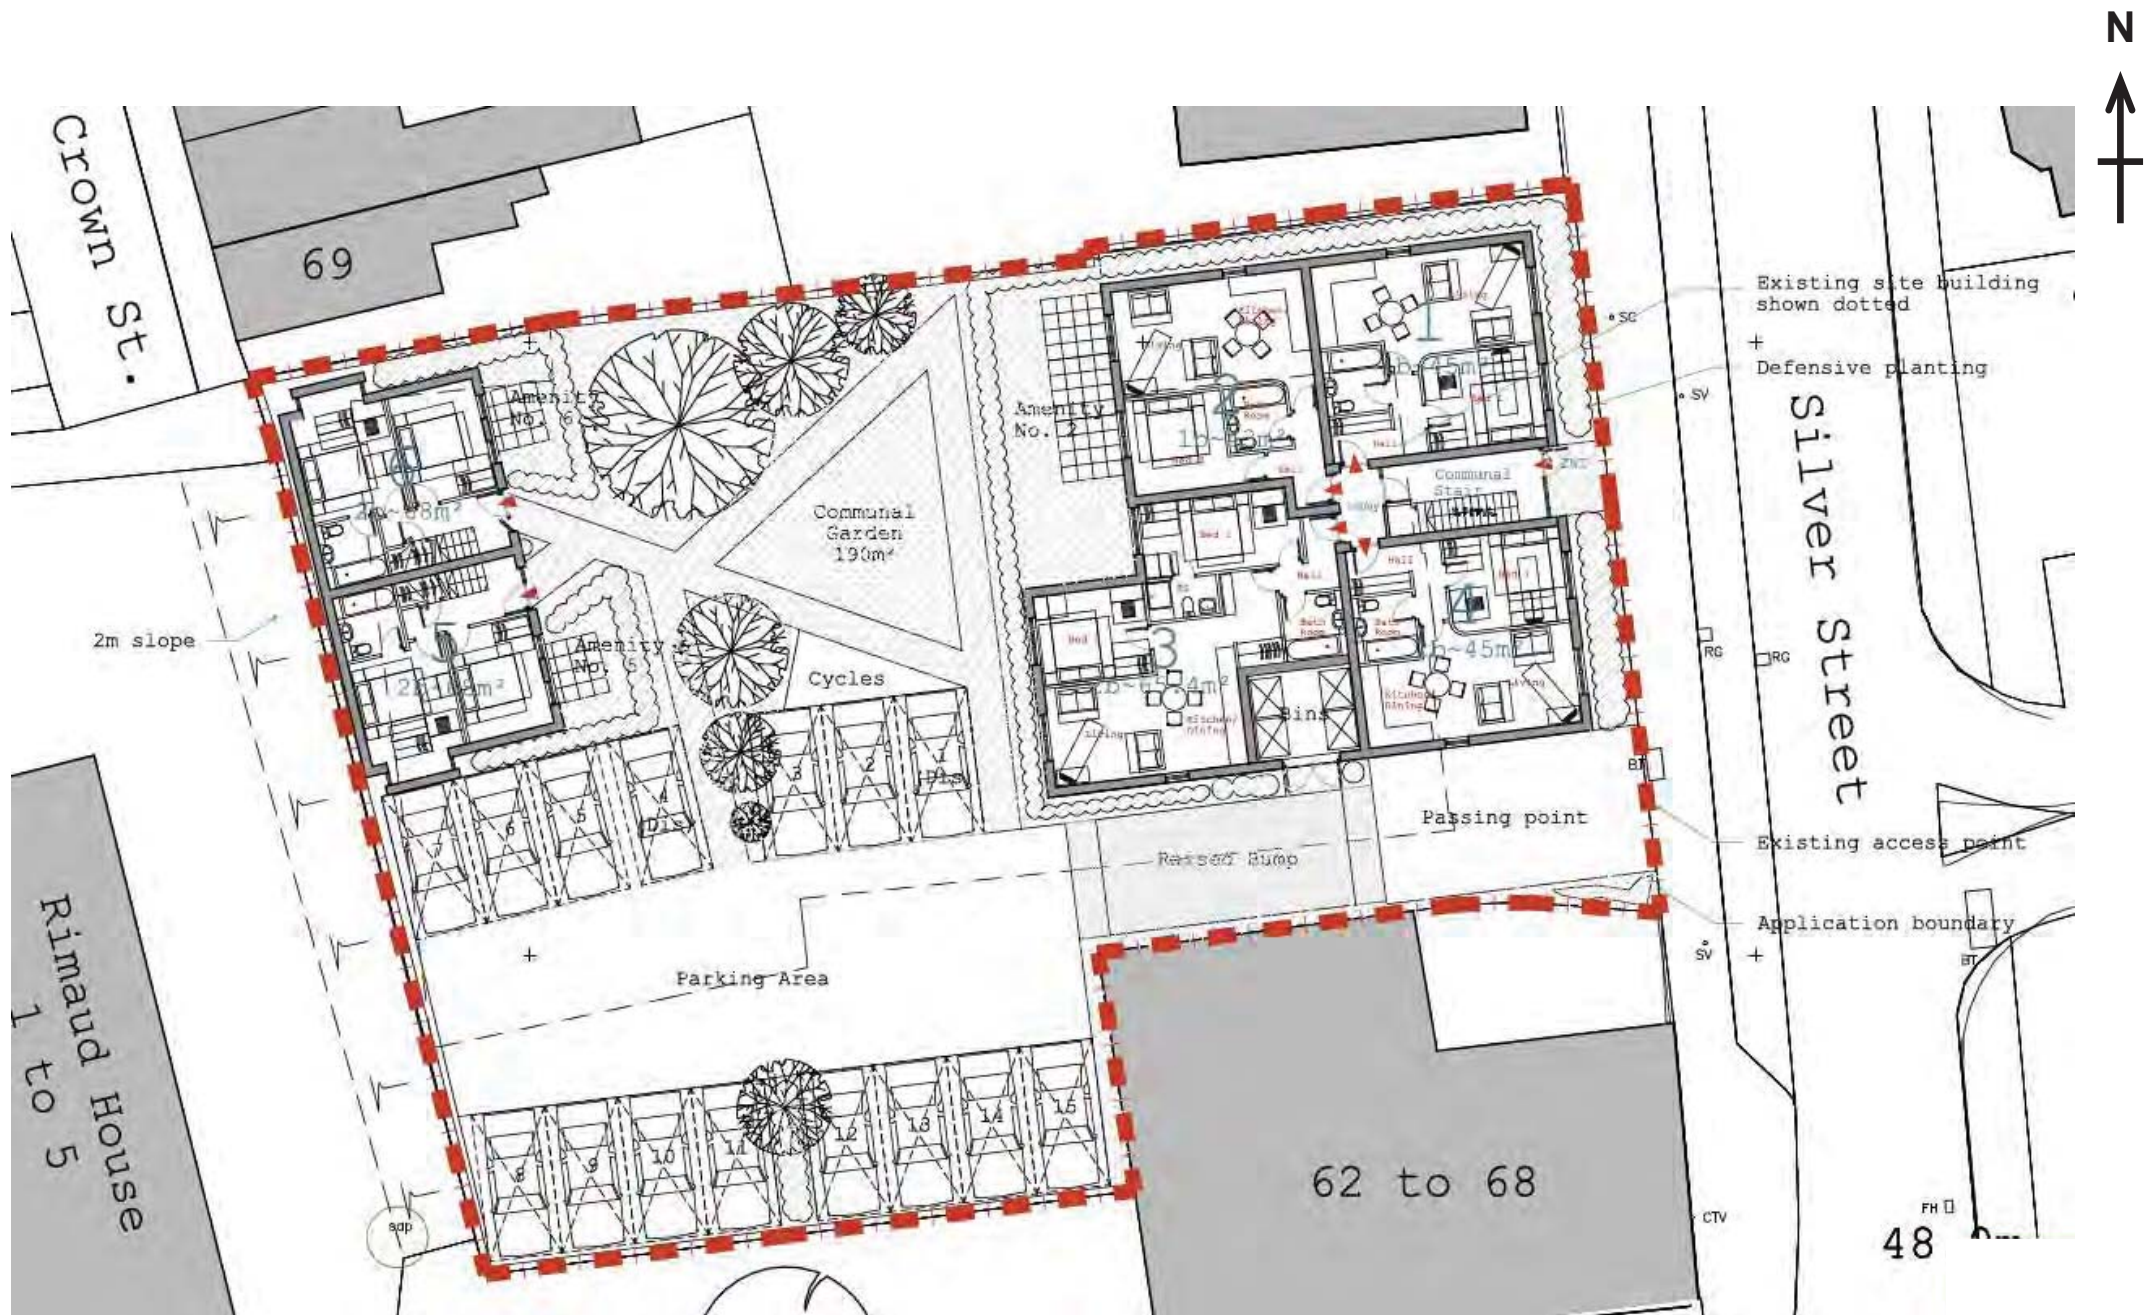
The proposed development layout is presented in Figure 3. Should the proposed development plans be altered, a revised risk assessment may be required.

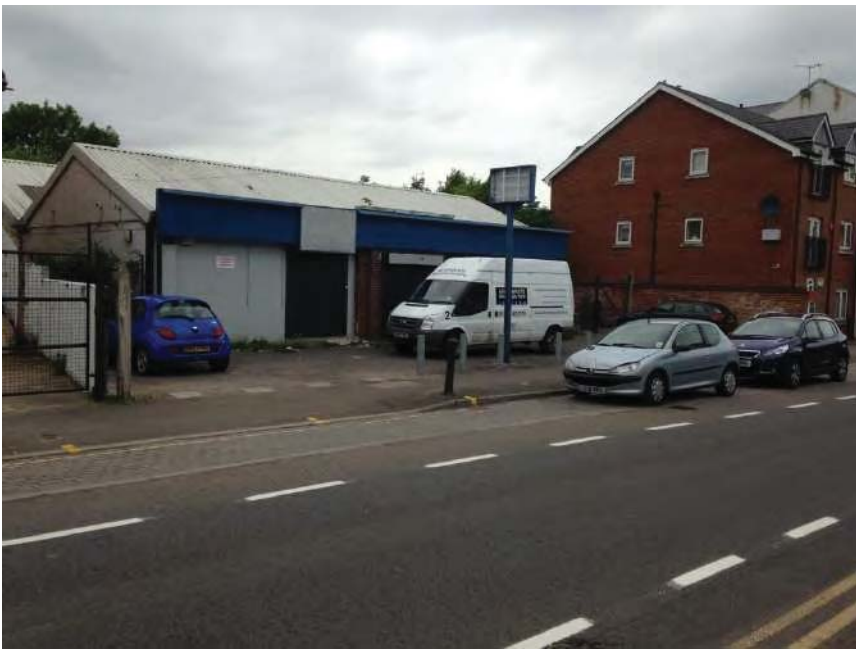
Site viewed from the east

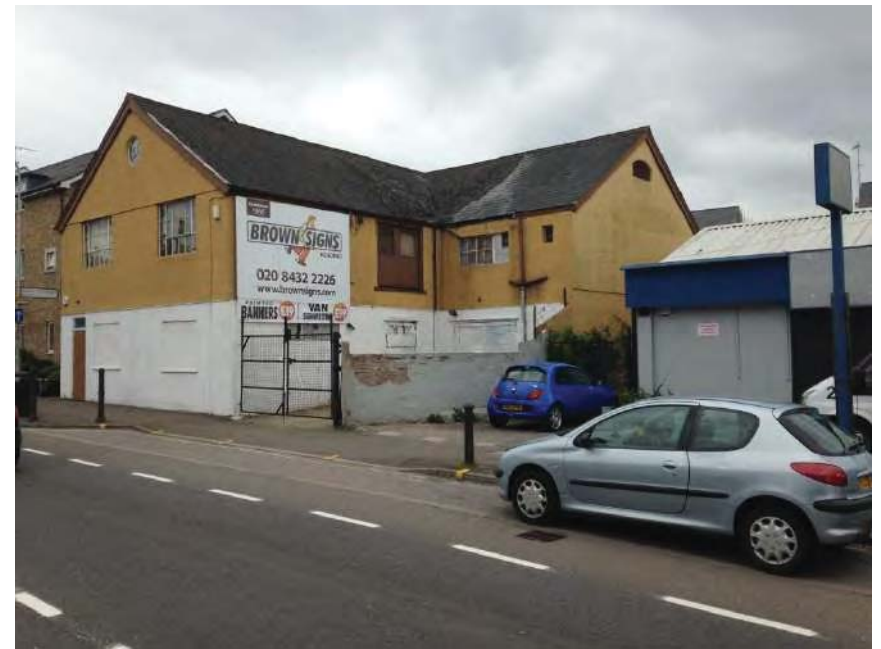
Derelict industrial unit to the south east of the site

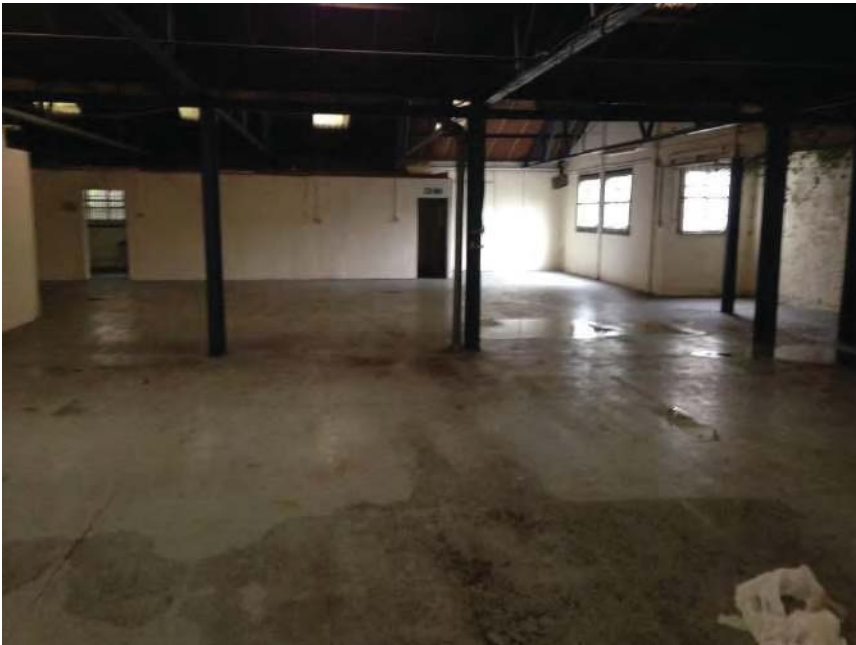
Western part of commercial unit on the site – warehouse area

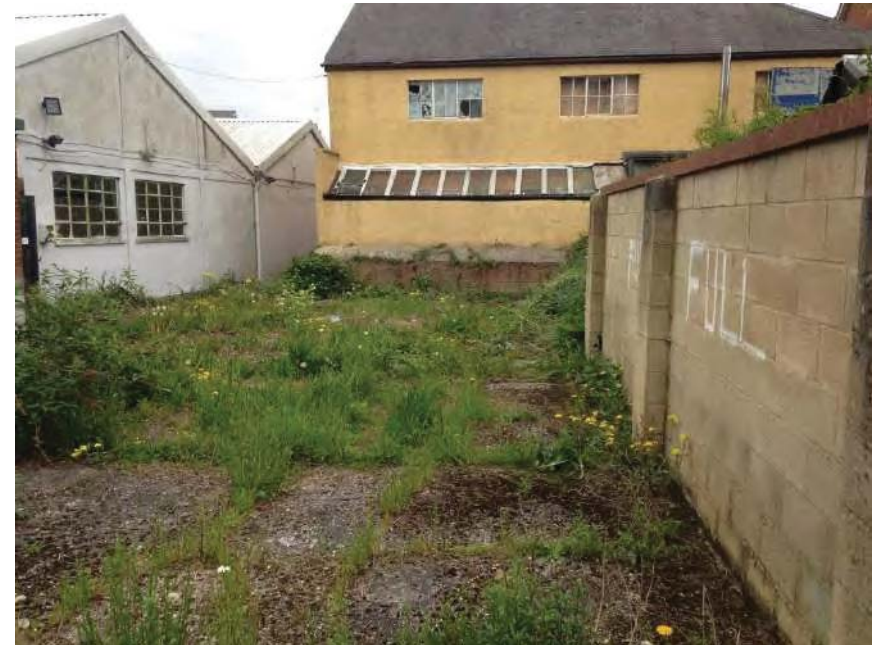
Southern part of the site – on-site chimney and area of former structure
