| Project Details | WIE14788-108: Station Hill, Reading |
| Figure Title | Figure 11.1: Noise Monitoring and Sensitive Receptor Locations |

| Figure Title | Figure 13.1: Seasonal Wind Roses for London Heathrow Airport |

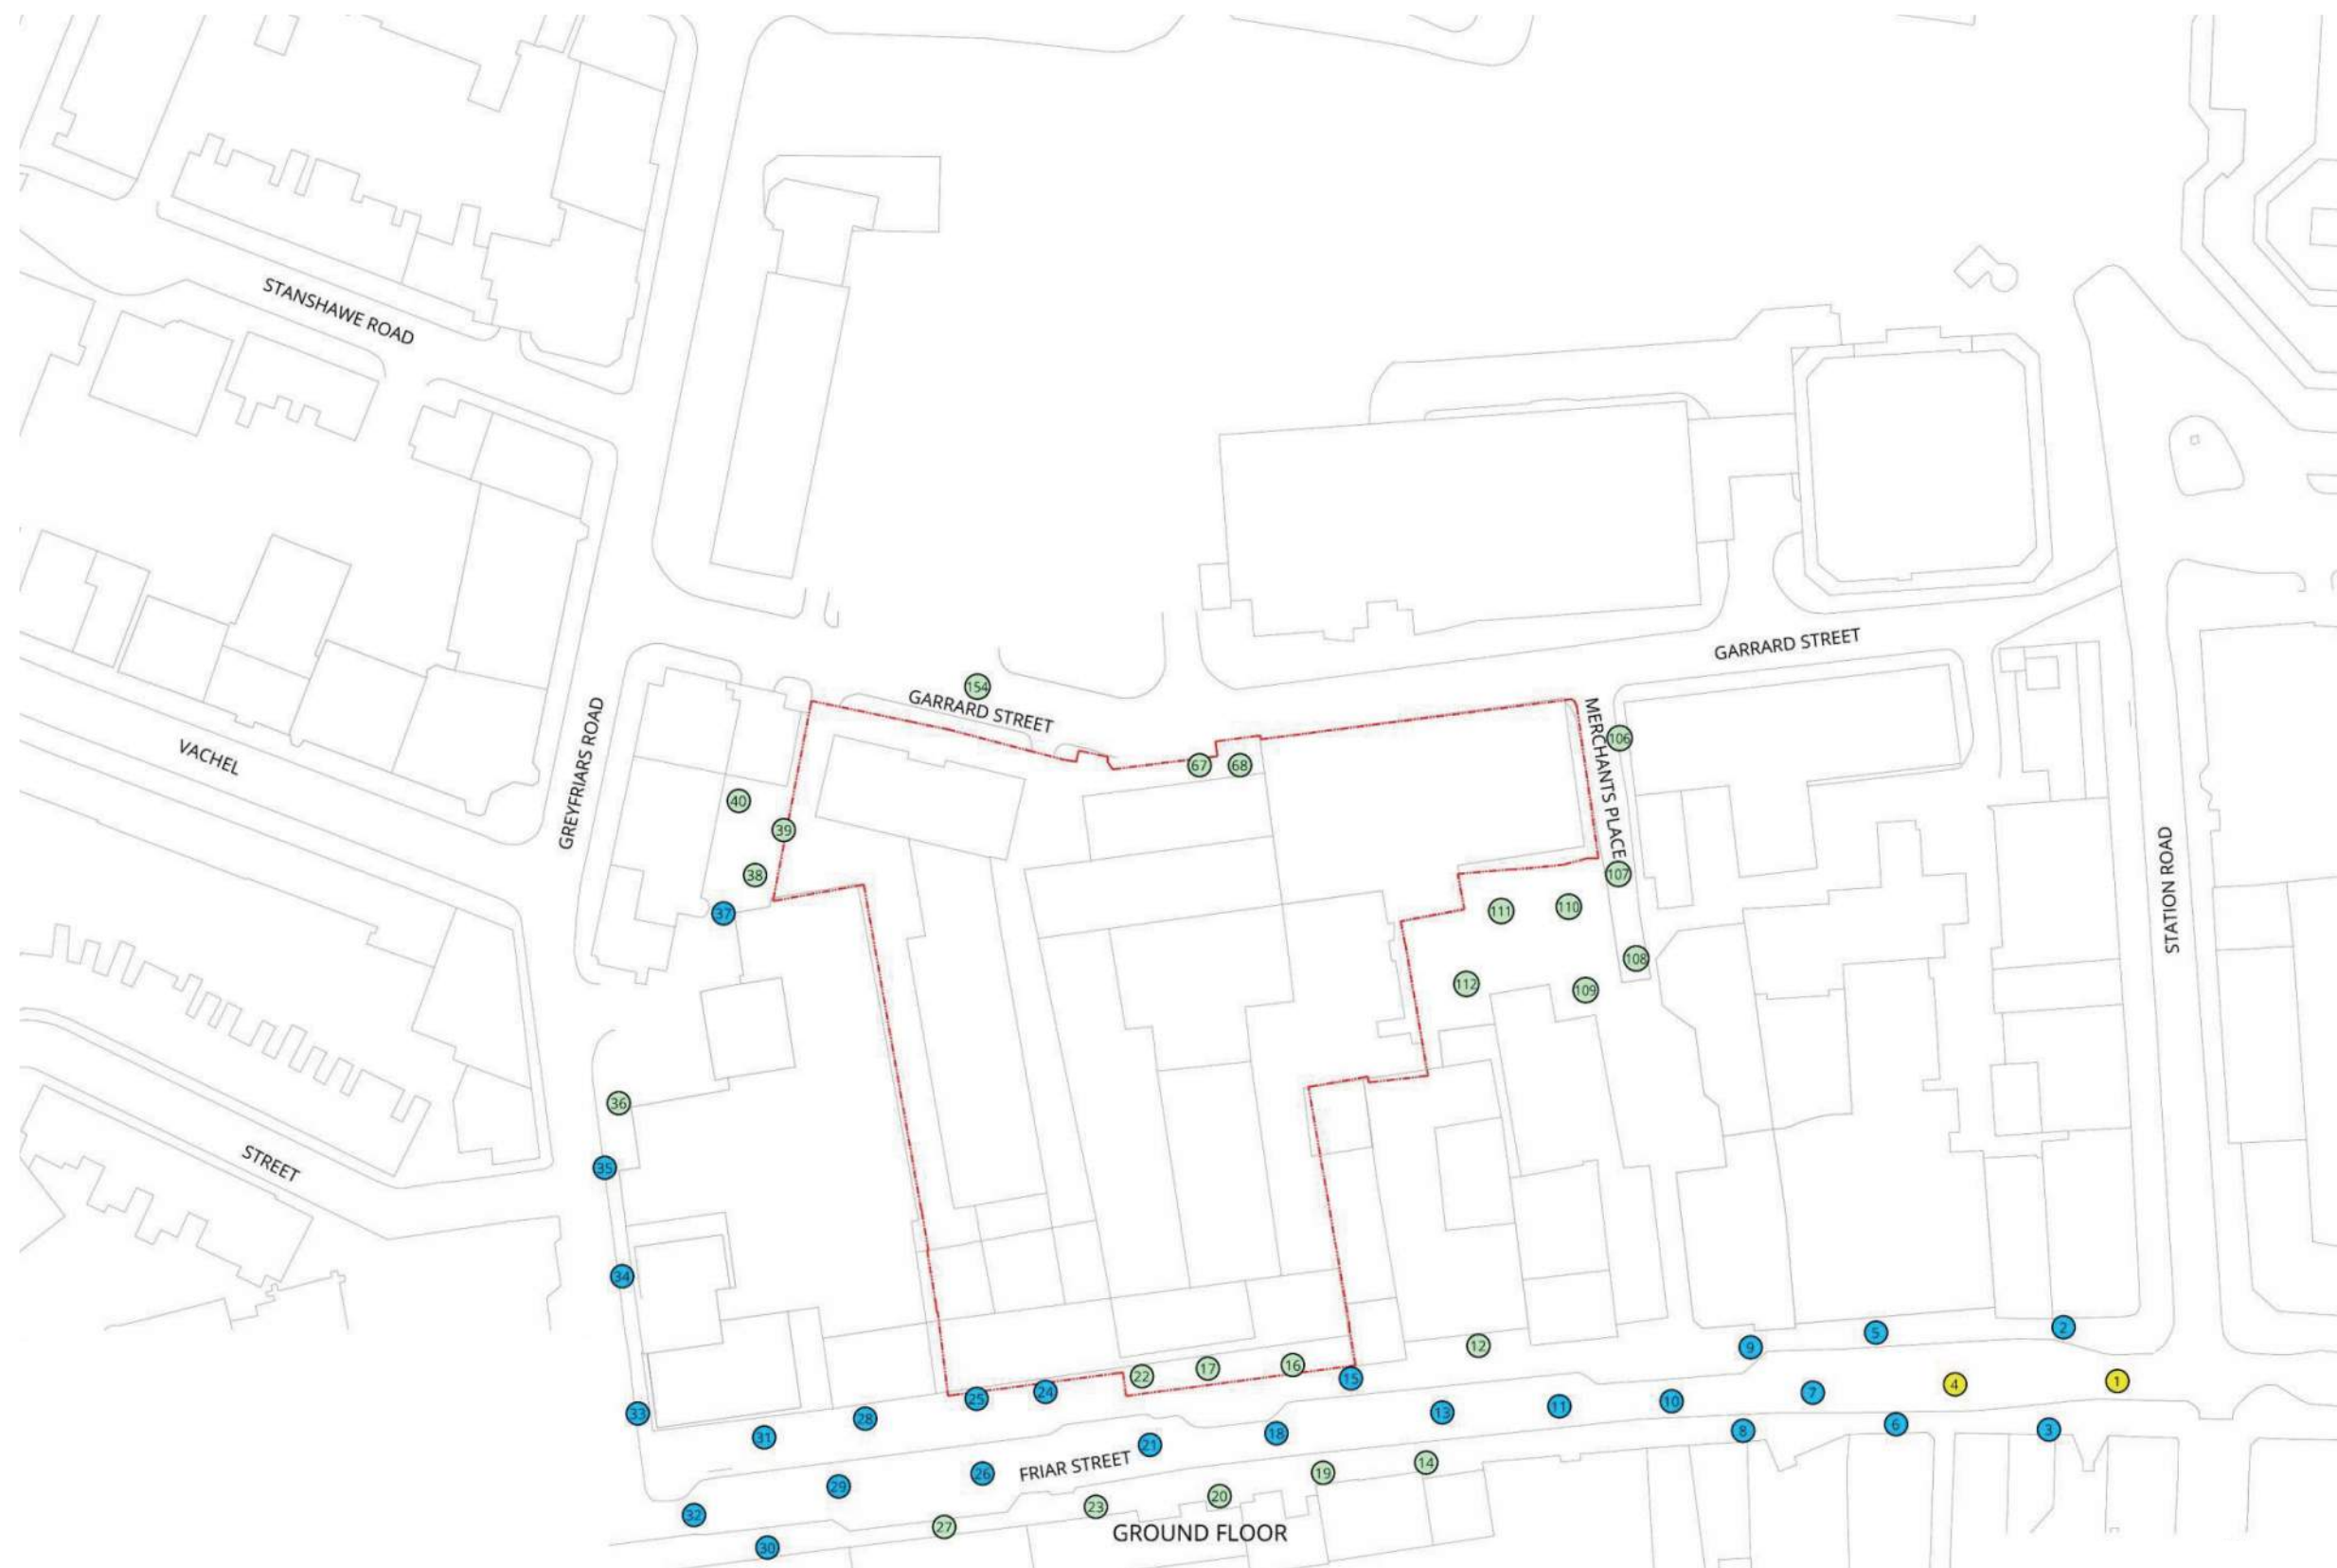
WIE14788-108\_GR\_ES\_13.2A

Figure 13.2: Configuration 1: Existing Site with the Existing Surrounding Buildings (South Site) – Windiest Season, Ground Level

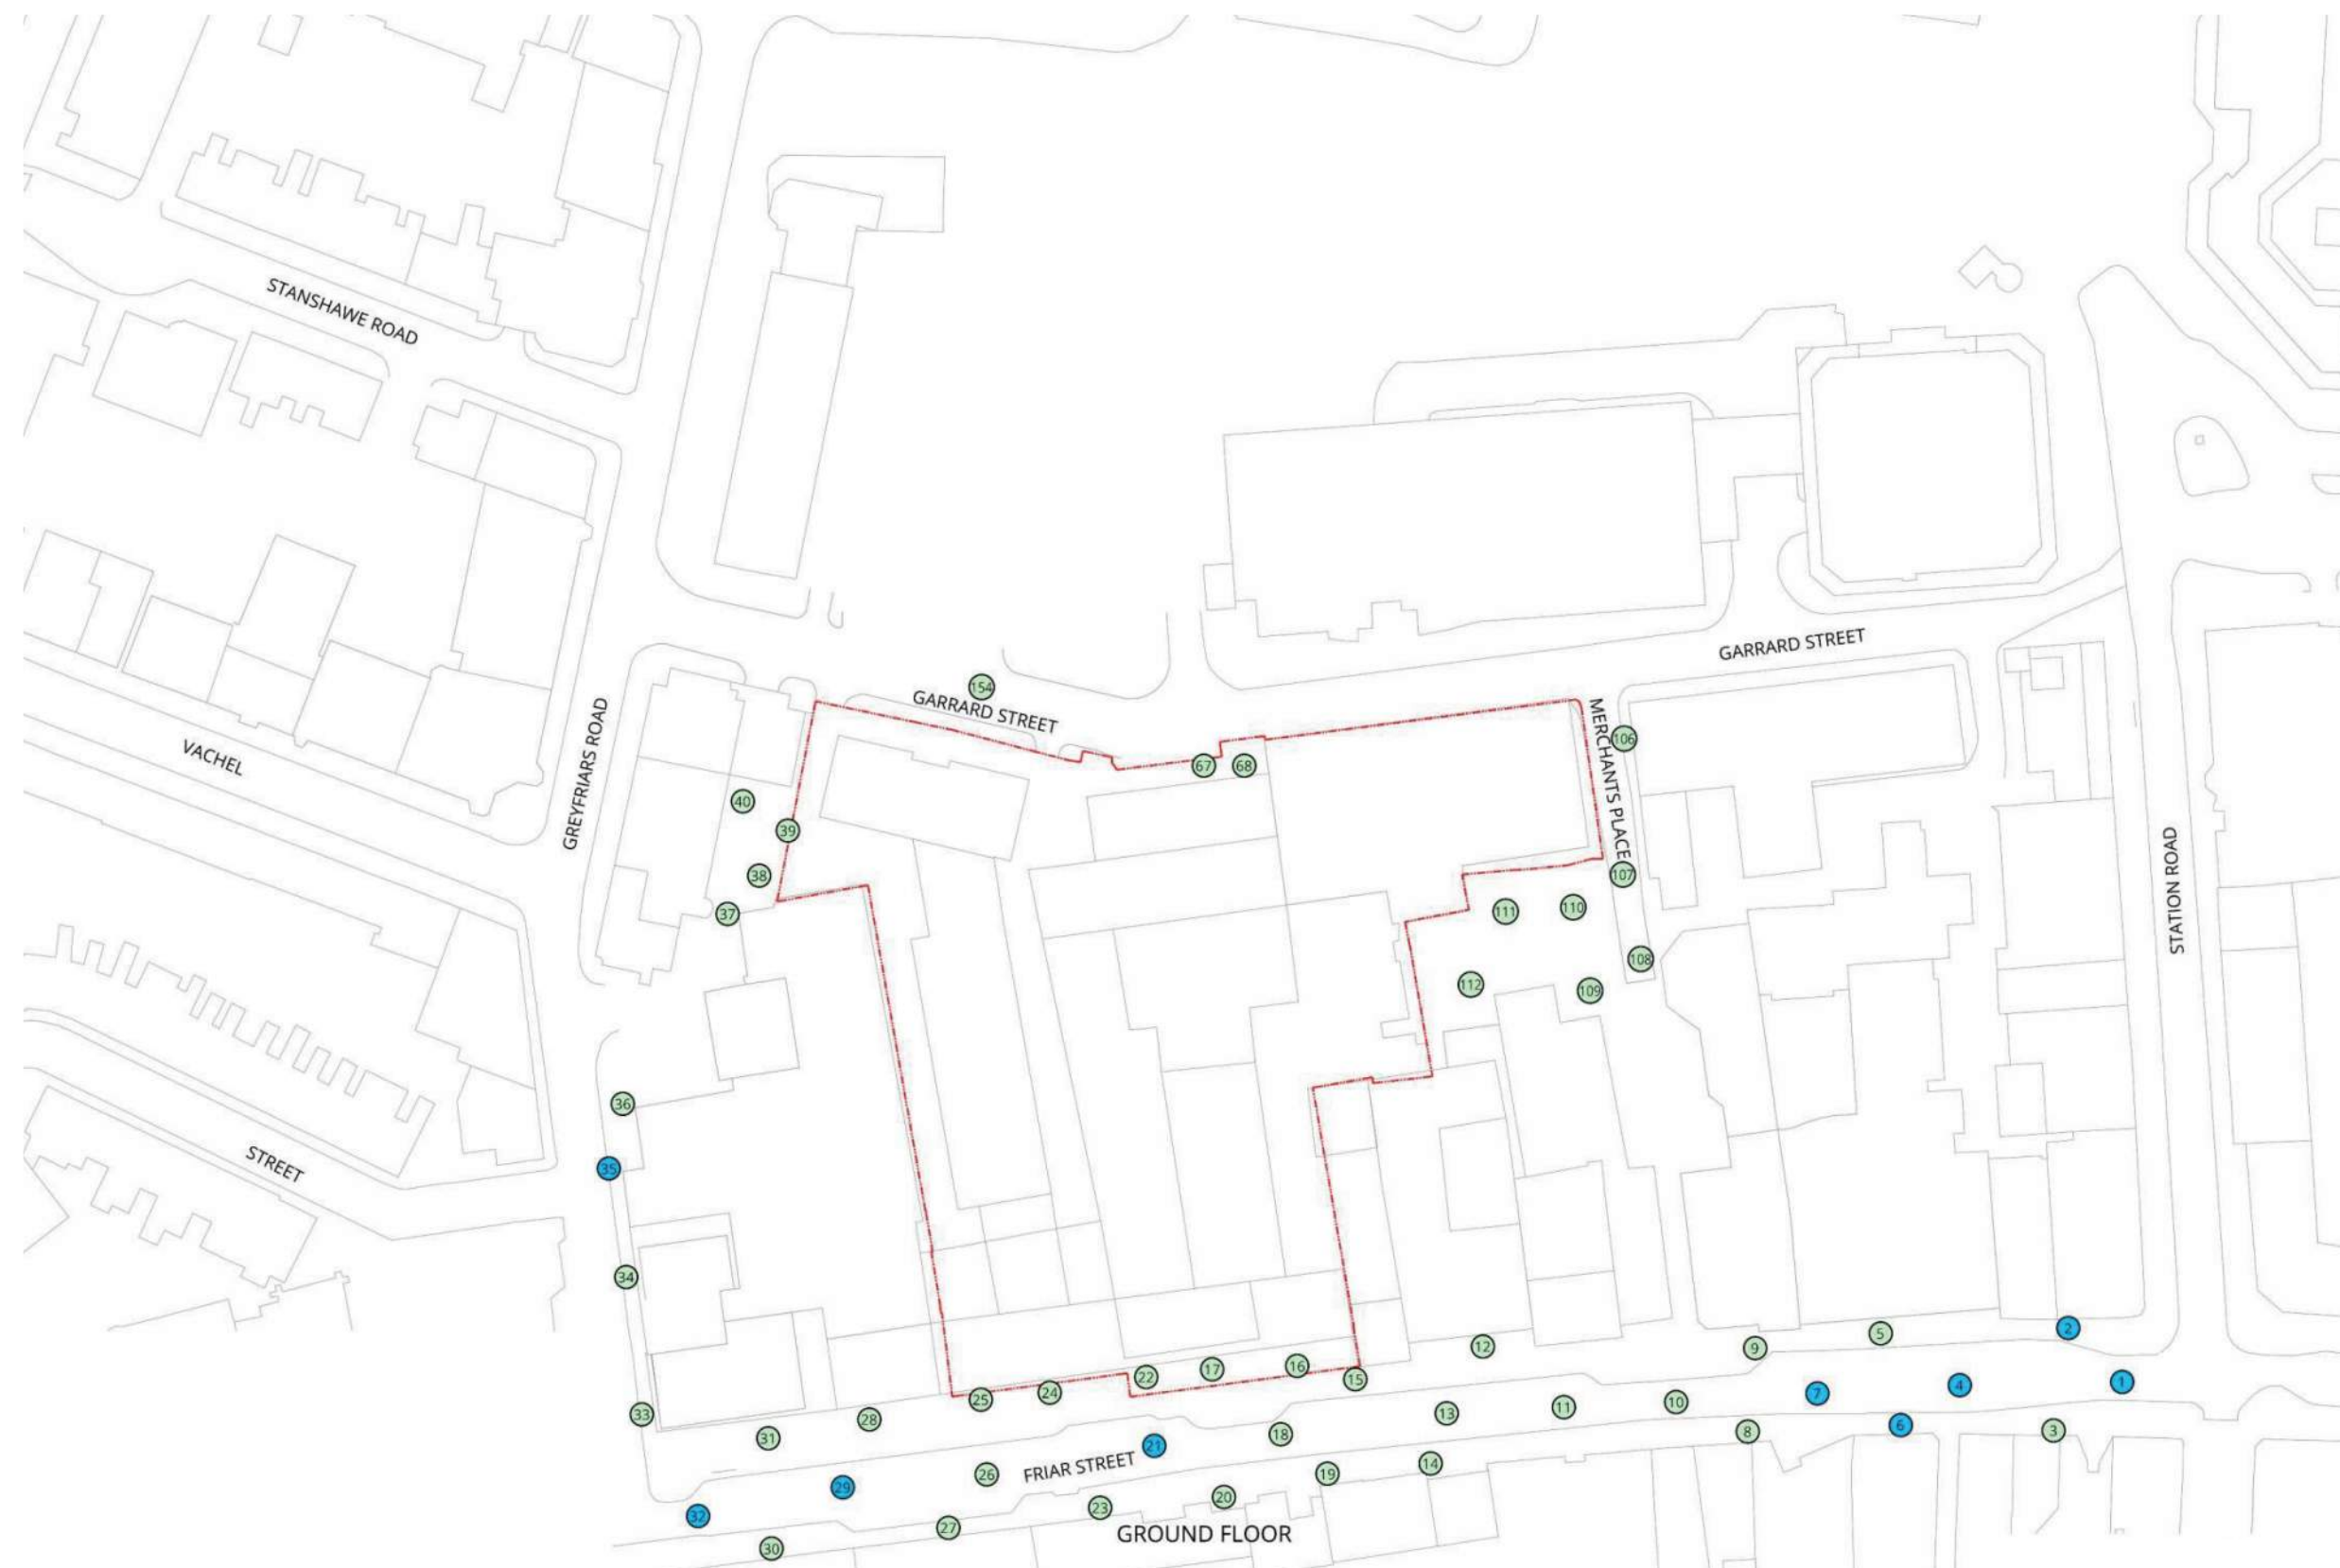
WIE14788-108\_GR\_ES\_13.3A

Figure 13.3: Configuration 1: Existing Site with the Existing Surrounding Buildings (South Site) – Summer Season, Ground Level

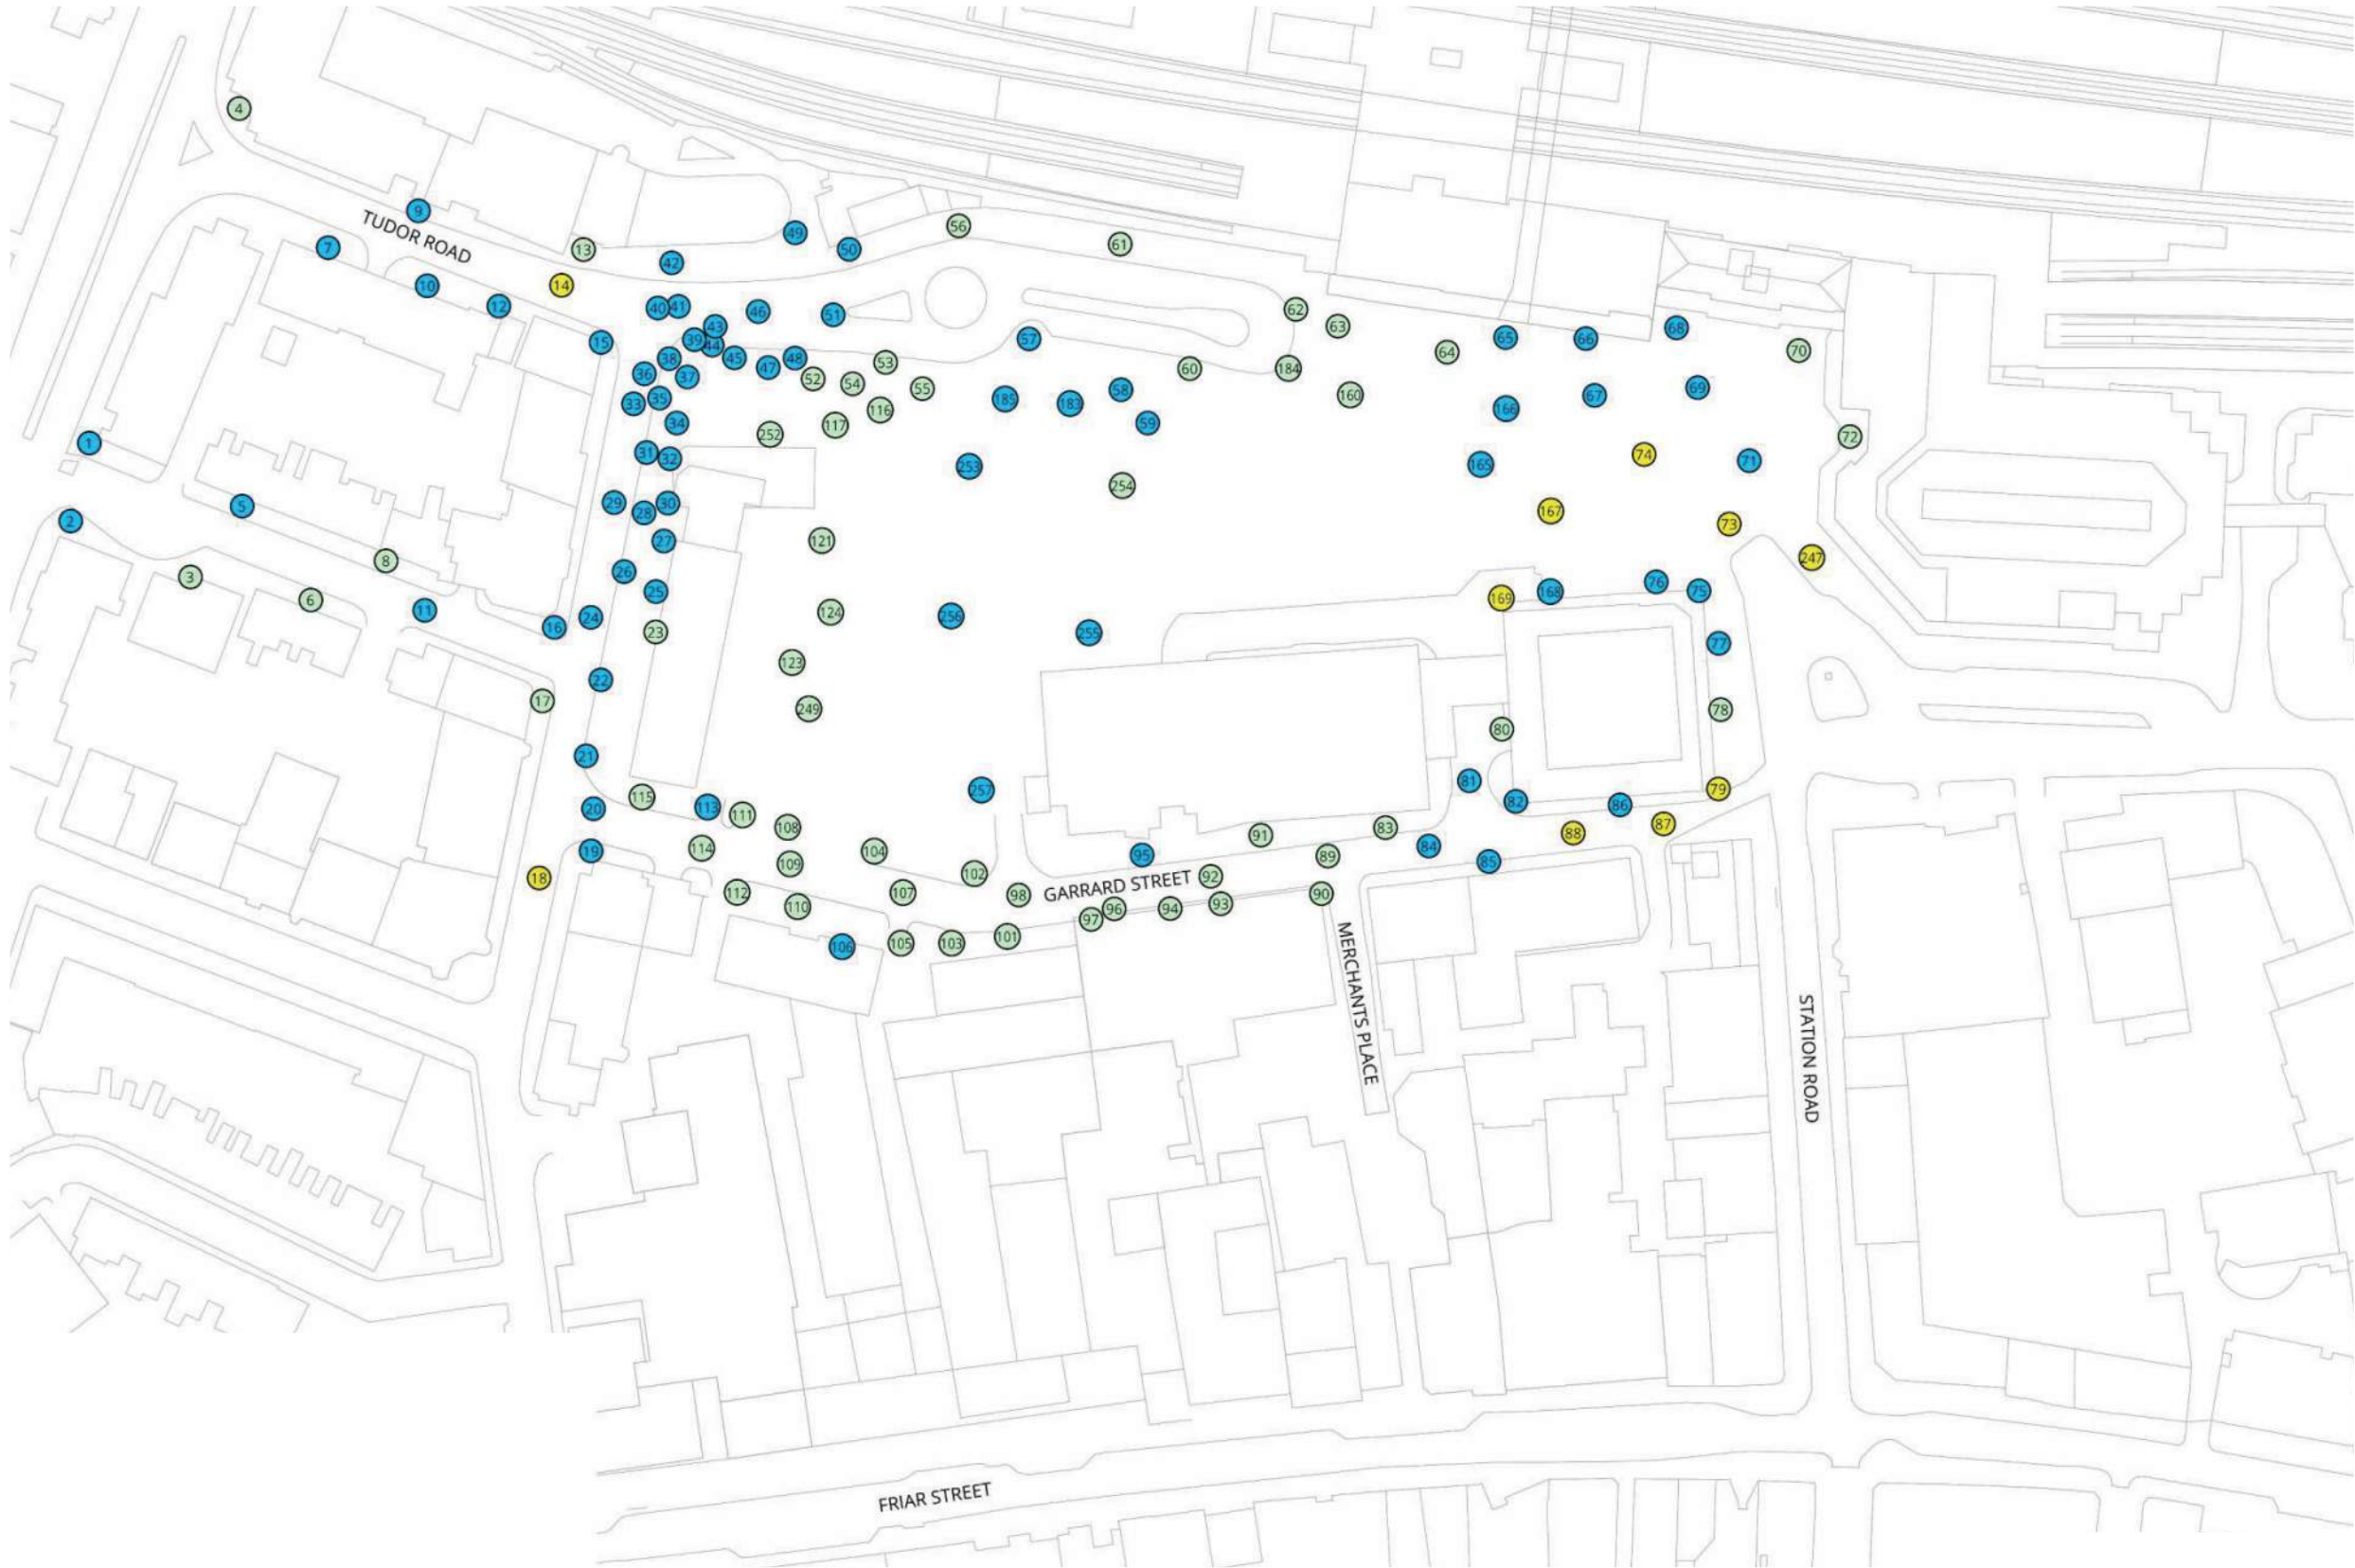
WIE14788-108\_GR\_ES\_13.4A

Figure 13.4: Configuration 1: Existing Site with the Existing Surrounding Buildings – Windiest Season, Ground Level

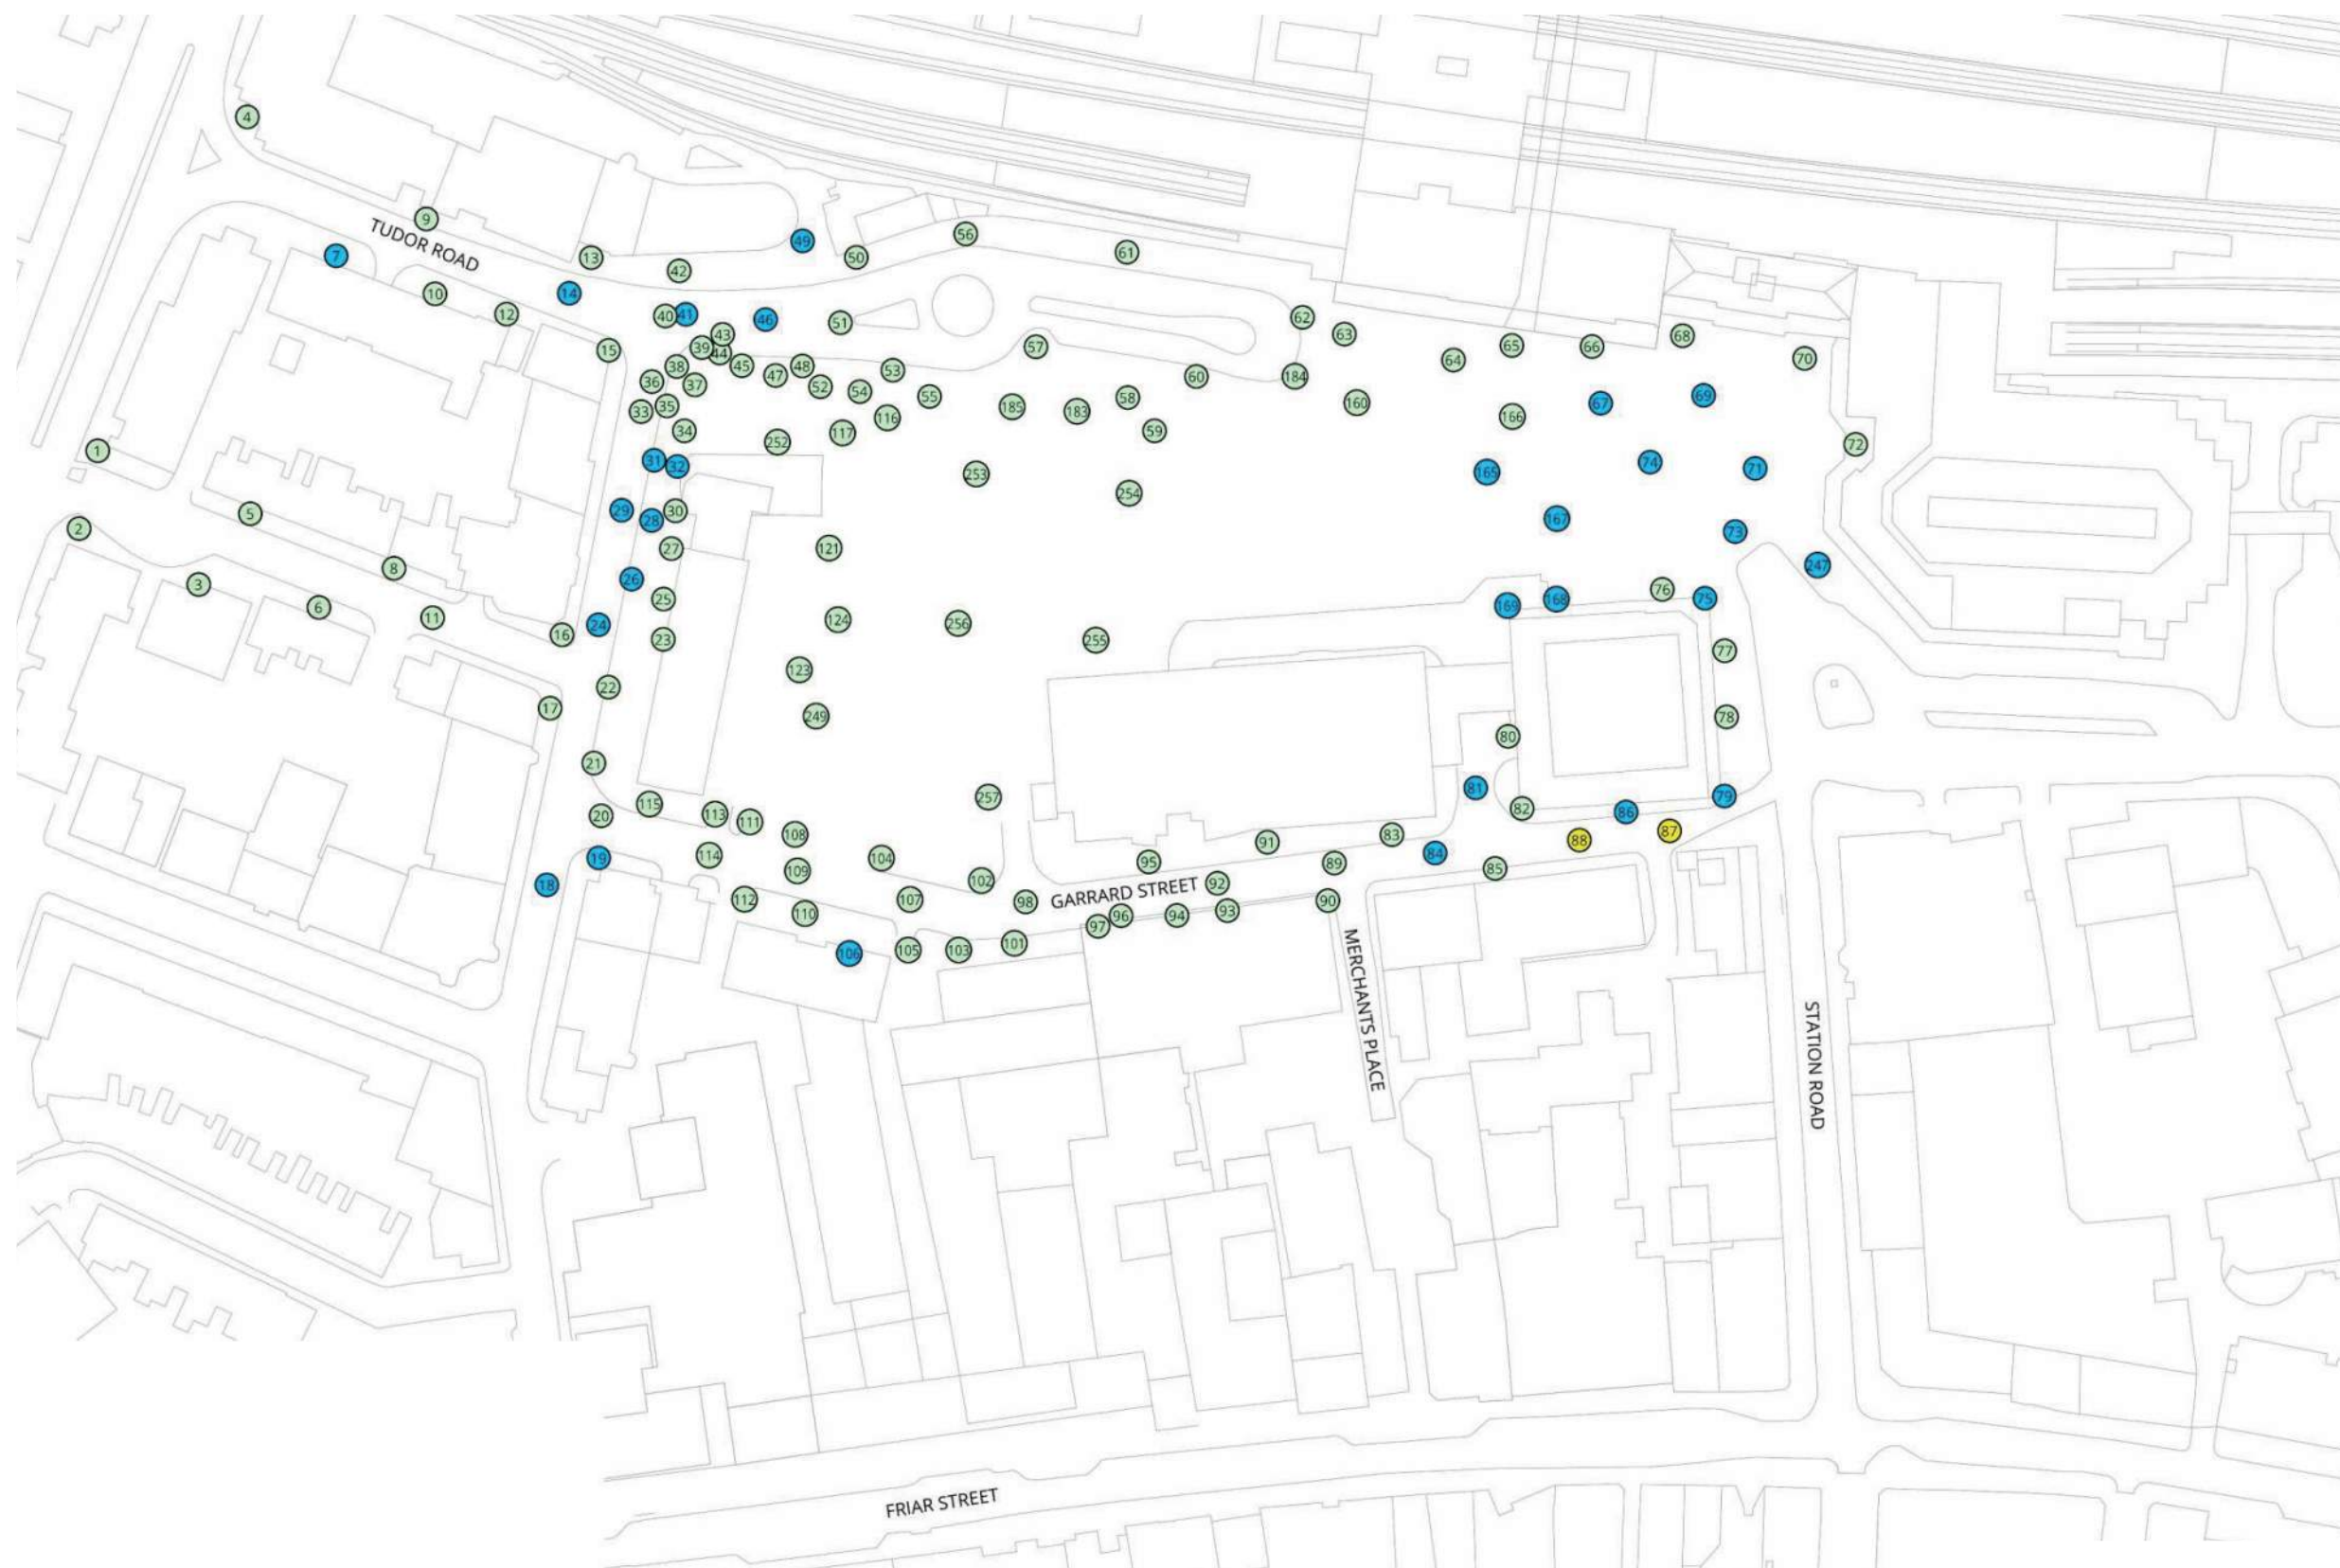
WIE14788-108\_GR\_ES\_13.5A

Figure 13.5: Configuration 1: Existing Site with the Existing Surrounding Buildings – Summer Season, Ground Level

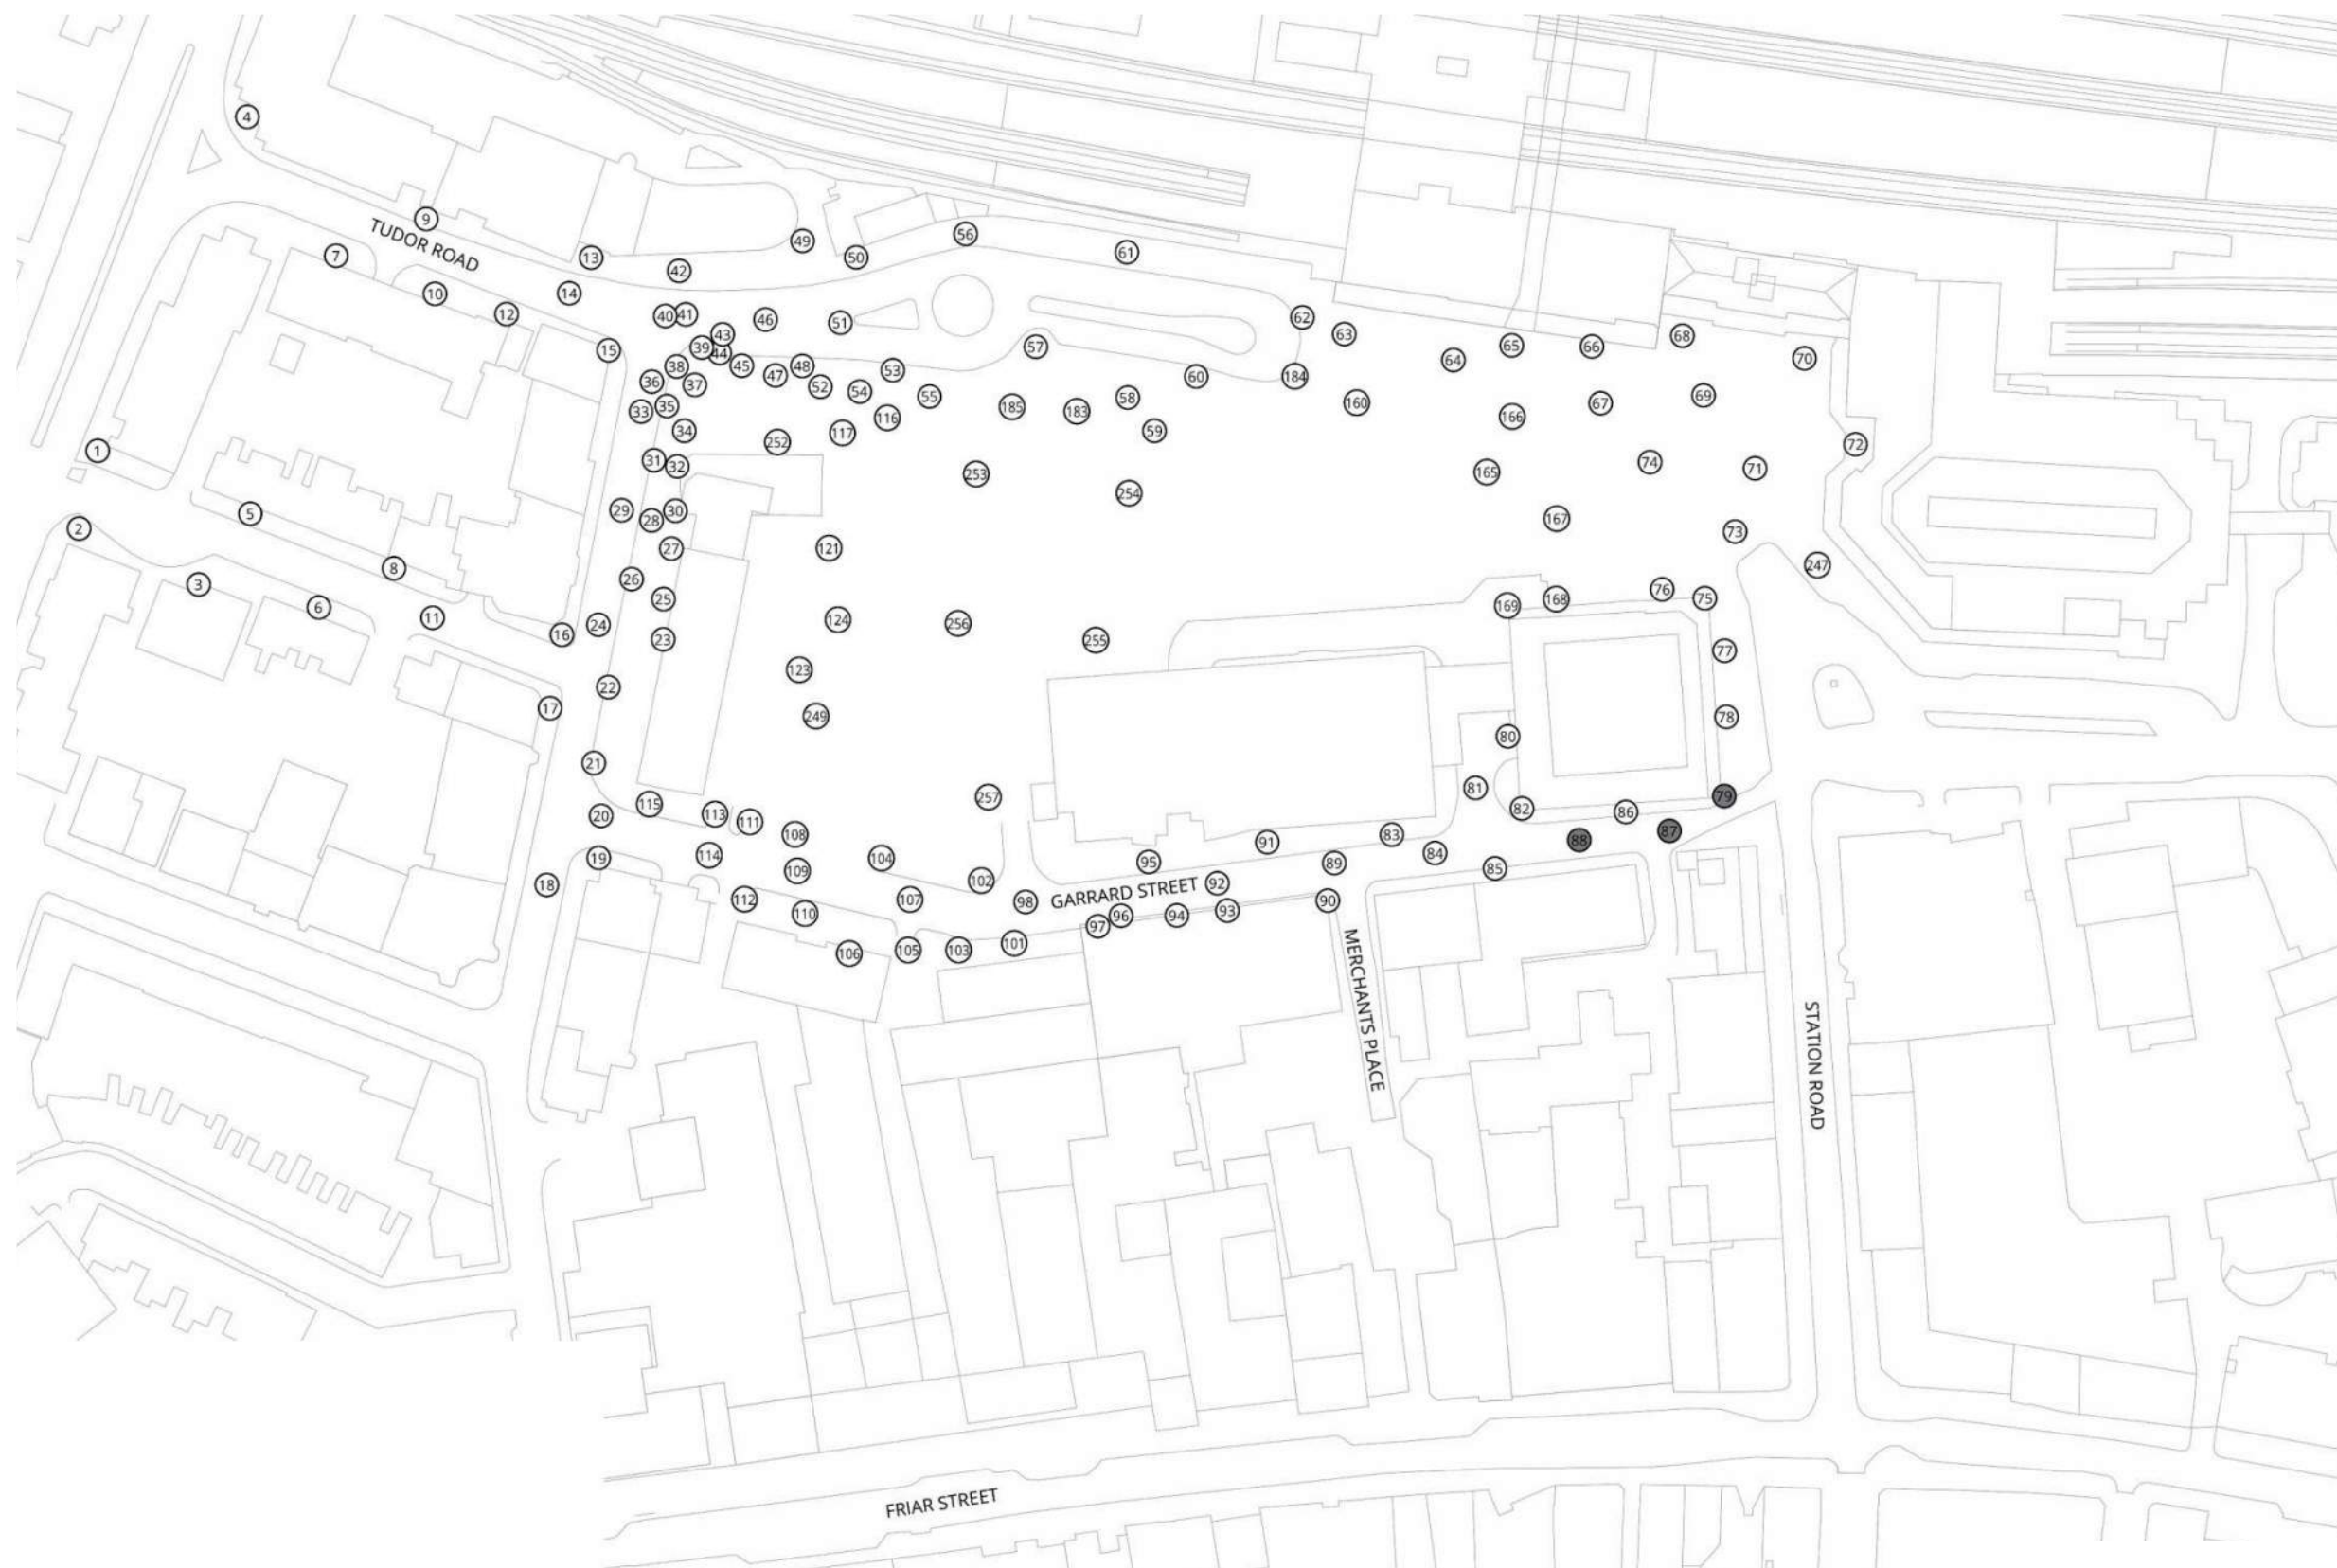
WIE14788-108\_GR\_ES\_13.6A

Figure 13.6: Configuration 1: Existing Site with the Existing Surrounding Buildings – Annual Safety Exceedances, Ground and Terrace Levels

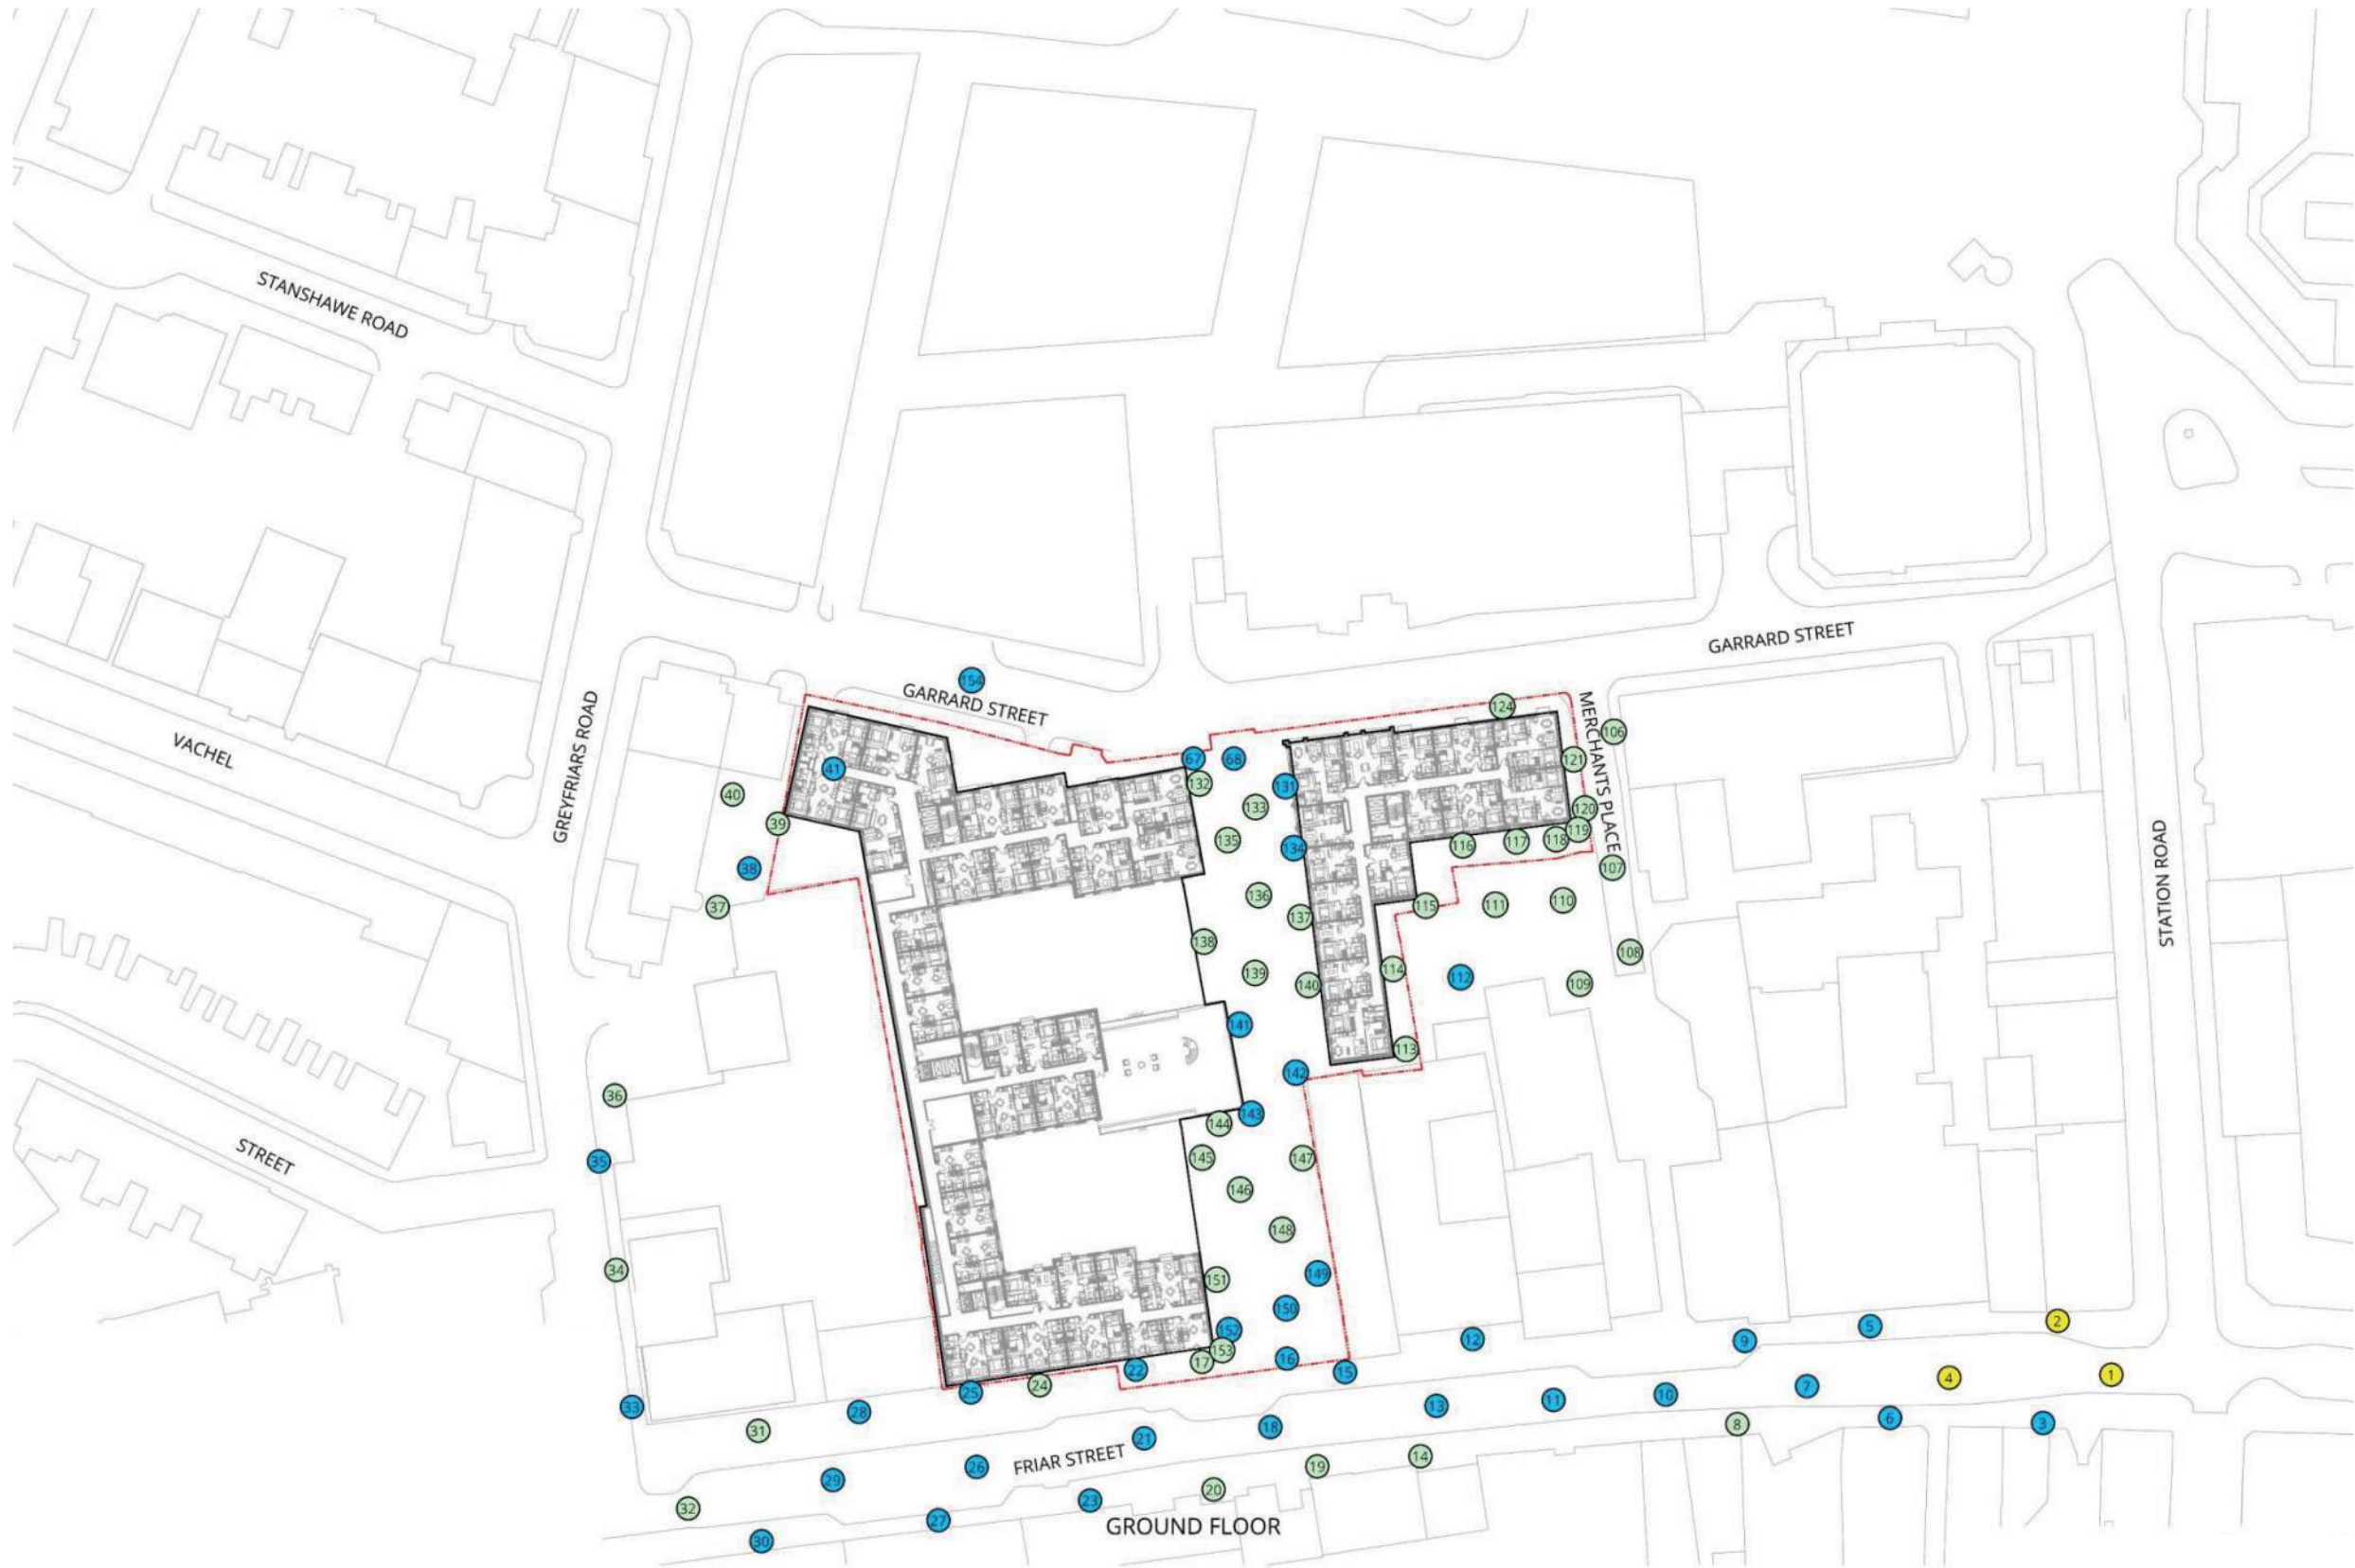
| WIE14788-108_GR_ES_13.7A |

| Figure 13.7: Configuration 2: South Site with Max Parameter North Site and the Existing Surrounding Buildings – Windiest Season, Ground and Terrace Levels |
