| Project Details | WIE14788-108: Station Hill, Reading |
| Figure Title | Figure 11.1: Noise Monitoring and Sensitive Receptor Locations |

| Figure Title | Figure 13.1: Seasonal Wind Roses for London Heathrow Airport |

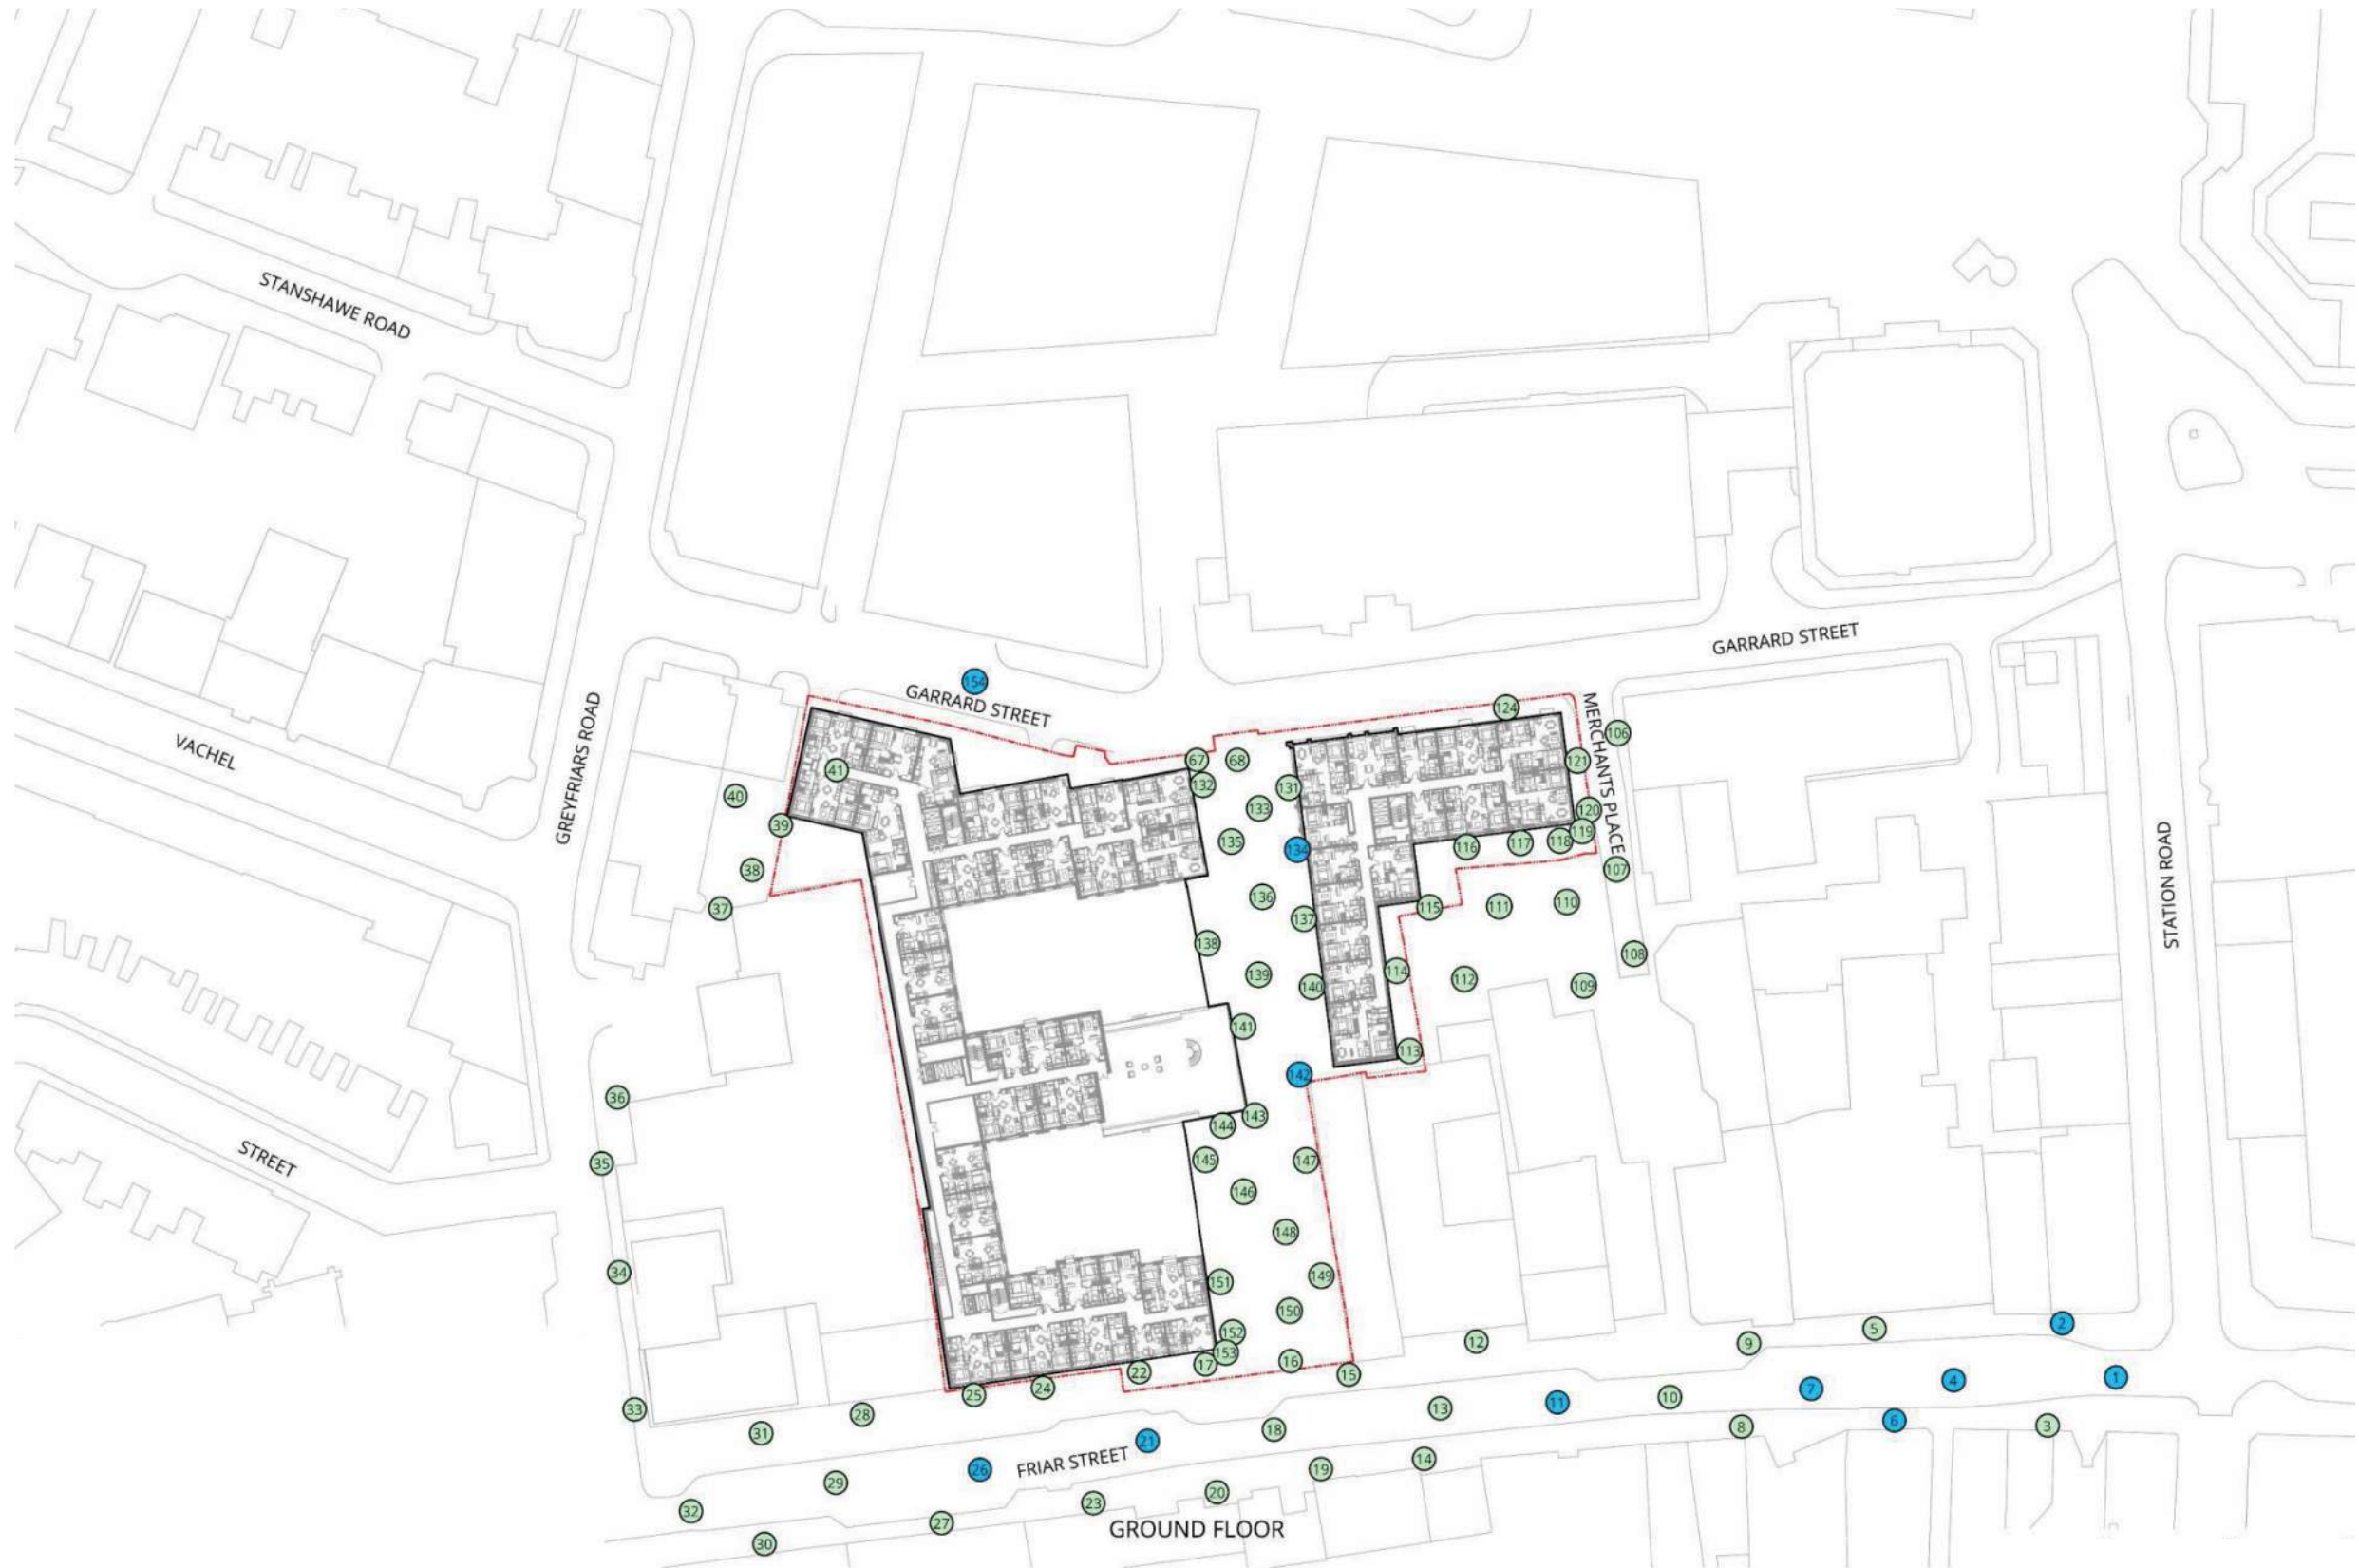
| Date | WIE14788-108_GR_ES_13.8A |

| Figure Ref | Figure 13.8: Configuration 2: South Site with Max Parameter North Site and the Existing Surrounding Buildings – Summer Season, Ground and Terrace Levels |

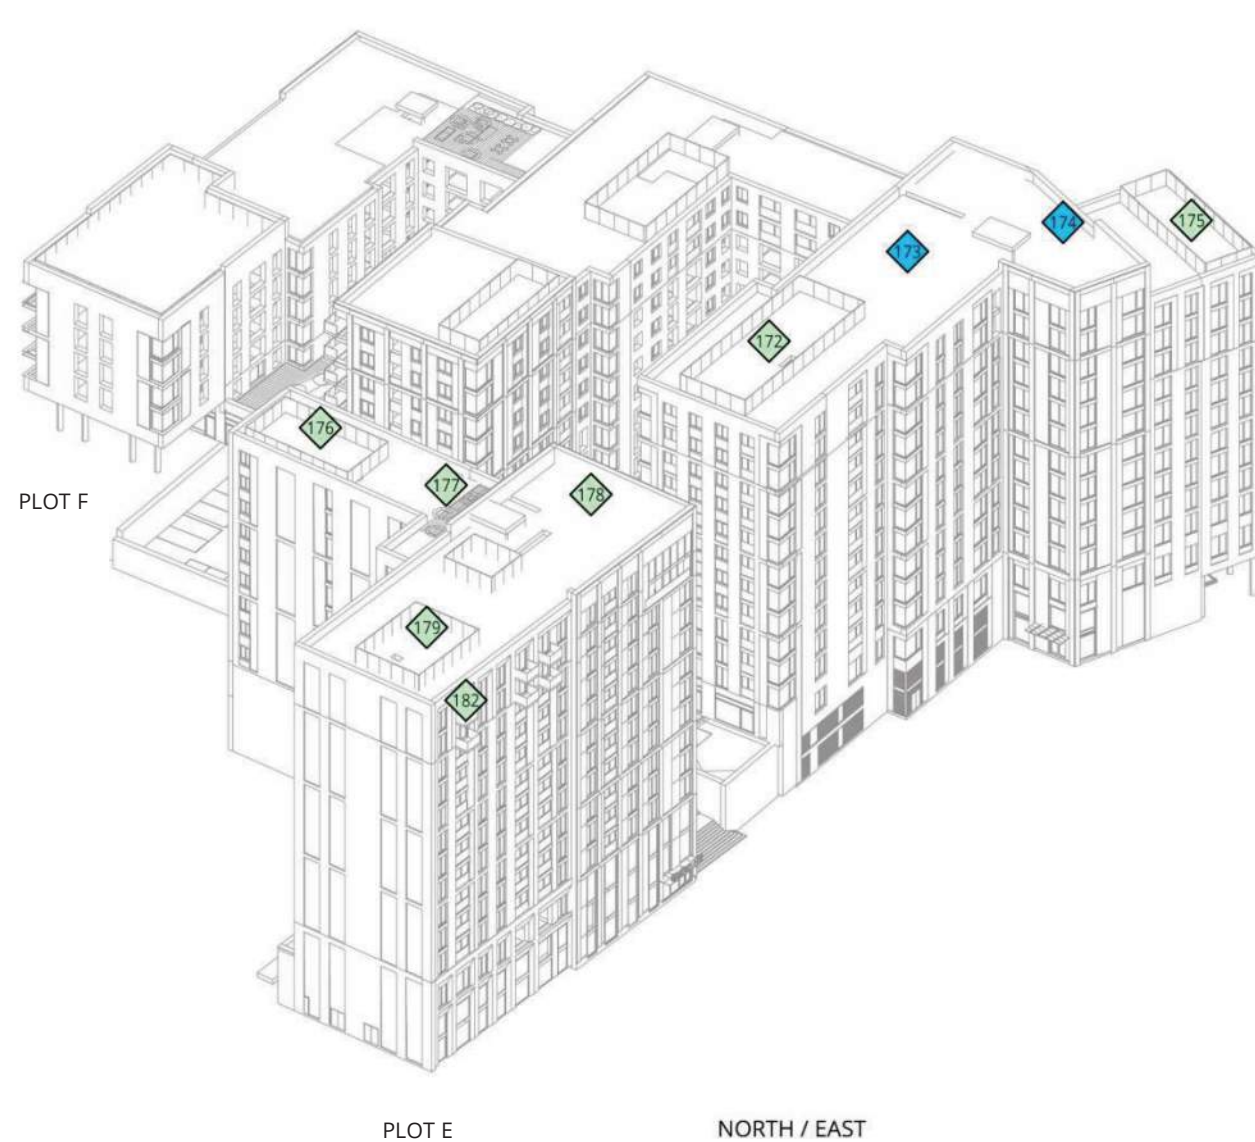
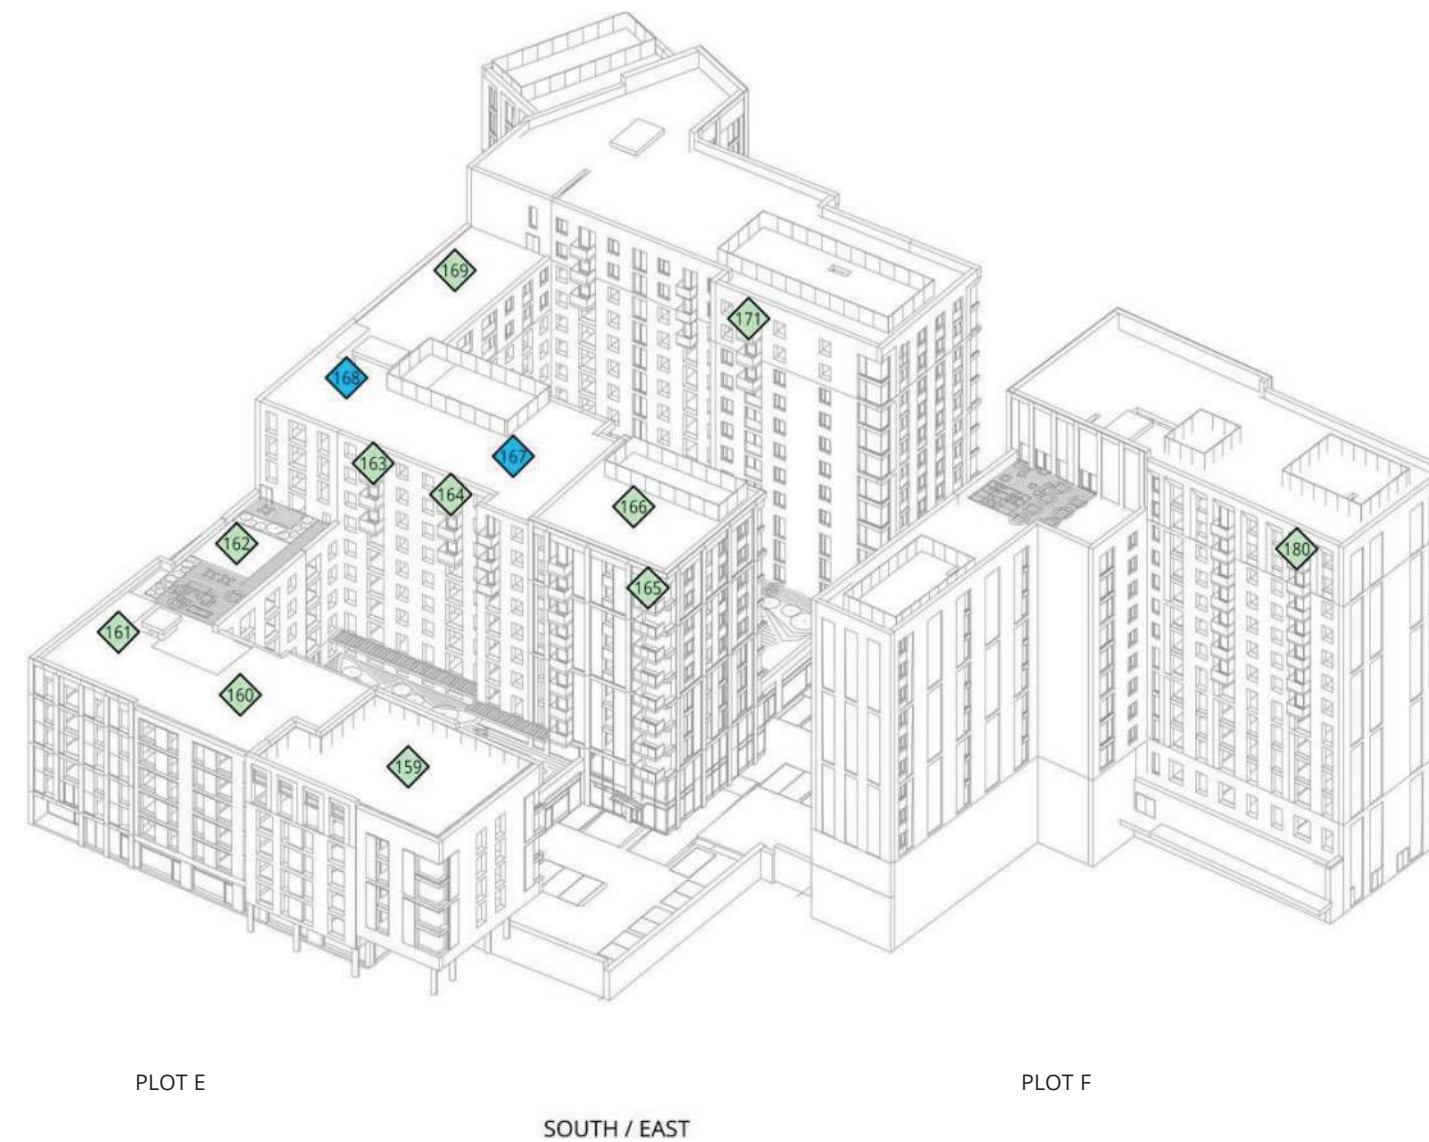
WIE14788-108\_GR\_ES\_13.9A

Figure 13.9: Configuration 2: South Site with Max Parameter North Site and the Existing Surrounding Buildings – Summer Season, Terrace Levels

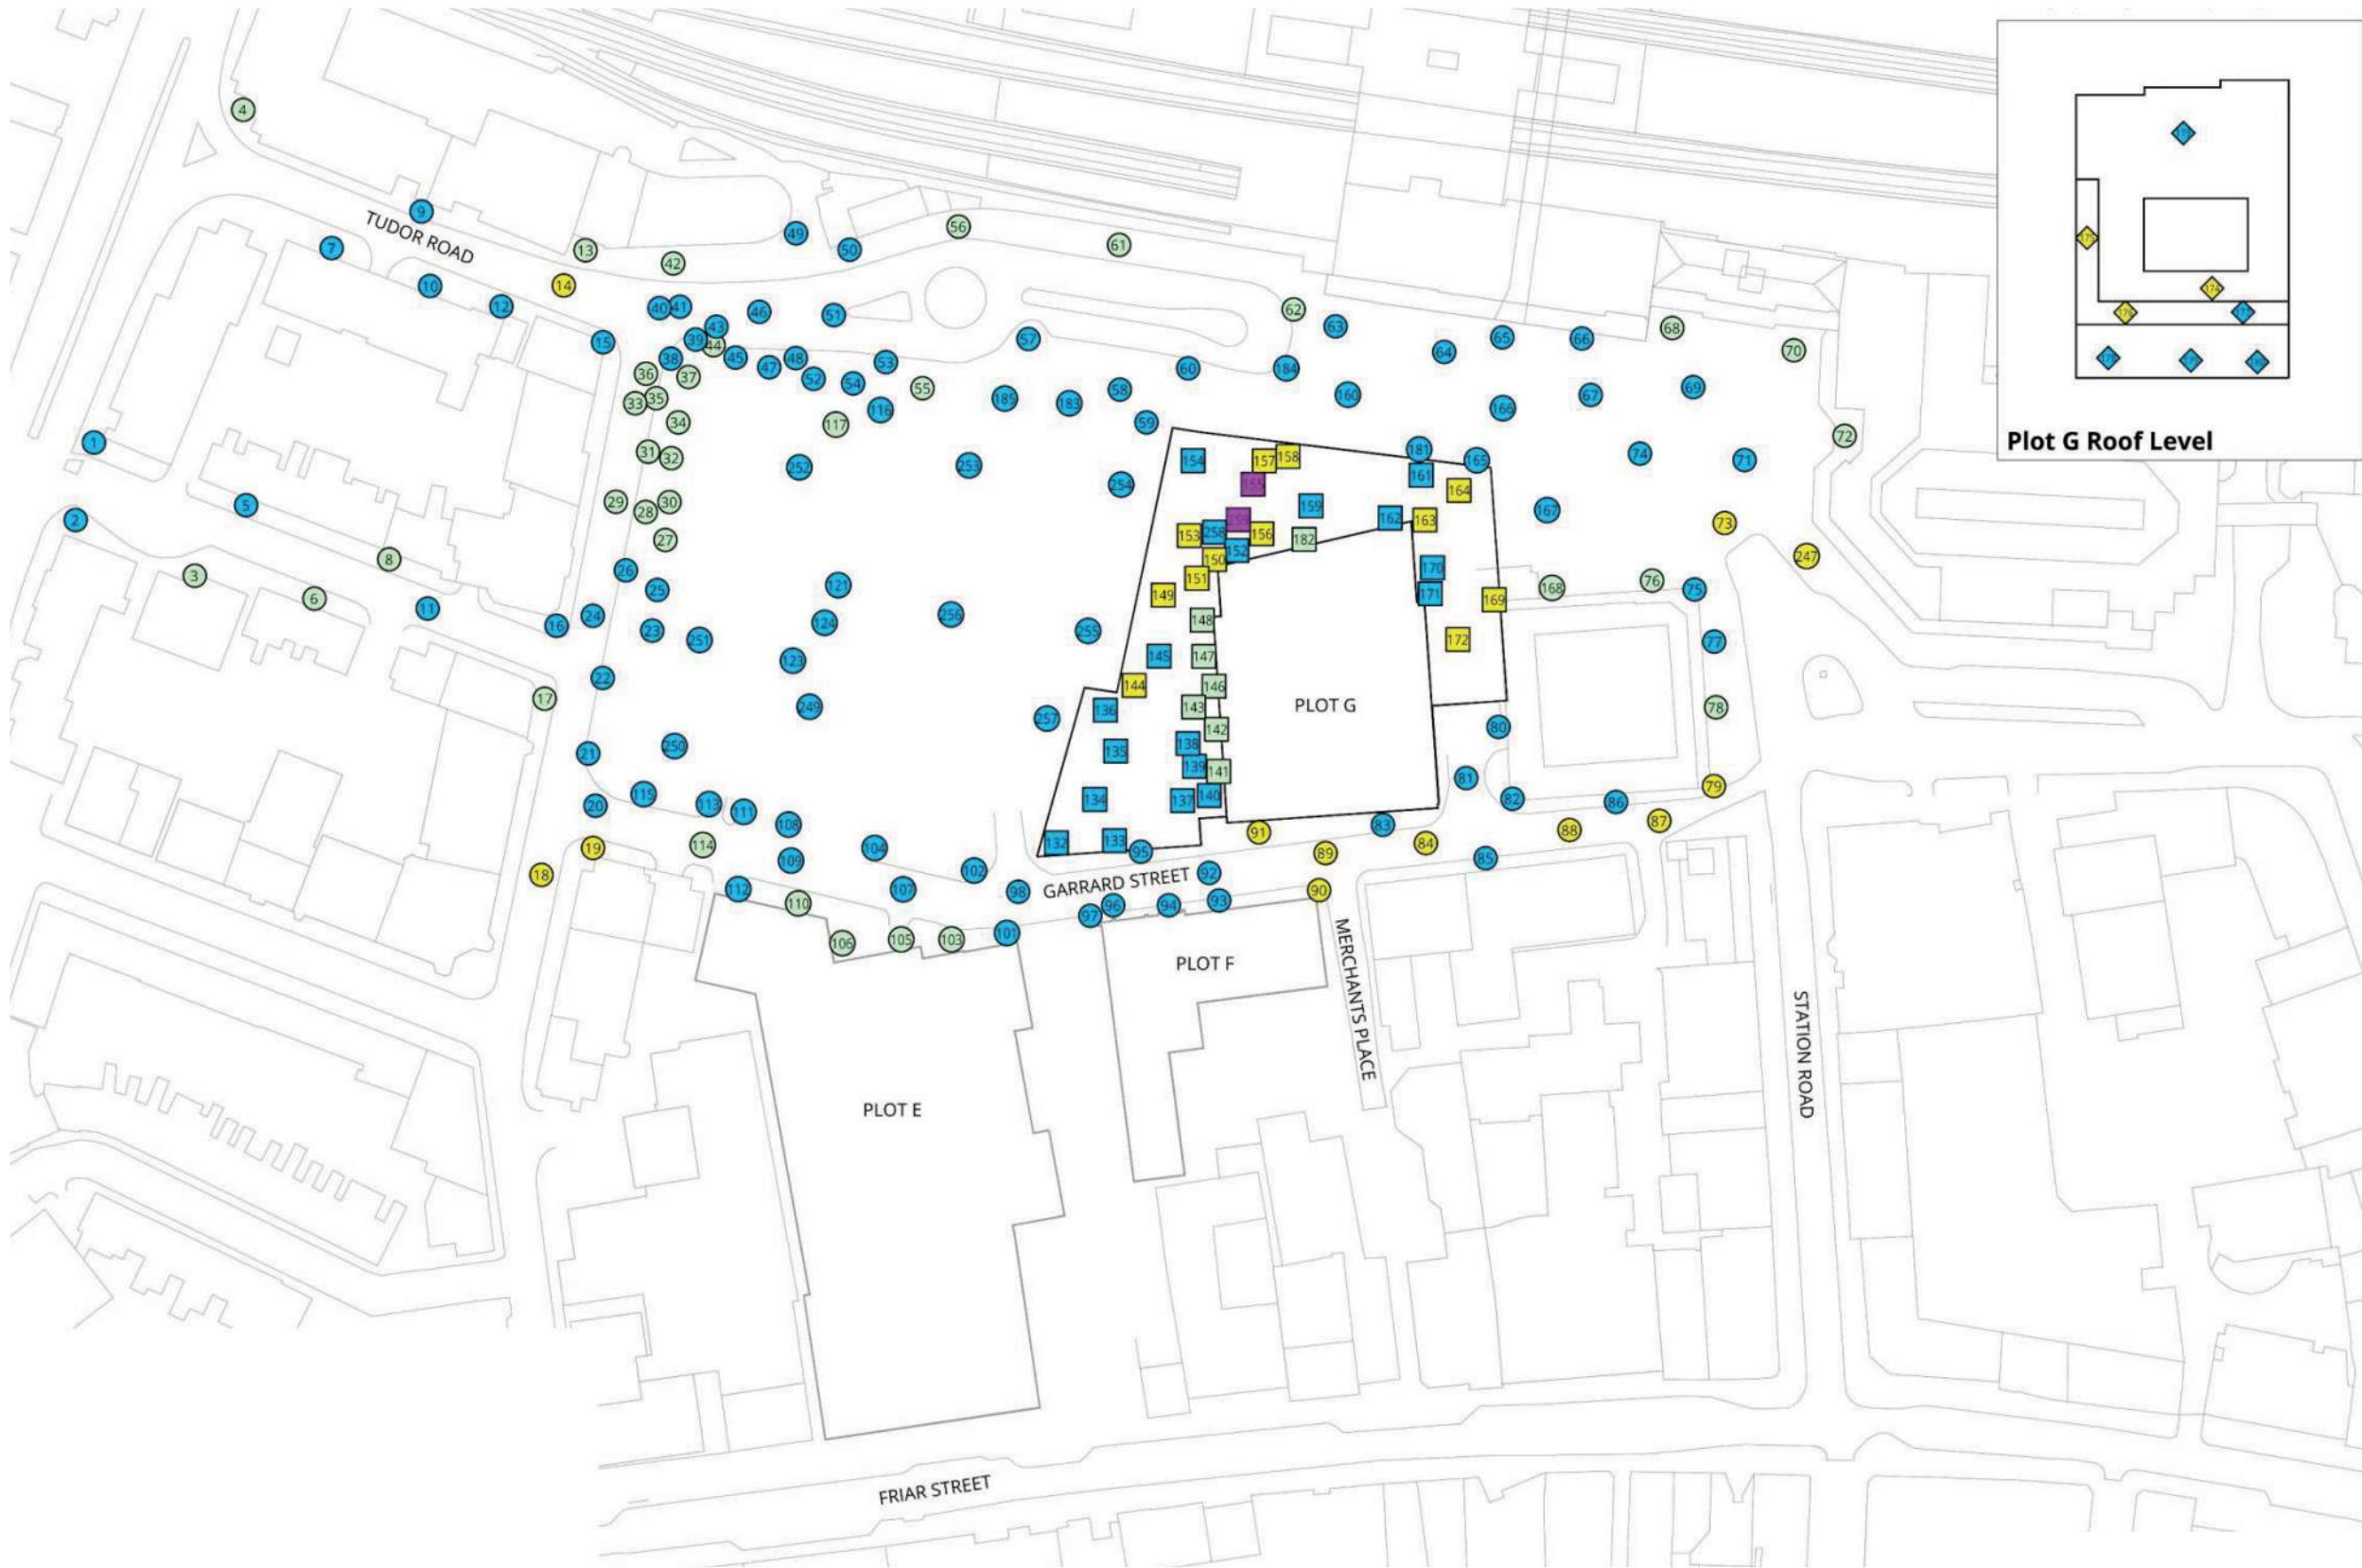
WIE14788-108\_GR\_ES\_13.10A

Figure 13.10: Configuration 2: Interim Development Scenario with the Existing Surrounding Buildings – Windiest Season, Ground and Terrace Levels

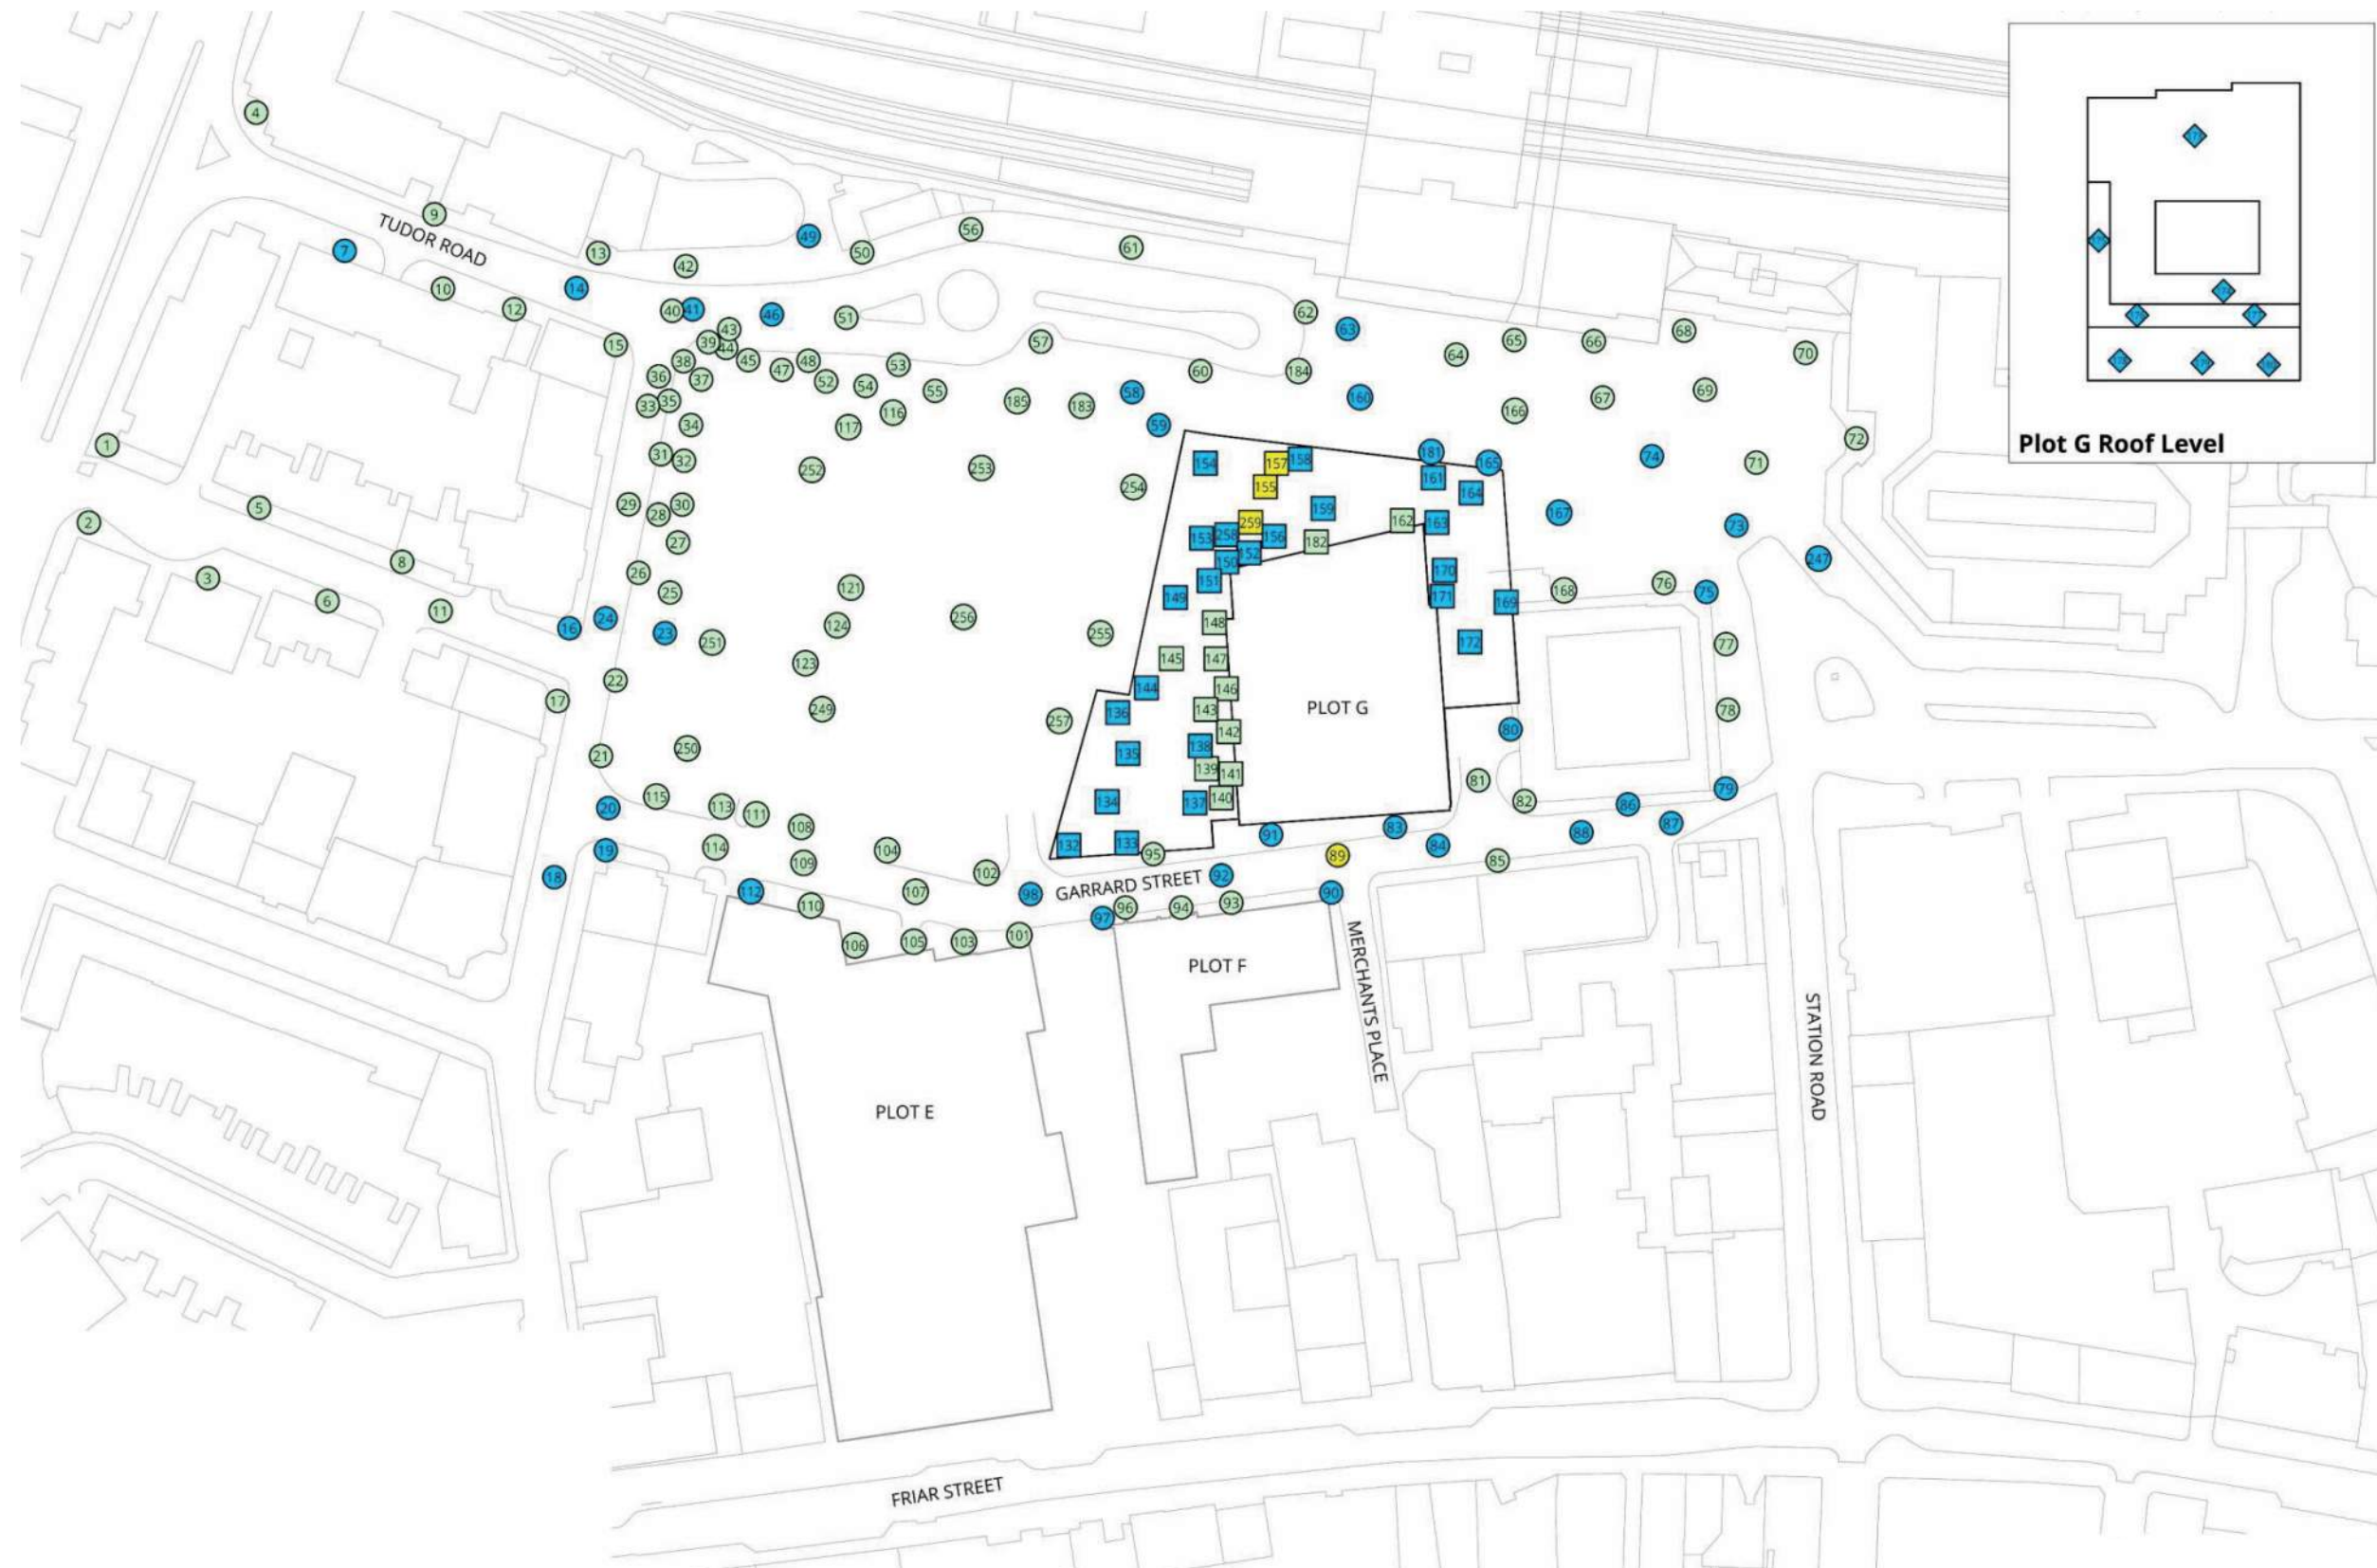
WIE14788-108\_GR\_ES\_13.11A

Figure 13.11: Configuration 2: Interim Development Scenario with the Existing Surrounding Buildings – Summer Season, Ground and Terrace Levels

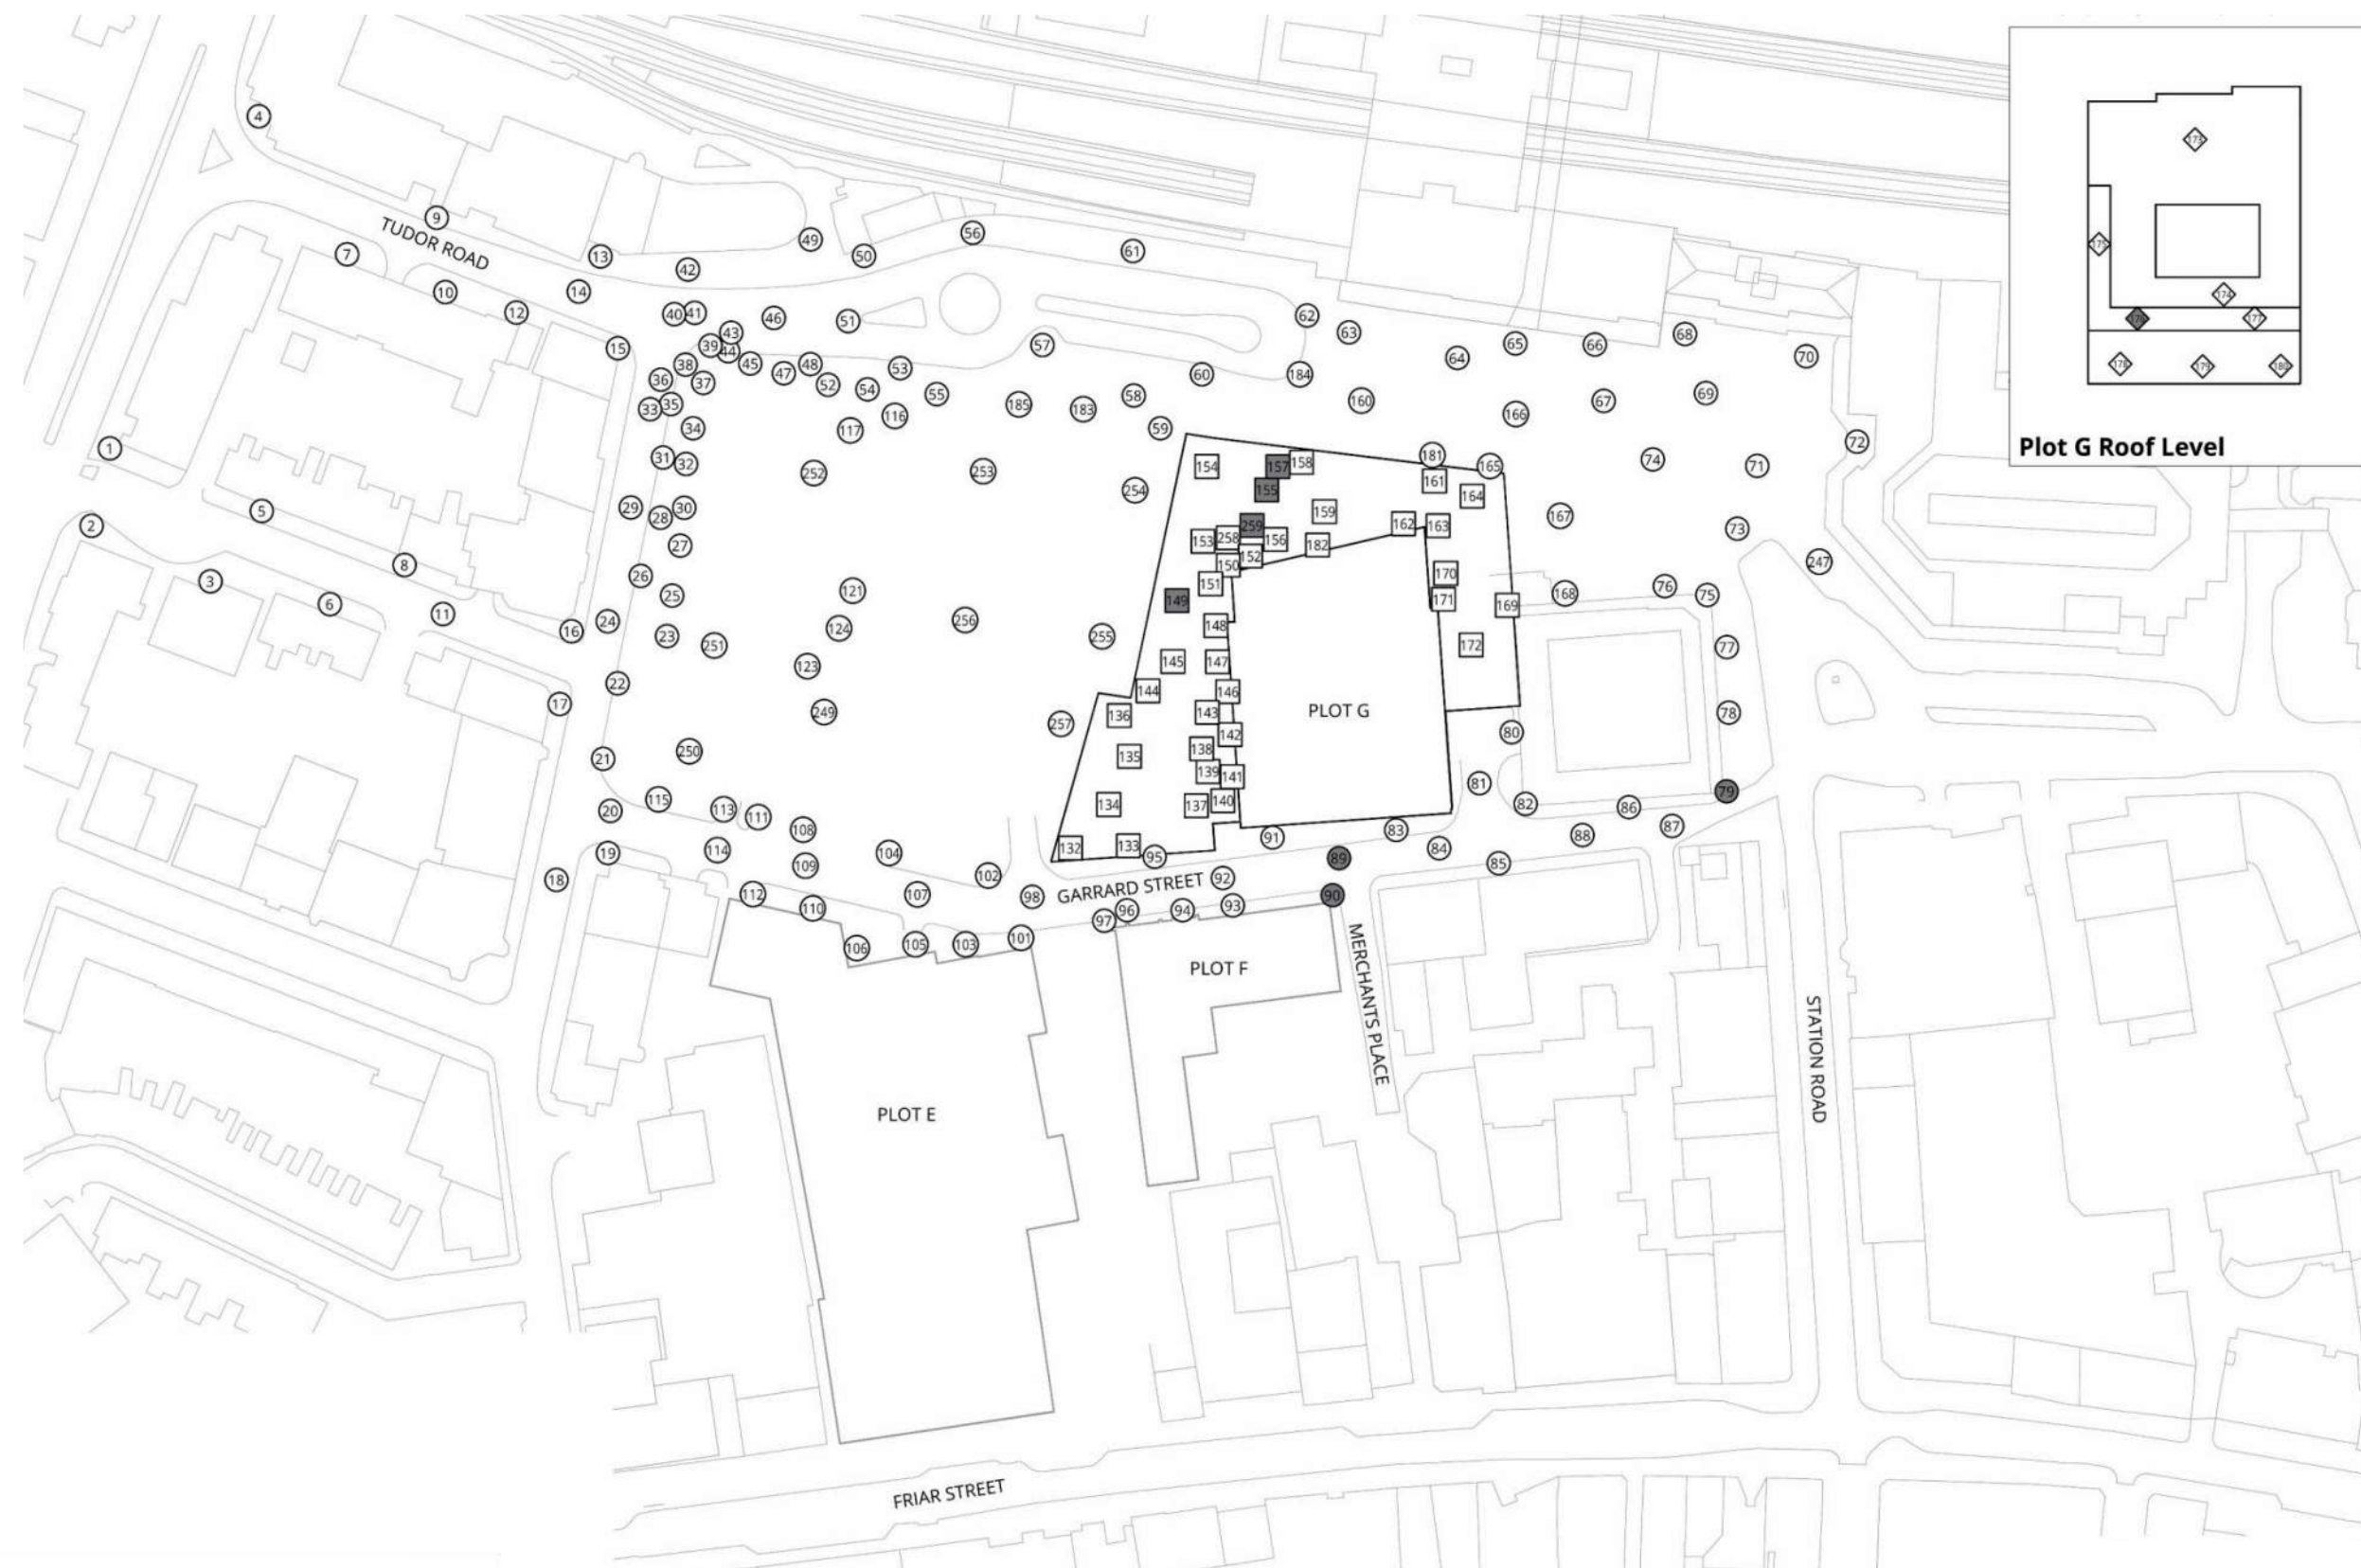
WIE14788-108\_GR\_ES\_13.12A

Figure 13.12: Configuration 2: Interim Development Scenario with the Existing Surrounding Buildings – Annual Safety Exceedances, Ground and Terrace Levels

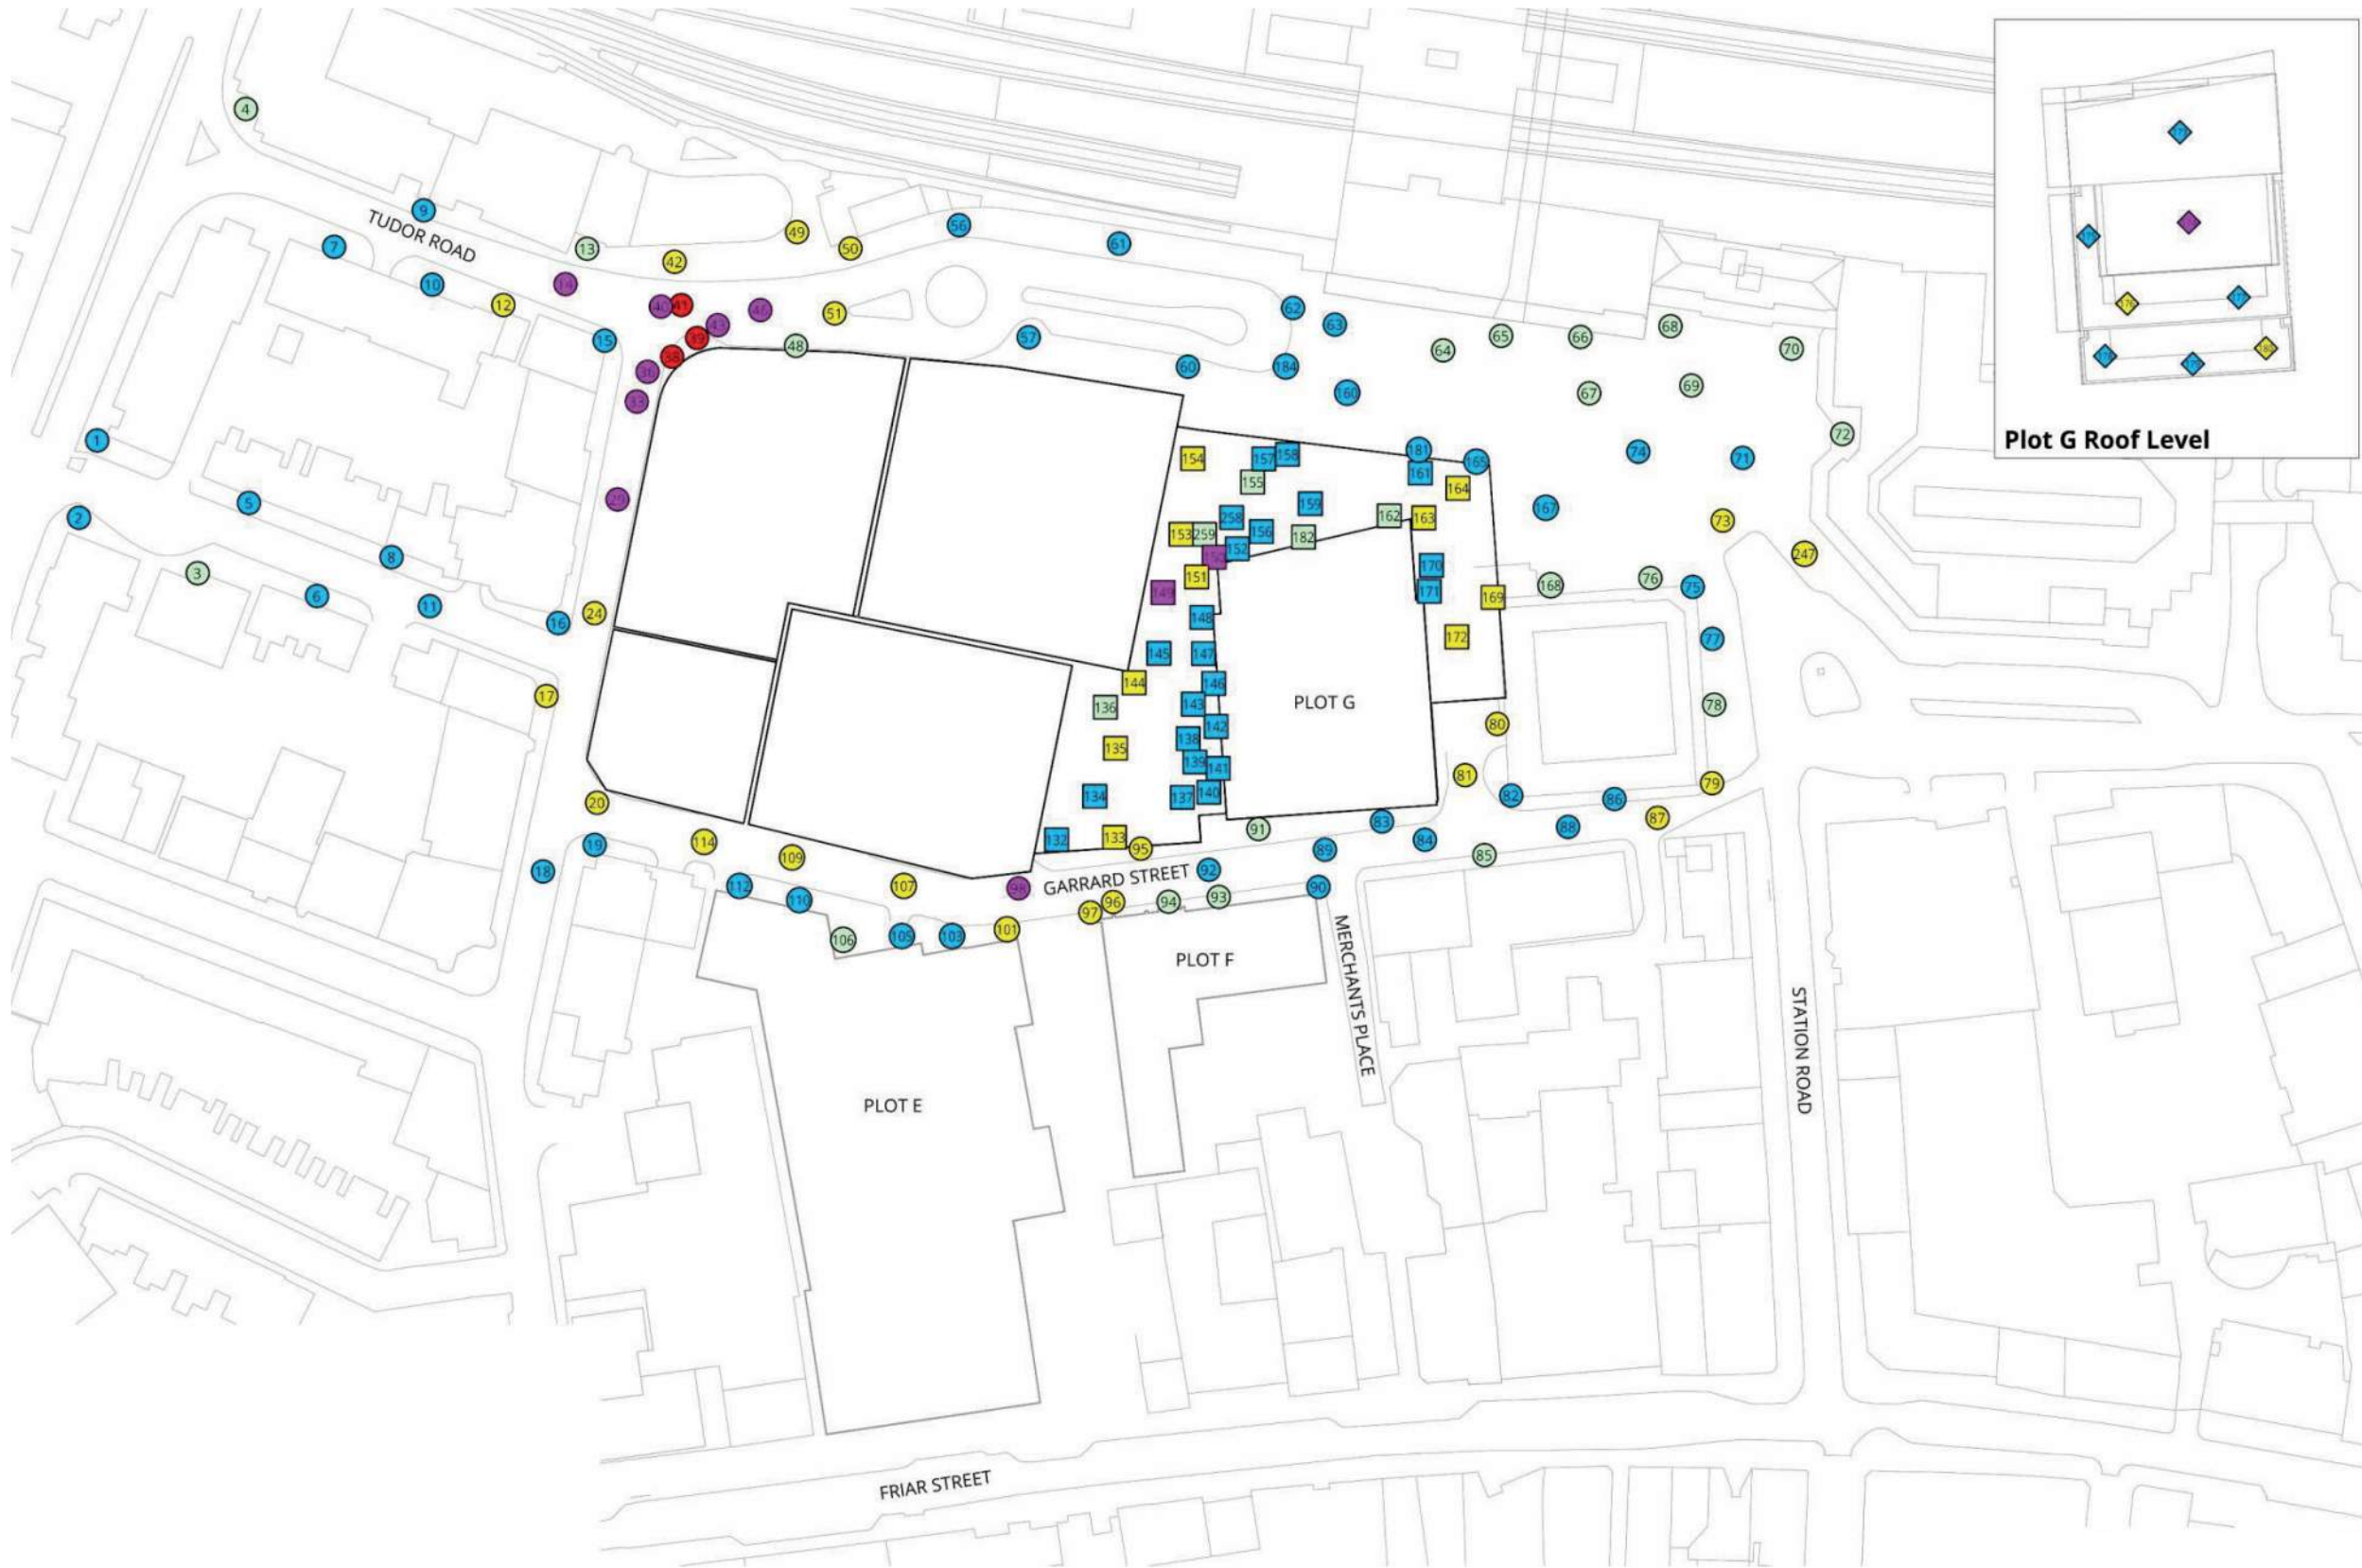
WIE14788-108\_GR\_ES\_13.13A

WIE14788-108: Station Hill, Reading  
Figure 13.13: Configuration 3: Maximum Parameter Development with the Existing Surrounding Buildings – Windiest Season, Ground and Terrace Levels
