| Project Details | WIE14788-108: Station Hill, Reading |
| Figure Title | Figure 11.1: Noise Monitoring and Sensitive Receptor Locations |

| Figure Title | Figure 13.1: Seasonal Wind Roses for London Heathrow Airport |

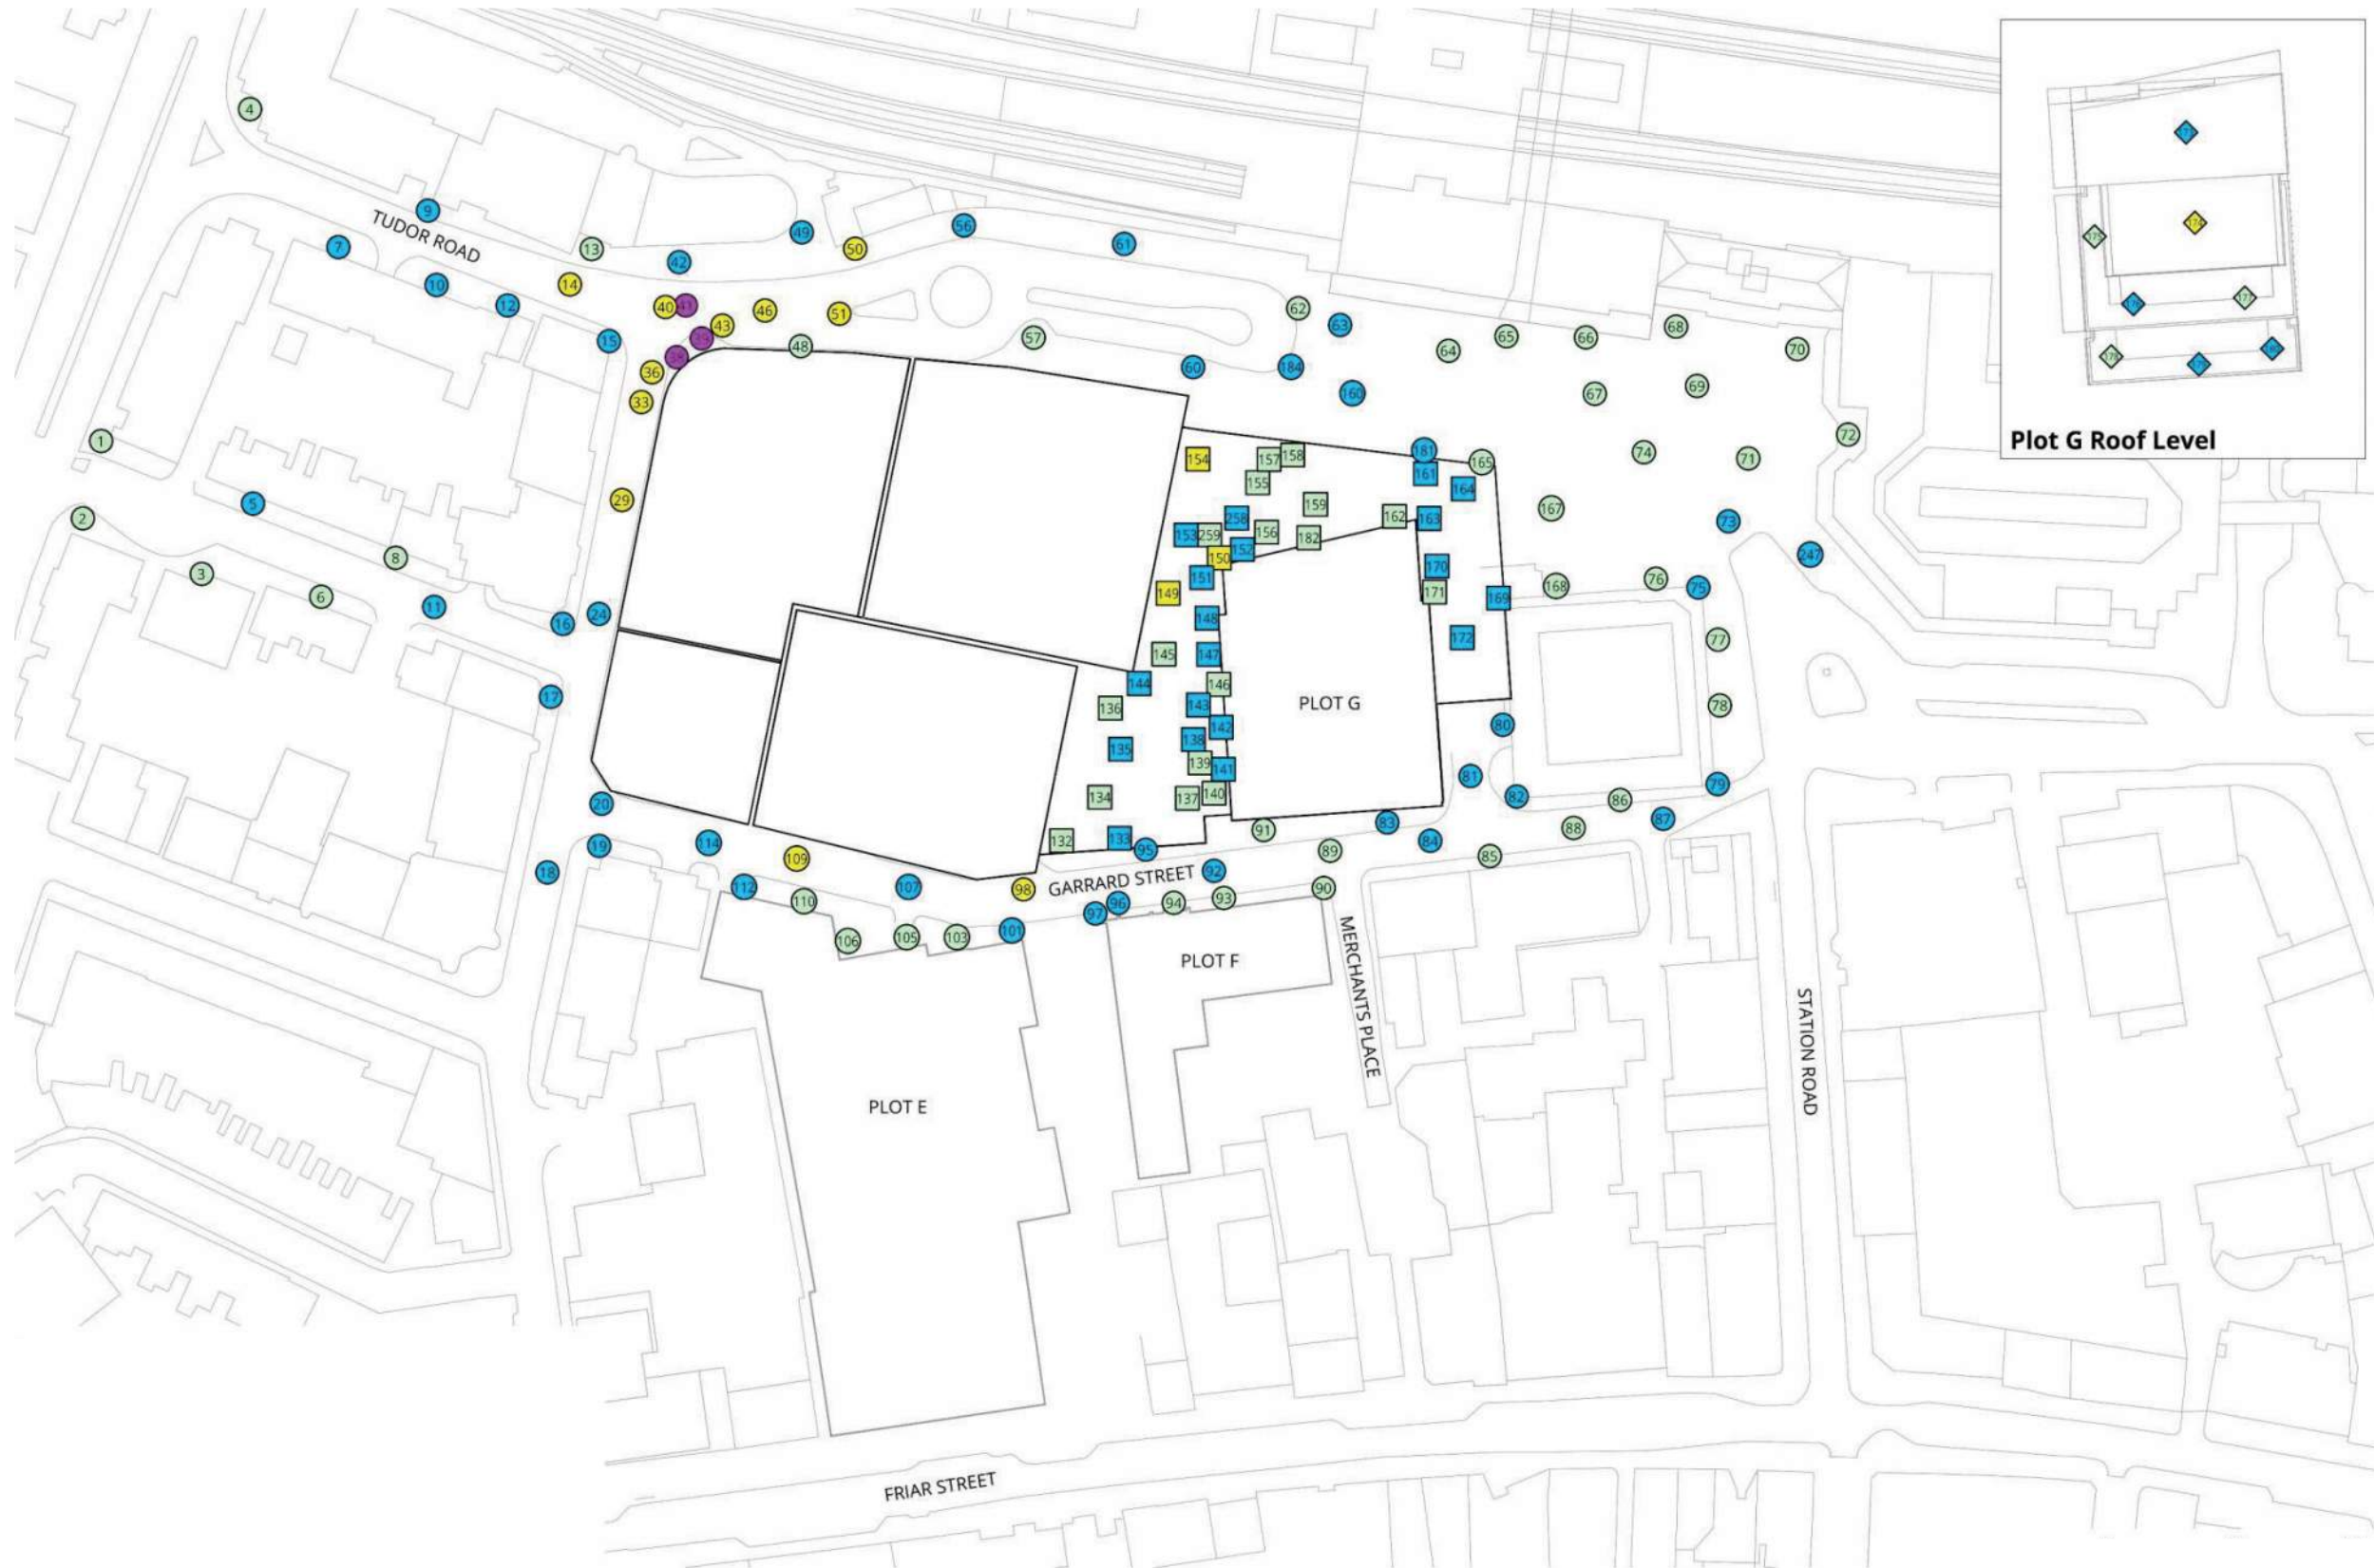
WIE14788-108\_GR\_ES\_13.14A

WIE14788-108: Station Hill, Reading  
Figure 13.14: Configuration 3: Maximum Parameter Development with the Existing Surrounding Buildings – Summer Season, Ground and Terrace Levels

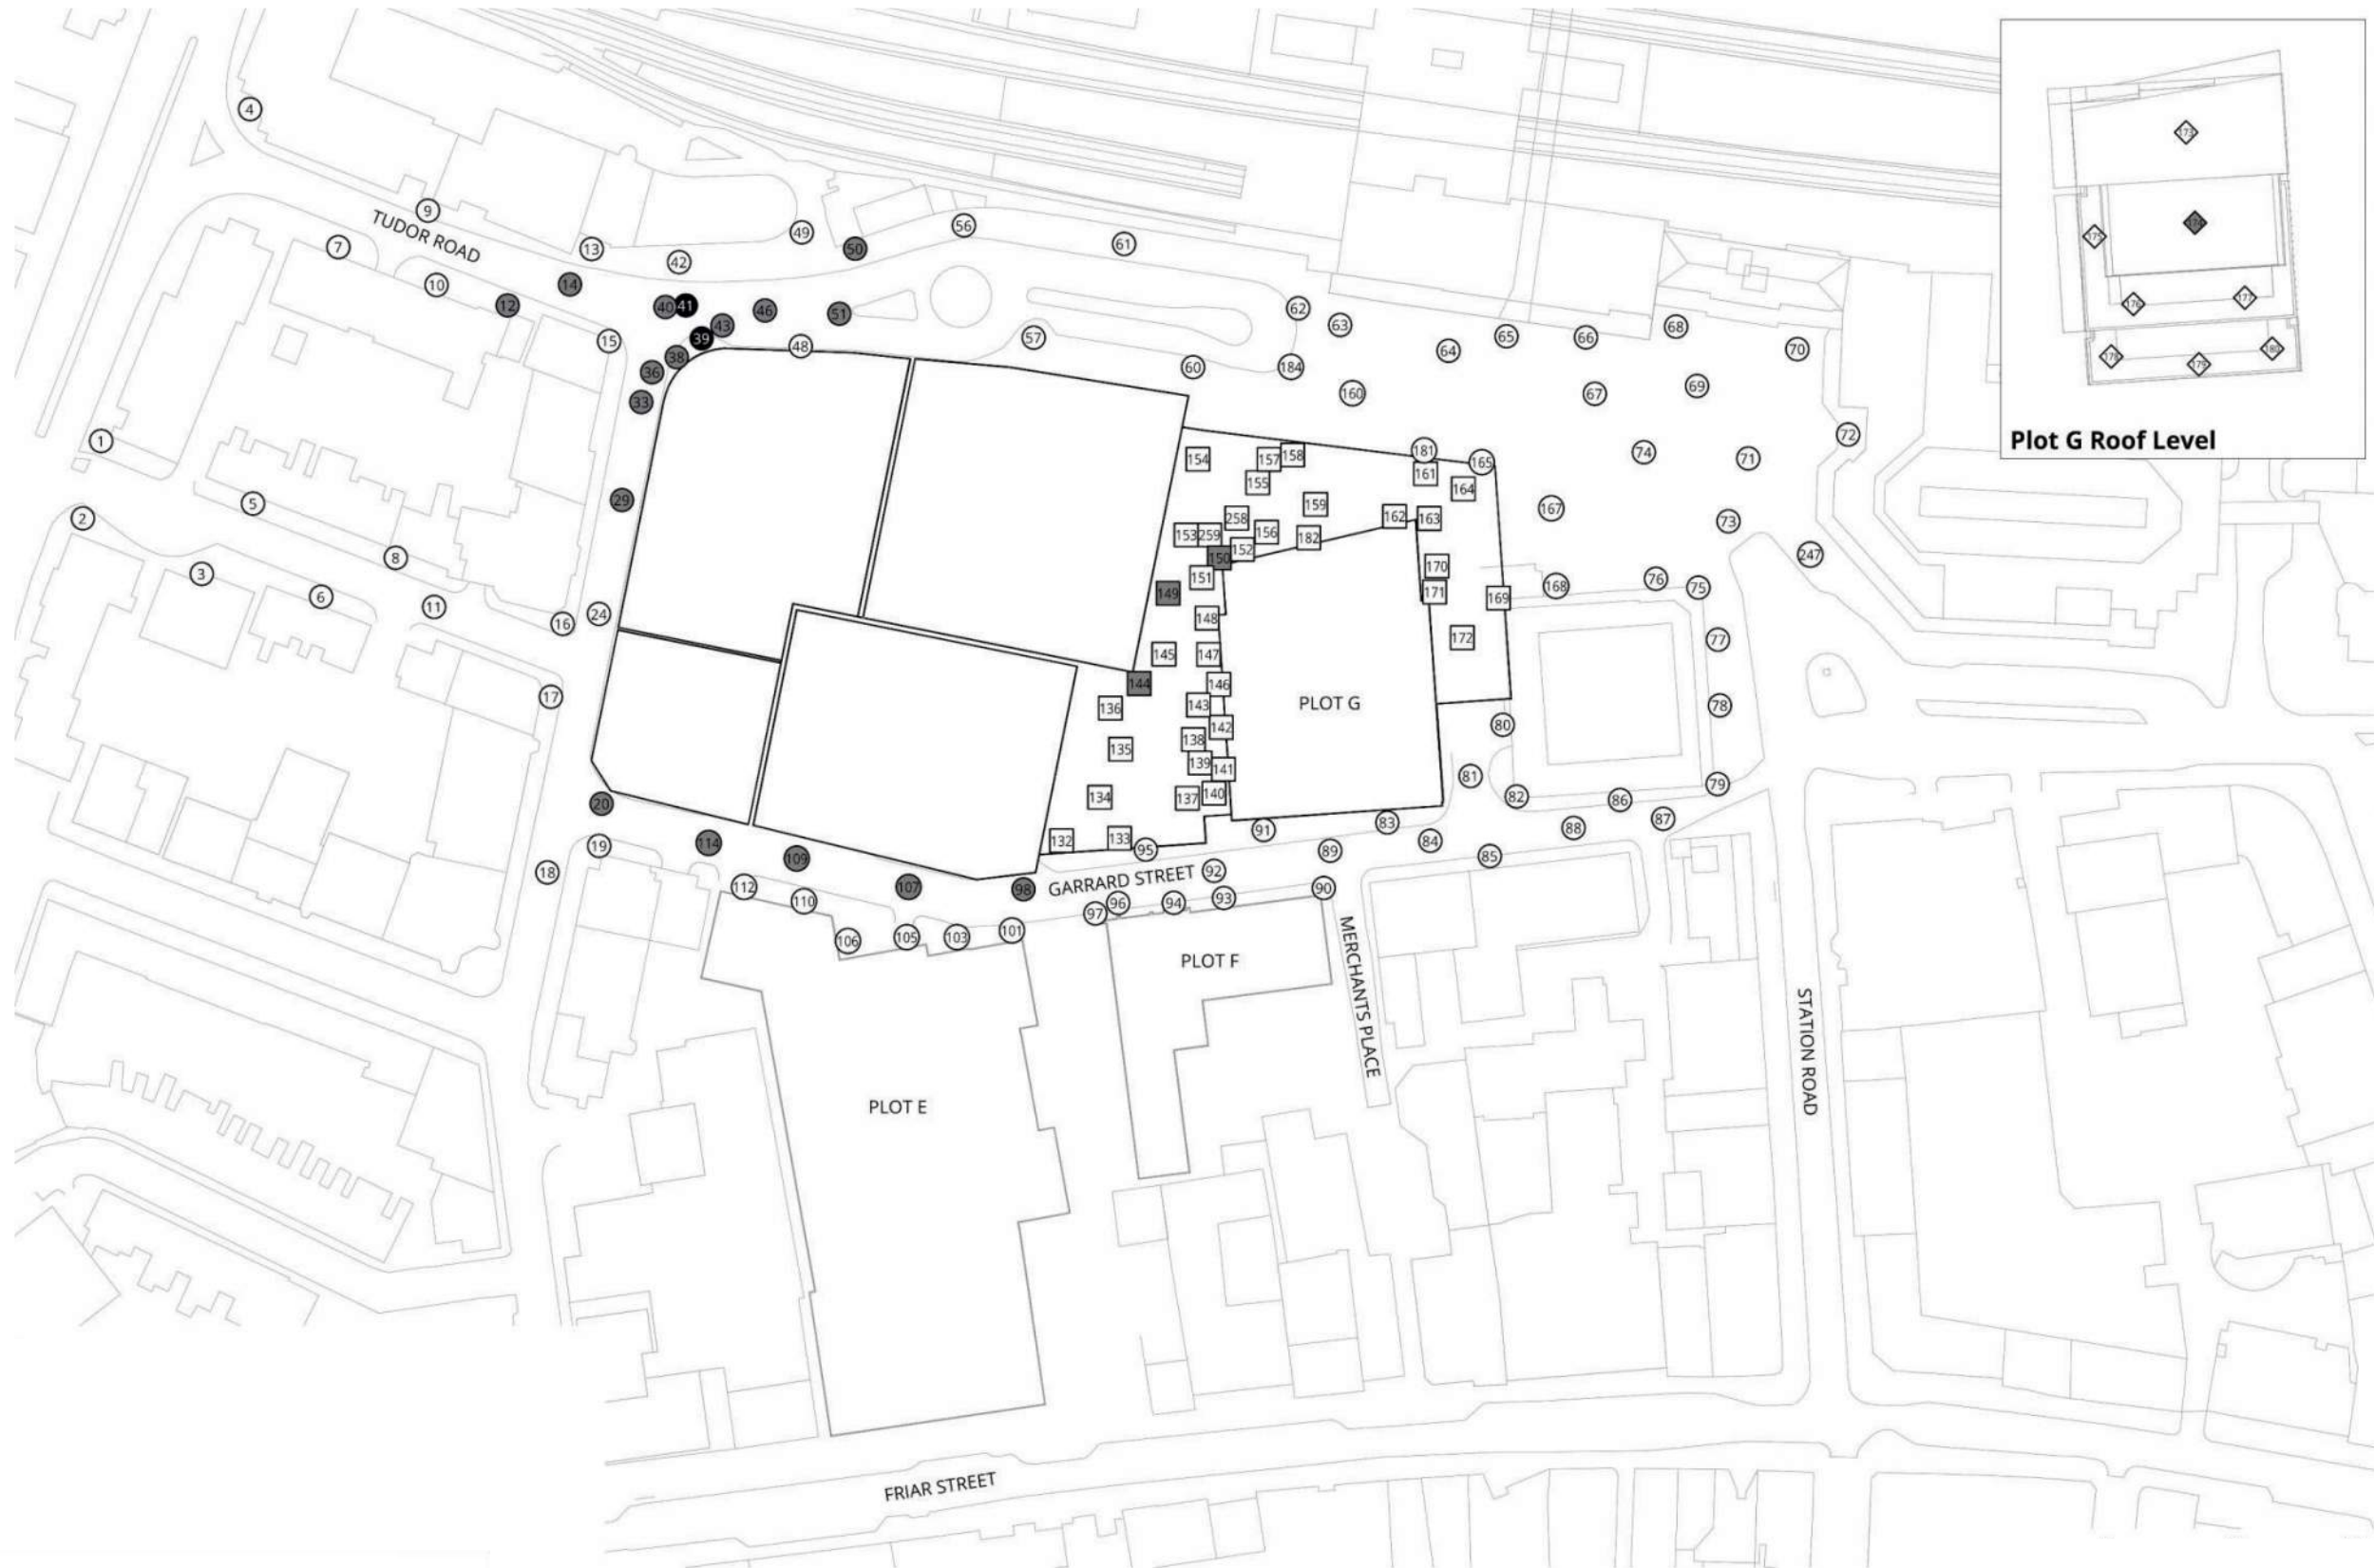
WIE14788-108\_GR\_ES\_13.15A

Figure 13.15: Configuration 3: Maximum Parameter Development with the Existing Surrounding Buildings – Annual Safety Exceedances, Ground and Terrace Levels

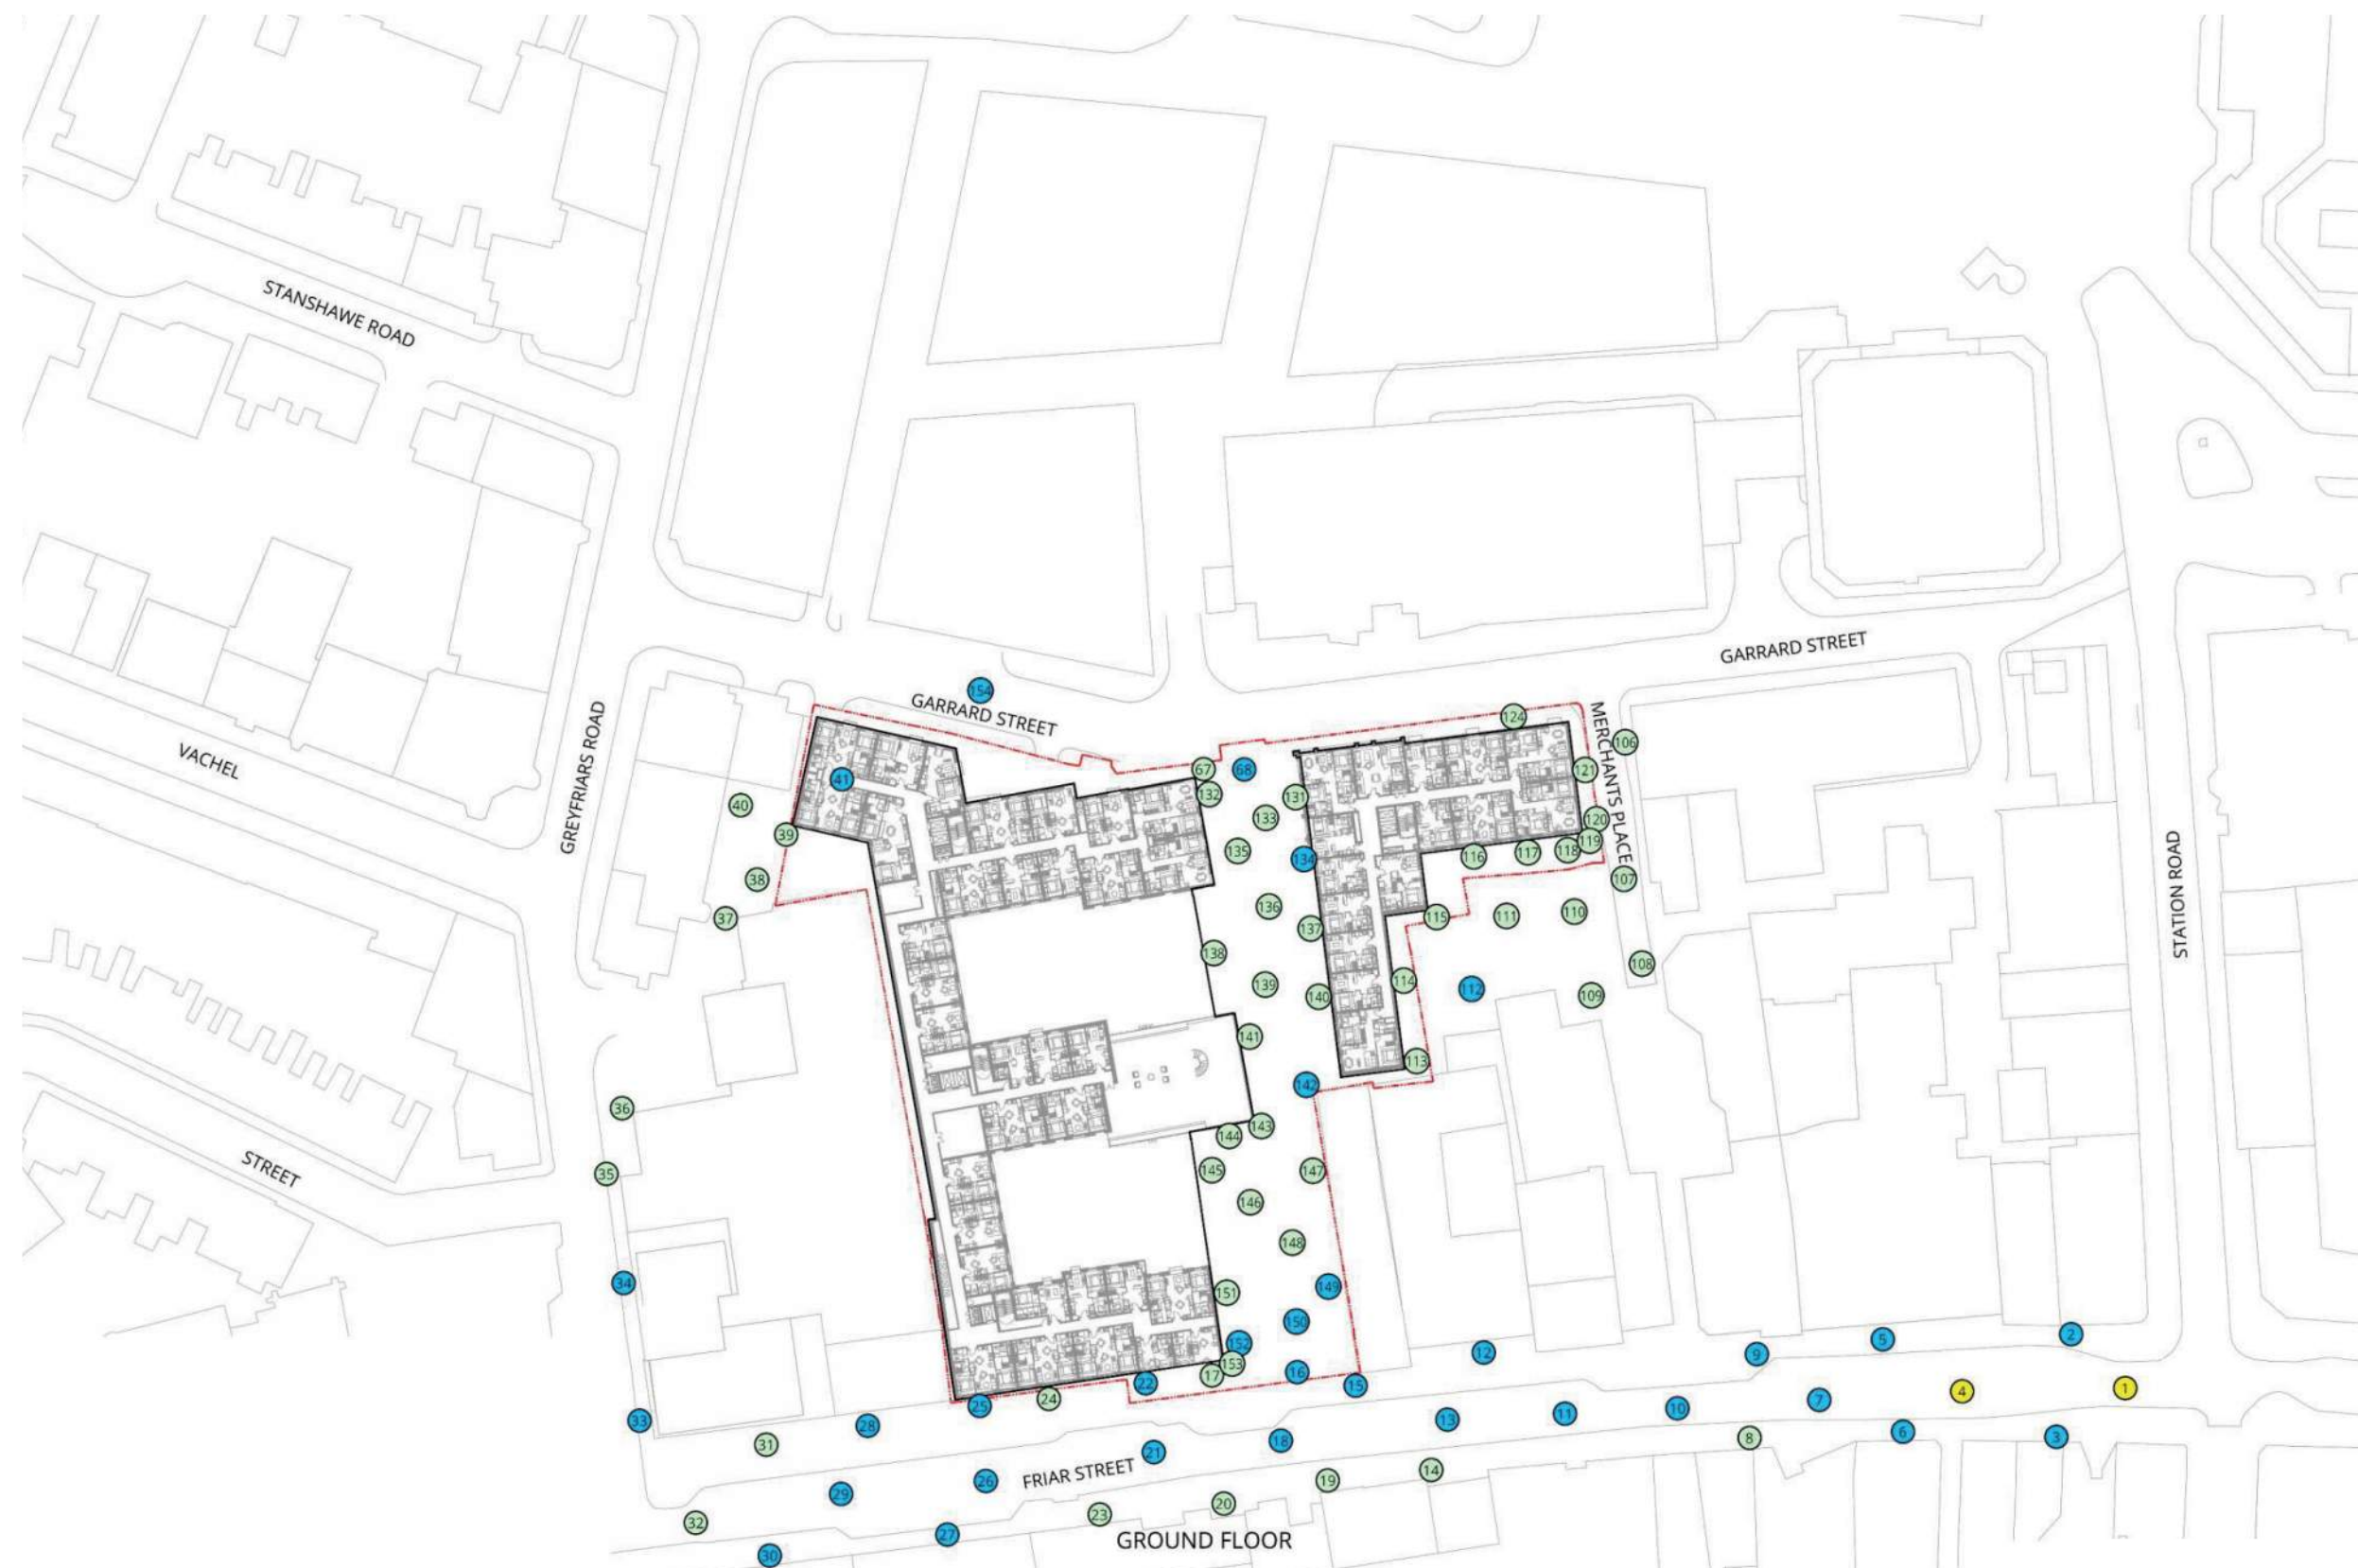
WIE14788-108\_GR\_ES\_13.16A

Figure 13.16: Mitigation: South Site with Wind Mitigation Measures, a Max Parameter North Site and the Existing Surrounding Buildings – Windiest Season, Ground and Terrace Levels

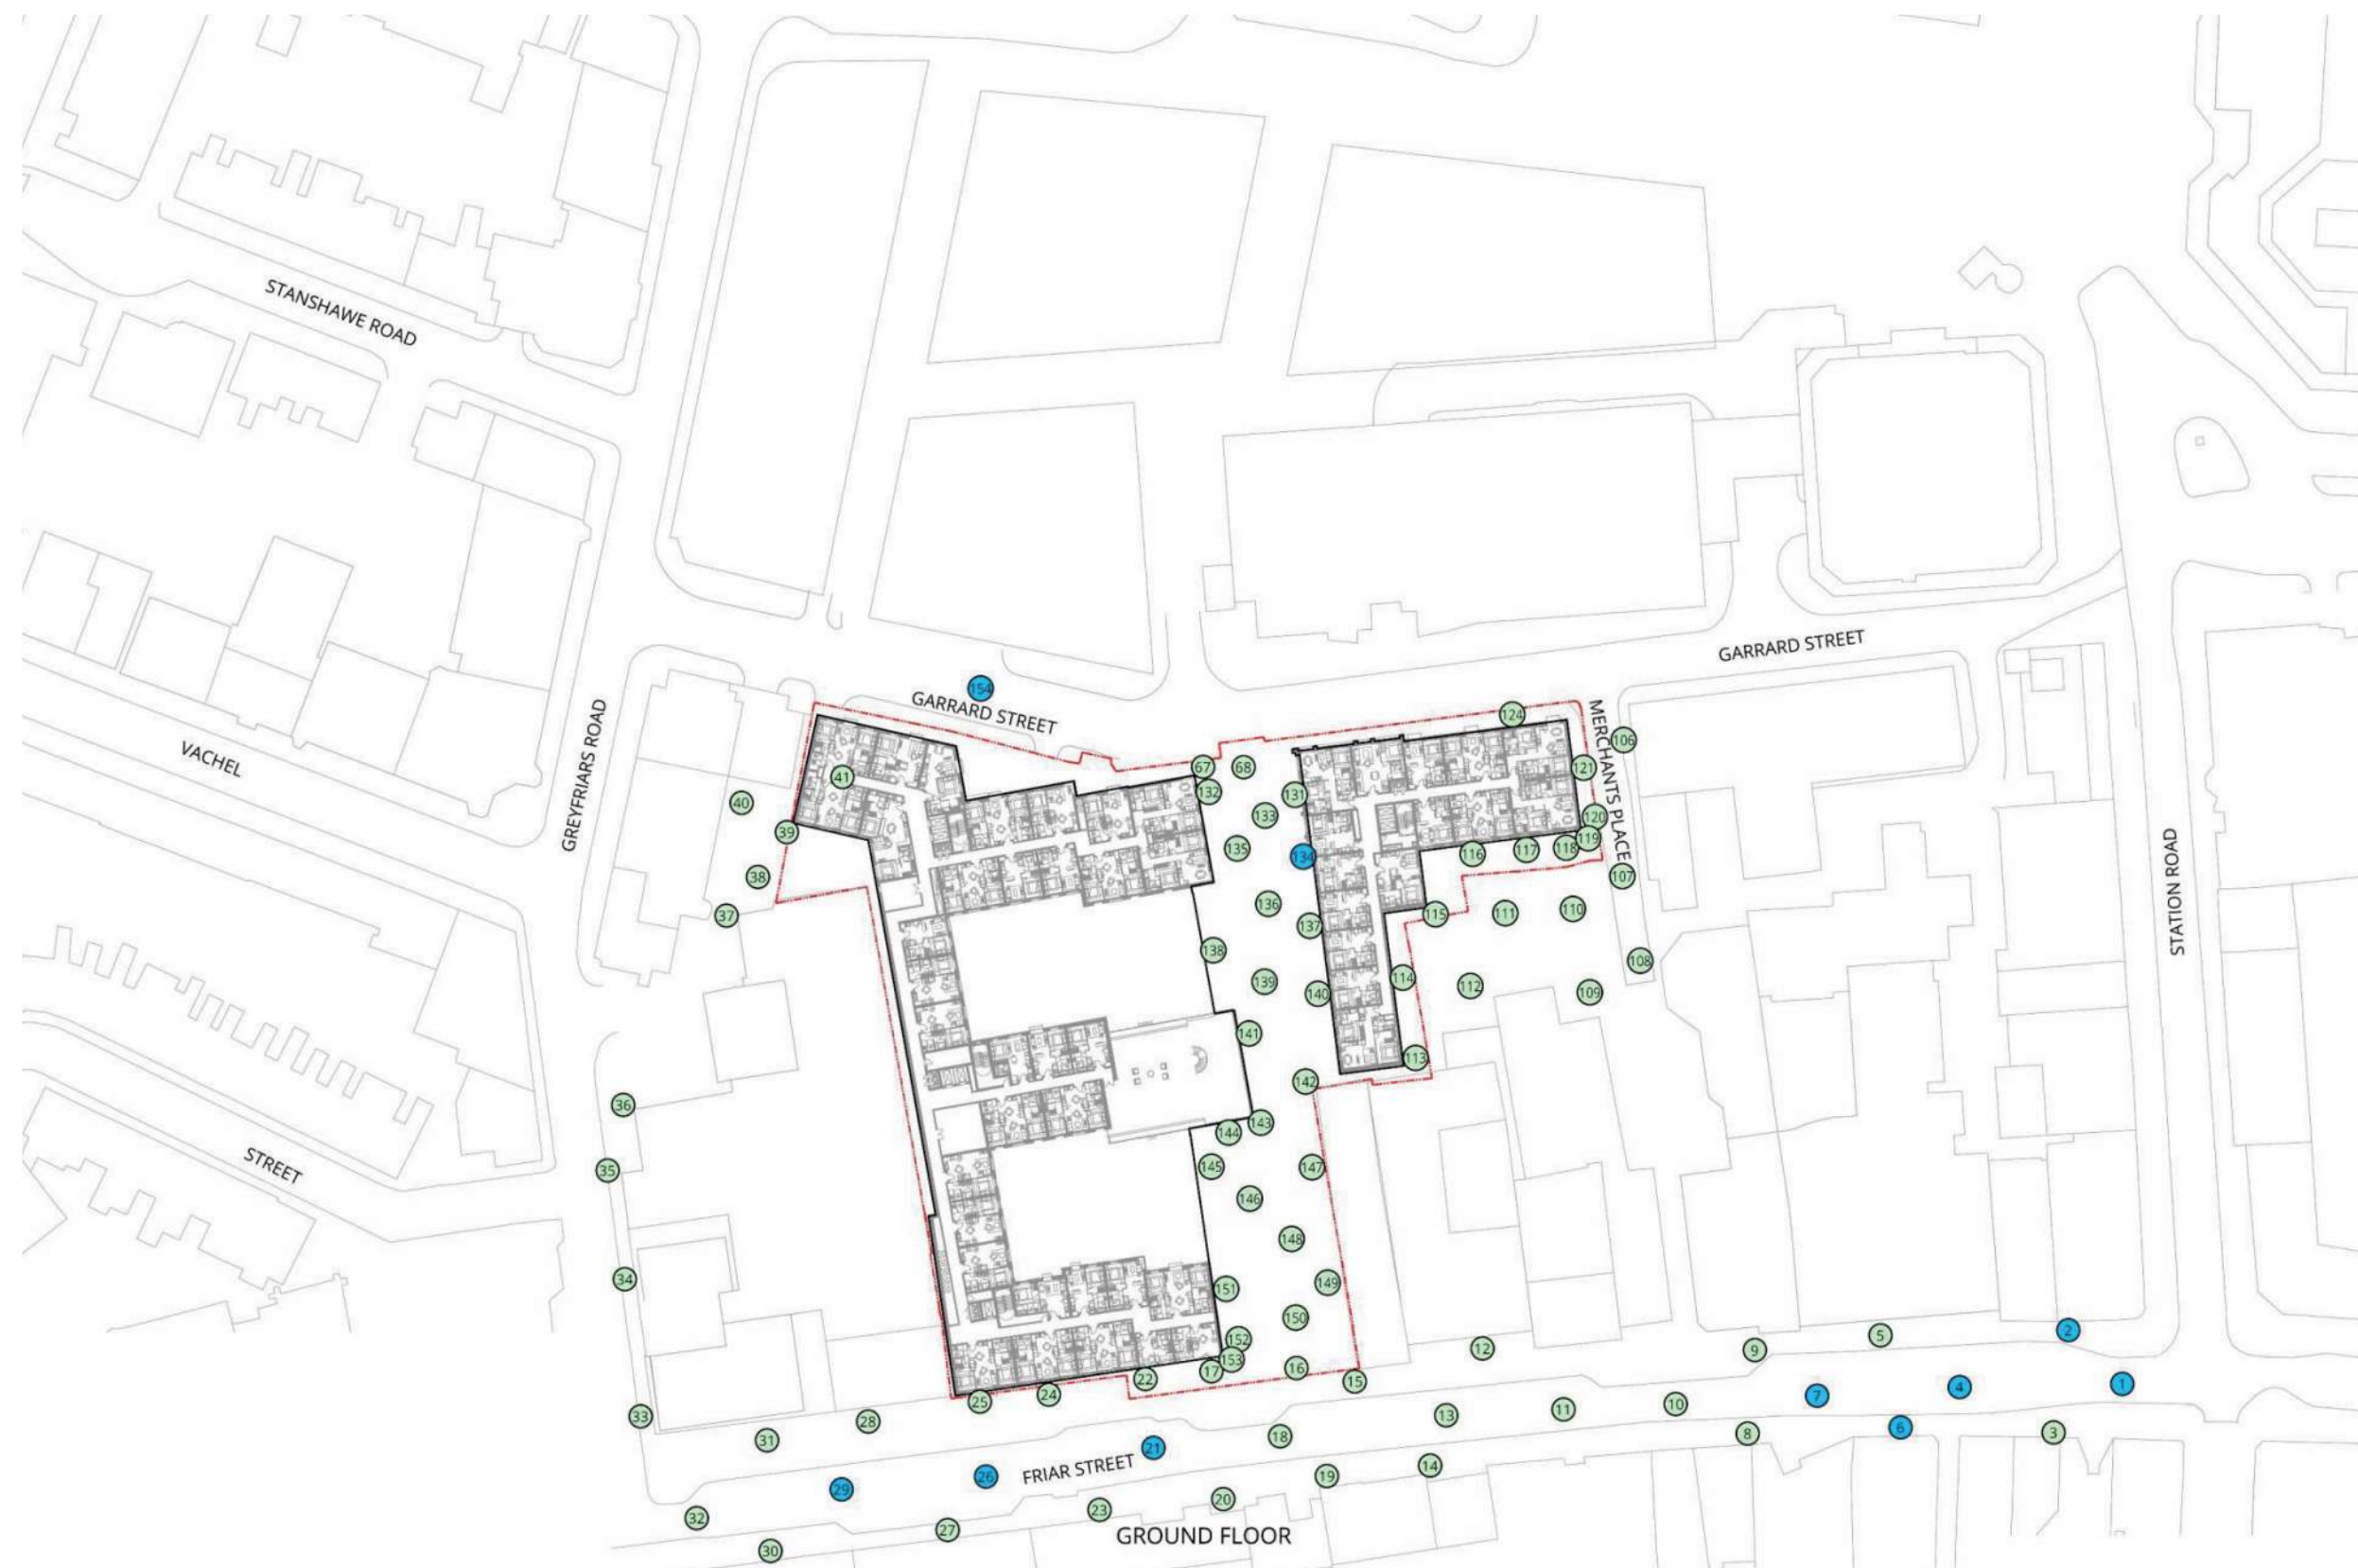
WIE14788-108\_GR\_ES\_13.17A

Figure 13.17: Mitigation: South Site with Wind Mitigation Measures, a Max Parameter North Site and the Existing Surrounding Buildings – Summer Season, Ground and Terrace Levels

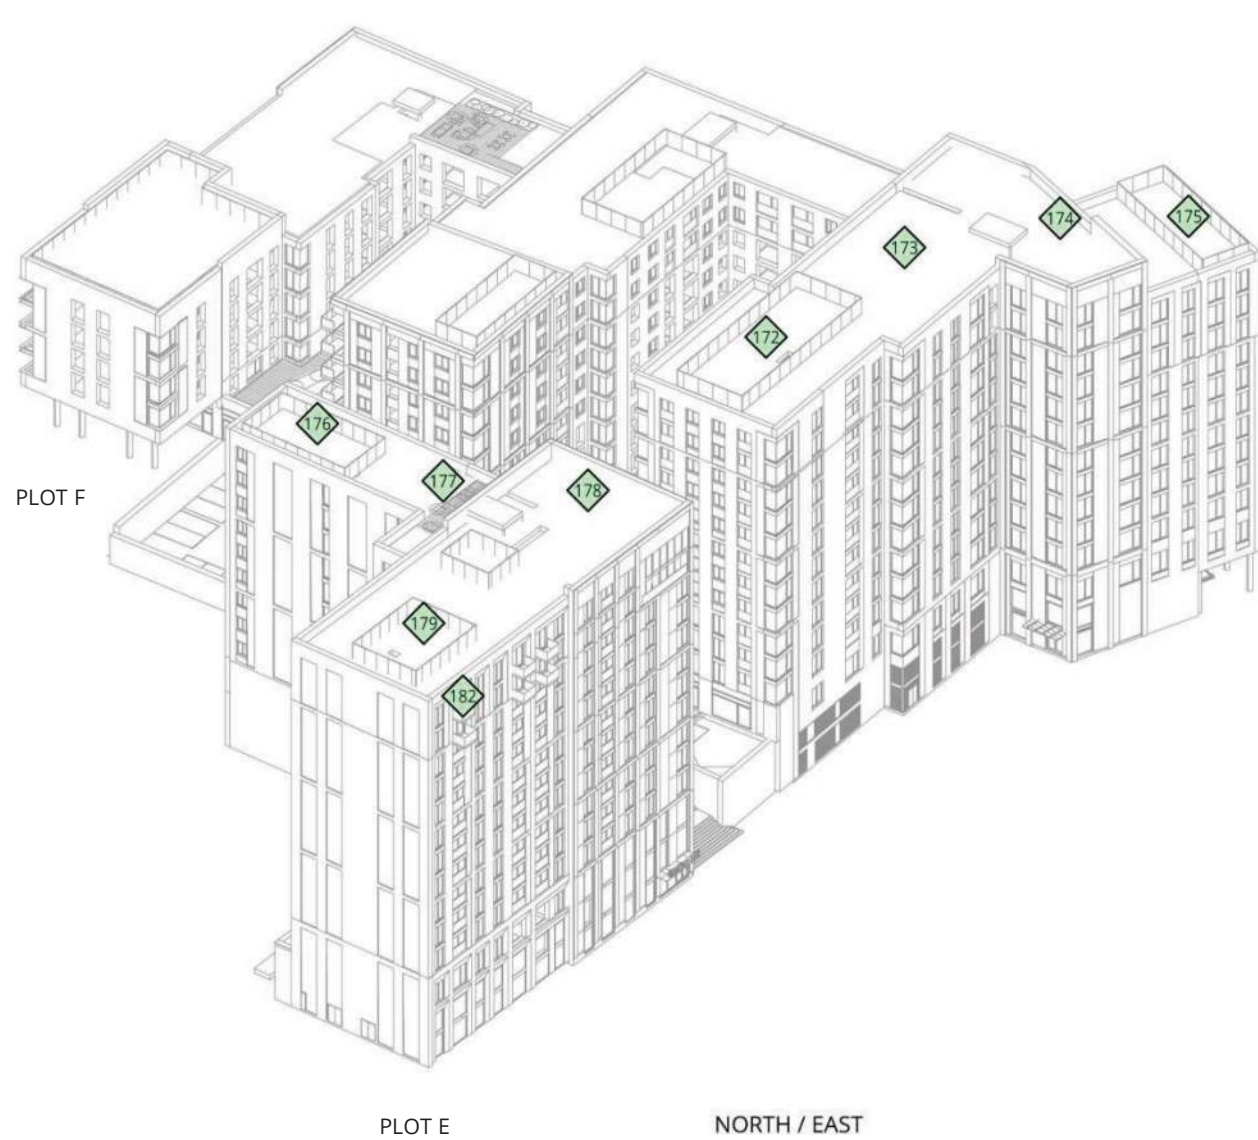
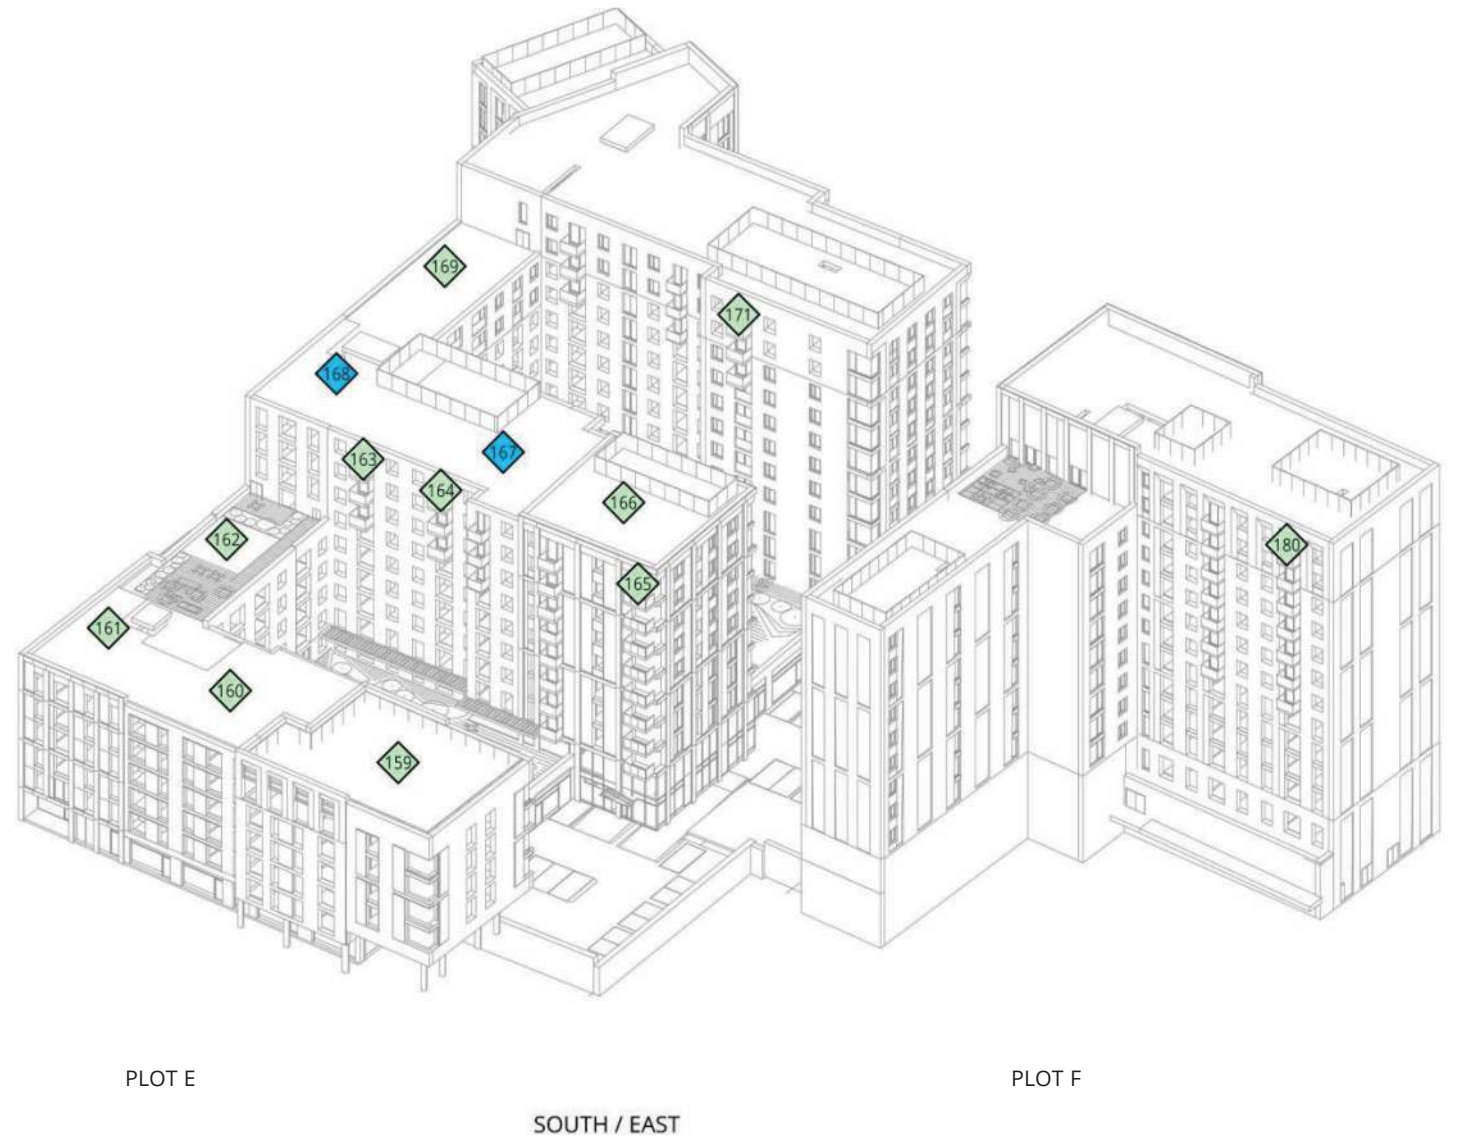
WIE14788-108\_GR\_ES\_13.18A

Figure 13.18: Mitigation: South Site with Wind Mitigation Measures, a Max Parameter North Site and the Existing Surrounding Buildings – Summer Season, Terrace Levels

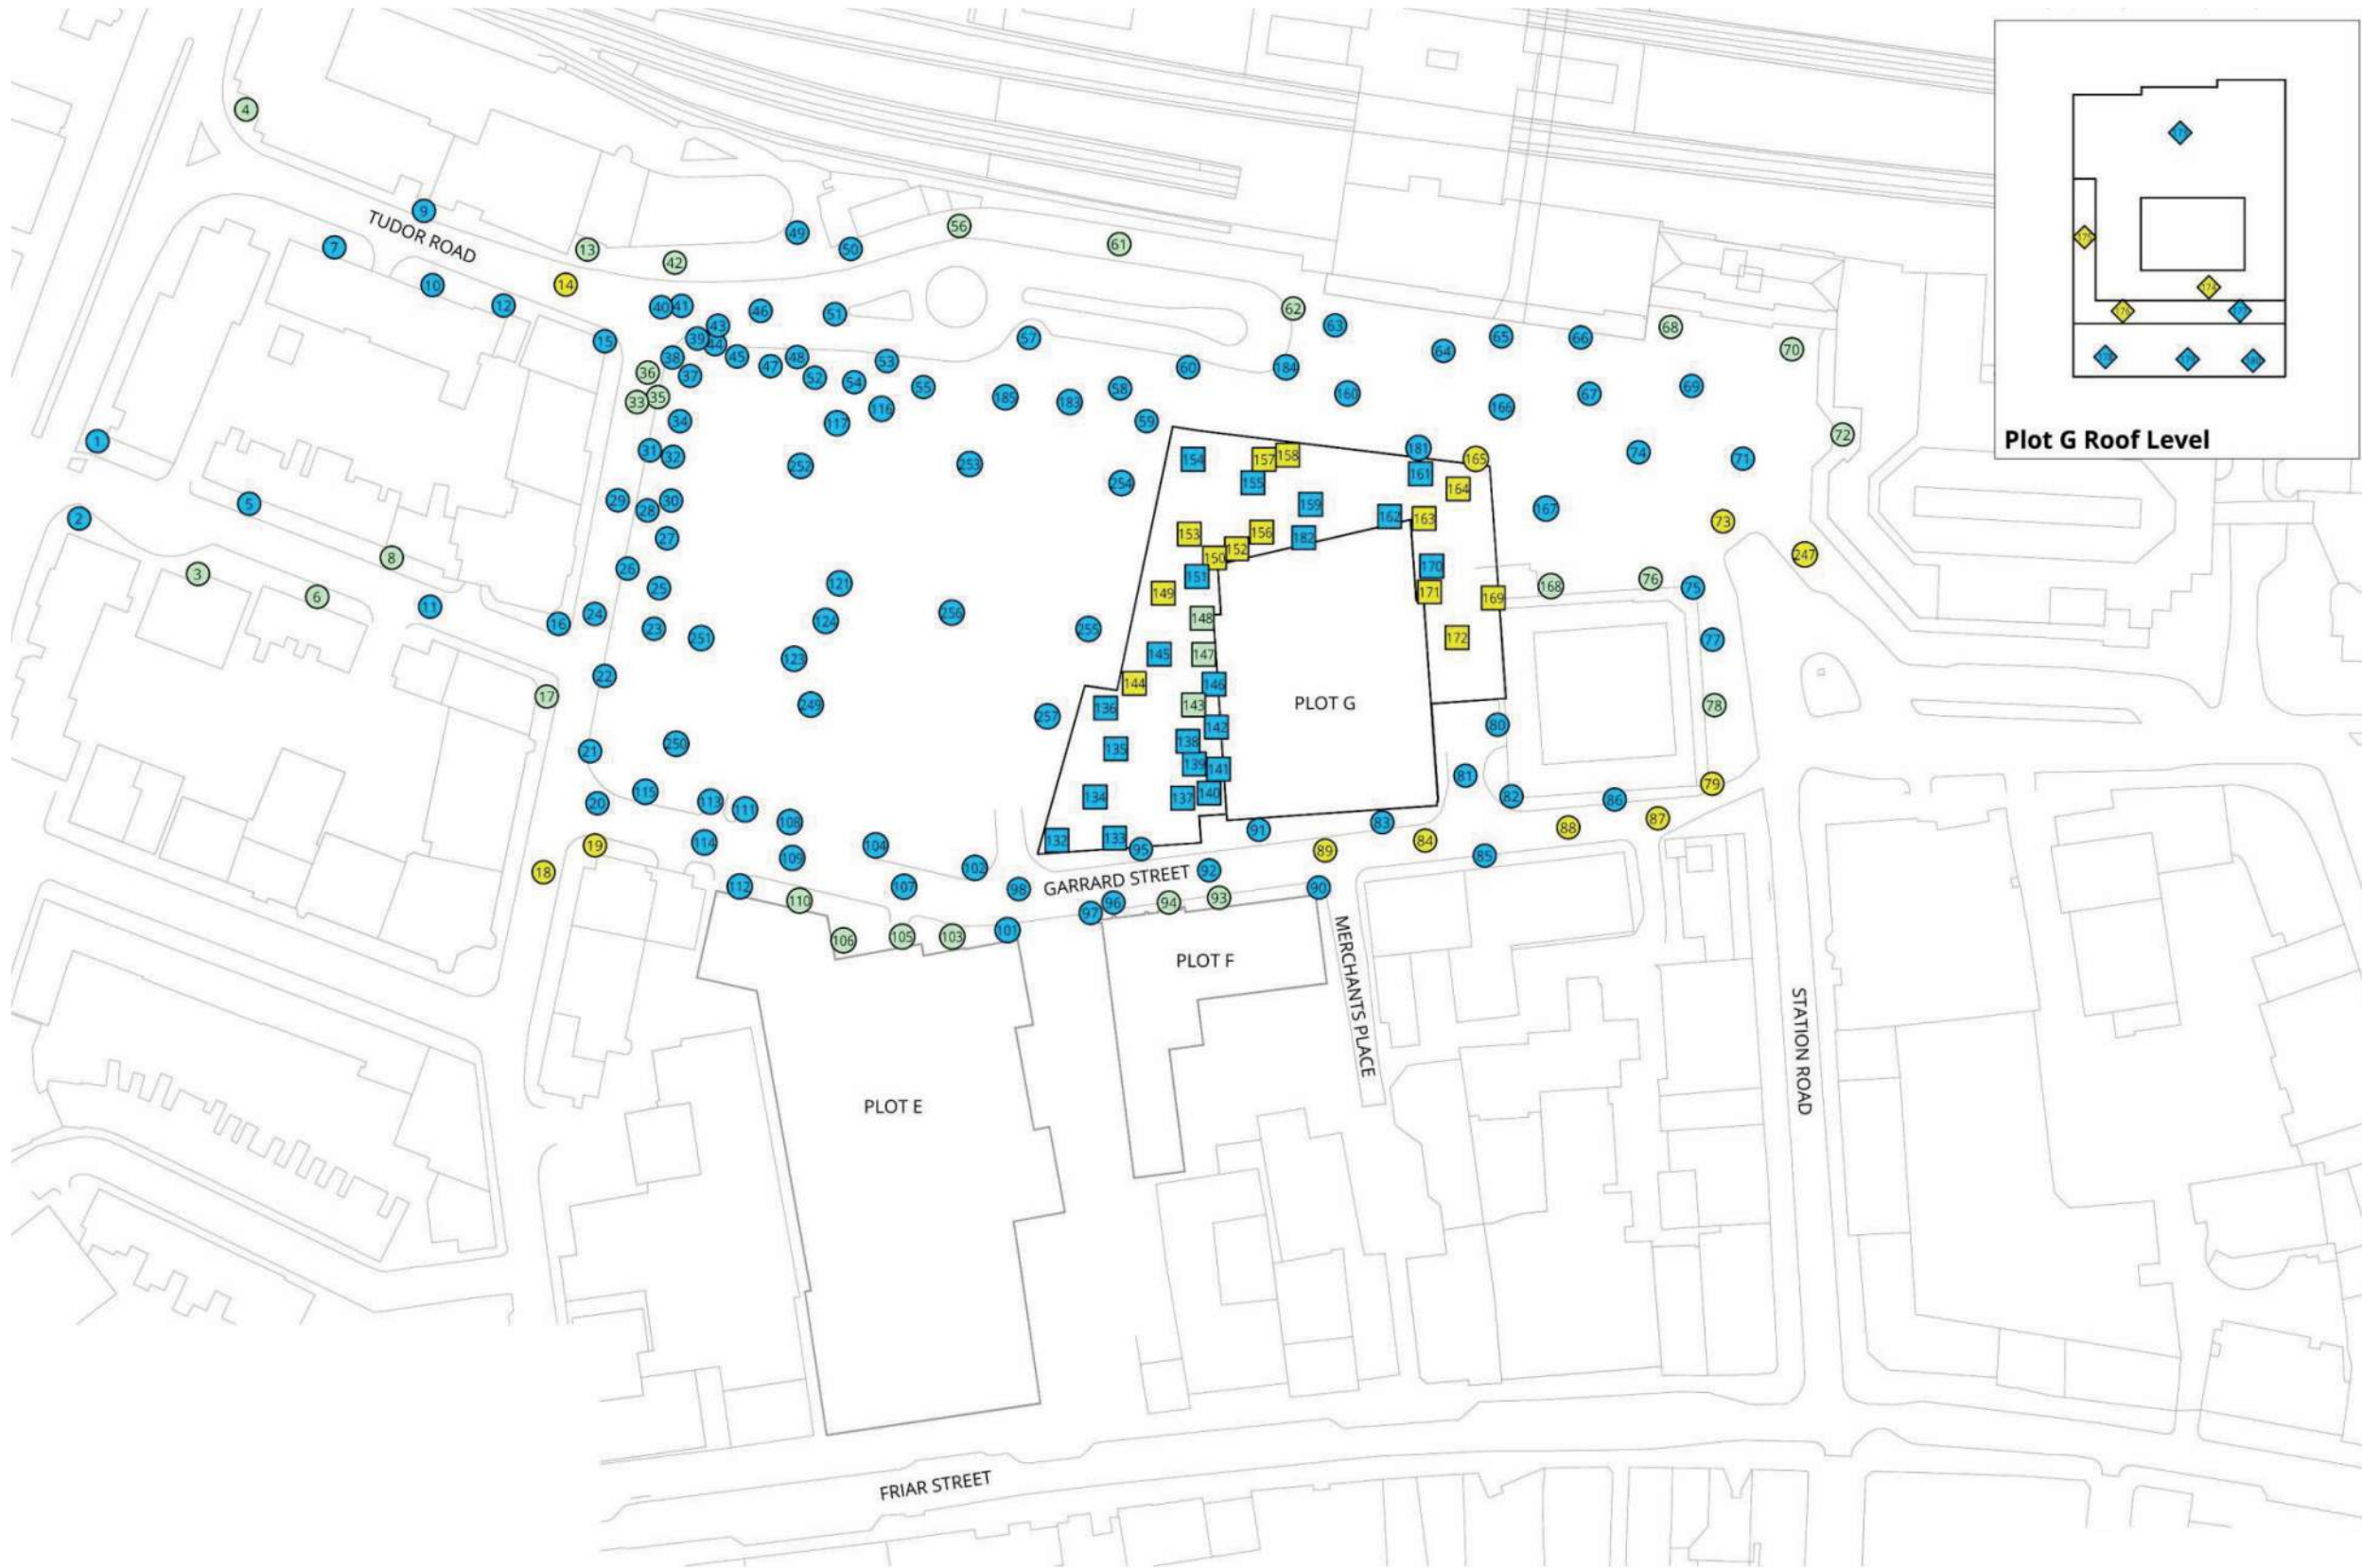
WIE14788-108\_GR\_ES\_13.19A

Figure 13.19: Mitigation: Interim Development Scenario with Wind Mitigation Measures and the Existing Surrounding Buildings – Windiest Season, Ground and Terrace Levels
