| Project Details | WIE14788-108: Station Hill, Reading |
| Figure Title | Figure 11.1: Noise Monitoring and Sensitive Receptor Locations |

| Figure Title | Figure 13.1: Seasonal Wind Roses for London Heathrow Airport |

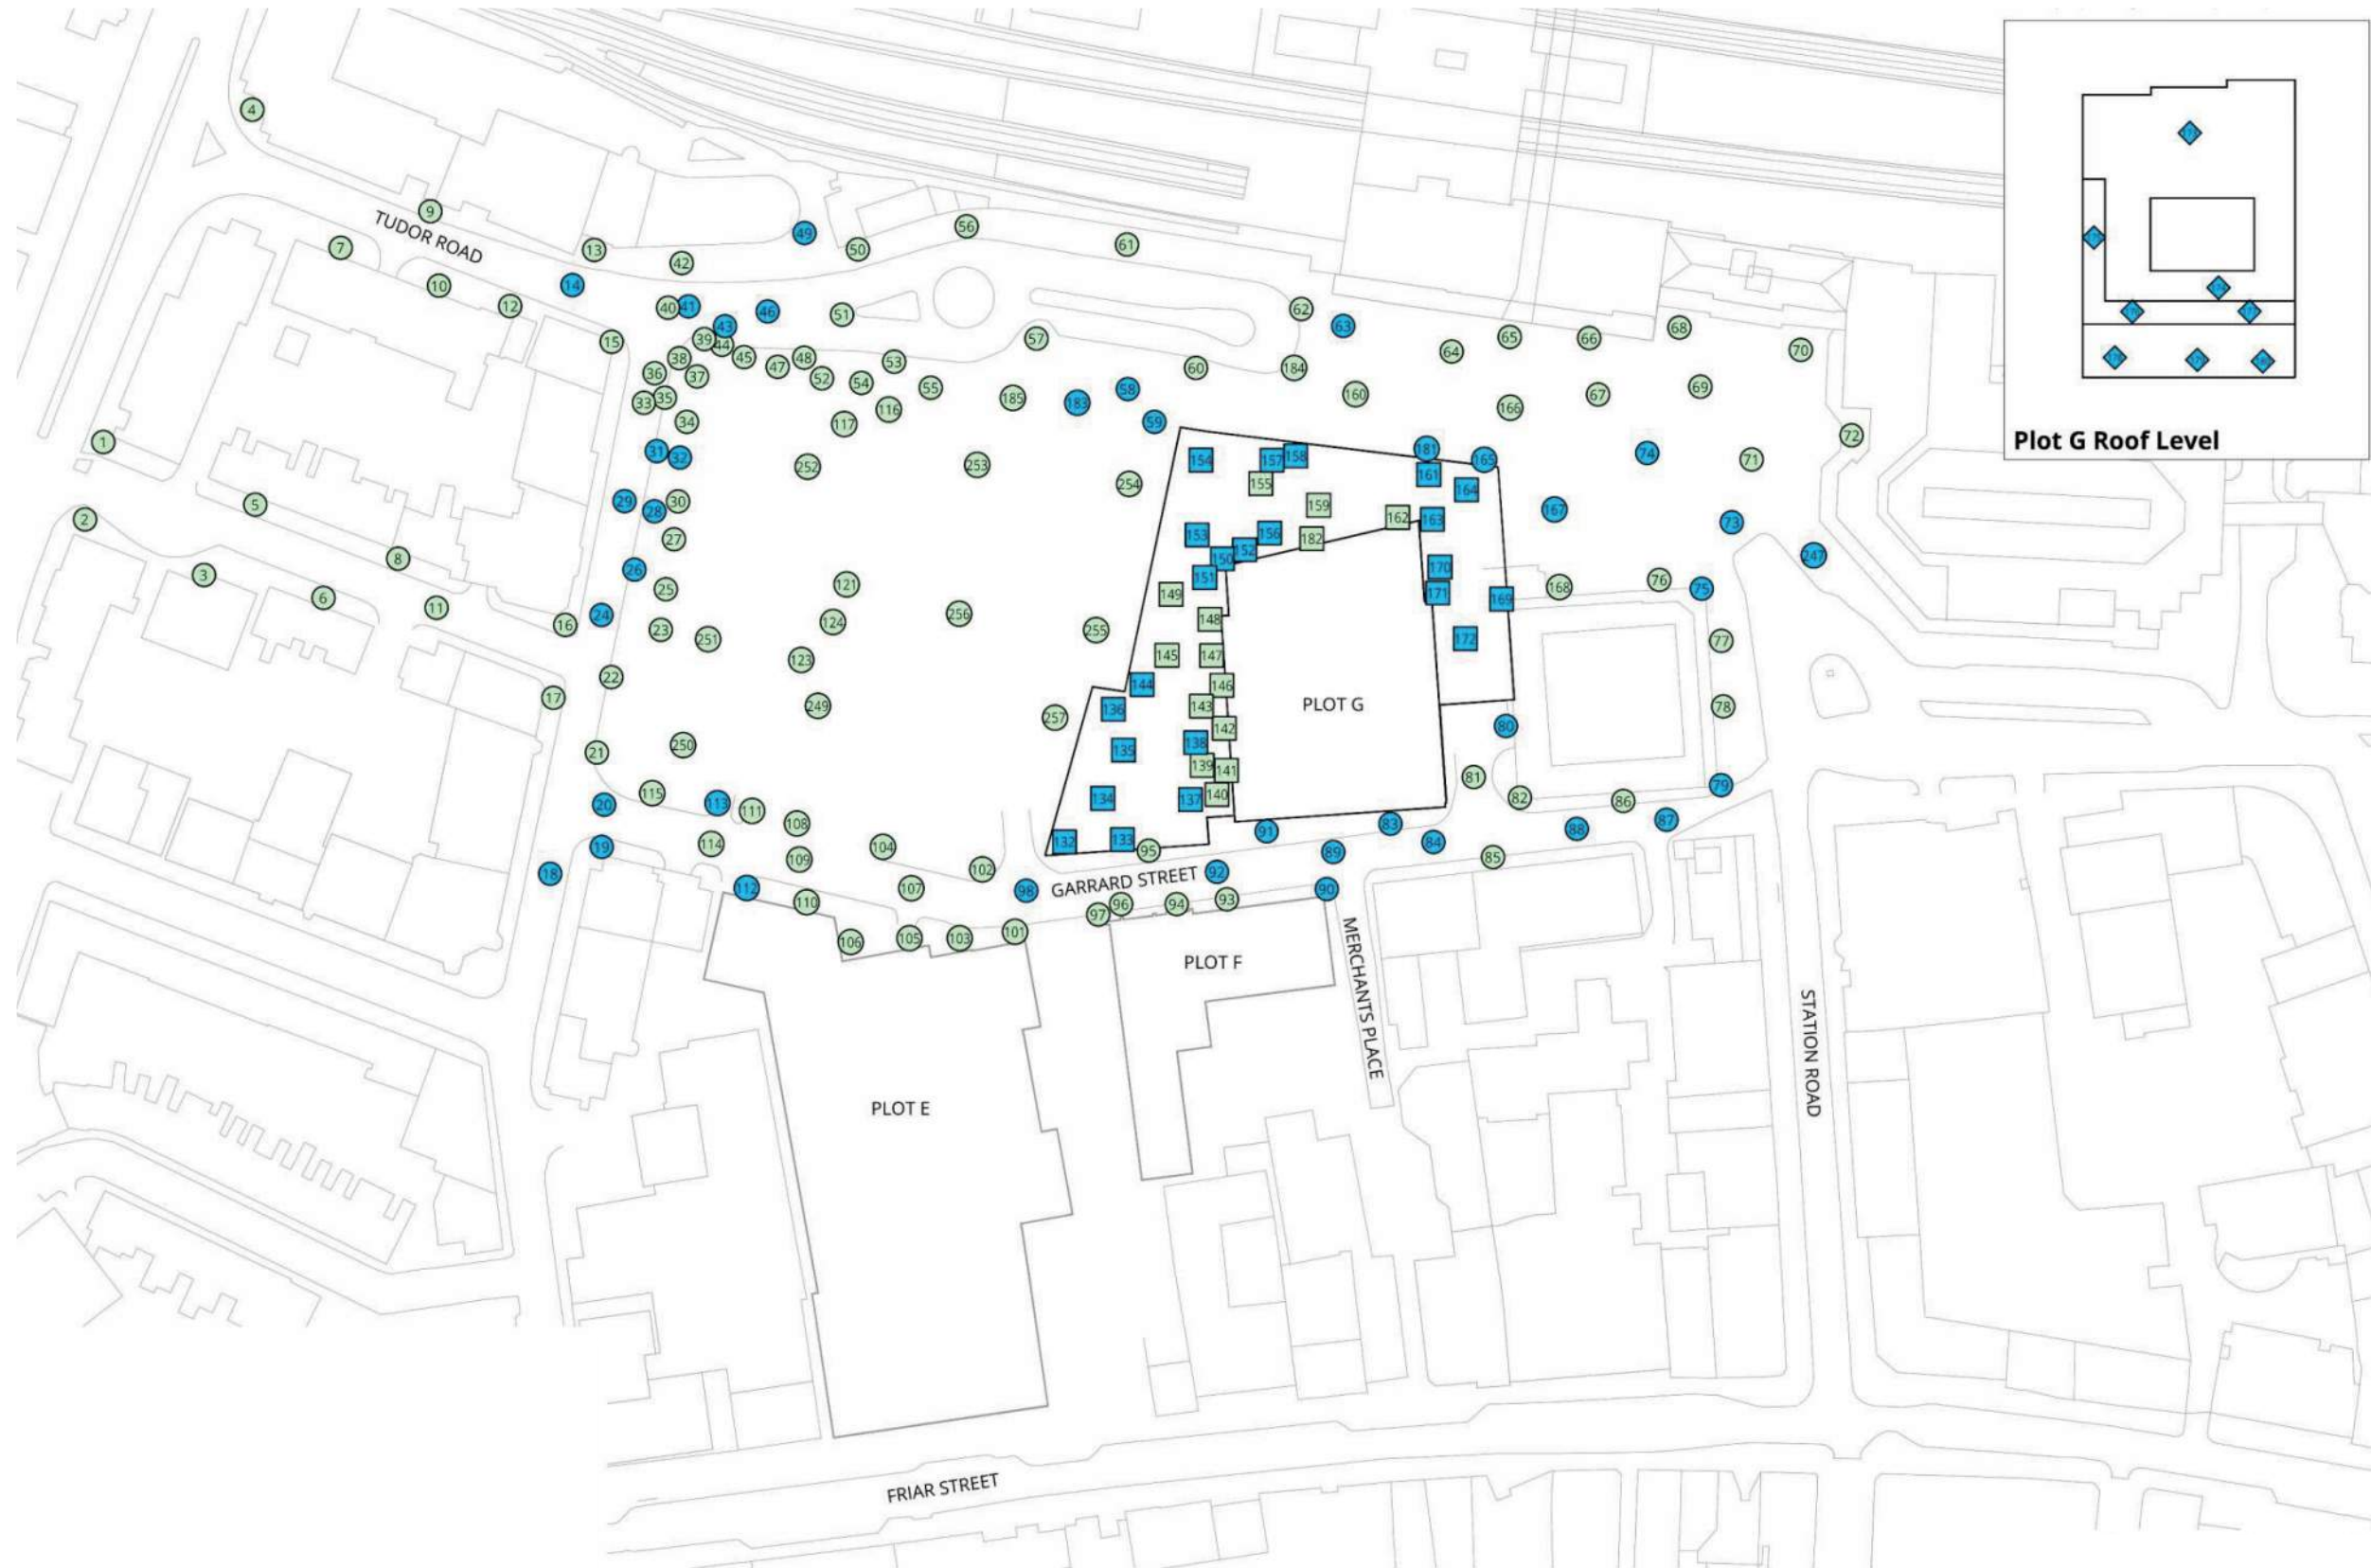
WIE14788-108\_GR\_ES\_13.20A

Figure 13.20: Mitigation: Interim Development Scenario with Wind Mitigation Measures and the Existing Surrounding Buildings – Summer Season, Ground and Terrace Levels

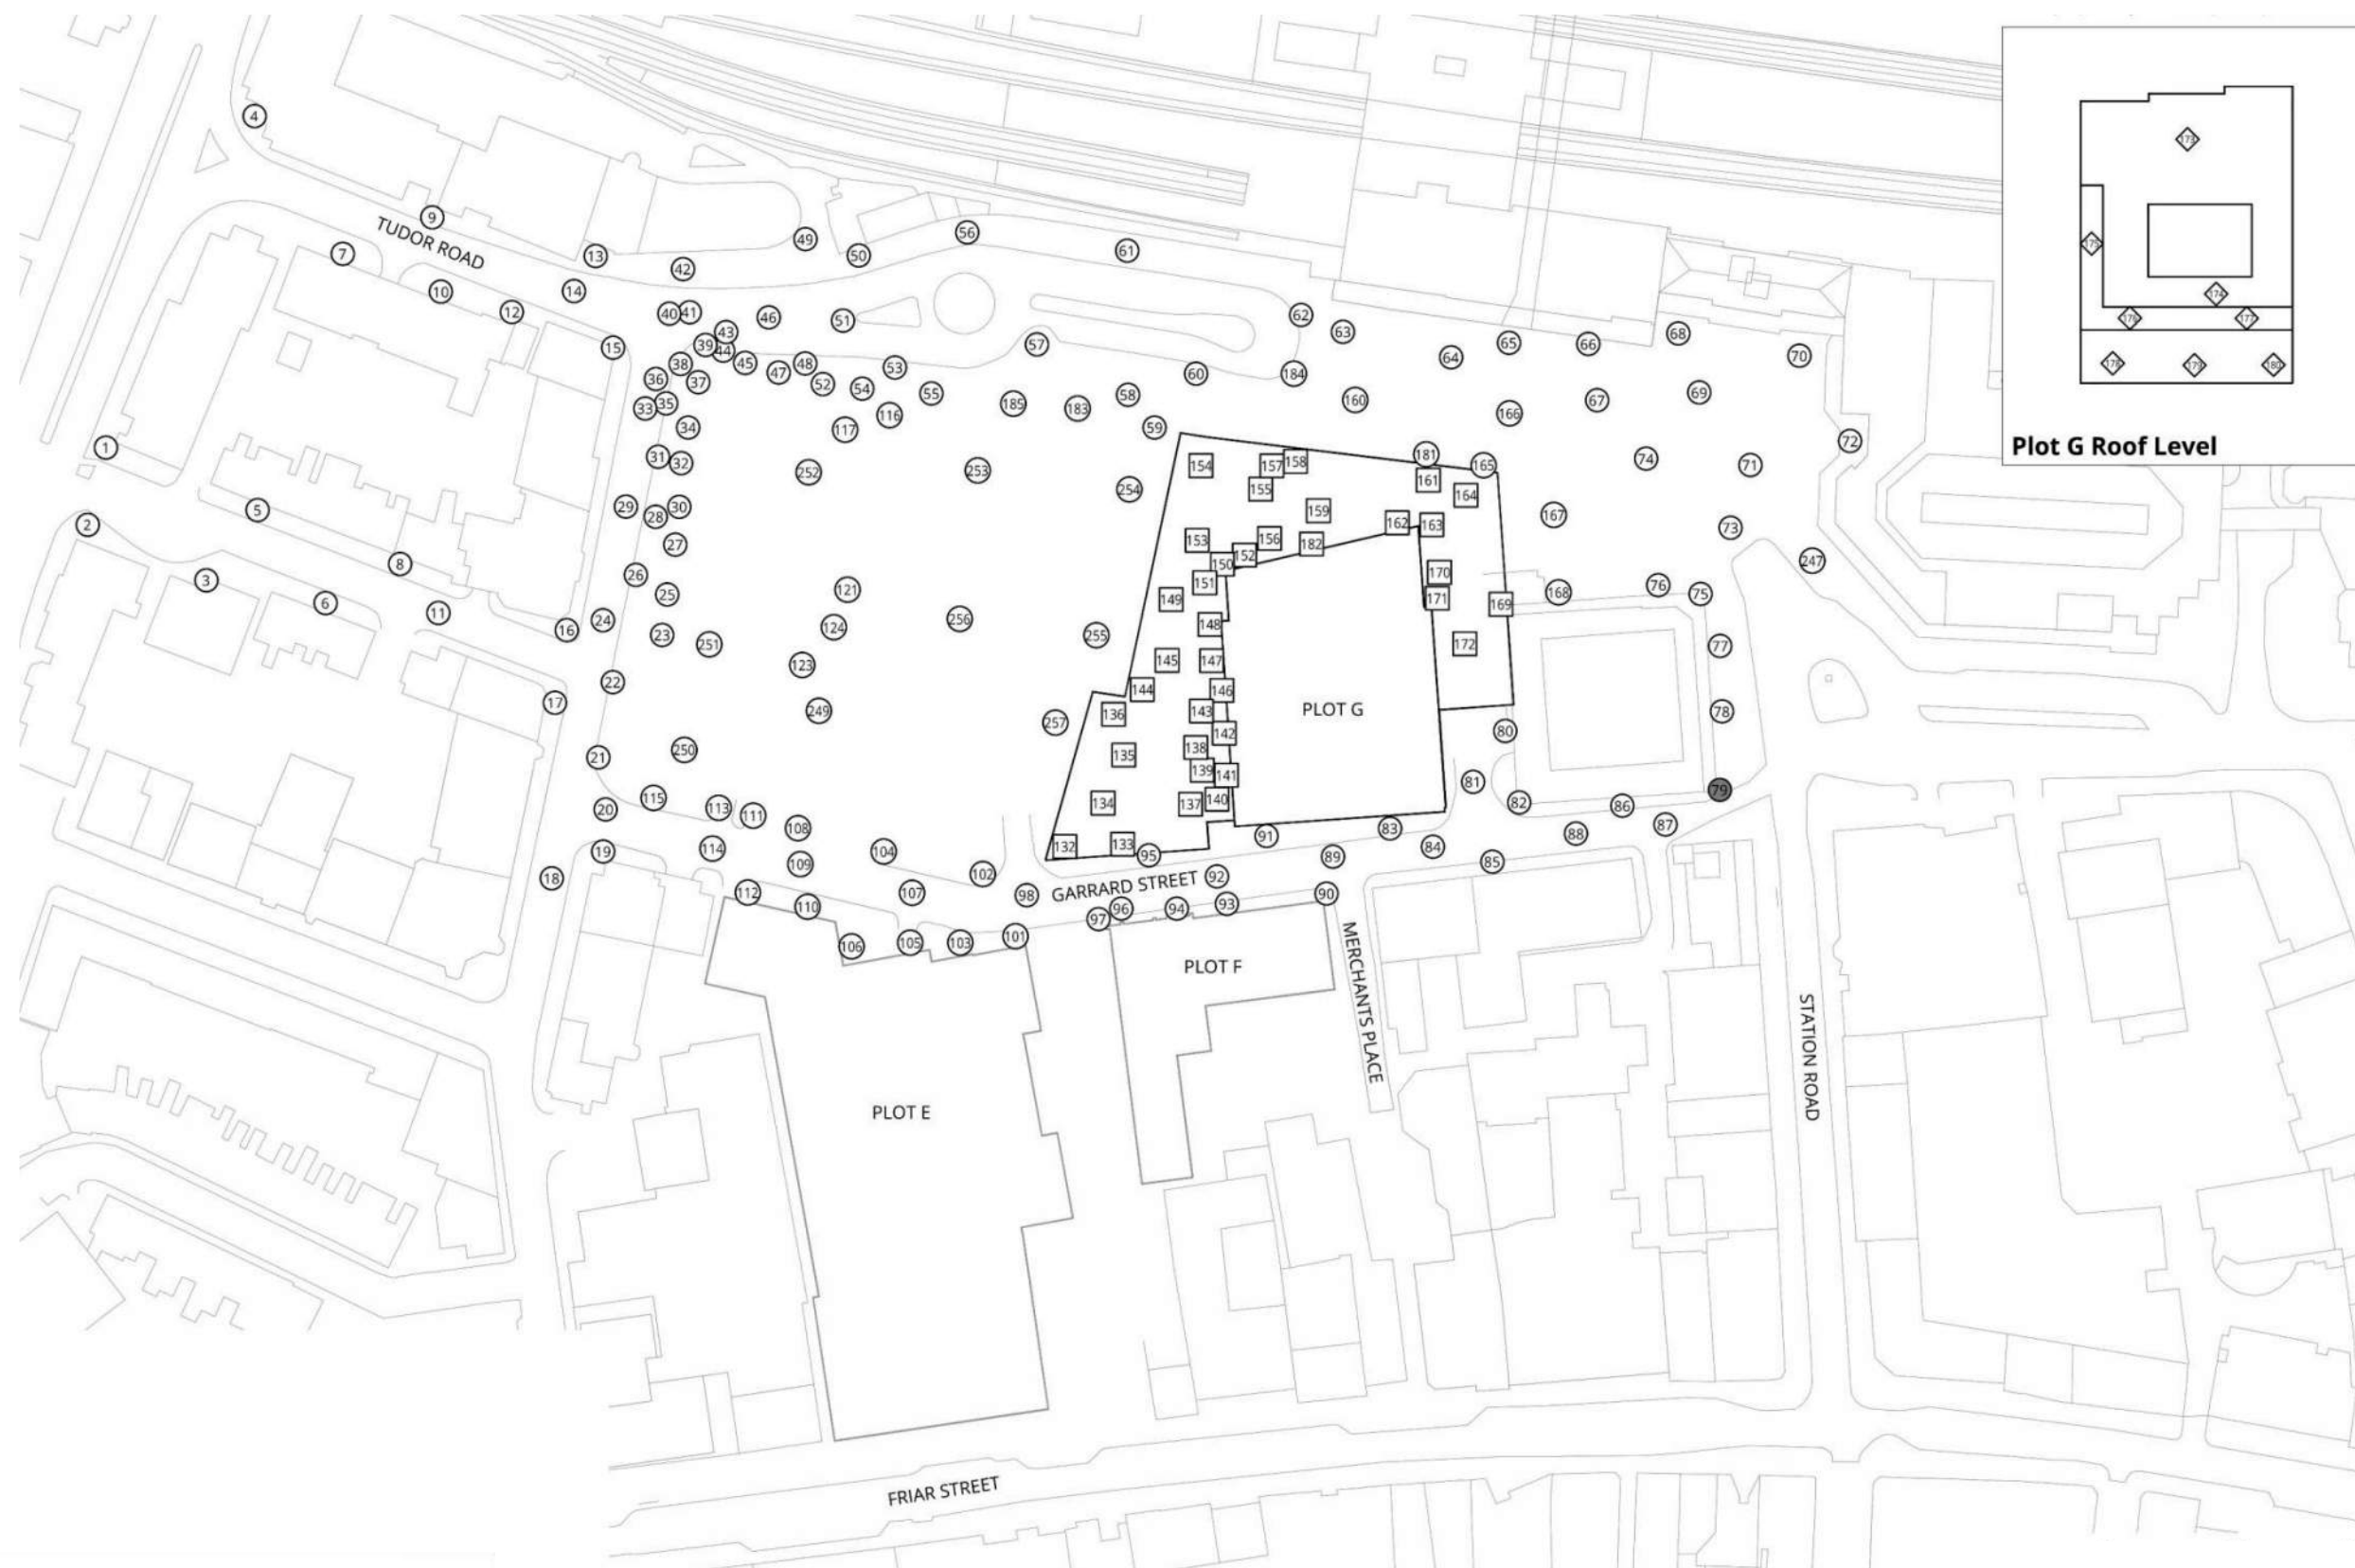
WIE14788-108\_GR\_ES\_13.21A

Figure 13.21: Mitigation: Interim Development Scenario with Wind Mitigation Measures and the Existing Surrounding Buildings – Annual Safety Exceedances, Ground and Terrace Levels

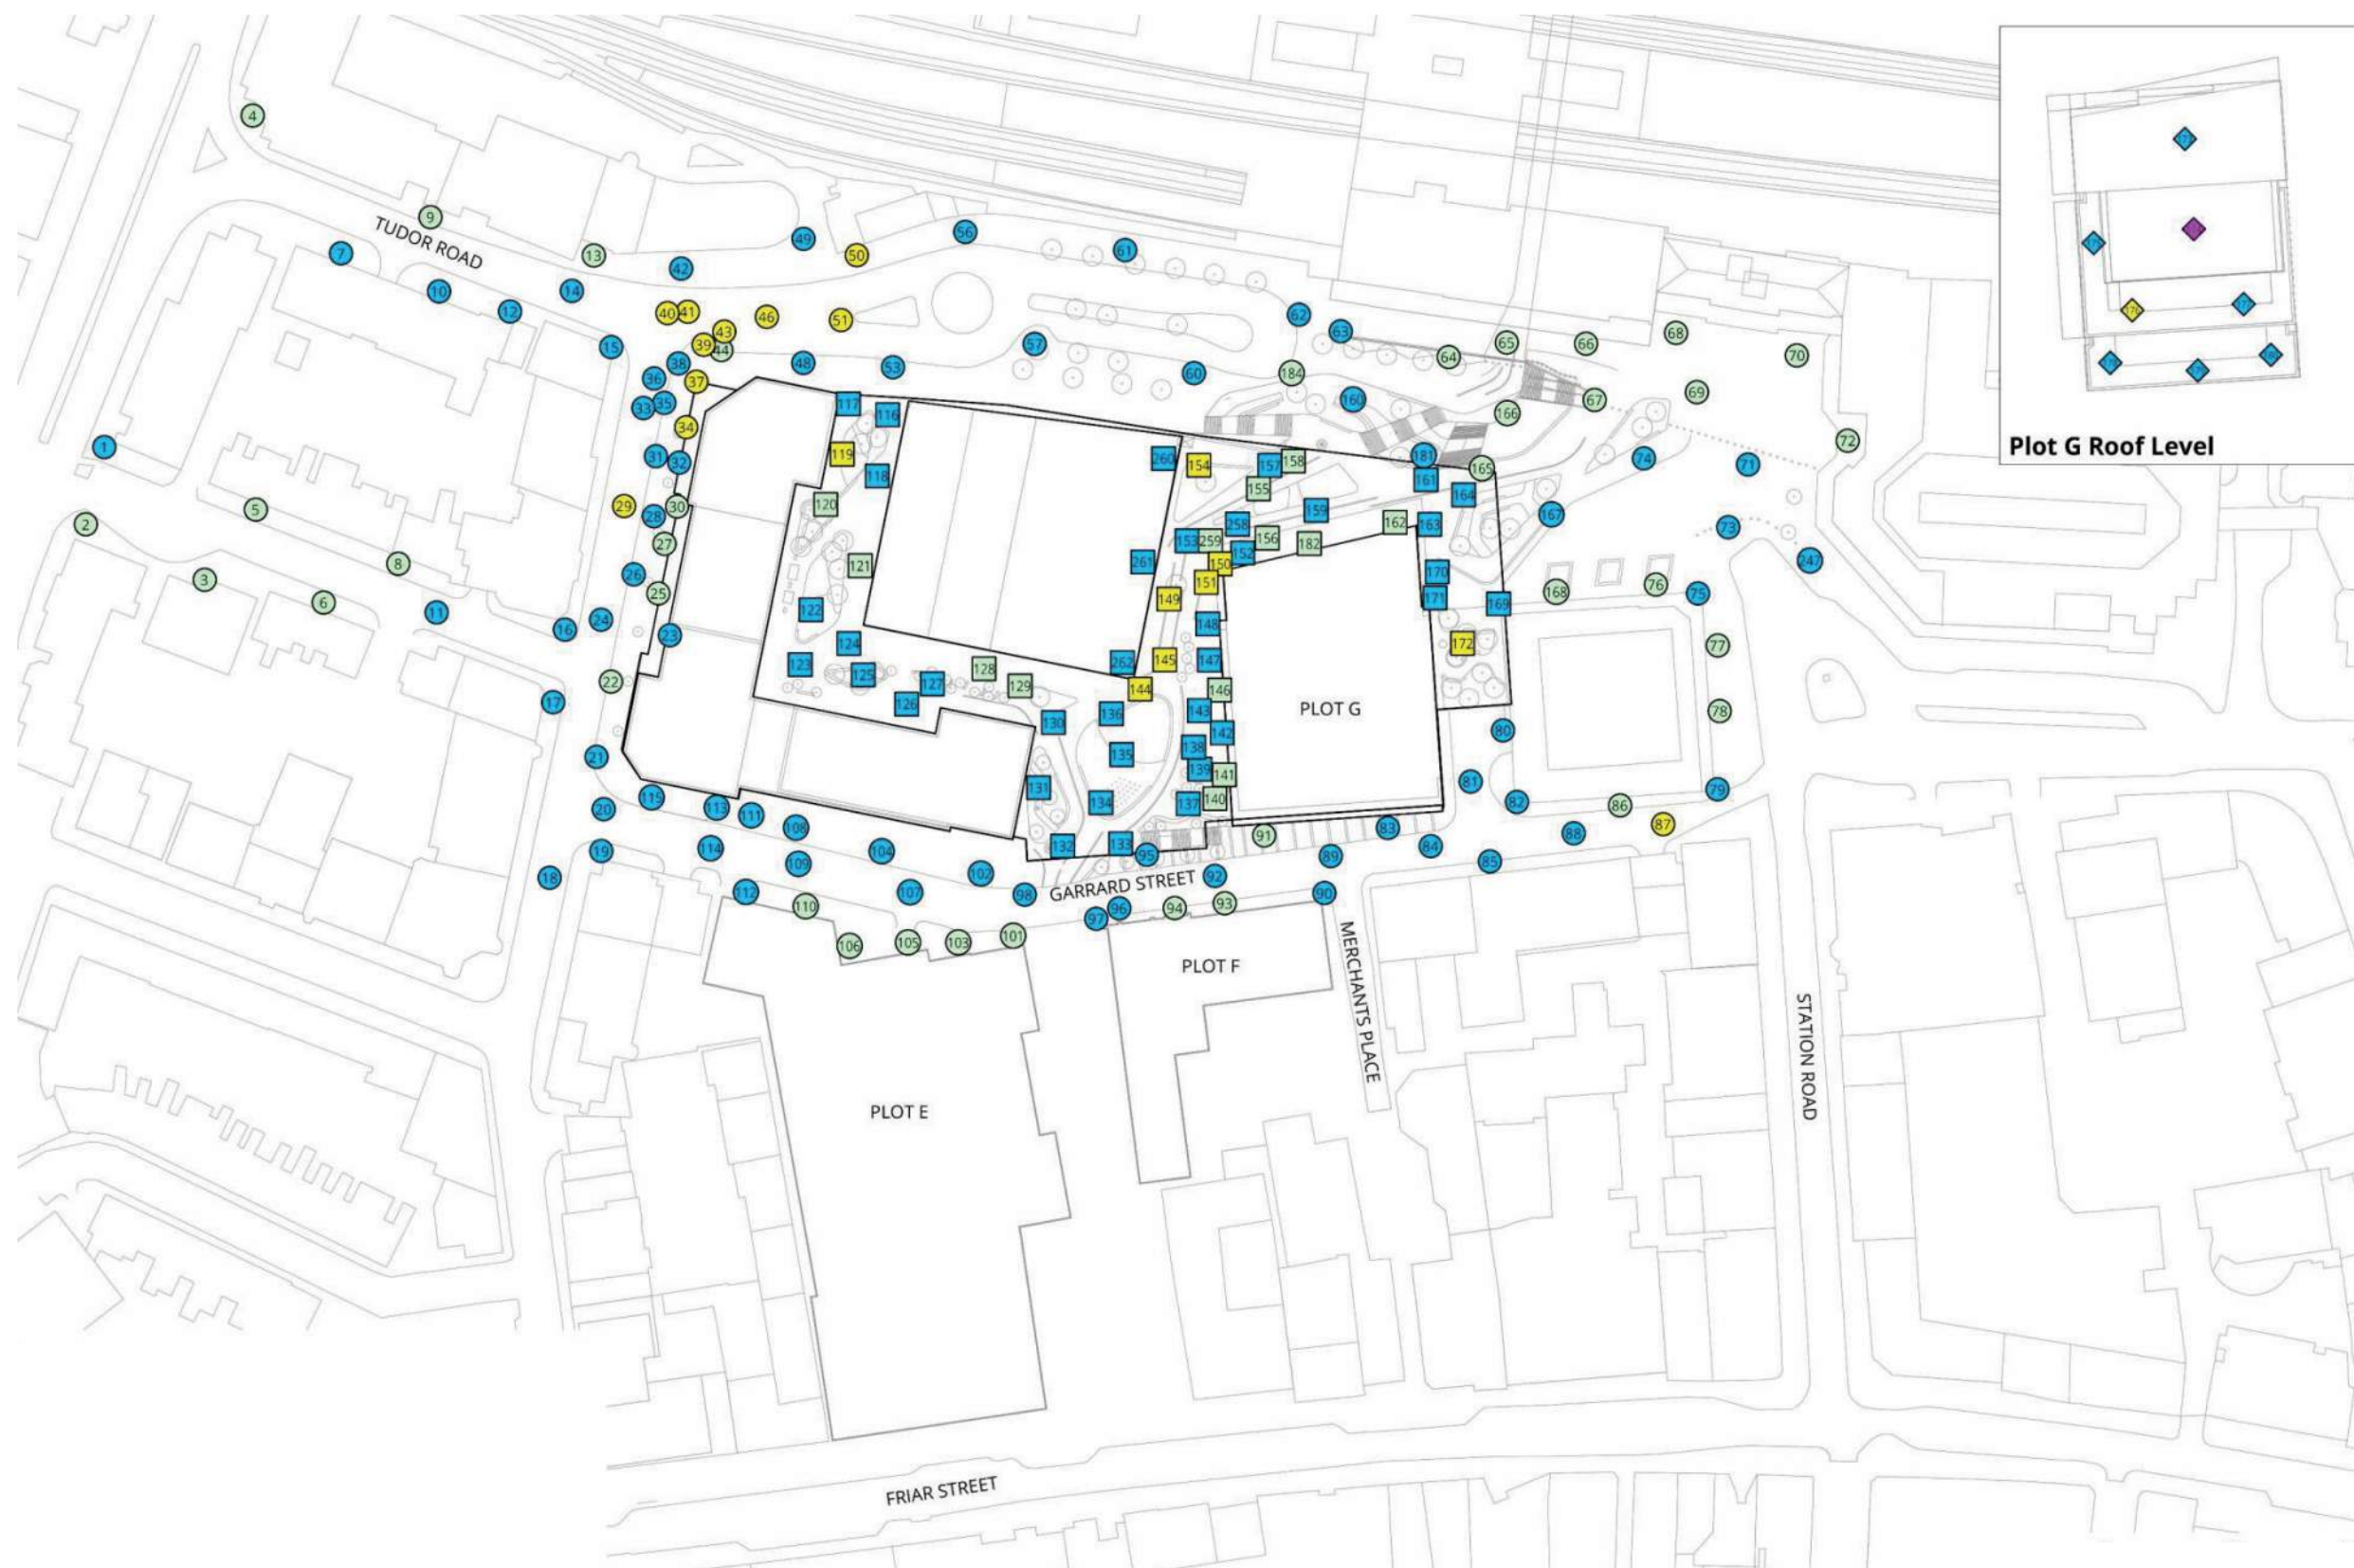
WIE14788-108\_GR\_ES\_13.22A

WIE14788-108: Station Hill, Reading  
Figure 13.22: Development Option 1 with Wind Mitigation Measures and the Cumulative Surrounding Buildings – Windiest Season, Ground and Terrace Levels

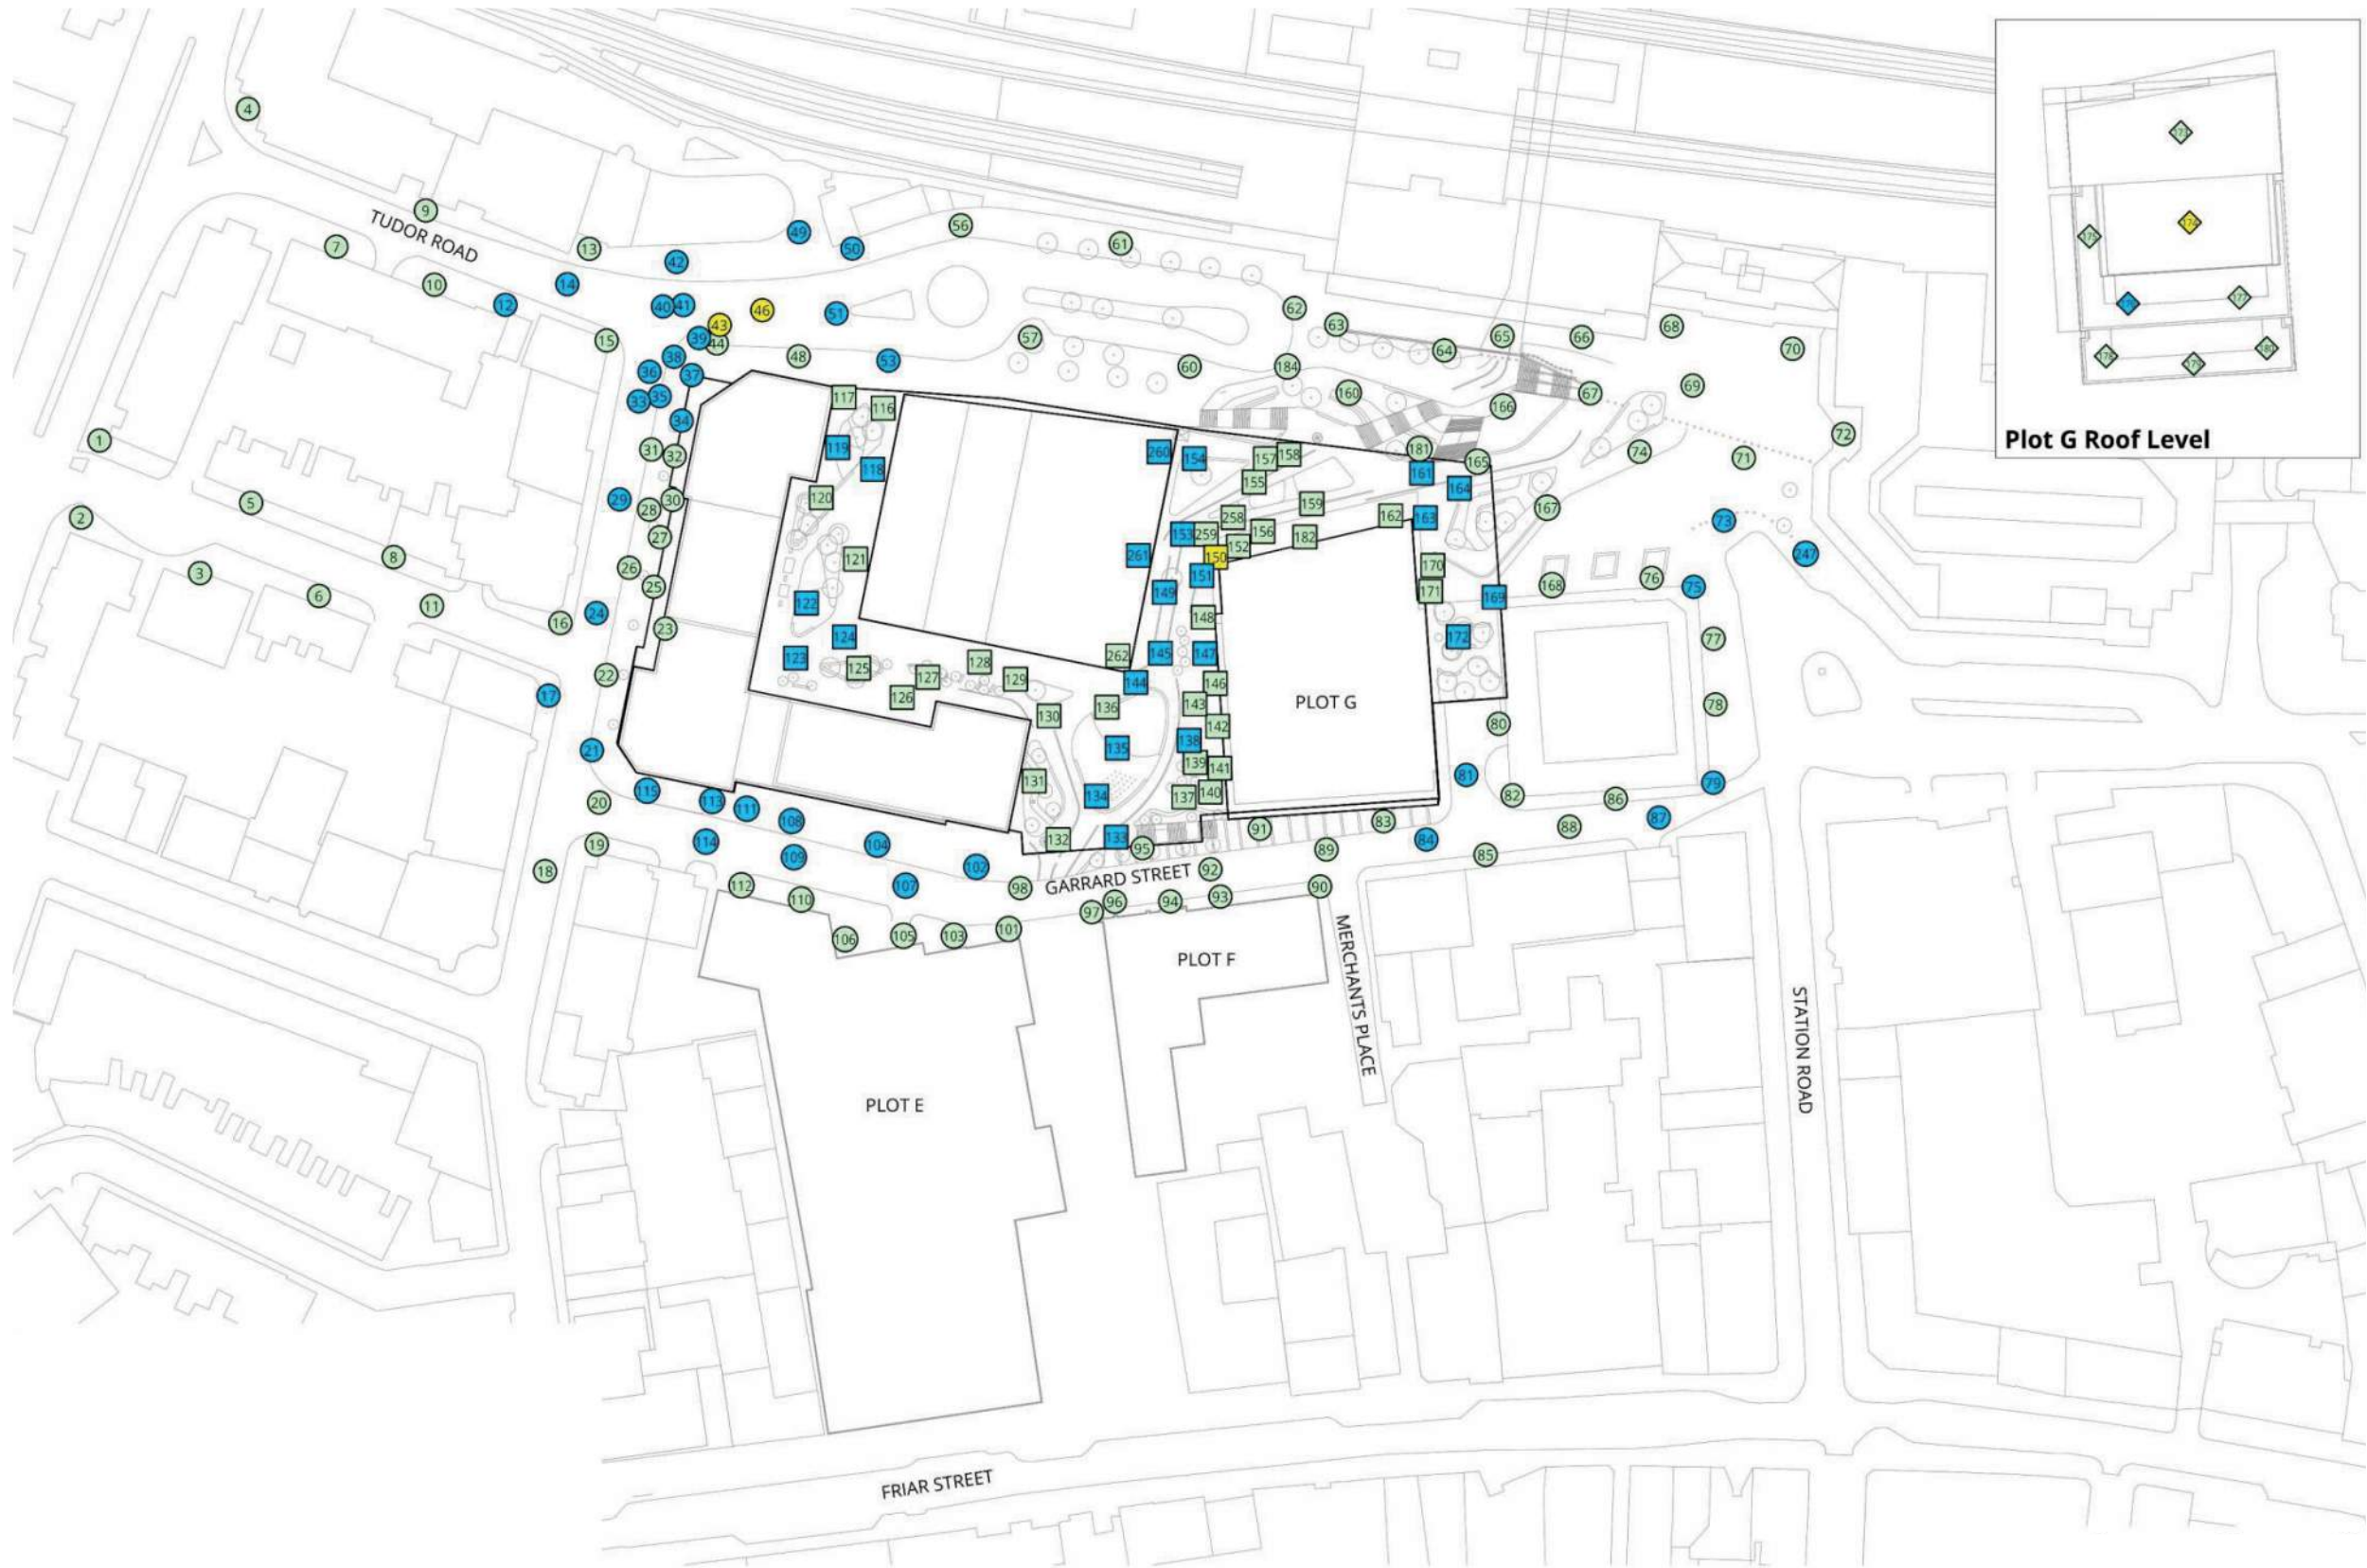
WIE14788-108\_GR\_ES\_13.23A

Figure 13.23: Development Option 1 with Wind Mitigation Measures and the Cumulative Surrounding Buildings – Summer Season, Ground and Terrace Levels

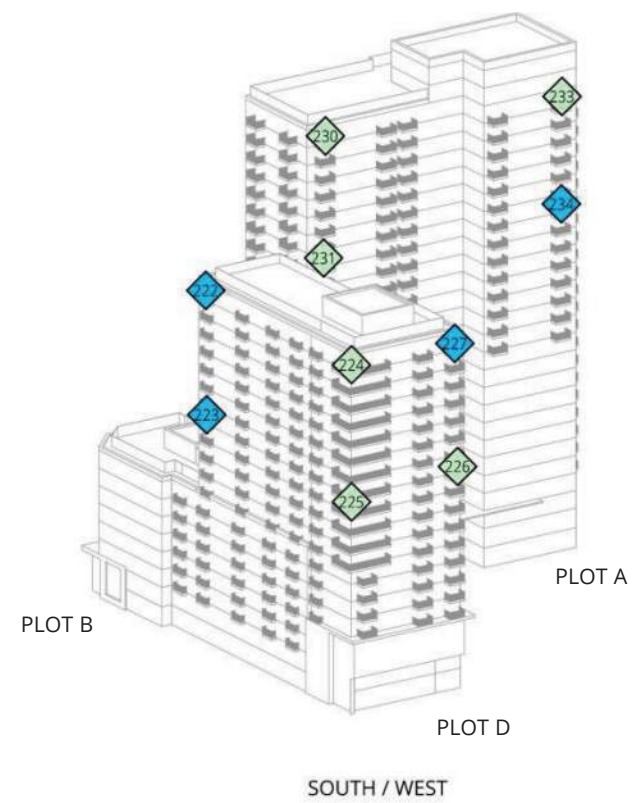
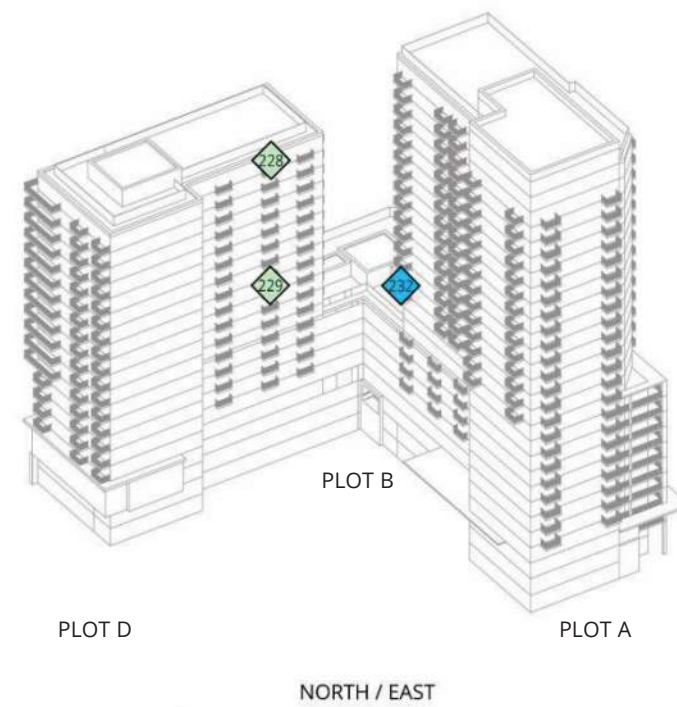
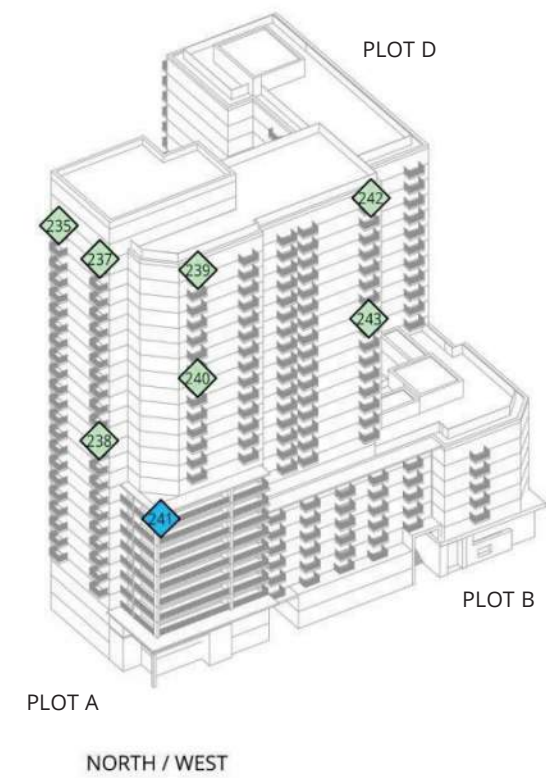
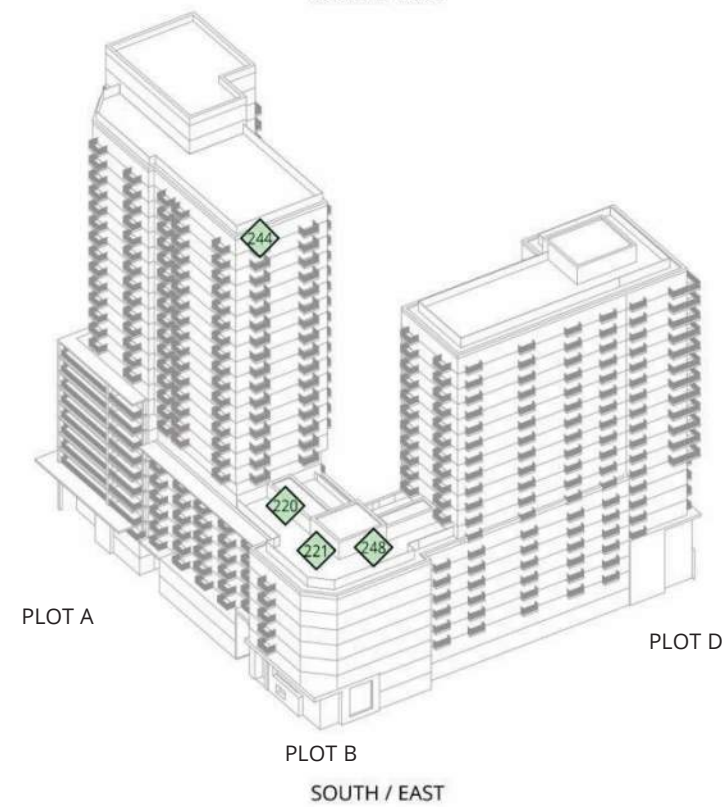
| Figure Ref | WIE14788-108_GR_ES_13.24A |

| Figure Title | Figure 13.24: Development Option 1 with Wind Mitigation Measures and the Cumulative Surrounding Buildings – Summer Season, Terrace and Balcony Levels |

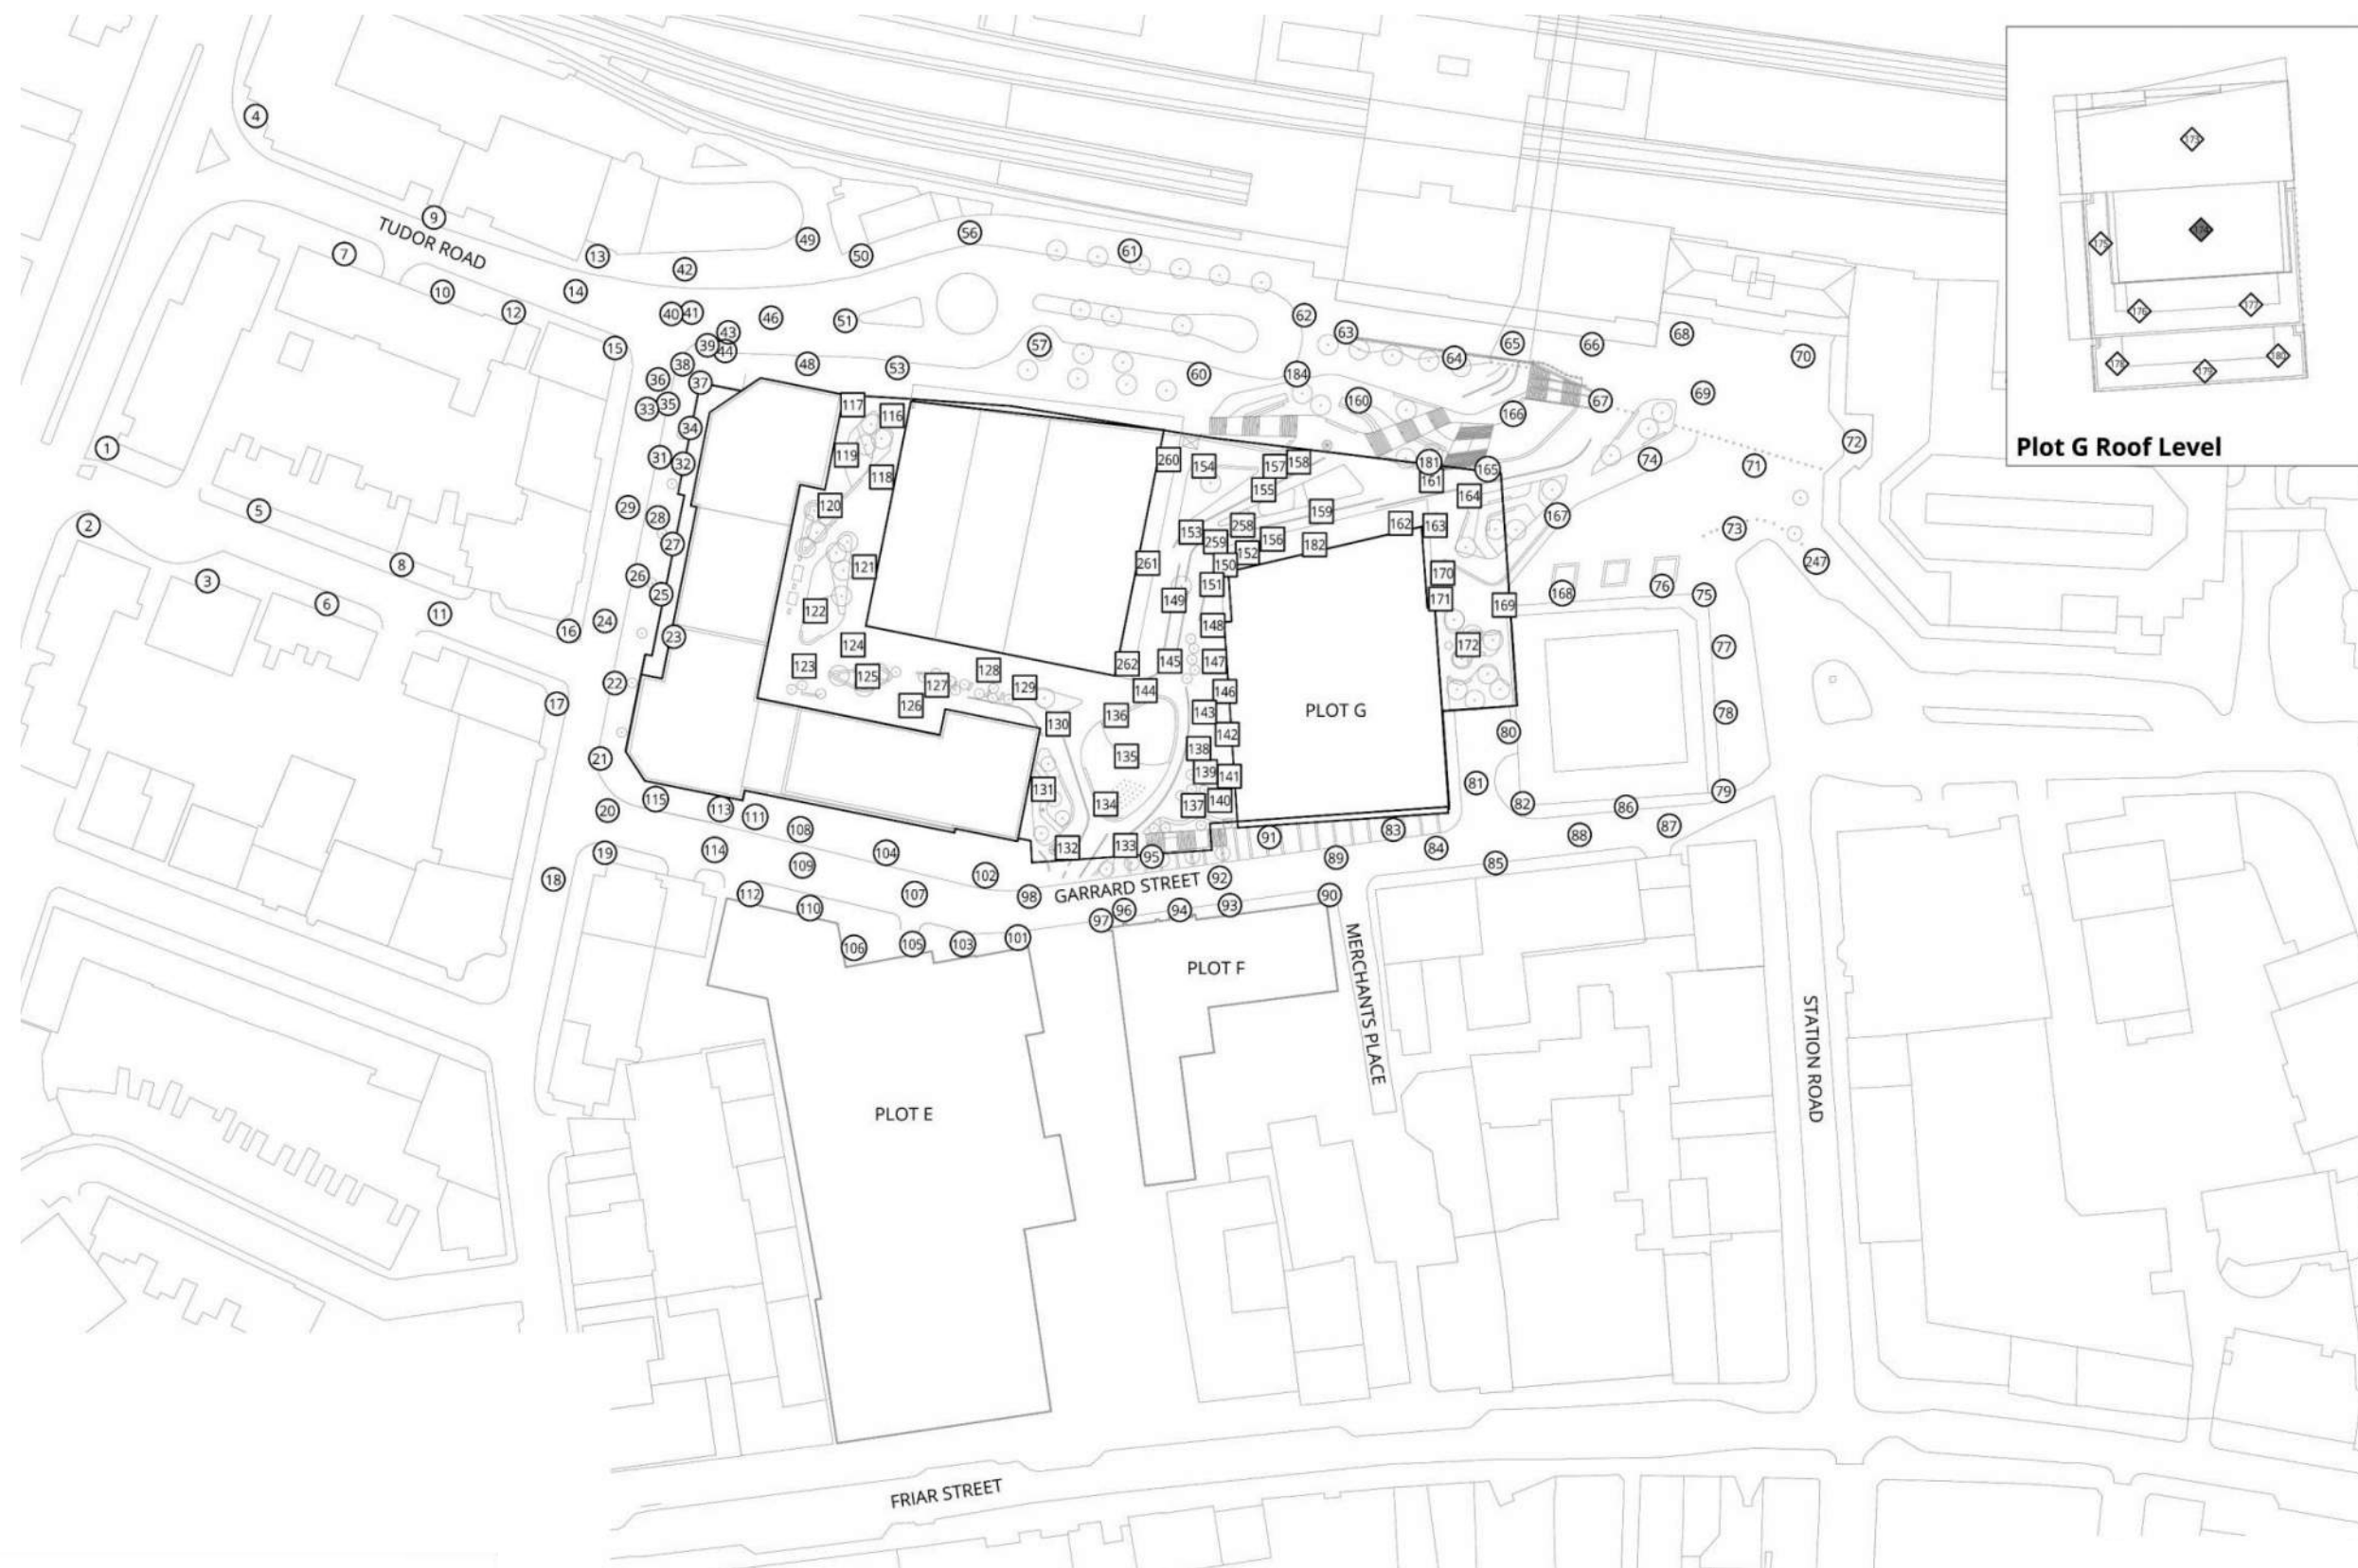
WIE14788-108\_GR\_ES\_13.25A

Figure 13.25: Development Option 1 with Wind Mitigation Measures and the Cumulative Surrounding Buildings – Annual Safety Exceedance, Ground and Terrace Levels

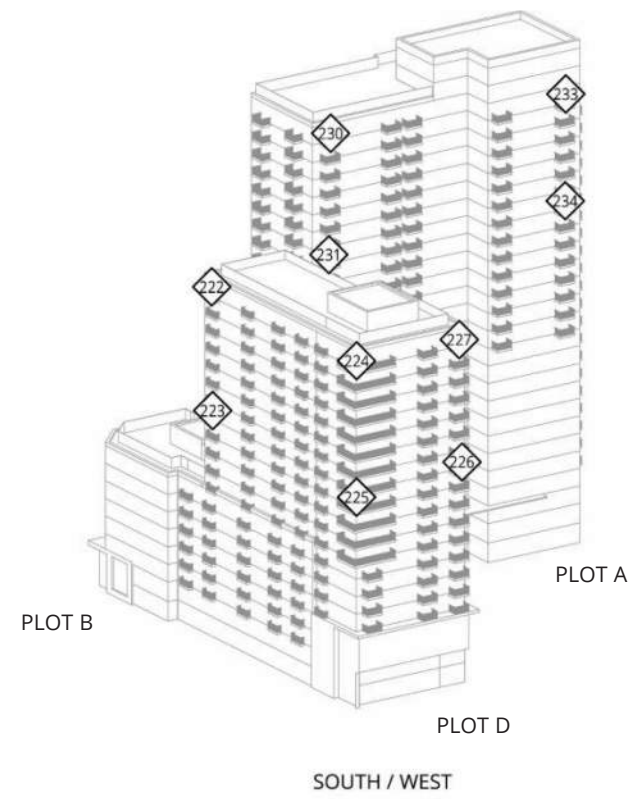
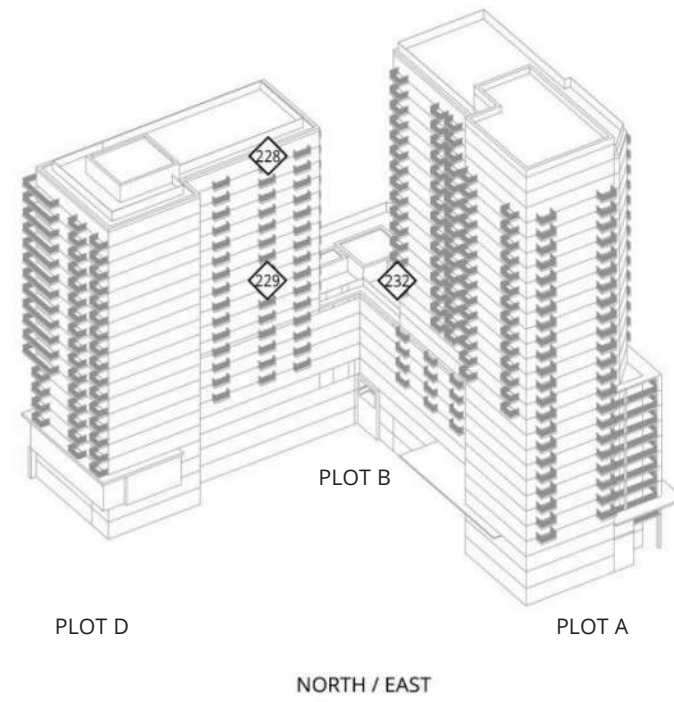
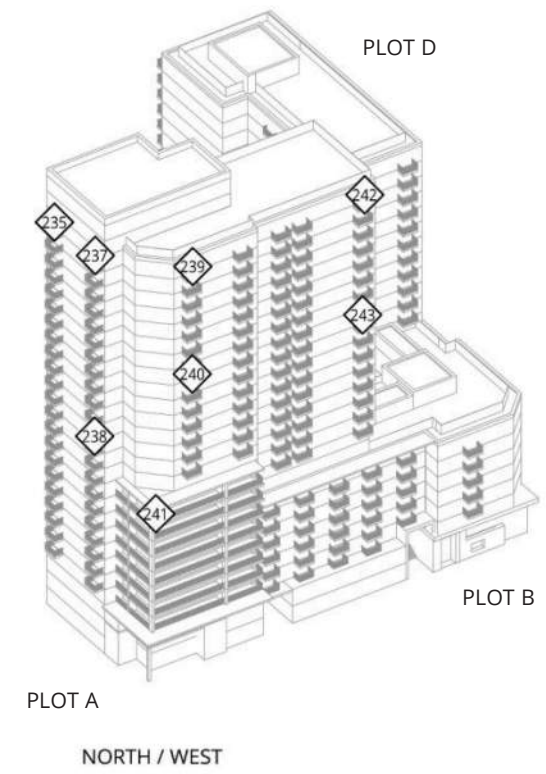
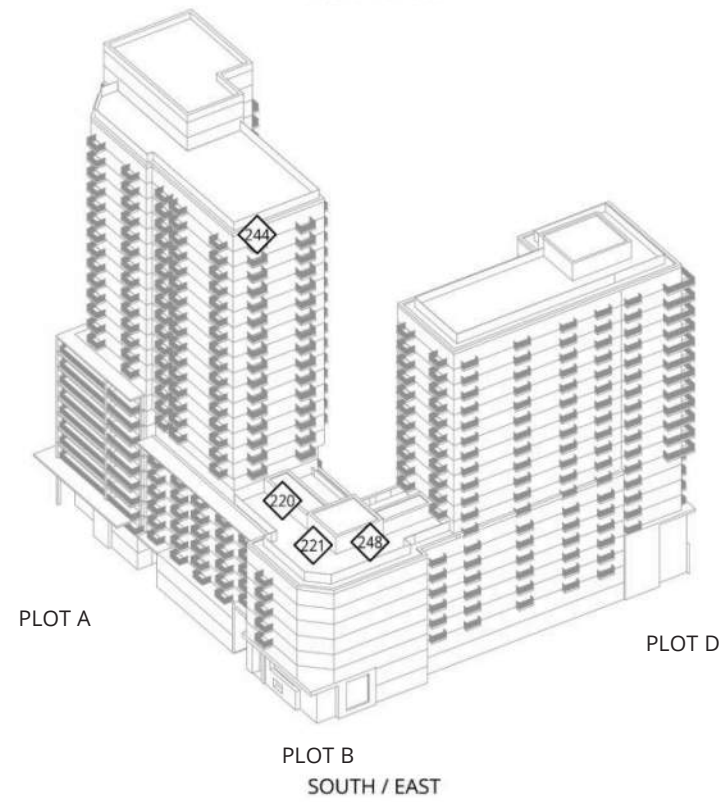
WIE14788-108\_GR\_ES\_13.26A

Figure 13.26: Development Option 1 with Wind Mitigation Measures and the Cumulative Surrounding Buildings – Annual Safety Exceedance, Terrace and Balcony Levels
