| Project Details | WIE14788-108: Station Hill, Reading |
| Figure Title | Figure 11.1: Noise Monitoring and Sensitive Receptor Locations |

| Figure Title | Figure 13.1: Seasonal Wind Roses for London Heathrow Airport |

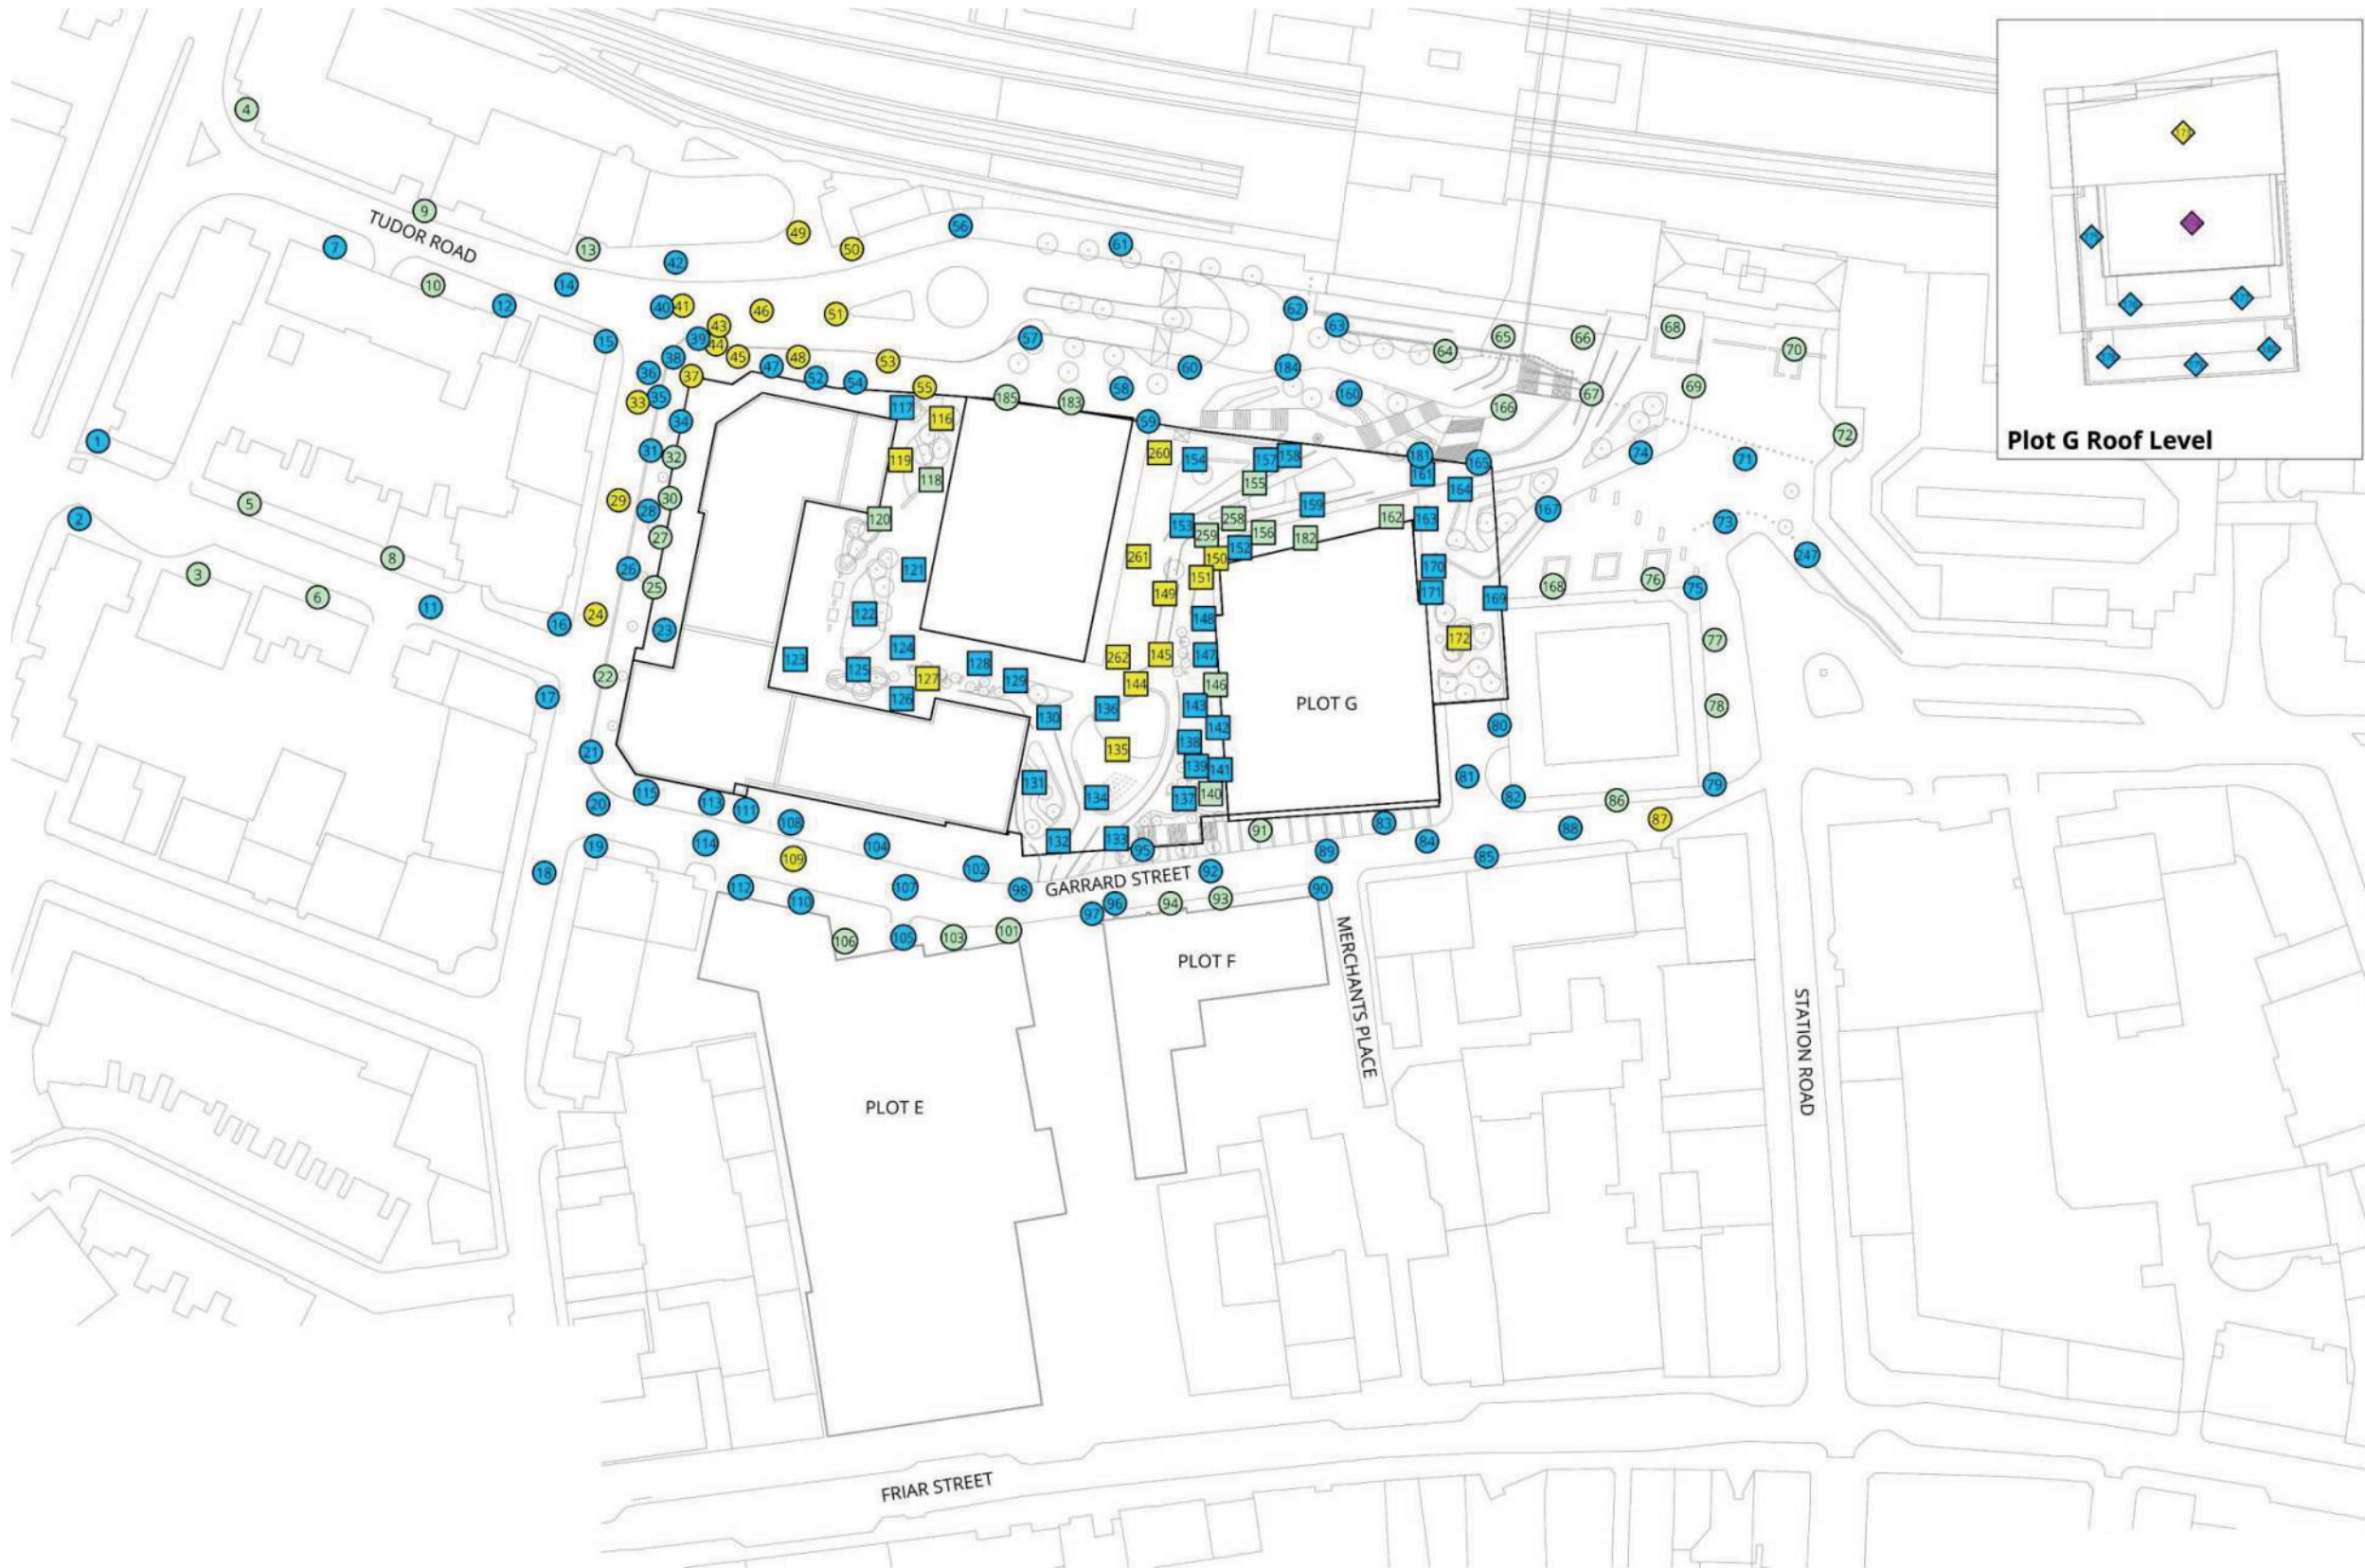
WIE14788-108\_GR\_ES\_13.27A

WIE14788-108: Station Hill, Reading  
Figure 13.27: Development Option 2 with Wind Mitigation Measures and the Cumulative Surrounding Buildings – Windiest Season, Ground and Terrace Levels

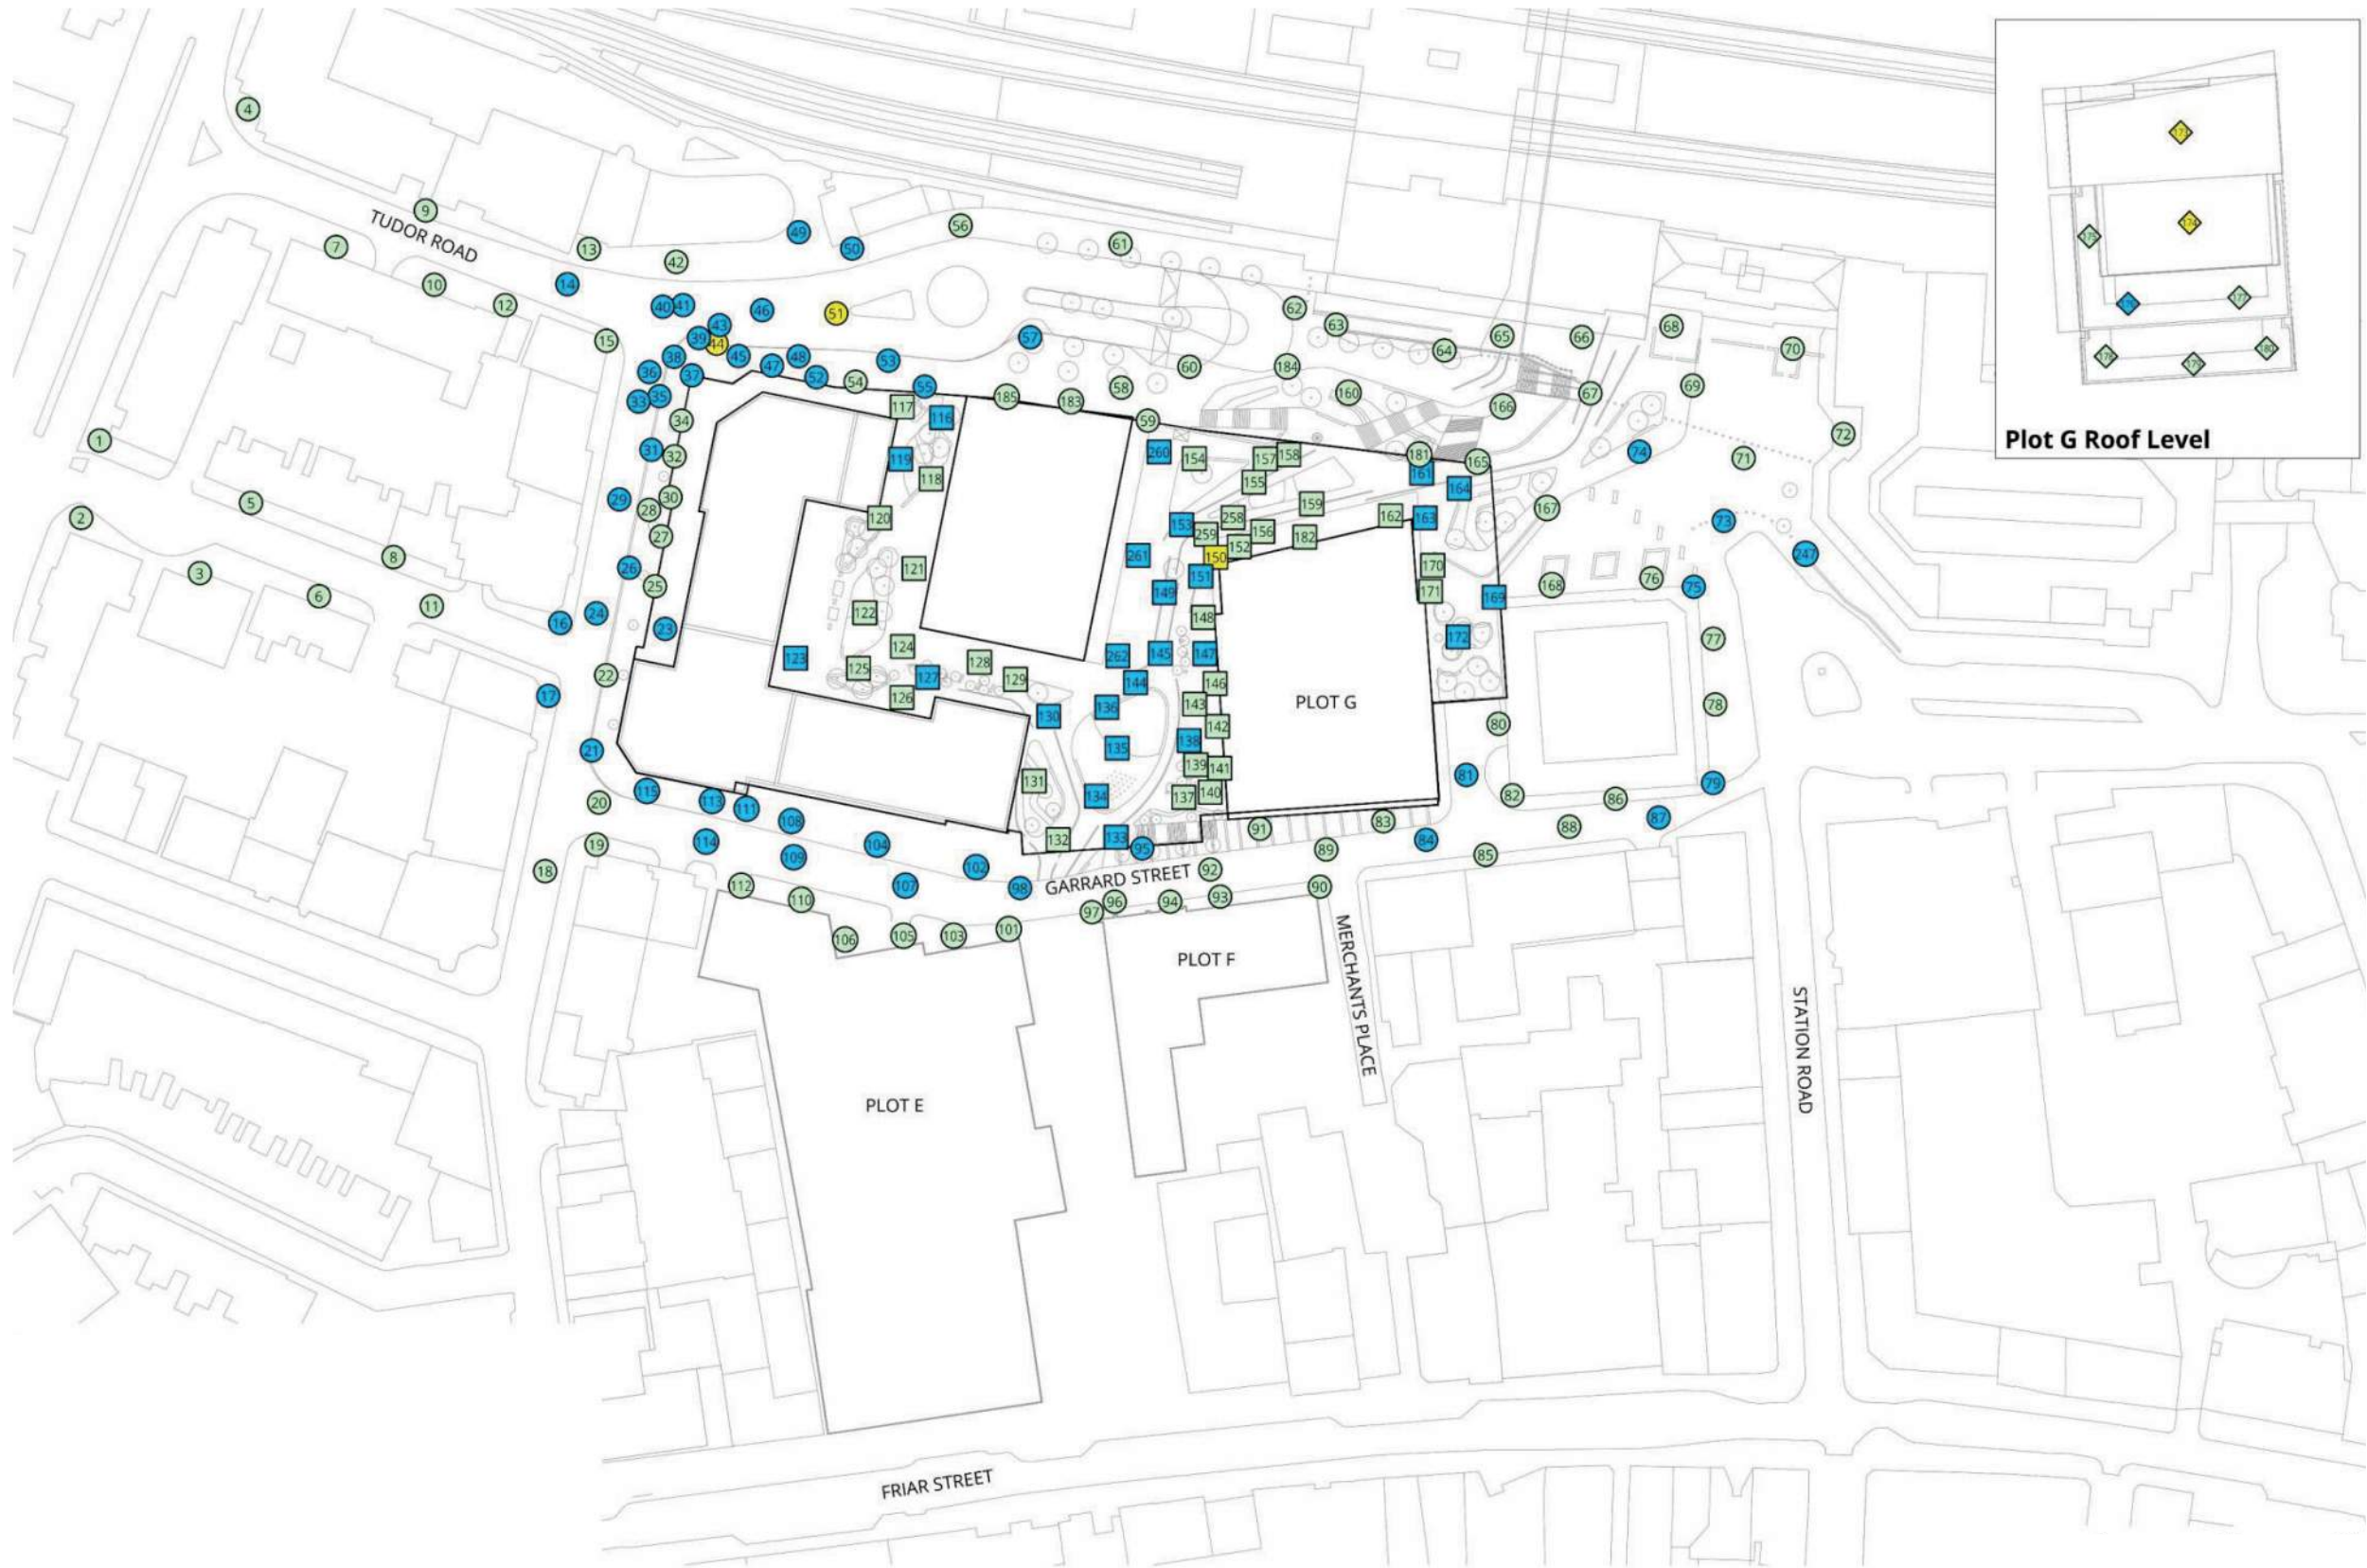
WIE14788-108\_GR\_ES\_13.28A

Figure 13.28: Development Option 2 with Wind Mitigation Measures and the Cumulative Surrounding Buildings – Summer Season, Ground and Terrace Levels
