**Pedestrian Wind Safety Conditions - Isometric Views**  
Mitigation: Development Option 3 with Landscaping, Mitigation and Cumulative Surrounding Buildings  
Annual

Station Hill - Reading, UK

Project #1803688

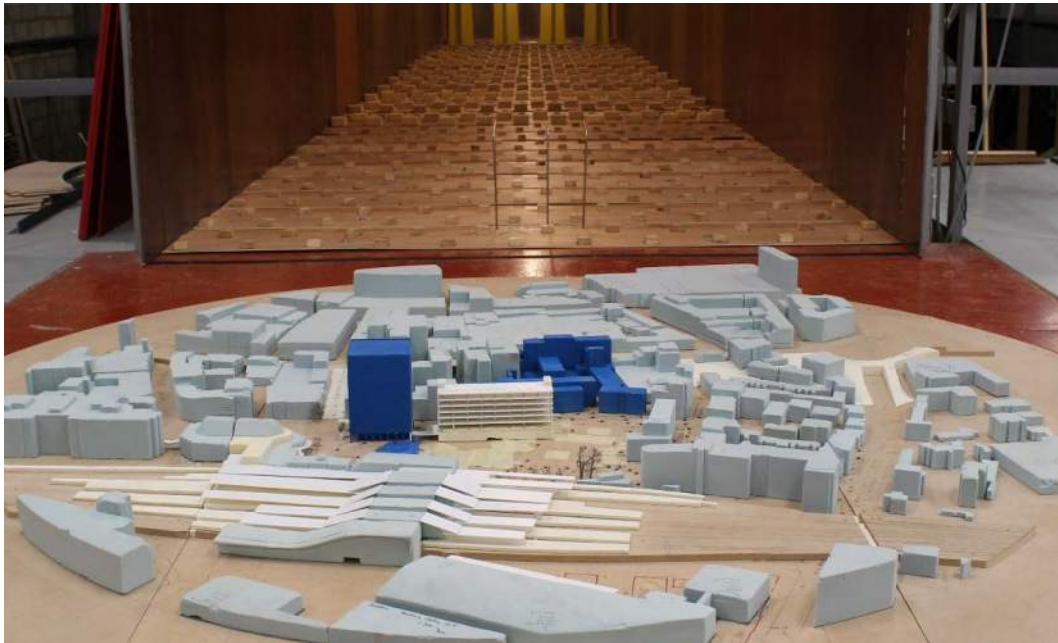
**Figure 33: Existing Site with the Existing Surrounding Buildings – View in the Wind Tunnel (from the north)**

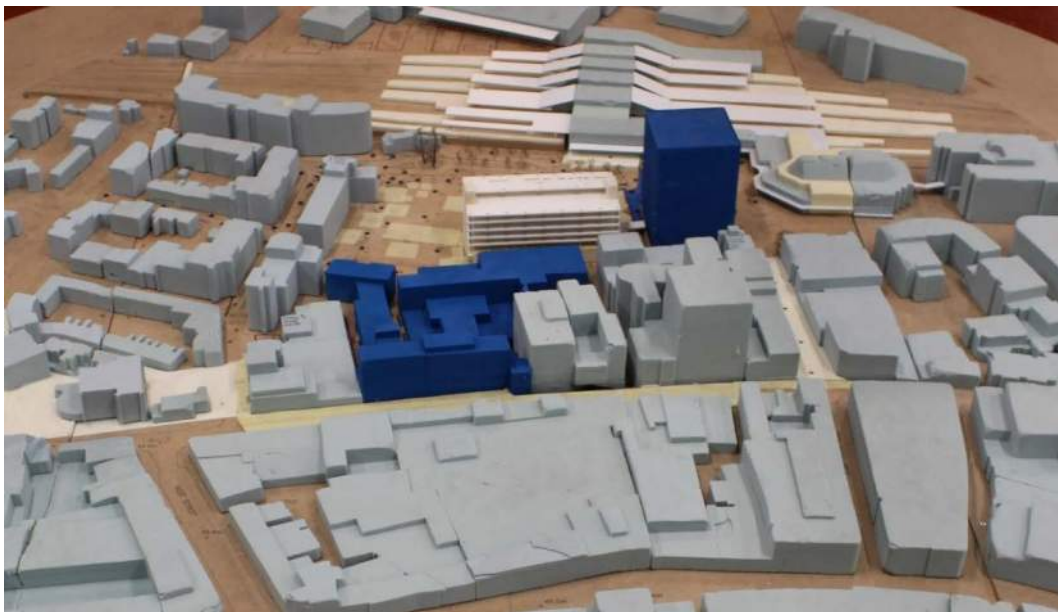
**Figure 34: Existing Site with the Existing Surrounding Buildings – View in the Wind Tunnel (from the south)**

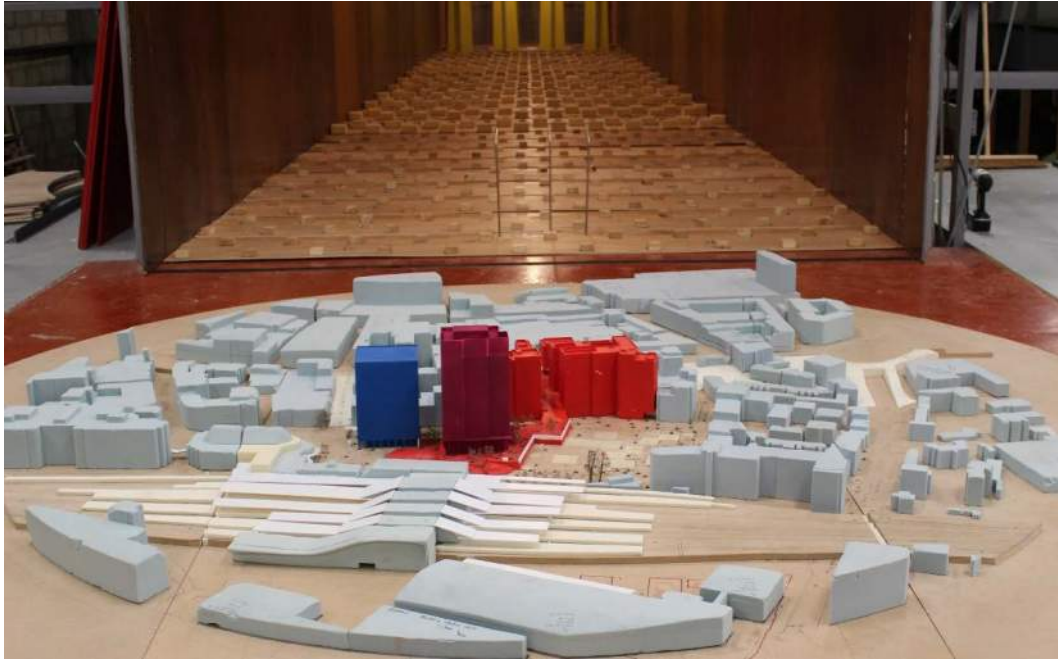
**Figure 35: Interim Development Scenario with Landscaping and the Existing Surrounding Buildings – View in the Wind Tunnel (from the north)**

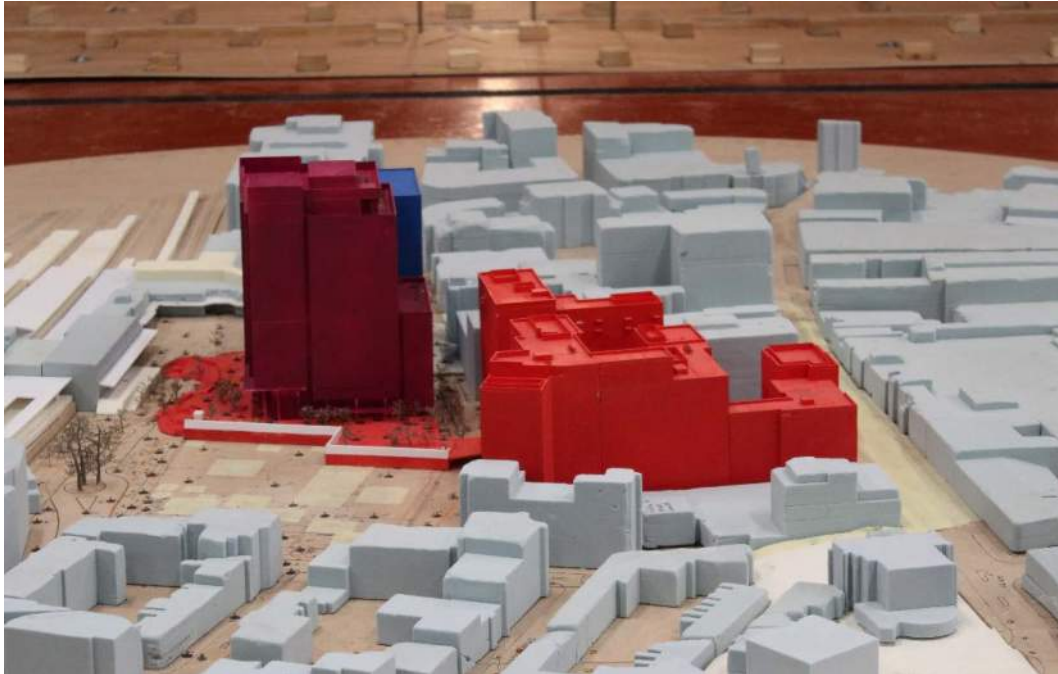
**Figure 36: Interim Development Scenario with Landscaping and the Existing Surrounding Buildings – View in the Wind Tunnel (from the west)**

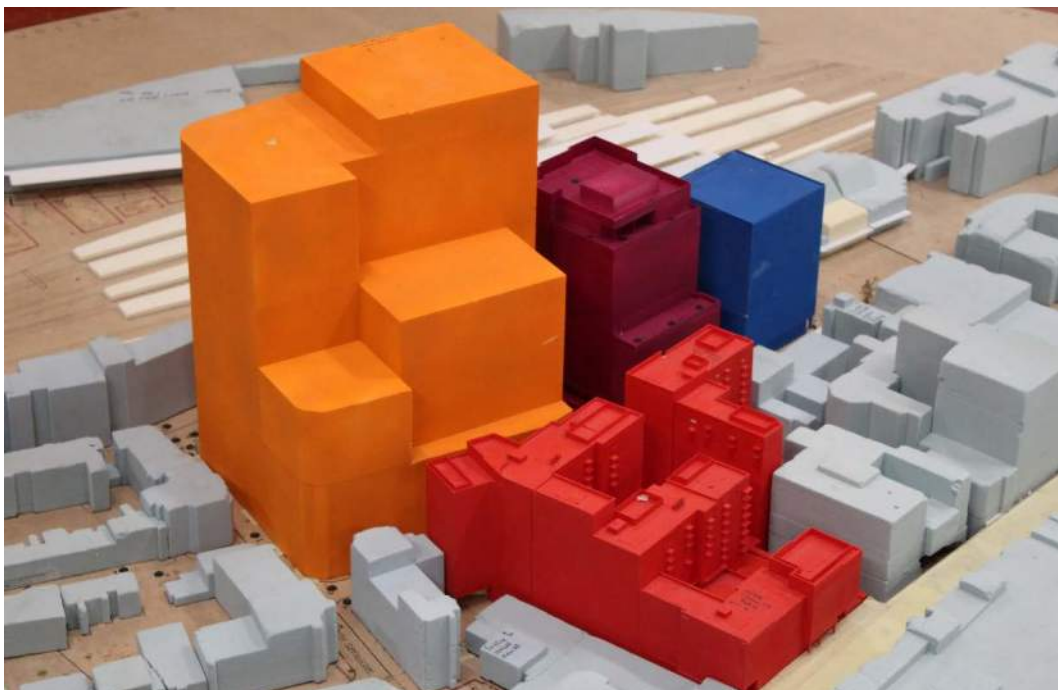
**Figure 38: Maximum Parameter Development with the Existing Surrounding Buildings – View in the Wind Tunnel (from the south-west)**

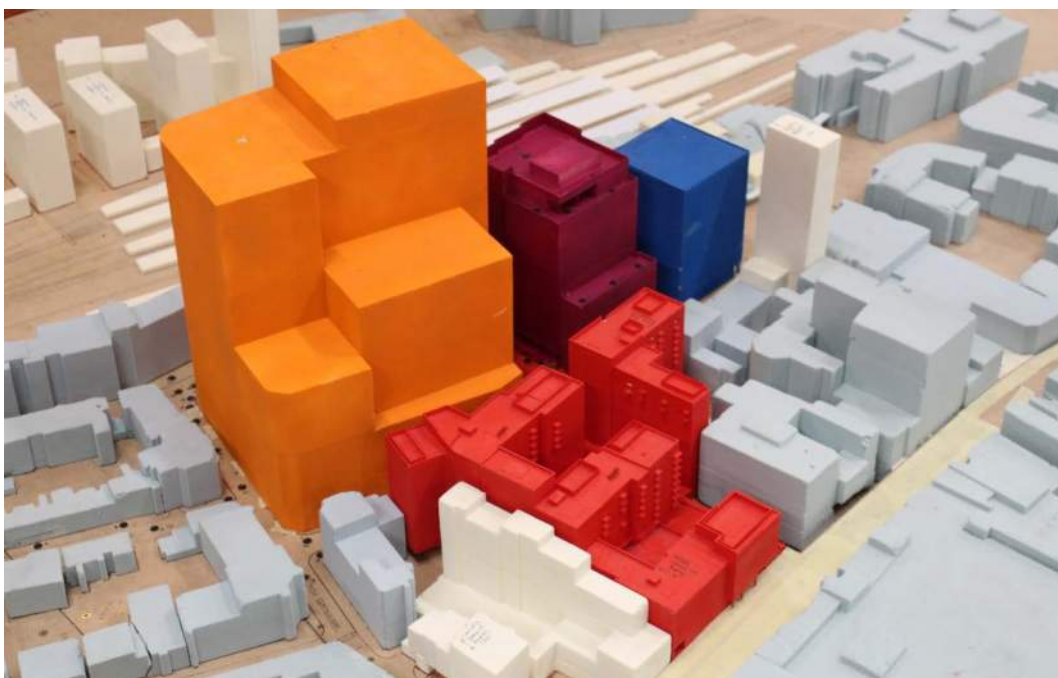
**Figure 40: Proposed Development with Landscaping, Embedded Mitigation and the Cumulative Surrounding Buildings – View in the Wind Tunnel (from the south-west)**

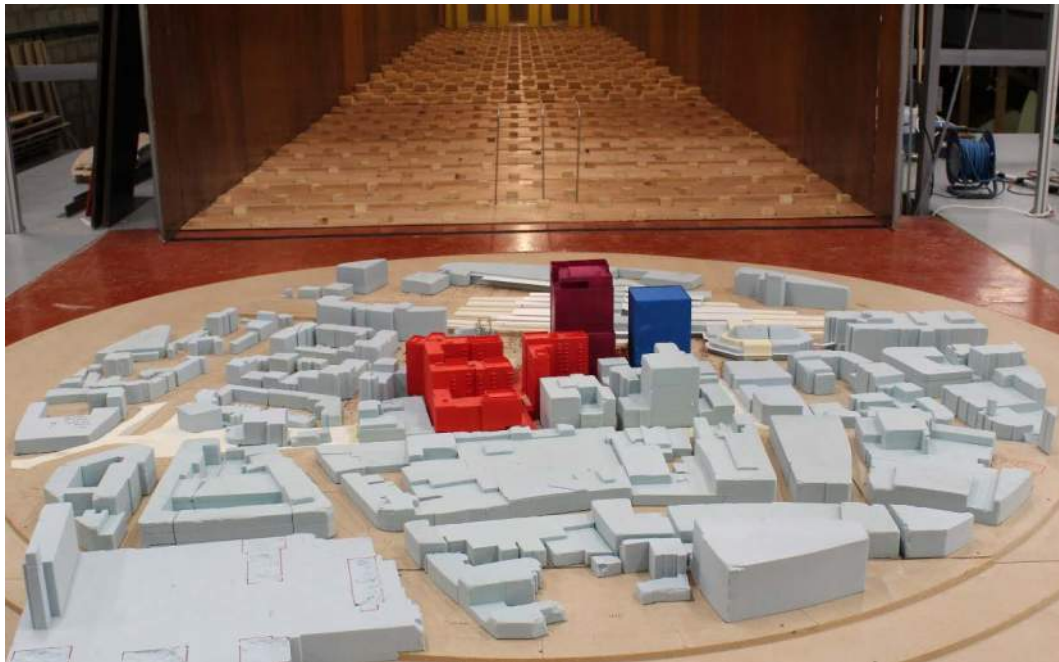
**Figure 41: Interim Development Scenario with Landscaping, Wind Mitigation and the Existing Surrounding Buildings – View in the Wind Tunnel (from the south)**

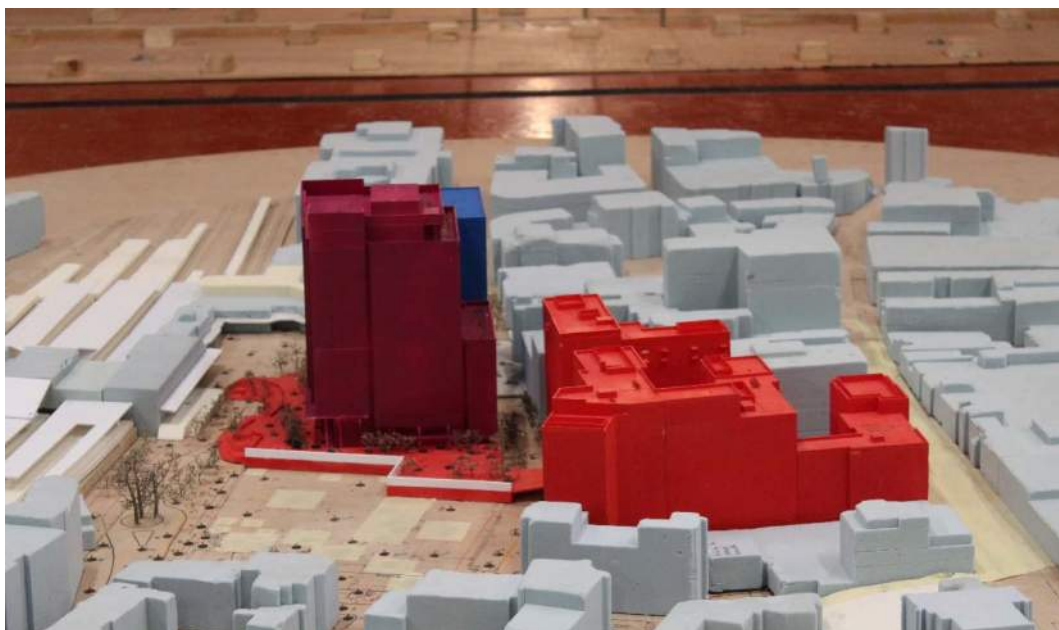
**Figure 42: Interim Development Scenario with Landscaping, Wind Mitigation and the Existing Surrounding Buildings – View in the Wind Tunnel (from the west)**

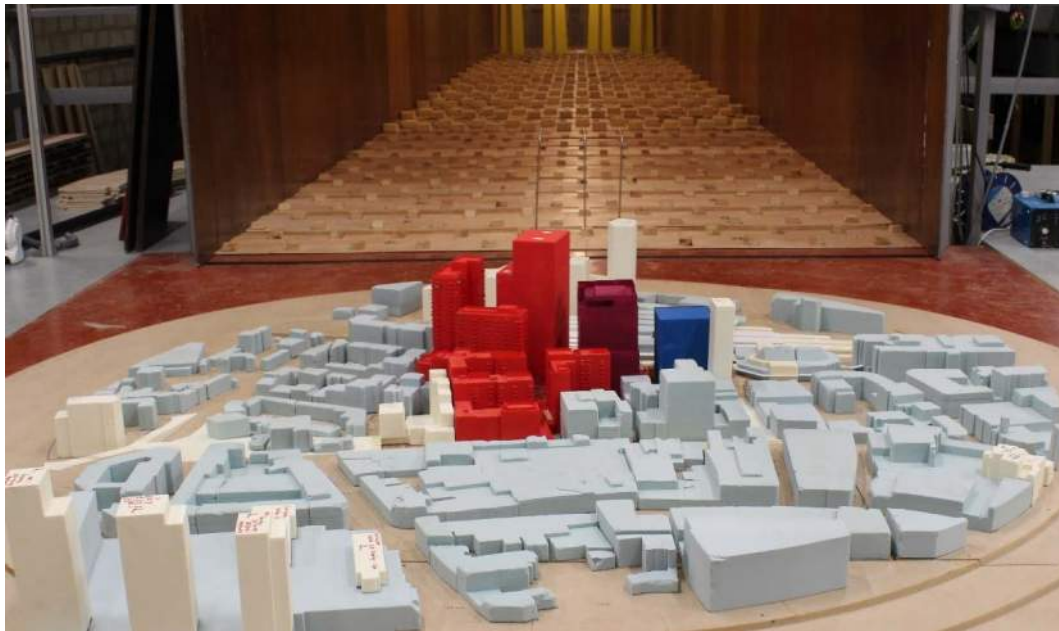
**Figure 43: Development Option 1 with Landscaping, Wind Mitigation and the Cumulative Surrounding Buildings – View in the Wind Tunnel (from the south)**

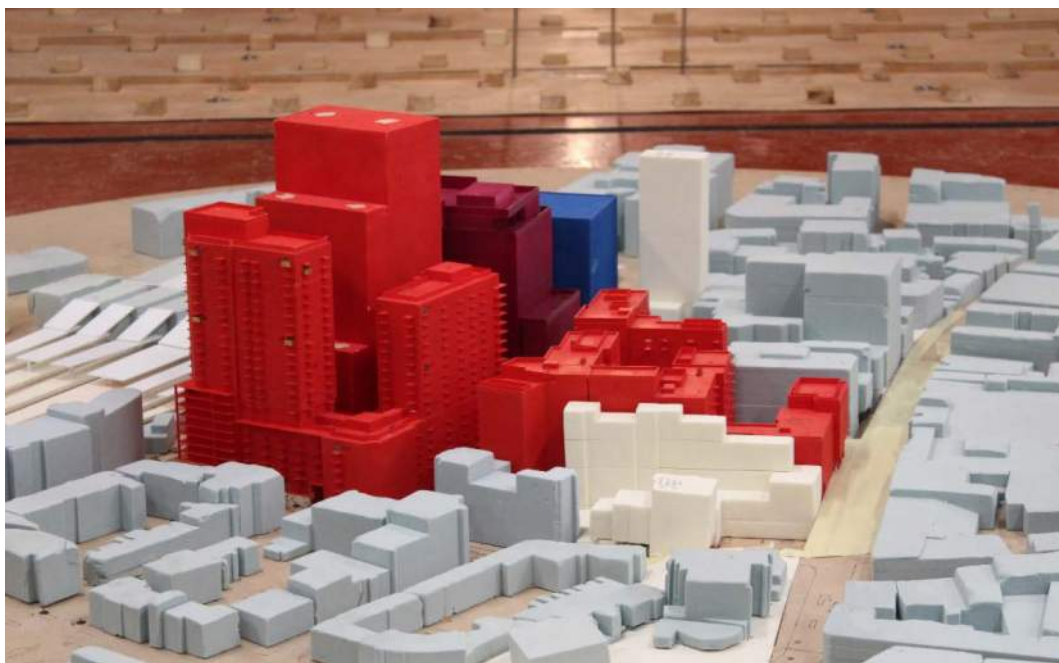
**Figure 44: Development Option 1 with Landscaping, Wind Mitigation and the Cumulative Surrounding Buildings – View in the Wind Tunnel (from the south-west)**

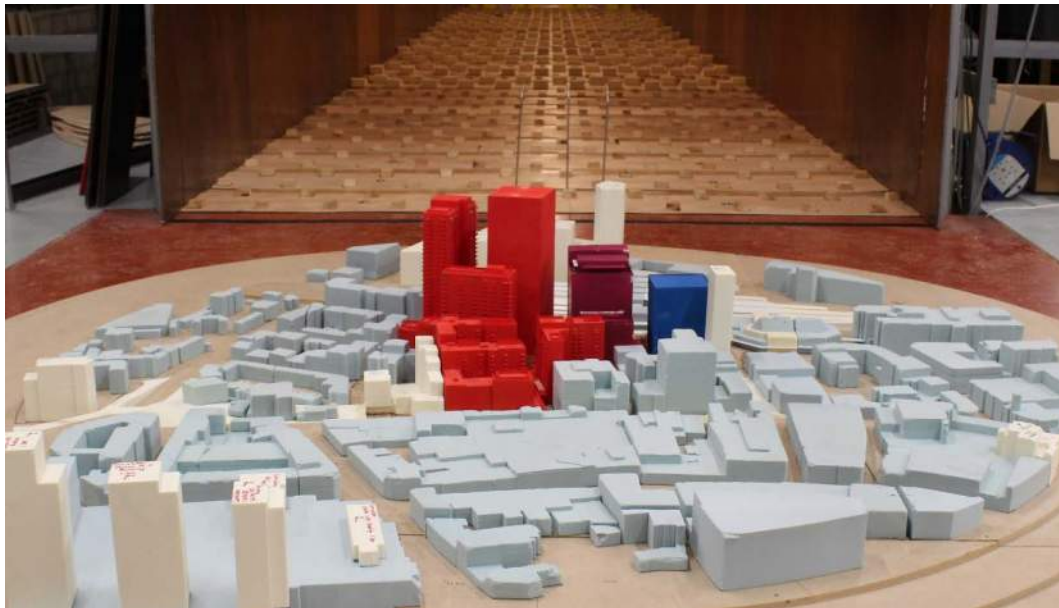
**Figure 45: Development Option 2 with Landscaping, Wind Mitigation and the Cumulative Surrounding Buildings – View in the Wind Tunnel (from the south)**

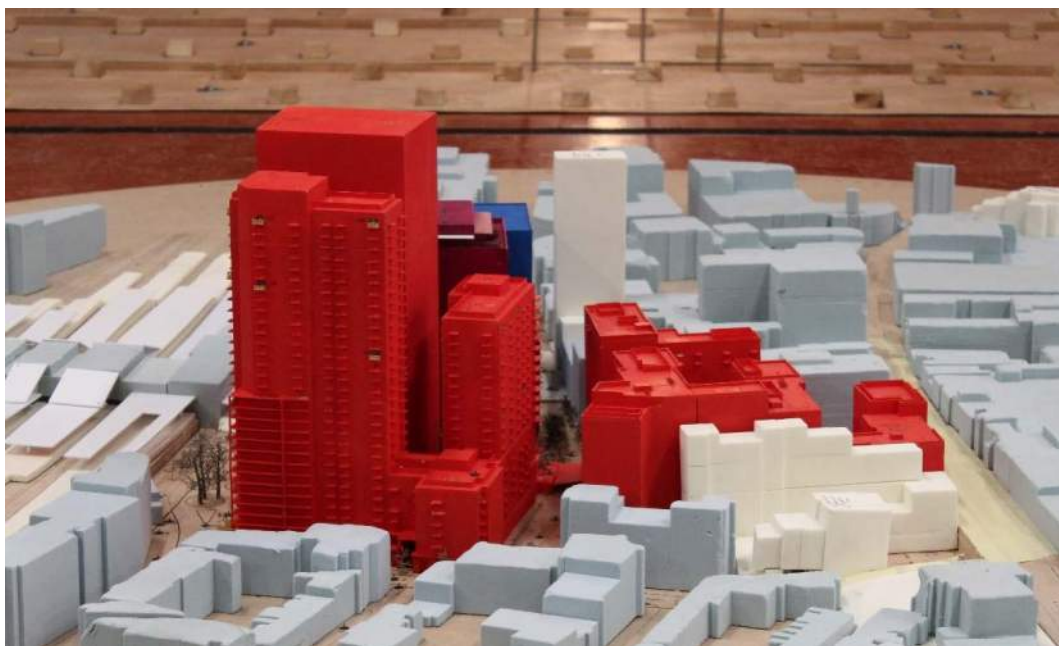
**Figure 46: Development Option 2 with Landscaping, Wind Mitigation and the Cumulative Surrounding Buildings – View in the Wind Tunnel (from the south-west)**

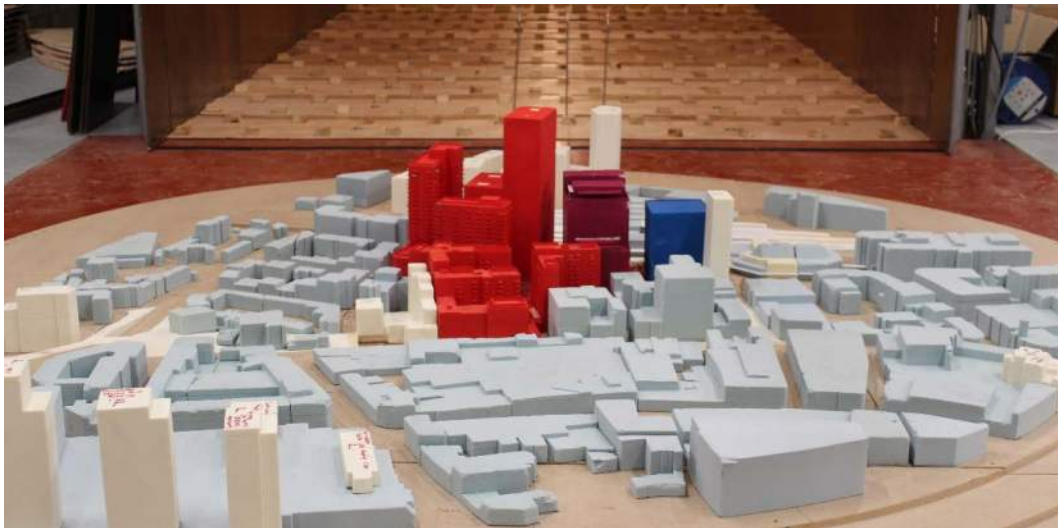
**Figure 47: Development Option 3 with Landscaping, Wind Mitigation and the Cumulative Surrounding Buildings – View in the Wind Tunnel (from the south)**

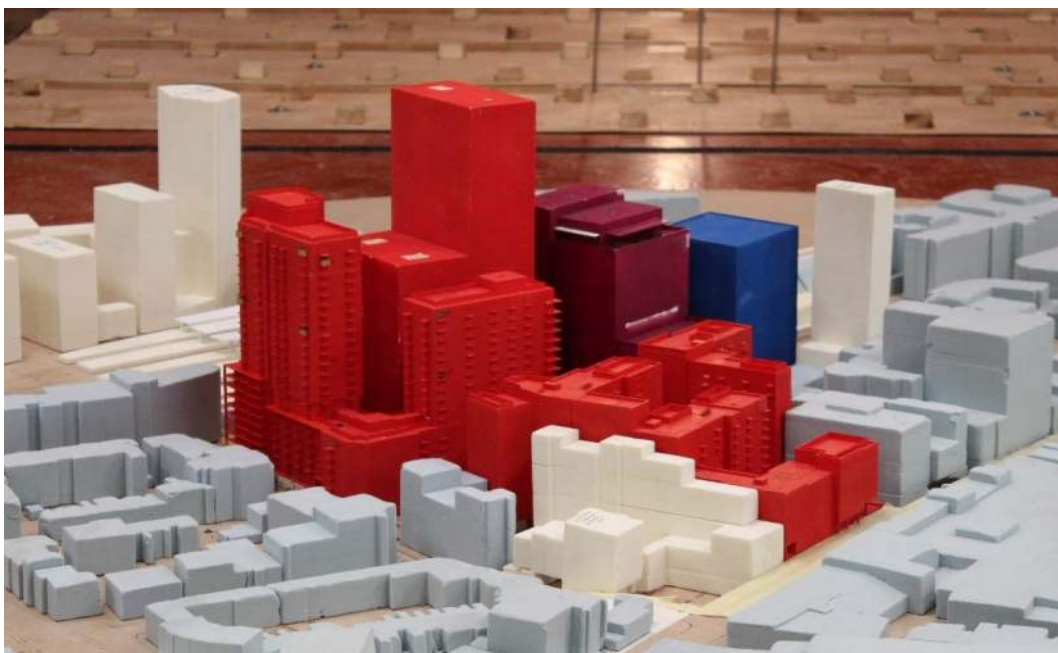
**Figure 48: Development Option 3 with Landscaping, Wind Mitigation and the Cumulative Surrounding Buildings – View in the Wind Tunnel (from the south-west)**

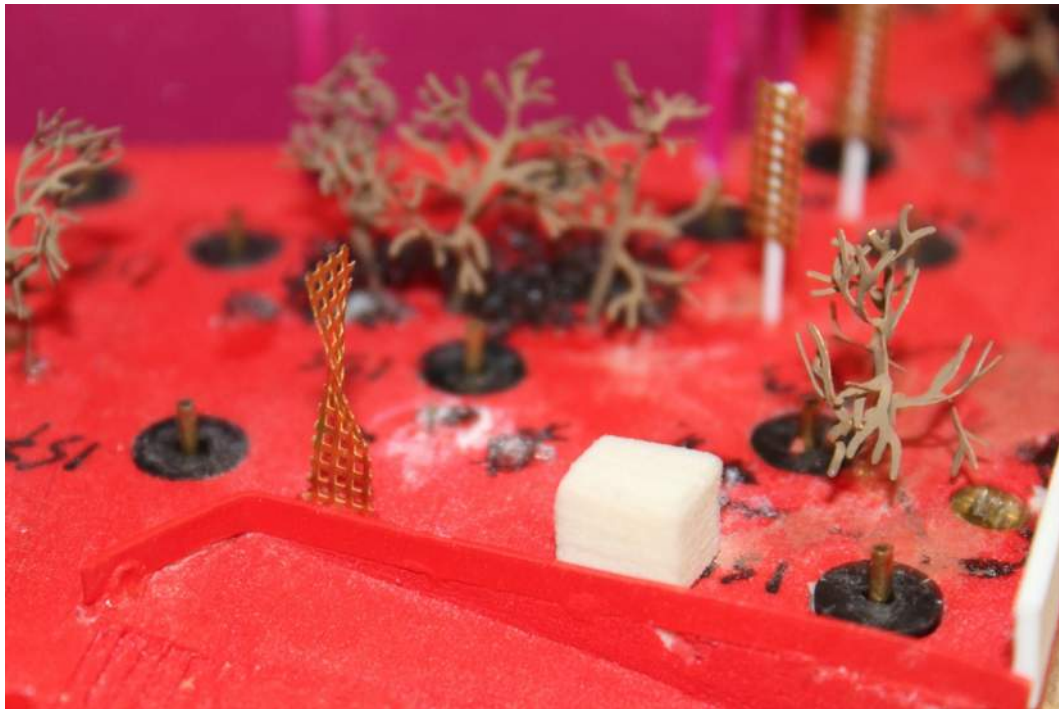
**Figure 50: Interim Development Scenario – Sculpture, 7m tall by 2m nominal width, approximately 50% overall porosity, located south of western podium access stairs**

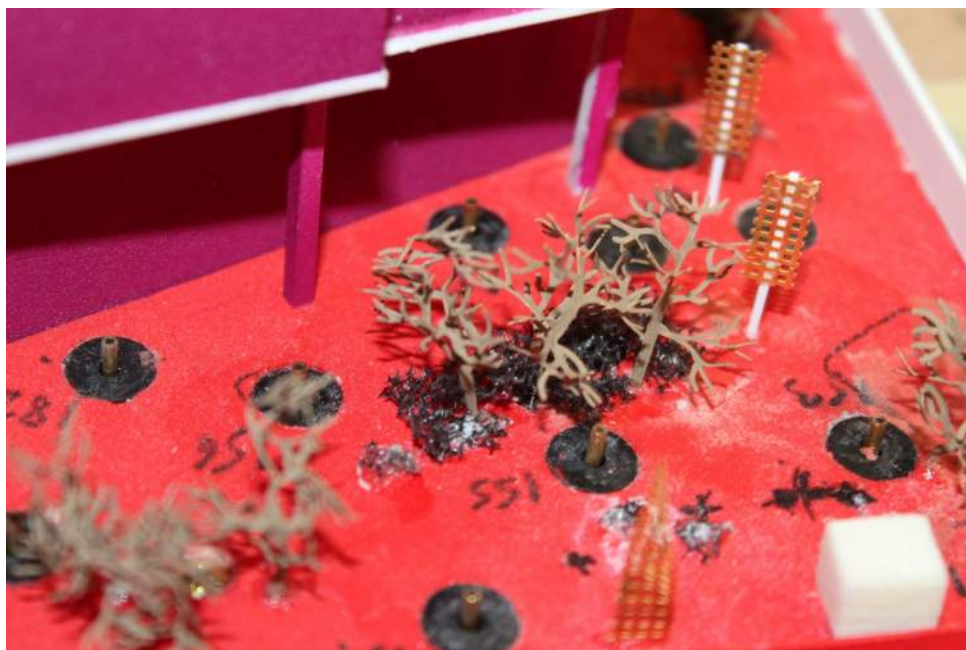
**Figure 51: Interim Development Scenario – Planter north of north-western corner of Plot G moved west by 3m with additional 7m tall tree, 1.5m height dense planting and two elevated porous (approximately 50% open) screens**

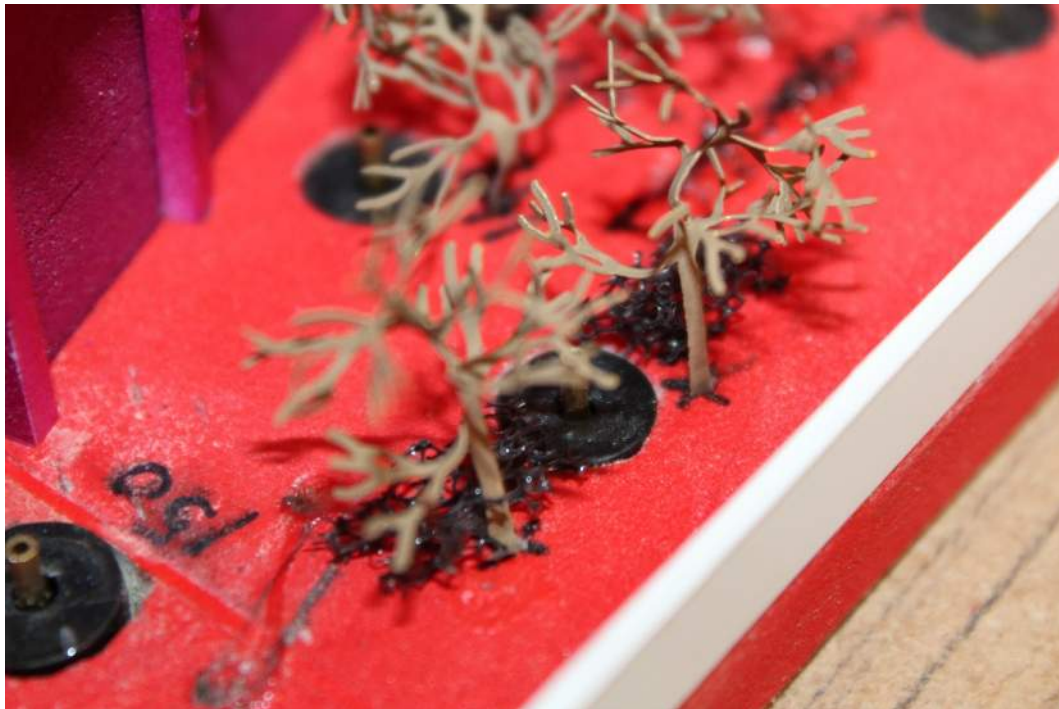
**Figure 52: Interim Development Scenario – Two 7m tall deciduous trees added to the north and the south of the intended route to the Plot C entrance with 1.5m tall dense planting**

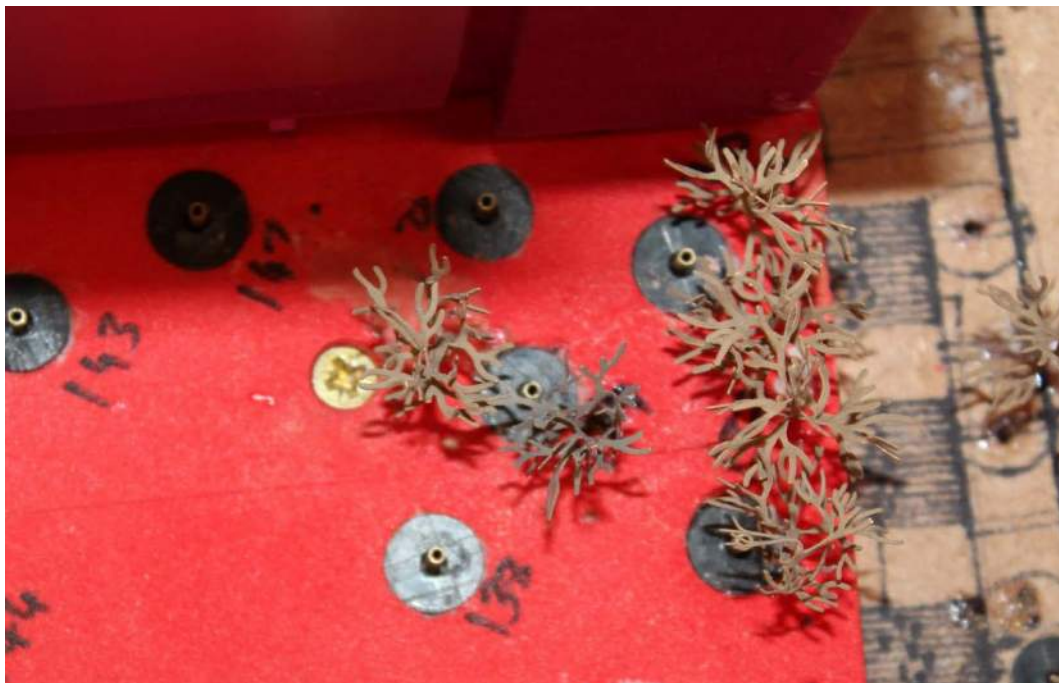
**Figure 53: Interim Development Scenario – Three 7m tall deciduous trees added along southern edge of podium at south-western corner of Plot G**

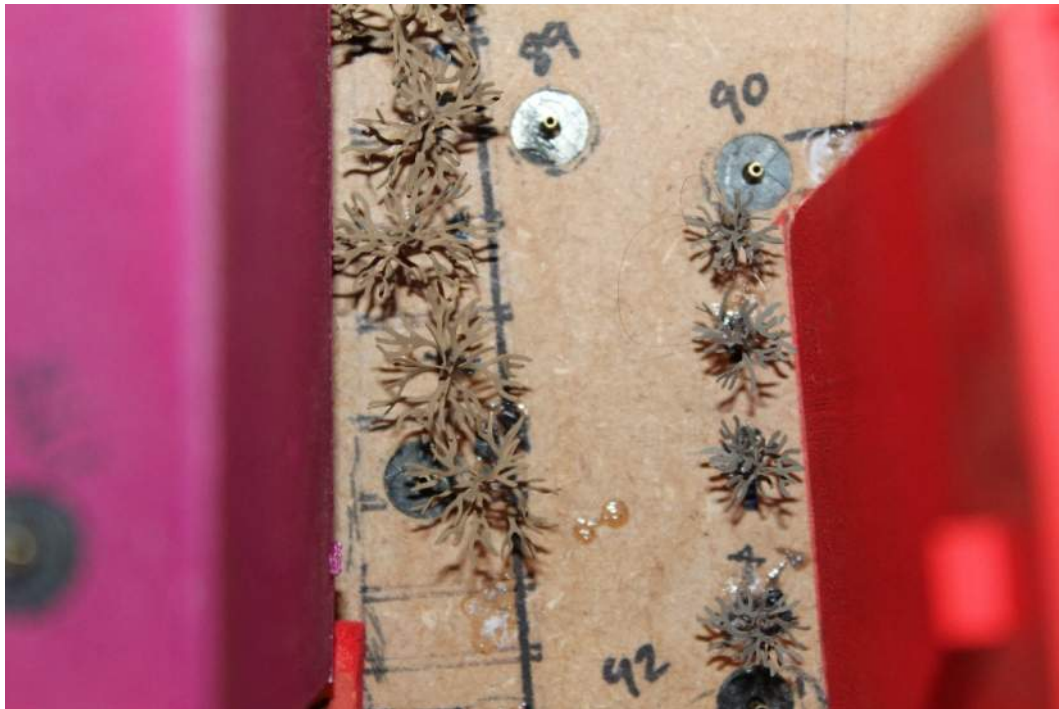
**Figure 54: Interim Development Scenario – Three 7m tall deciduous trees added north of proposed loading bay on northern side and two 5m tall deciduous trees in planters between proposed Phase 1 trees on southern side of Garrard Street west of Merchant's Place**

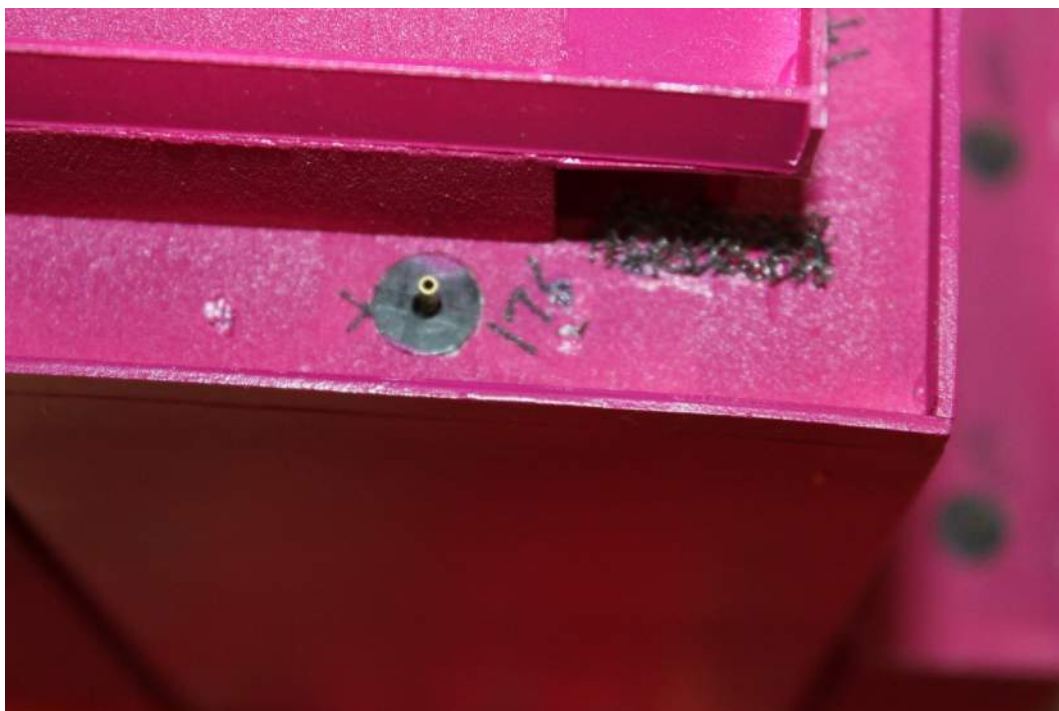
**Figure 55: Interim Development Scenario – Dense planting on upper terrace, 1.5m in height**

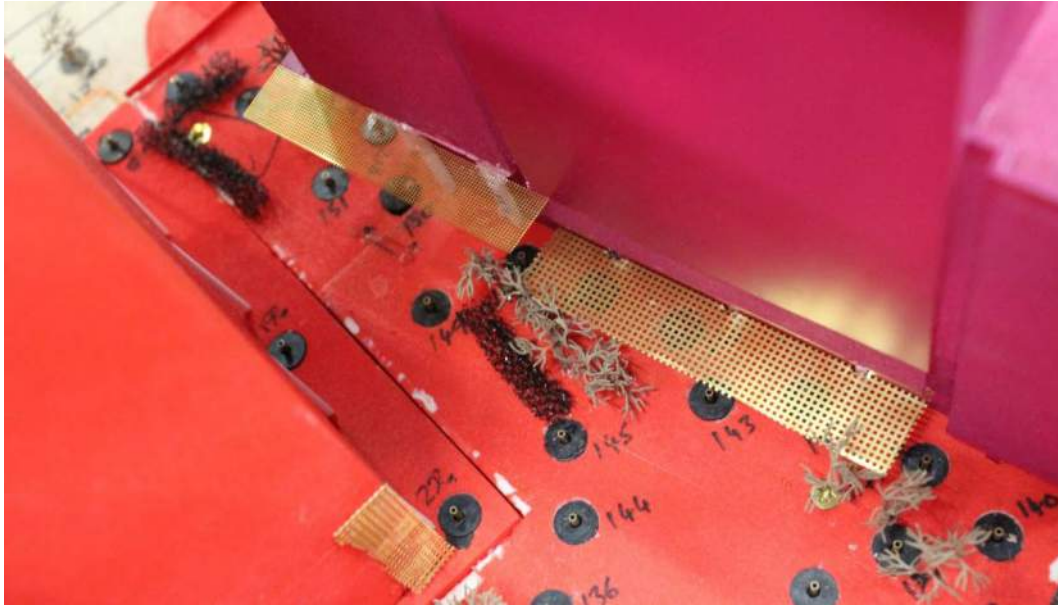
**Figure 56: Completed Development Options – Porous canopy on Plot G western elevation, full height porous (up to 50% open) screening at southern end of Plot C undercut and dense planting bordering amenity/landscaping areas to west of Plot C**

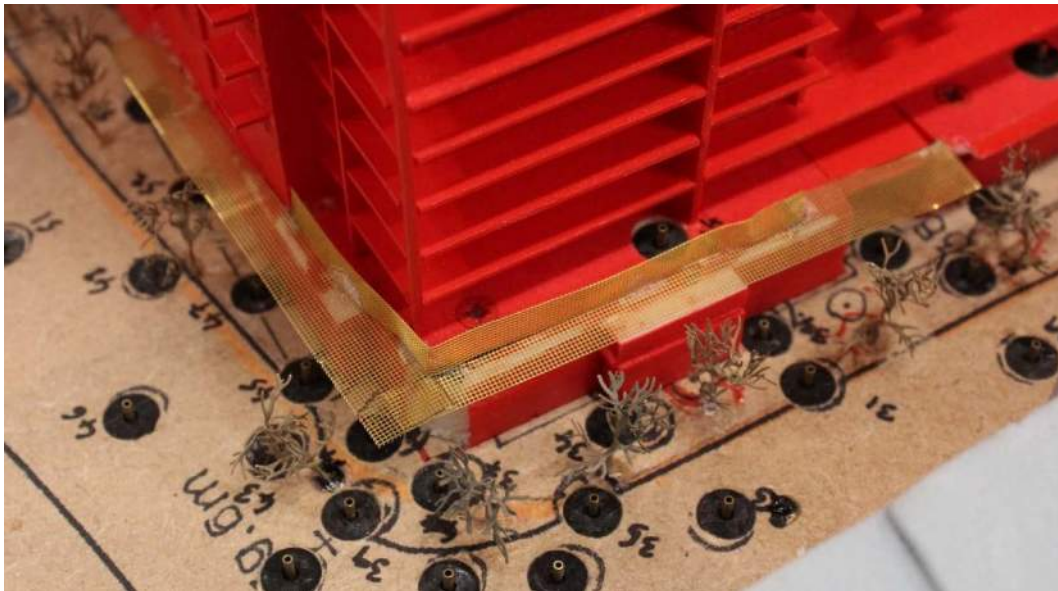
**Figure 57: Completed Development Options – Porous canopy around north-western corner of Plot A, chamfer at Plot A north-western corner ground floor and 1.5m tall porous (up to 50% open) balustrade**

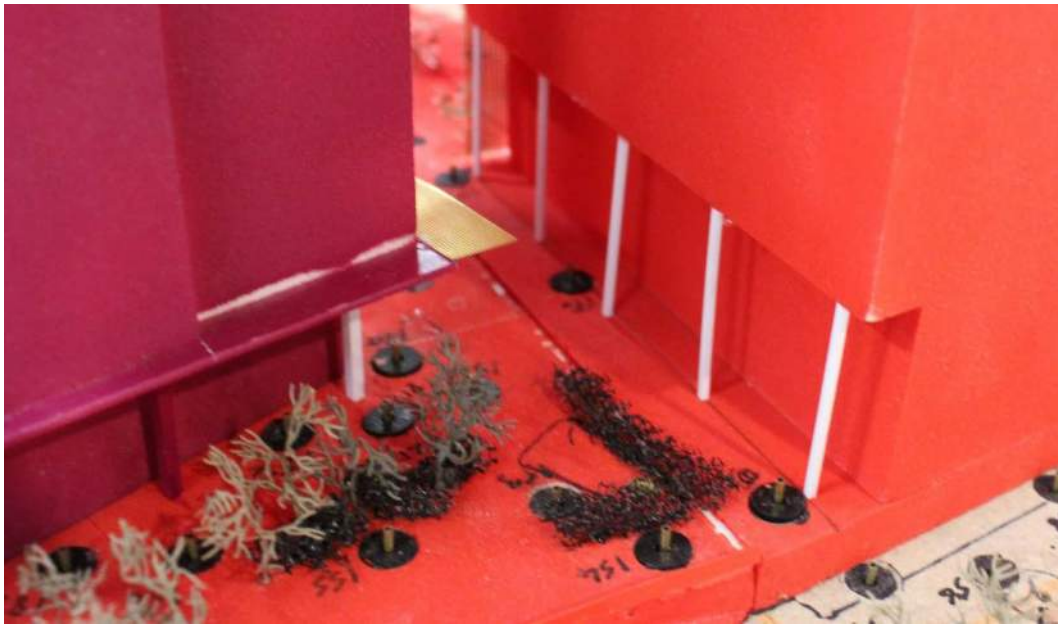
**Figure 58: Completed Development Options – Dense planting backing amenity spaces between Plot A and Plot C**

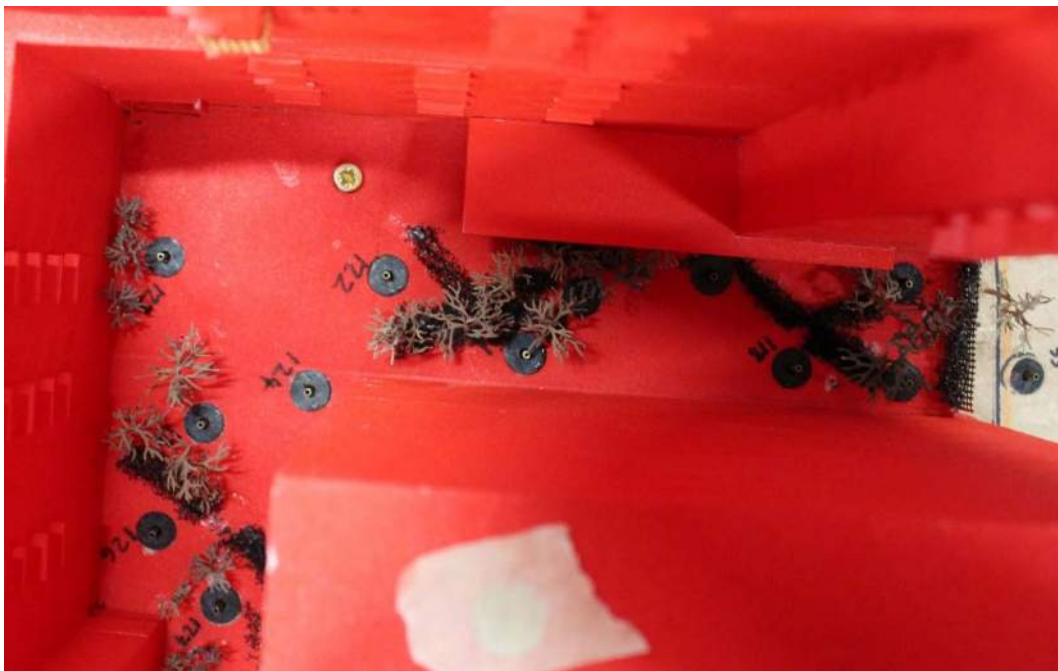
**Figure 59: Completed Development Options –Dense planting at northern edge of podium between Plot A and Plot C and between Plot C and Plot D**
