# Geotechnical and Geo- Environmental Ground Investigation Report

**Weldale Street, Reading**

**June 2019**

**DOCUMENT NUMBER:** 112990/R5

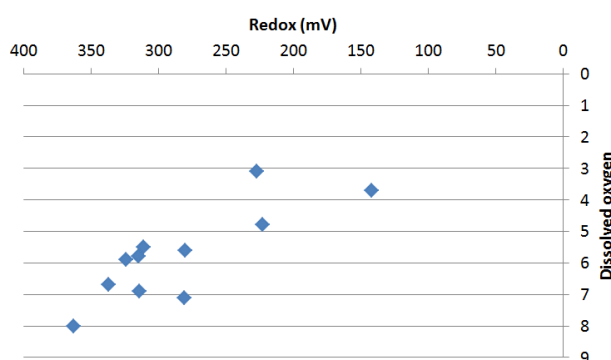
**Figure 7-1 – Redox vs dissolved oxygen found as part of the most recent monitoring event**

Monitoring found redox values within a range of approximately 140 and 360 mV, indicating degradation to generally occur under aerobic conditions<sup>10</sup>. Although, oxygen reduction rates are not prevalent to an extent, where 'reducing' conditions exist, in some areas oxygen depletion and can be observed and the depletion correlates to redox values. Some correlation between the oxygen depletion / reduced redox values and maximum concentrations of TPH CWG fractions can also be found, indicating the bulk of petroleum hydrocarbon contamination (see above Table 7 – 10) to be present in and around the area of BH1 but in and around north-eastern parts of the site. (*For the concentrations of aromatic EC12 – EC16 see also Figure 7 – 2 below*).

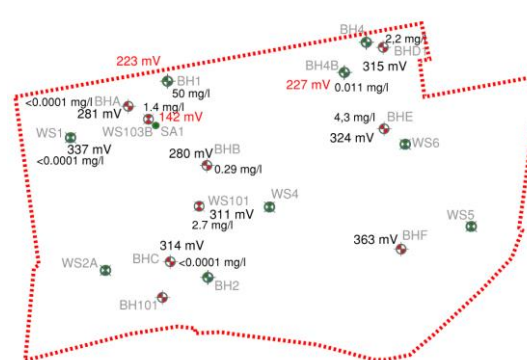
**Figure 7-2 – Redox values**

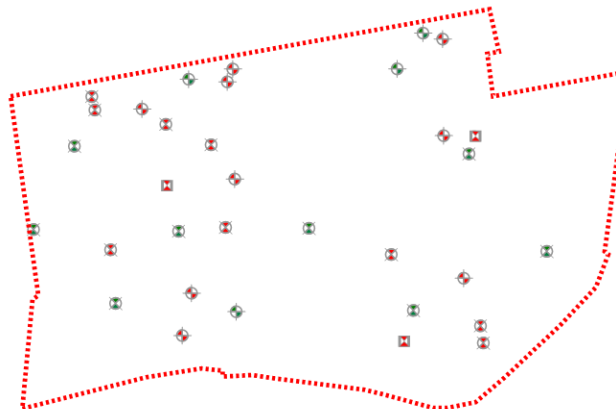
**Figure 7-3: Exploratory holes advanced over three phases of site investigations**

However, data and information obtained from approximately thirty (30) exploratory holes advanced as part of three phases of ground investigations (see Figure 7 – 3) did not reveal petroleum hydrocarbon contamination to be present at shallow depths (<4.5 m bgl). Instead, petroleum hydrocarbon contamination was invariably observed at depths near the groundwater table or beyond. As such, the point of origin of the contamination having entered the groundwater Chalk principal aquifer could not be identified.

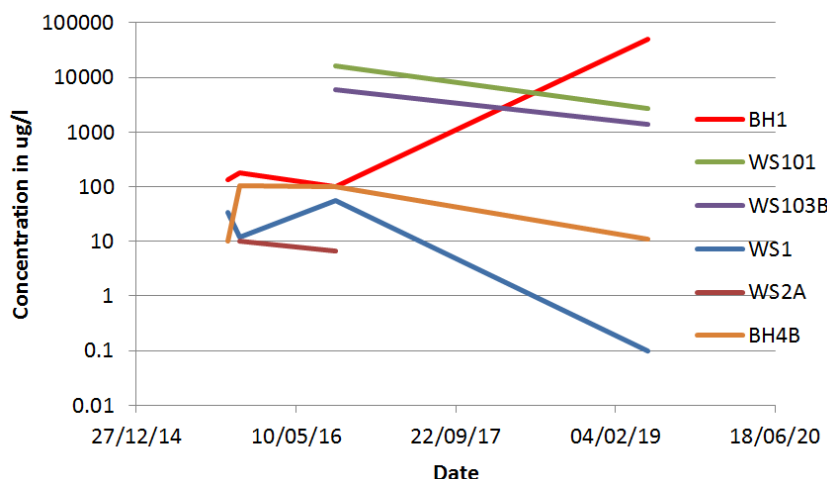
**Figure 7-4: 'Aromatic EC12-EC16' fraction results over the three phases of site investigations**

In addition, over the three site investigation phases, concentrations, including the 'aromatic EC12-EC16' fraction results have been extremely variable. In general as illustrated in Figure 7-4, concentrations of the 'aromatic EC12-EC16' fraction decreased. This is with the exception of concentration found in a sample from BH1. Here, the levels increased from a concentration near the WQS for this hydrocarbon fraction (90 µg/l) to the aforementioned value of 50,000 µg/l.

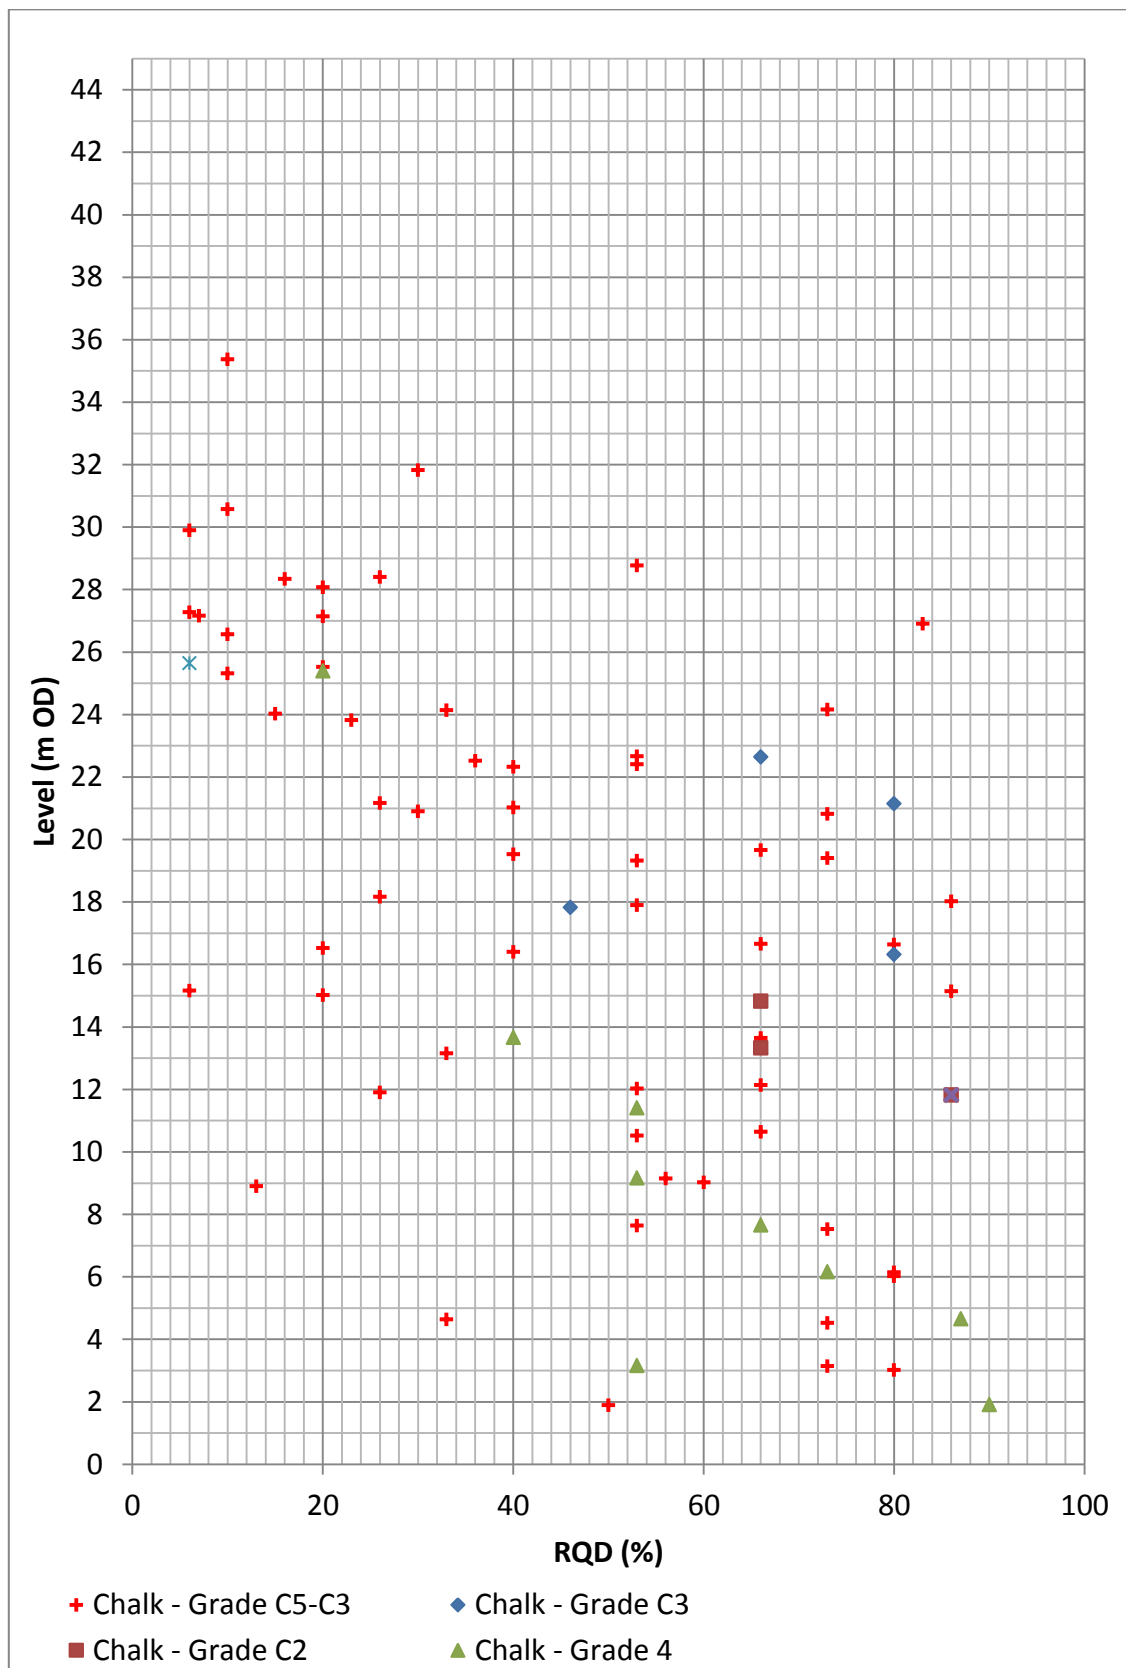
FIGURE 4 – RQD VS LEVEL (WHITE CHALK SUBGROUP)

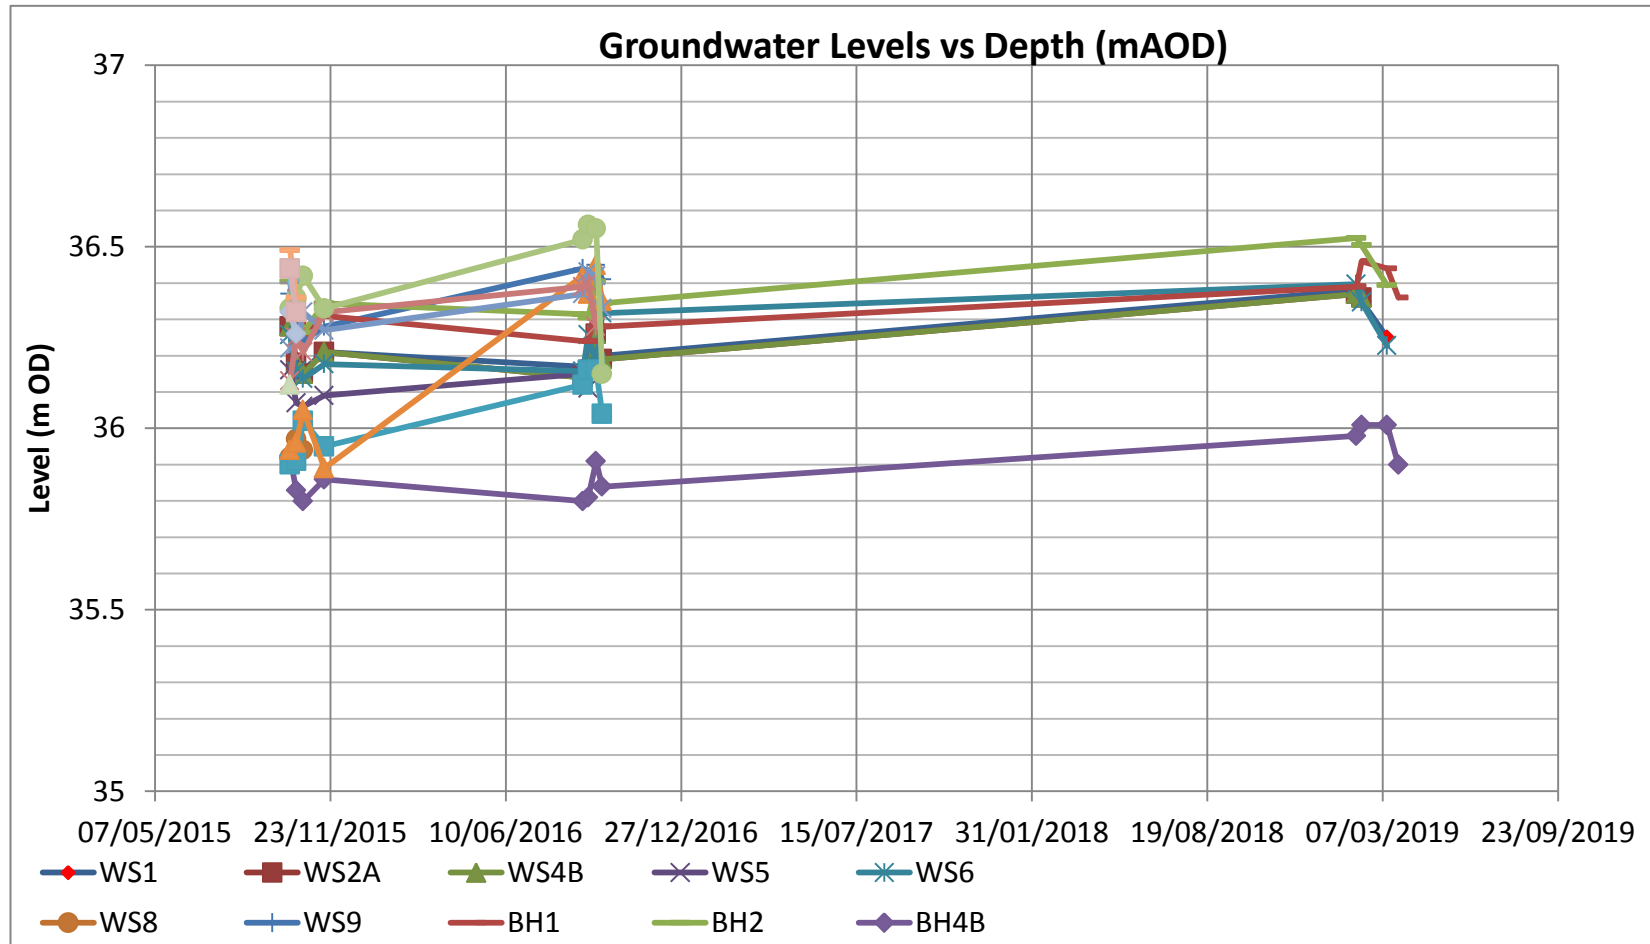
FIGURES 5 – GROUNDWATER MONITORING LEVELS VS TIME

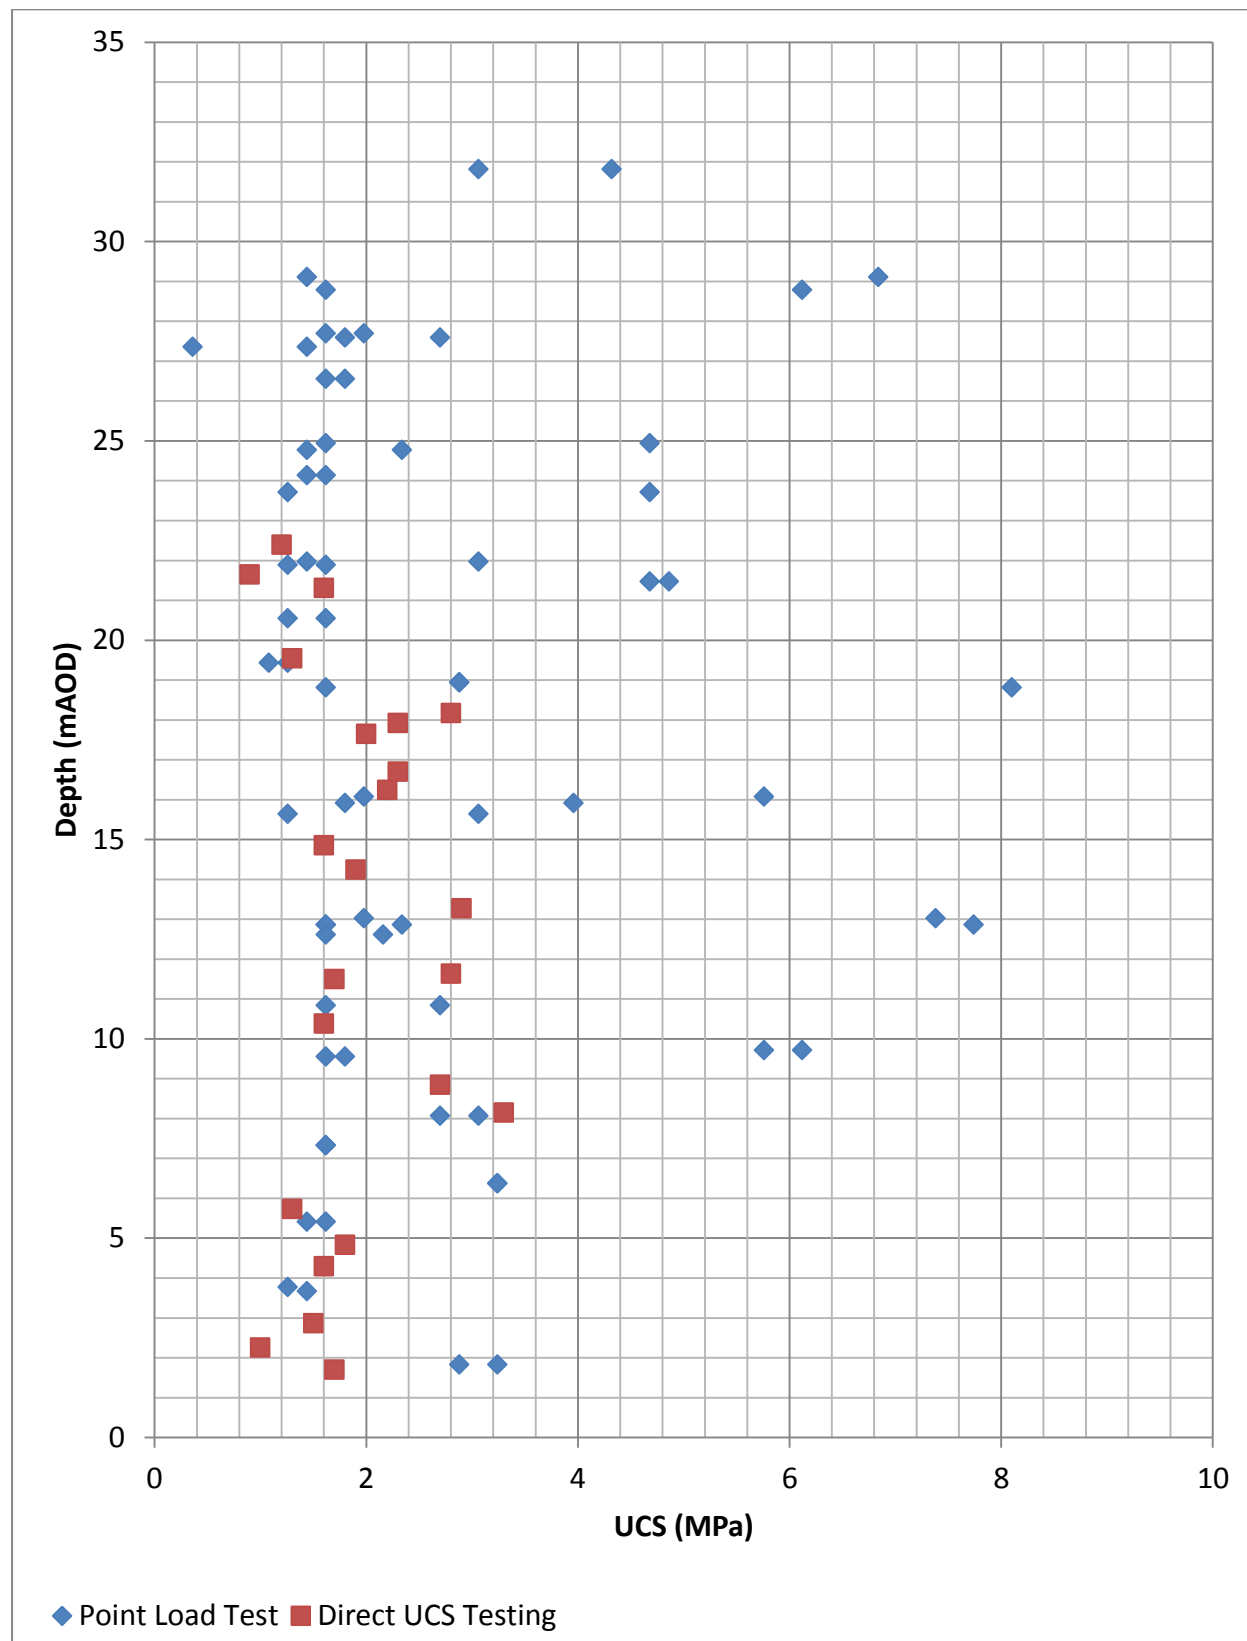
FIGURE 6 – UCS VS ELEVATION (WHITE CHALK SUBGROUP)

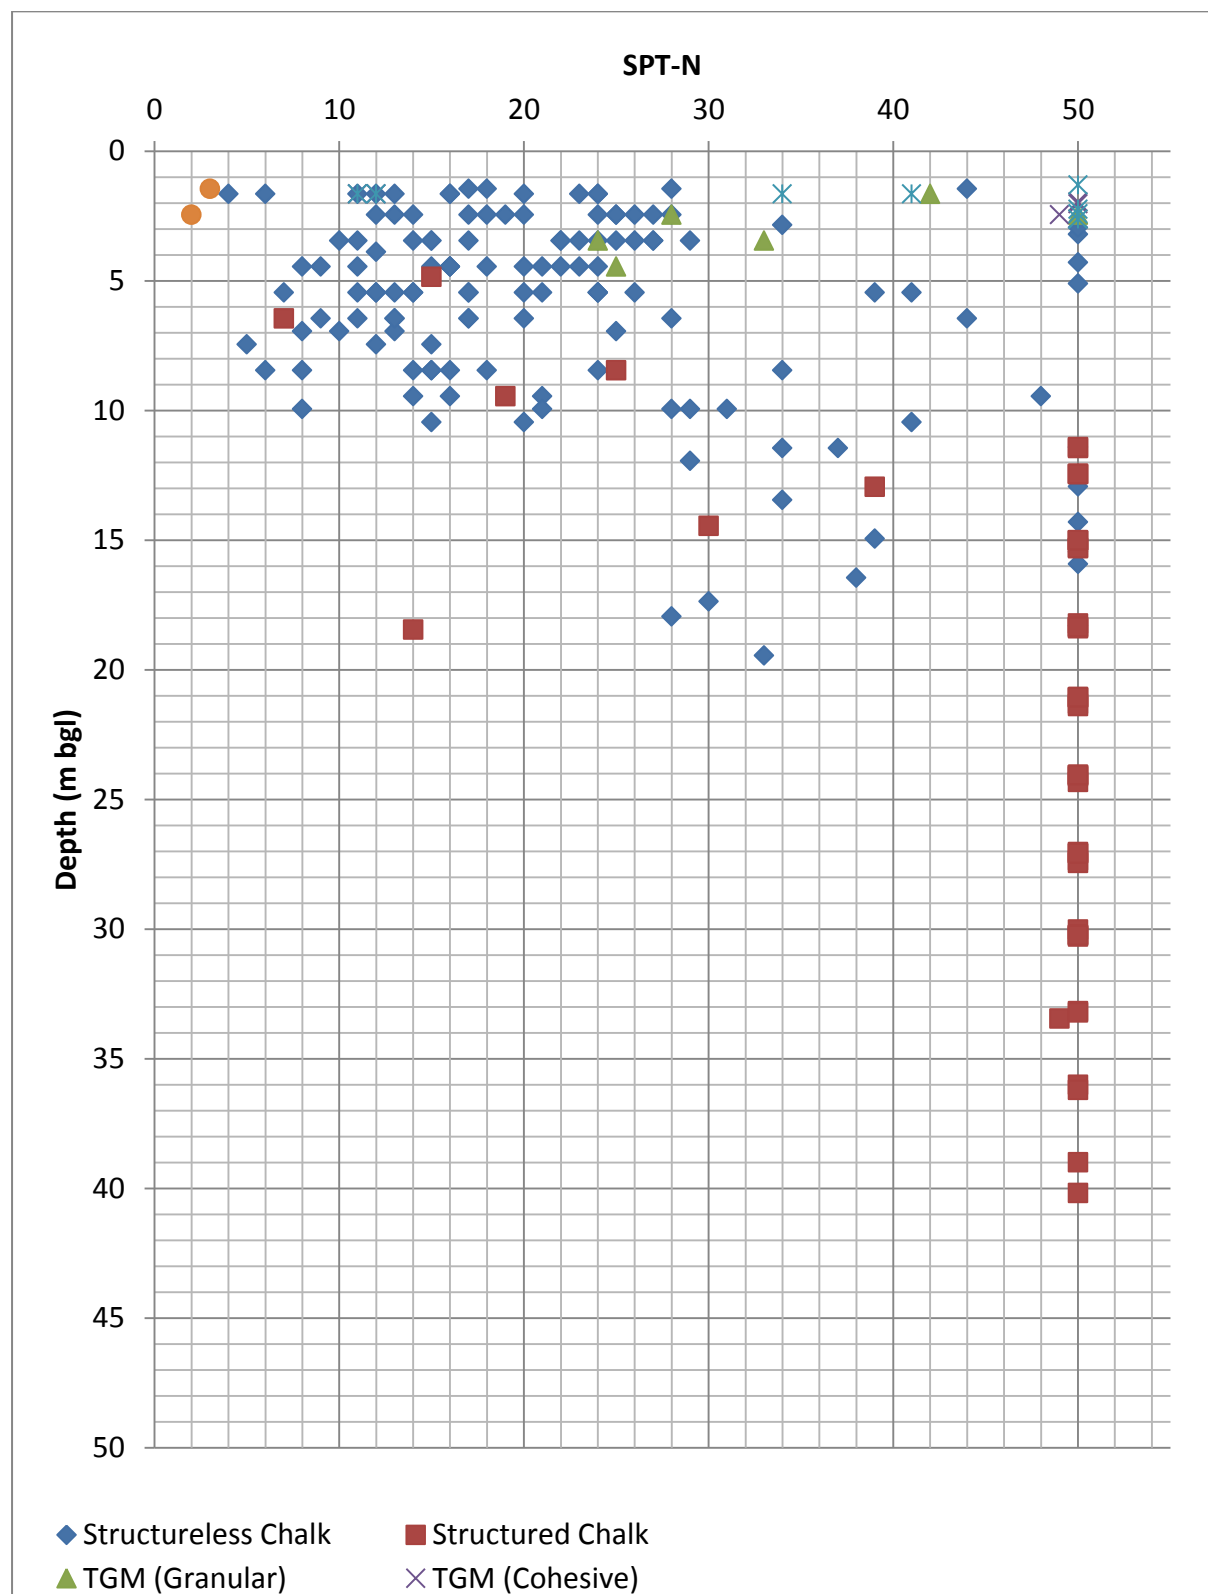
**FIGURE 7 – SPT VS DEPTH**

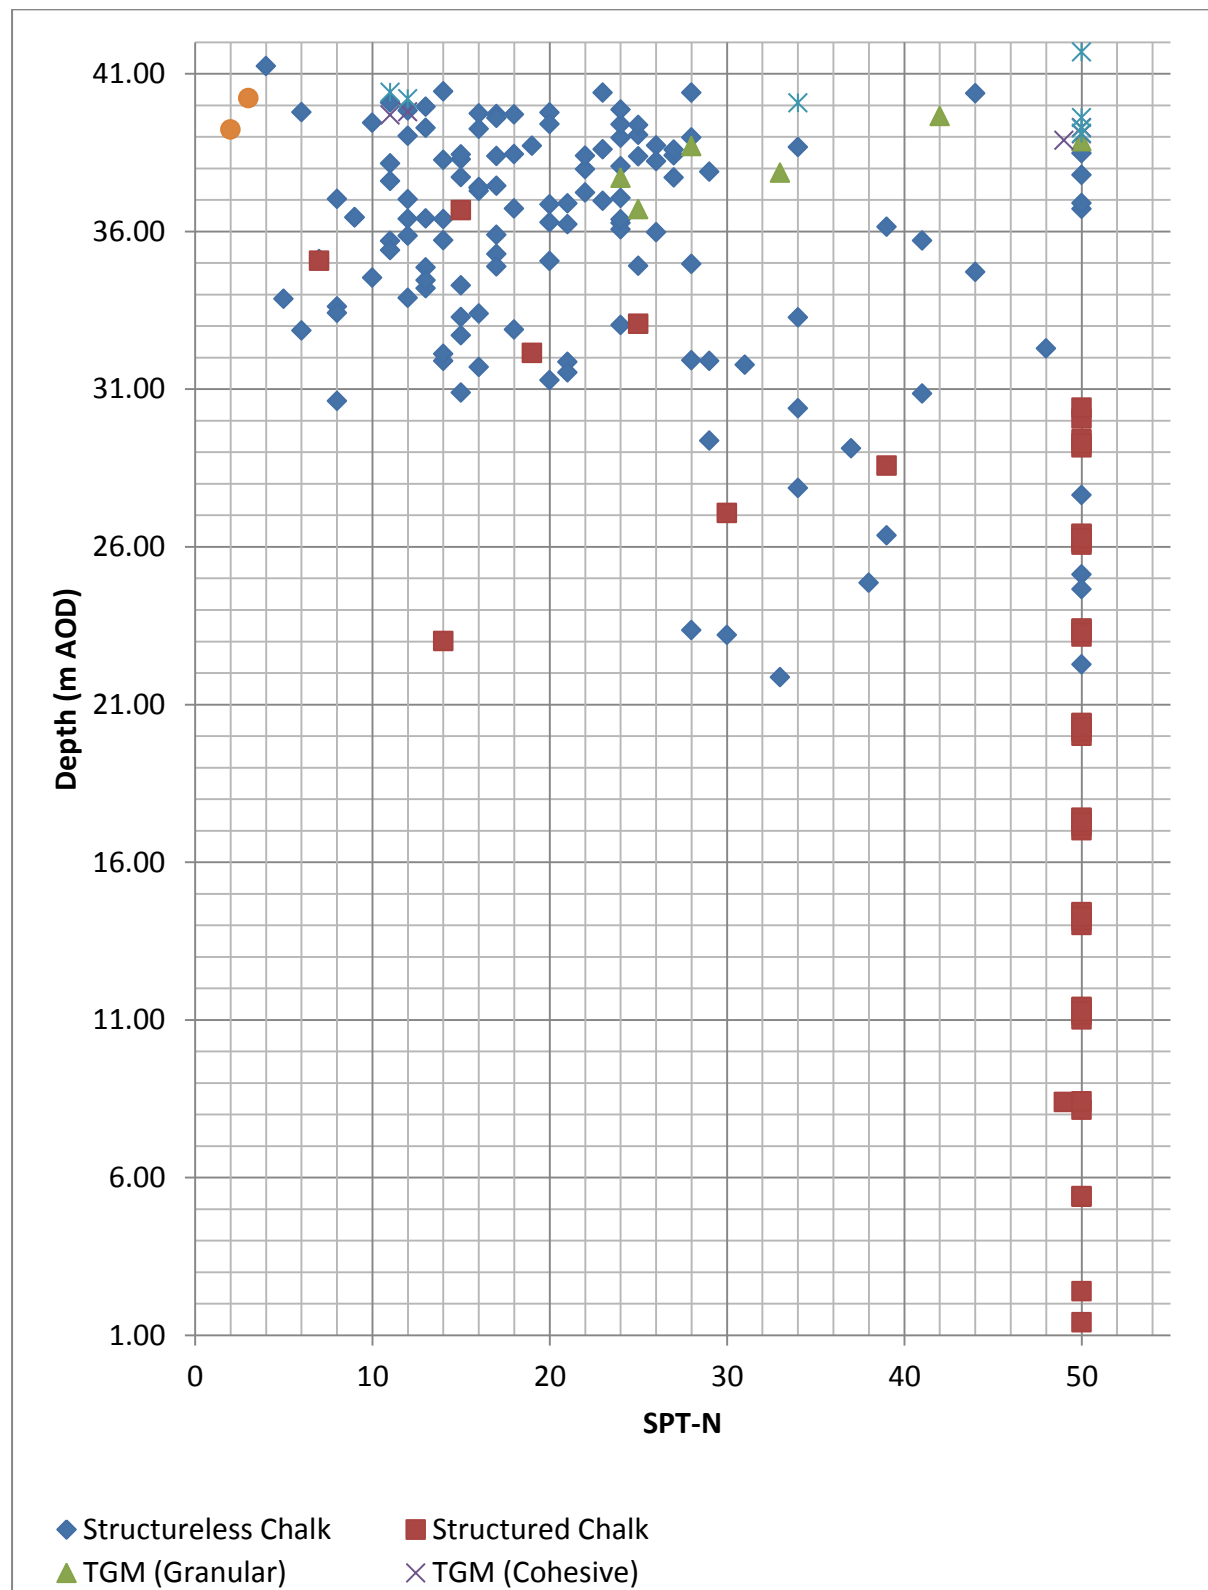
FIGURE 8 – SPT VS ELEVATION

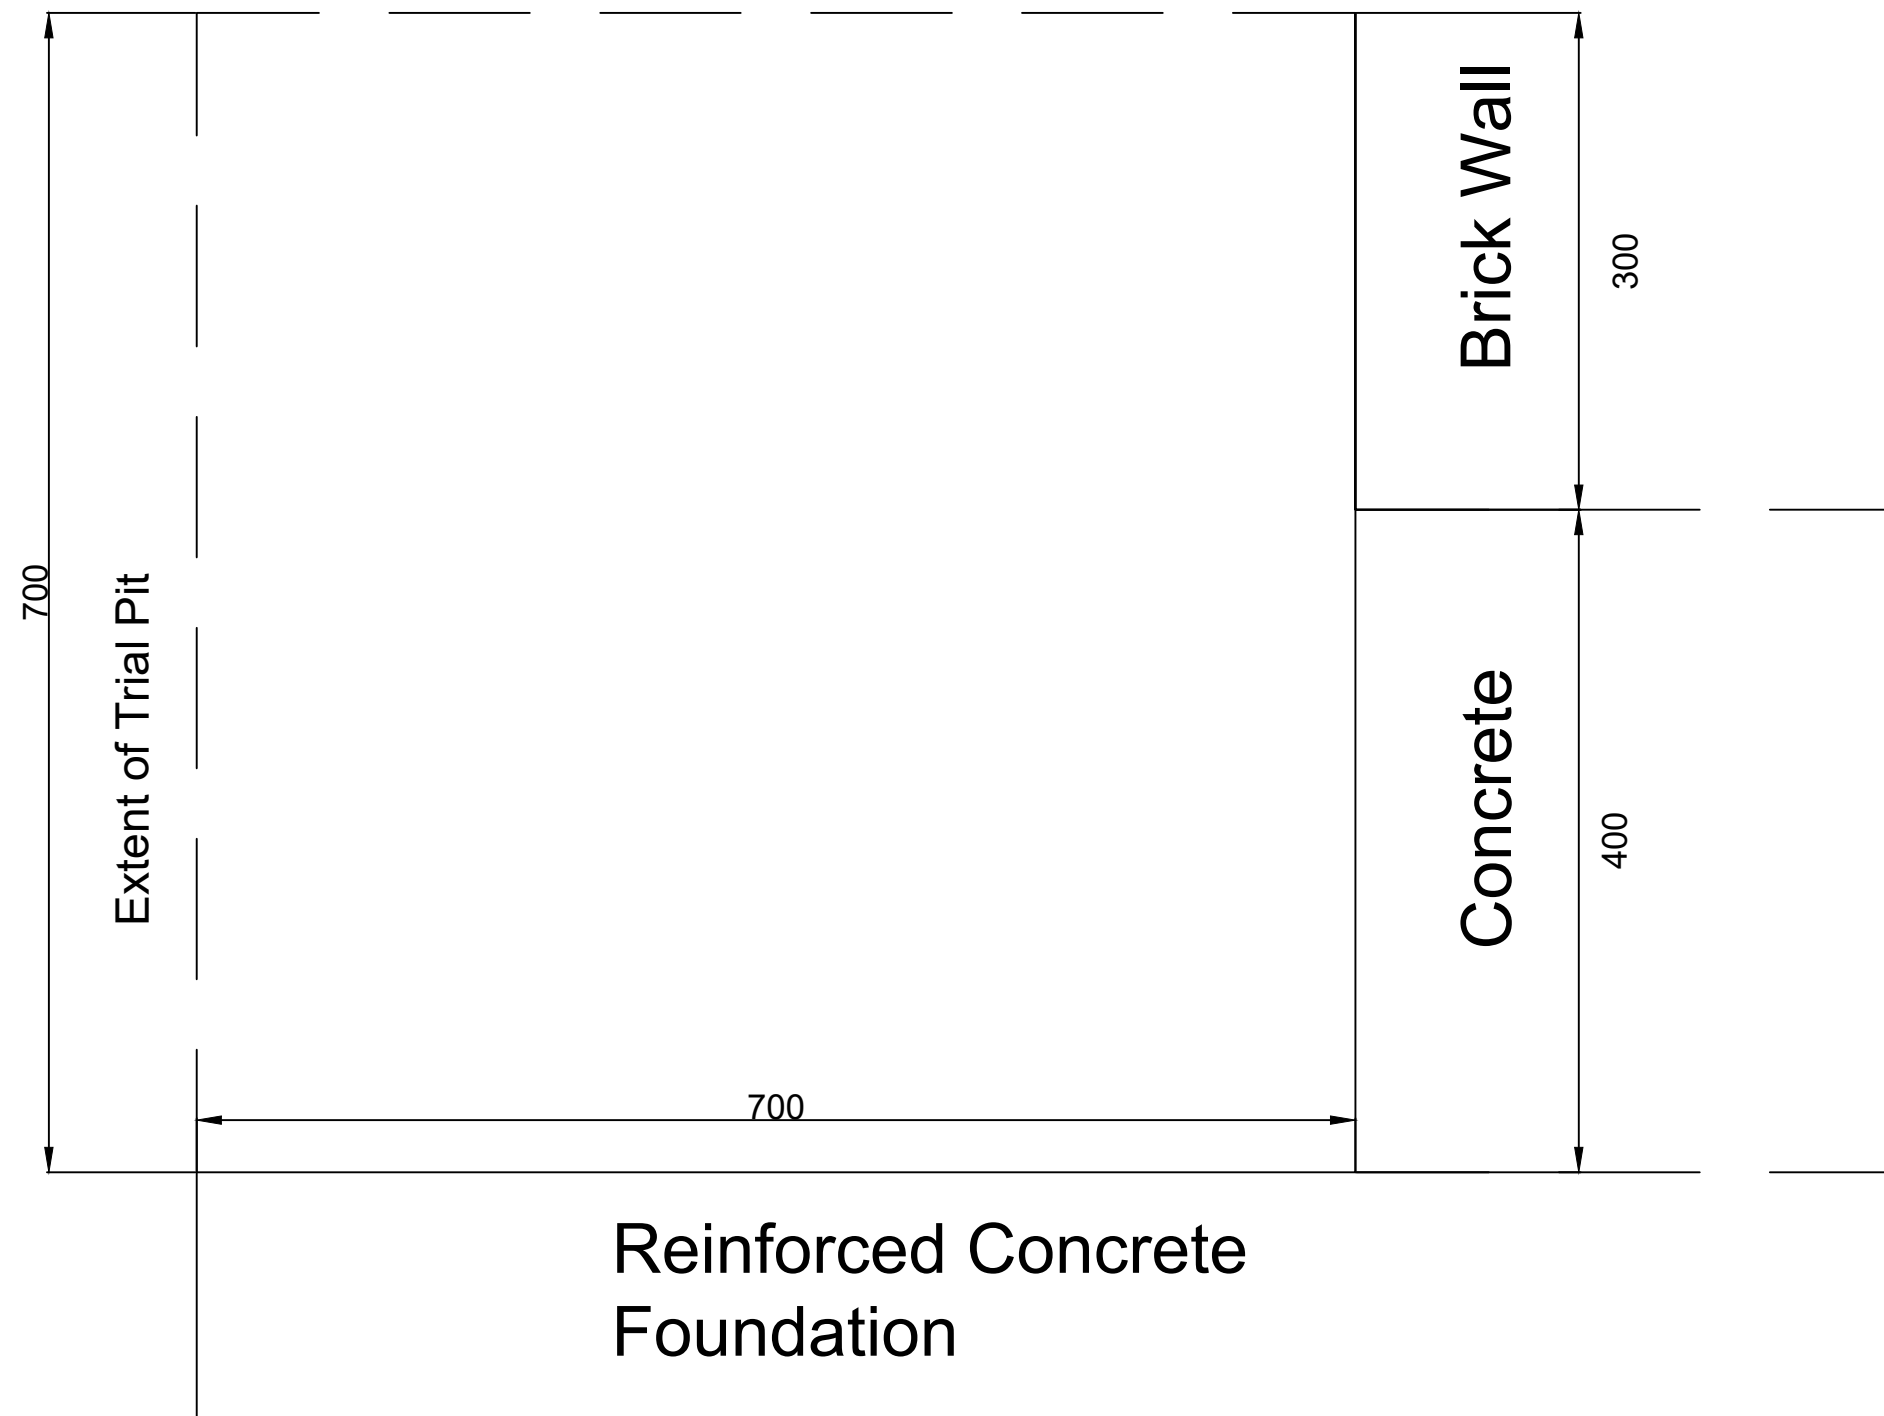
Unable to locate edge of concrete foundation due to large amounts of rebar present

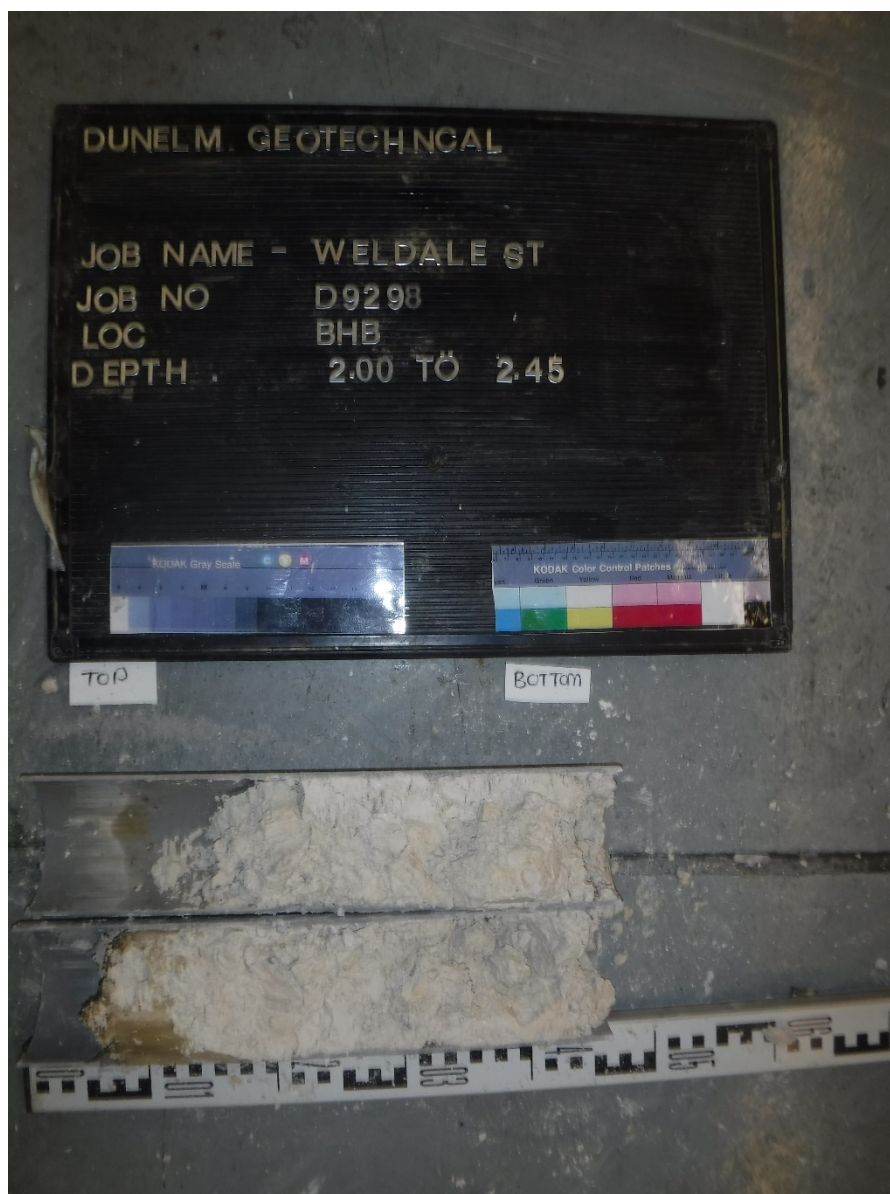
| BHB | 2.00-2.45 | U100 | Structureless CHALK composed of sandy slightly gravelly SILT. Sand is fine to coarse. Gravel is extremely weak to weak, low to medium density white chalk. Matrix is white with occasional orange staining. (Grade DM). |

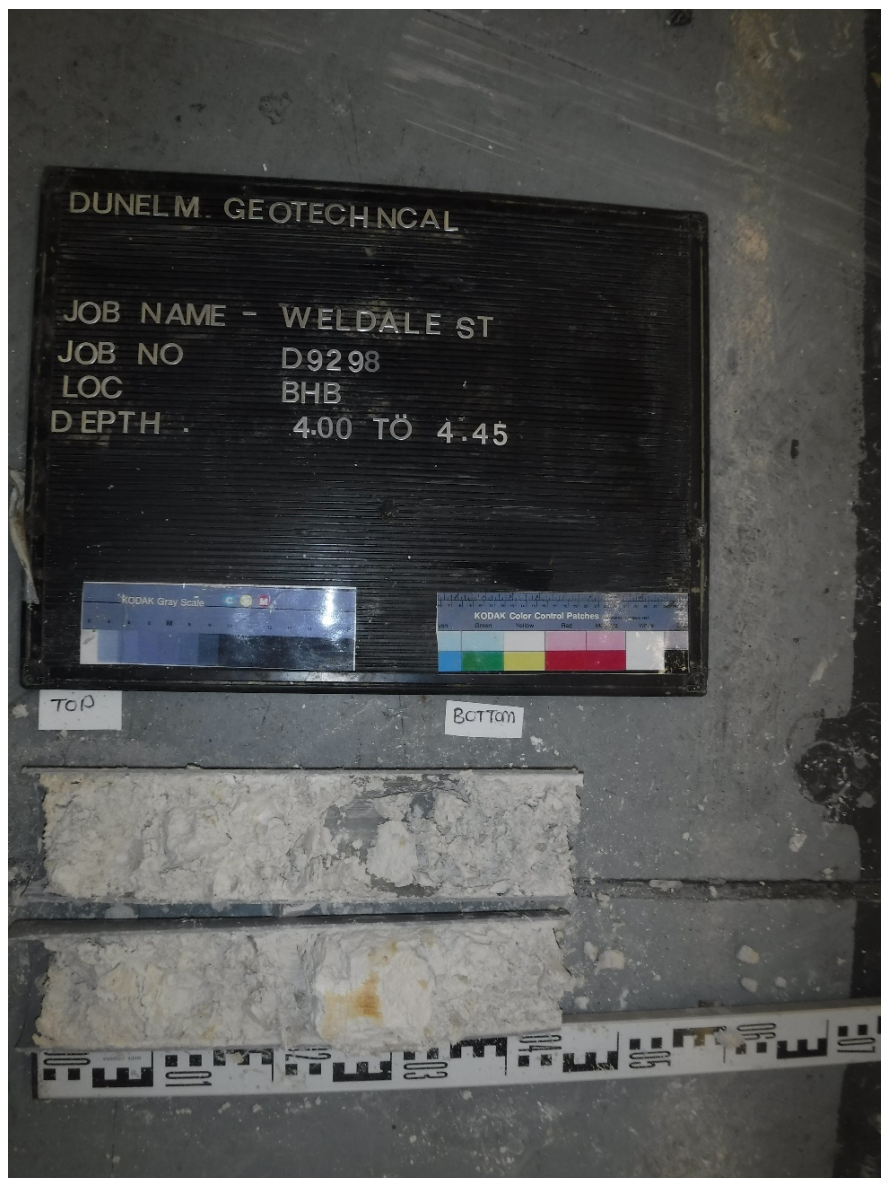
| BHB | 4.00-4.45 | U100 | Structureless CHALK composed of sandy slightly gravelly SILT. Sand is fine to coarse. Gravel is extremely weak to weak, low to medium density white chalk. Matrix is white with occasional orange staining. (Grade DM). |

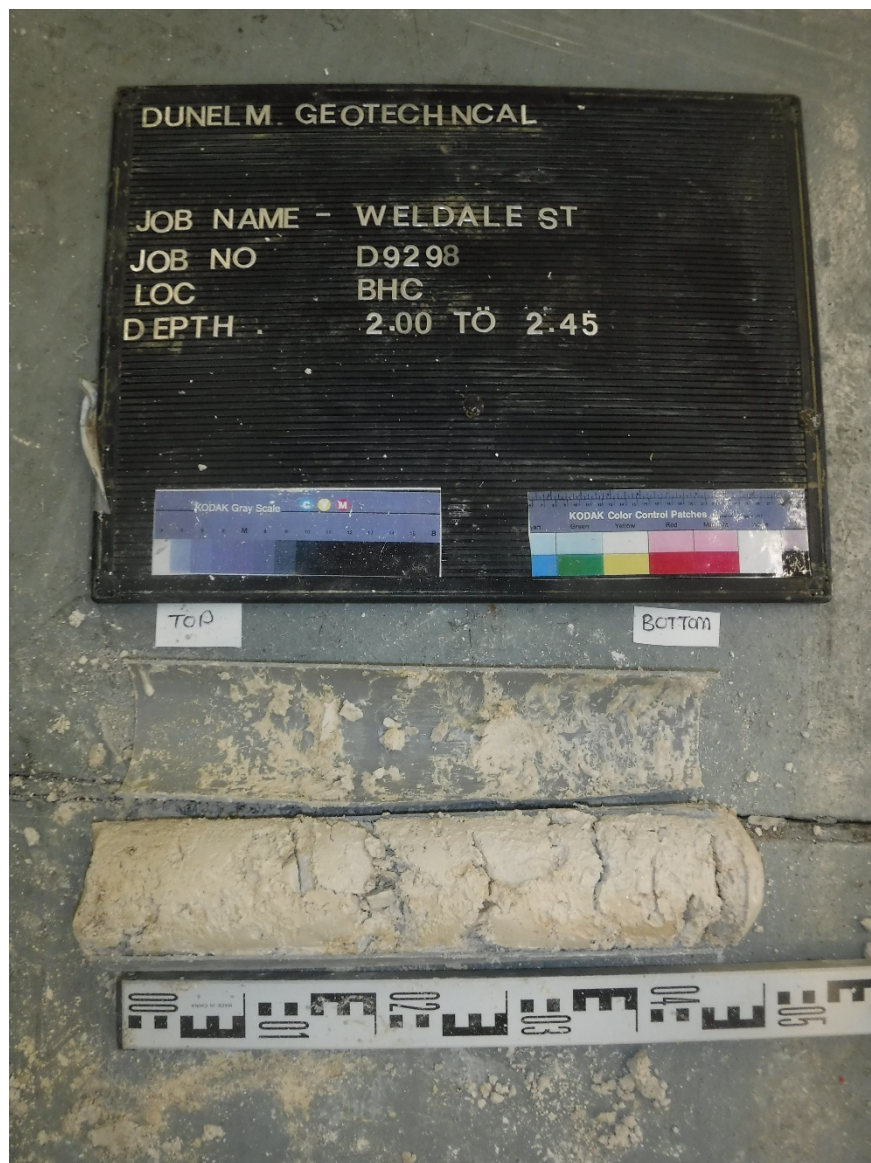
| BHC | 2.00-2.45 | U100 | Structureless CHALK composed of sandy slightly gravelly SILT. Sand is fine to coarse. Gravel is extremely weak to weak, low to medium density white chalk. Matrix is white with occasional orange staining. (Grade DM). |

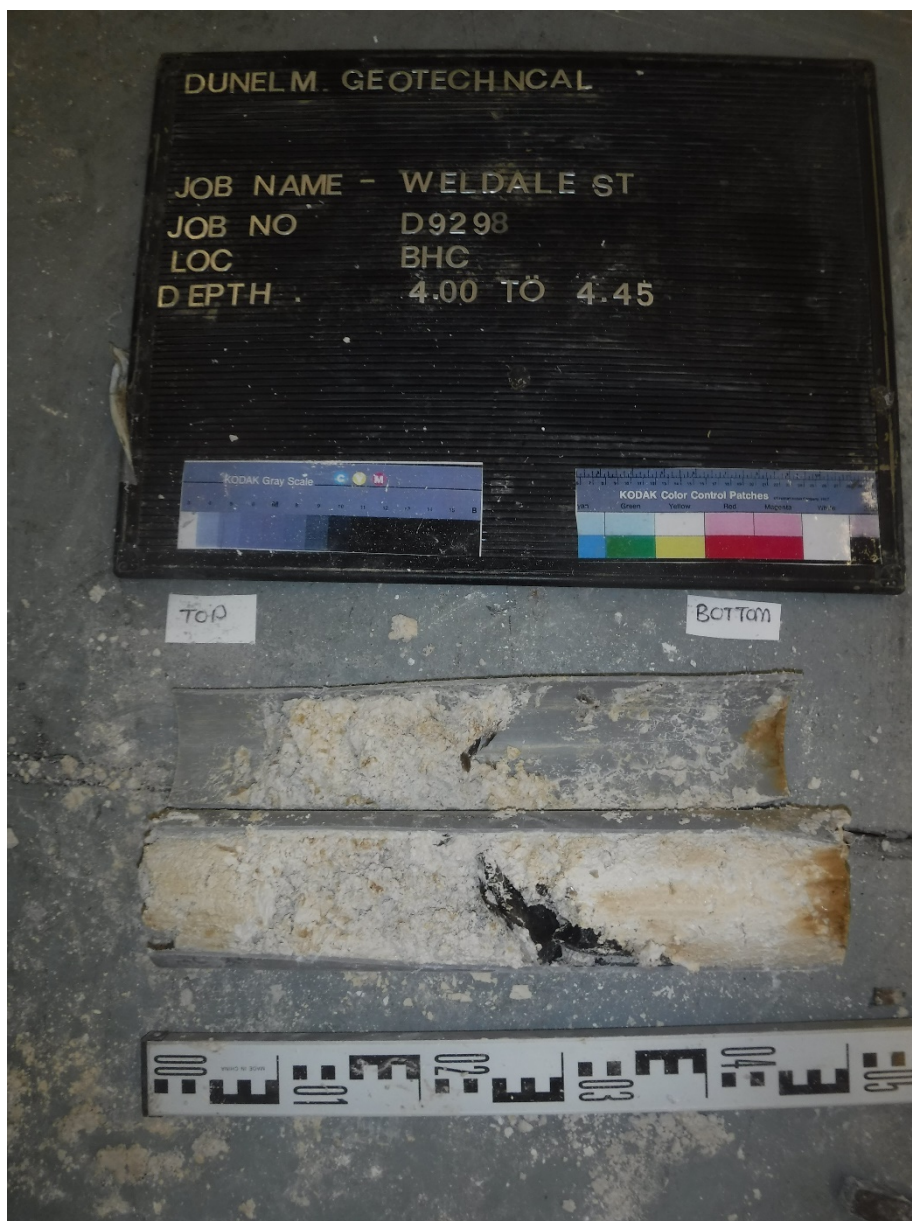
| BHC | 4.00-4.45 | U100 | Structureless CHALK composed of sandy slightly gravelly SILT. Sand is fine to coarse. Gravel is extremely weak to weak, low to medium density white chalk. Matrix is white with occasional orange staining. (Grade DM). |

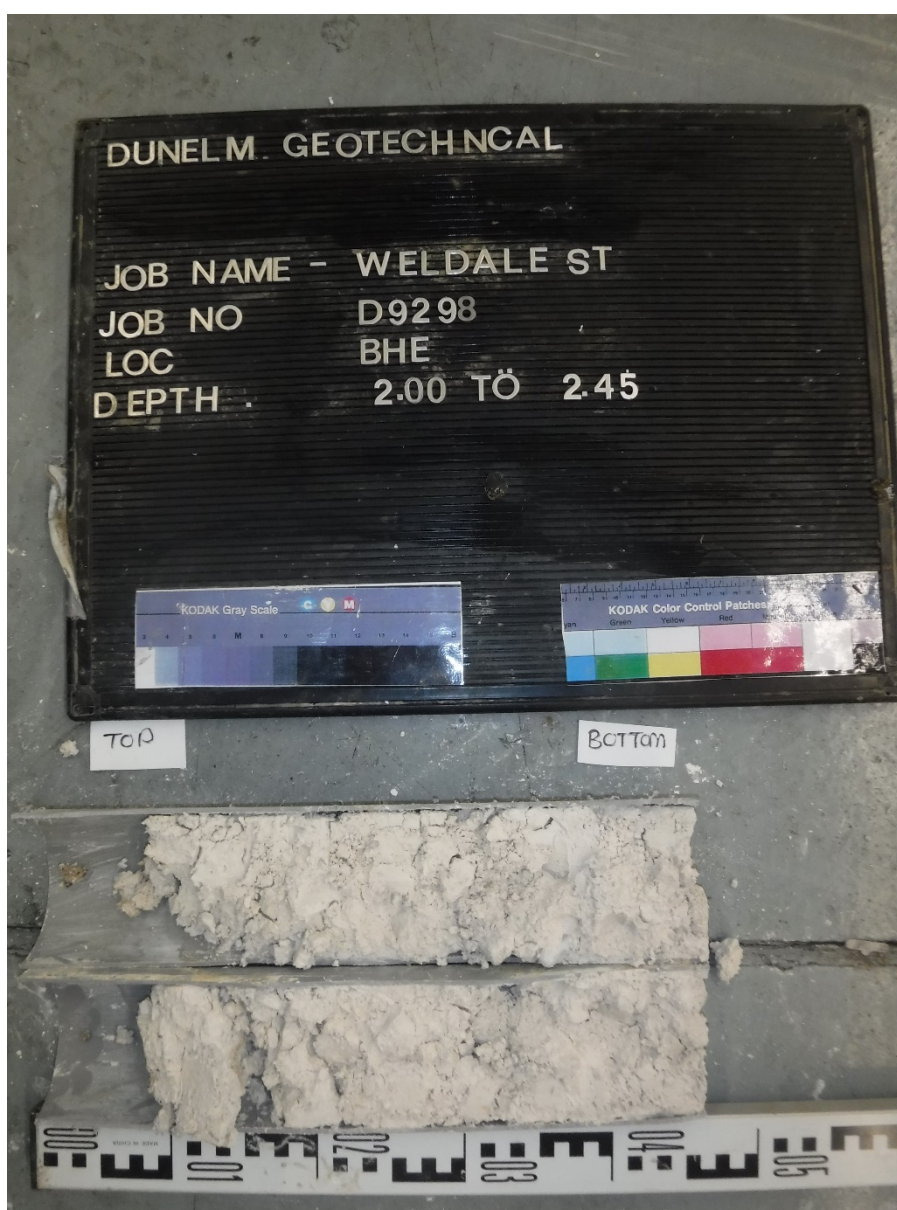
| BHE | 2.00-2.45 | U100 | Structureless CHALK composed of sandy slightly gravelly SILT. Sand is fine to coarse. Gravel is extremely weak to weak, low to medium density white chalk. Matrix is white with occasional orange staining. (Grade DM). |

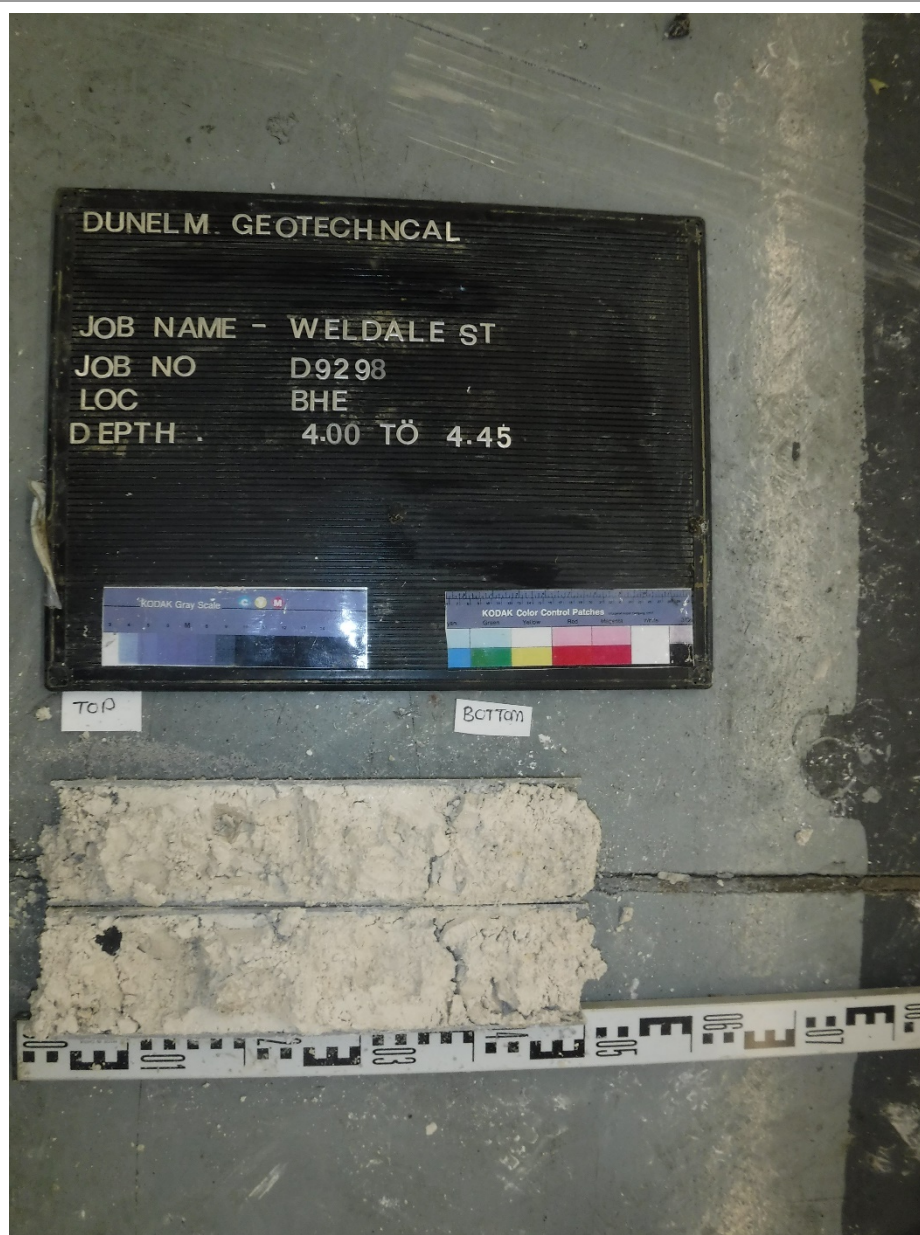
| BHE | 4.00-4.45 | U100 | Structureless CHALK composed of sandy slightly gravelly SILT. Sand is fine to coarse. Gravel is extremely weak to weak, low to medium density white chalk. Matrix is white with occasional orange staining. (Grade DM). |

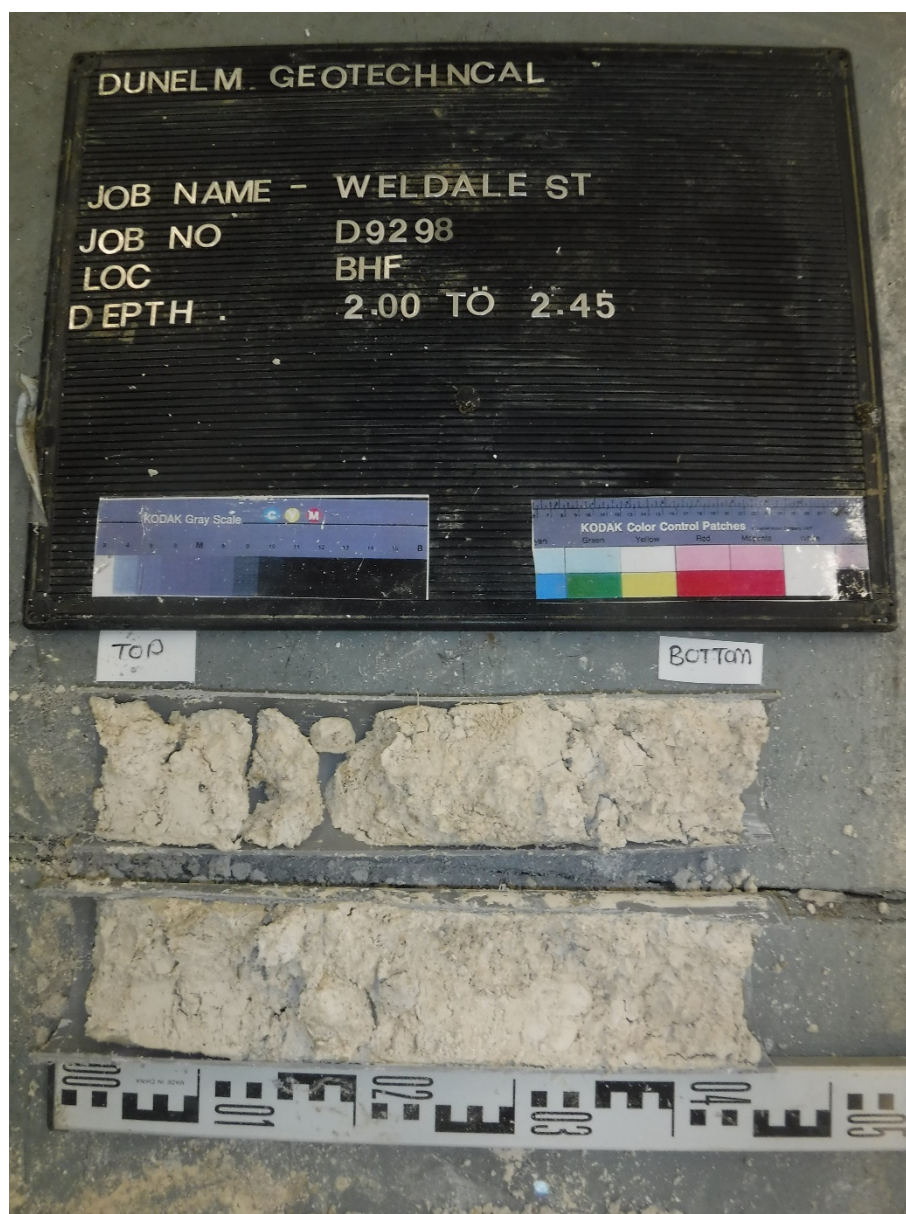
| BHF | 2.00-2.45 | U100 | Structureless CHALK composed of sandy slightly gravelly SILT. Sand is fine to coarse. Gravel is extremely weak to weak, low to medium density white chalk. Matrix is white with occasional orange staining. (Grade DM). |

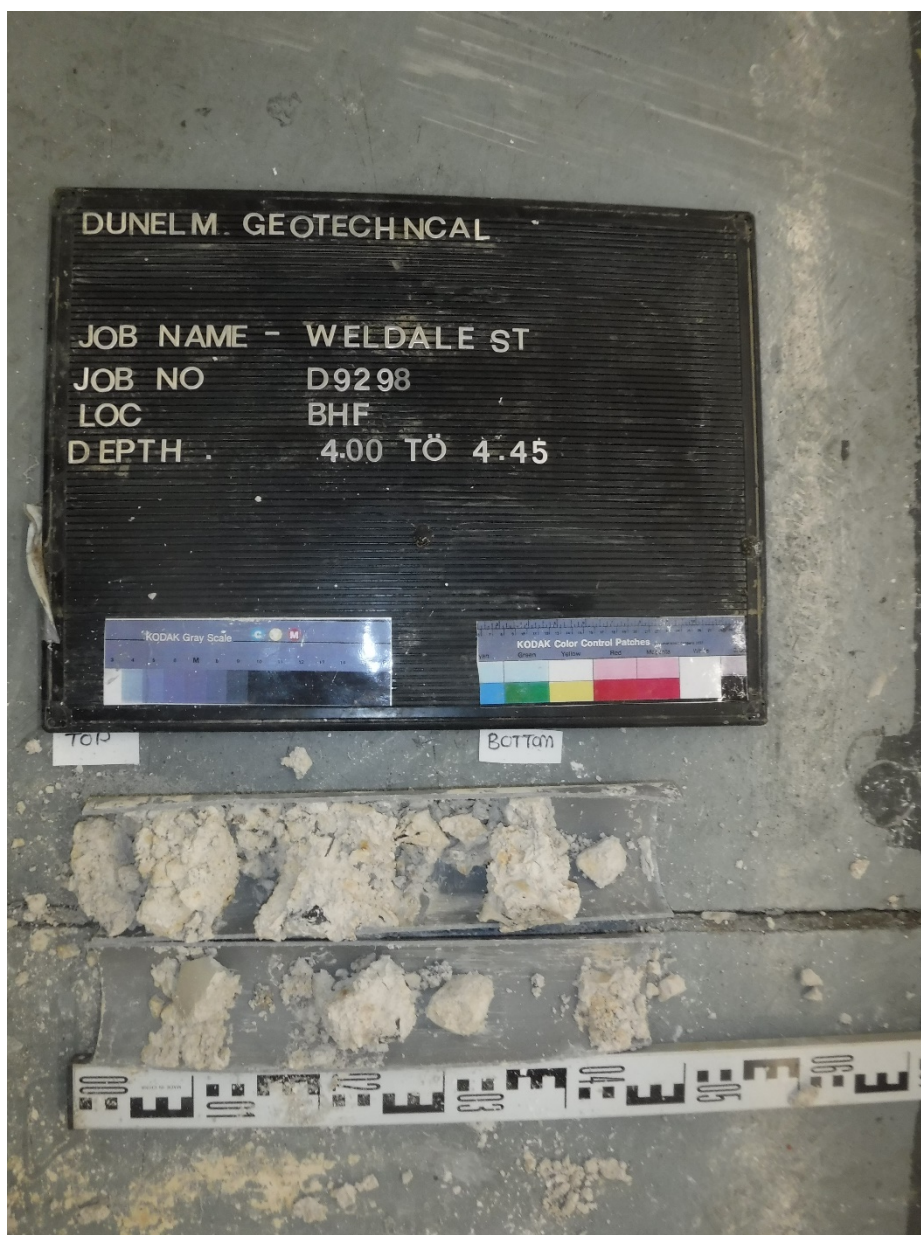
| BHF | 4.00-4.45 | U100 | Structureless CHALK composed of sandy slightly gravelly SILT. Sand is fine to coarse. Gravel is extremely weak to weak, low to medium density white chalk. Matrix is white with occasional orange staining. (Grade DM). |
