## **PHASE I GEO-ENVIRONMENTAL SITE ASSESSMENT**

**GEORGE STREET, READING**

**REC REFERENCE: 1CO107010/P1/R0**

**MARCH 2019**

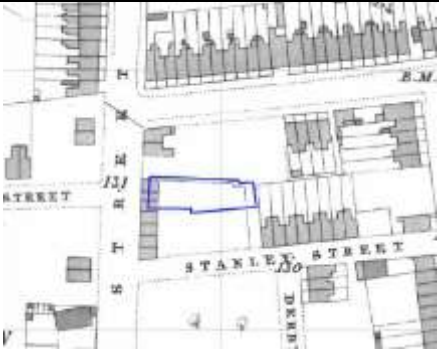
| Map Edition | Historical Land Use | Historical Map Excerpt |
|---|---|---|
| 1877 - 1879<br>(1:500,<br>1:2,500 &<br>1:10,560) | <p>The site comprises of three terrace properties and associated gardens.</p> <p>The surrounding area comprises of terrace housing and open space with Stanley Dairy located approximately 60m south west and the Great Western Railway is 110m north.</p> | <p>Map extract from 1870 (1:2,500)</p> |

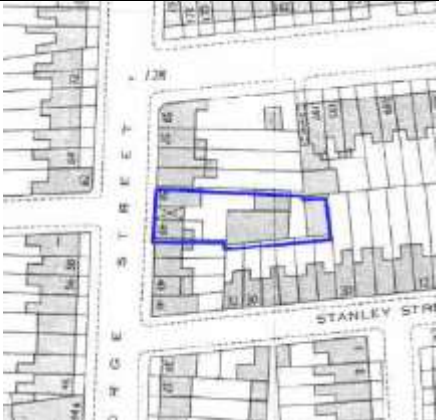
| Map Edition | Historical Land Use | Historical Map Excerpt |
|---|---|---|
| 1900 - 2014<br>(1:2,500,<br>1:10,000 &<br>1:10,560) | <p>In 1900 three outbuildings to the east of the site have been constructed.</p> <p>The surrounding area remains predominantly residential. In 1912, a corporation yard is located approximately 200m north east. From 1959 to 1993, a depot is located circa 150m south west of the site. Various other depots and works are located within 500m of the site.</p> | <p>Map extract from 1961 (1:2,500)</p> |

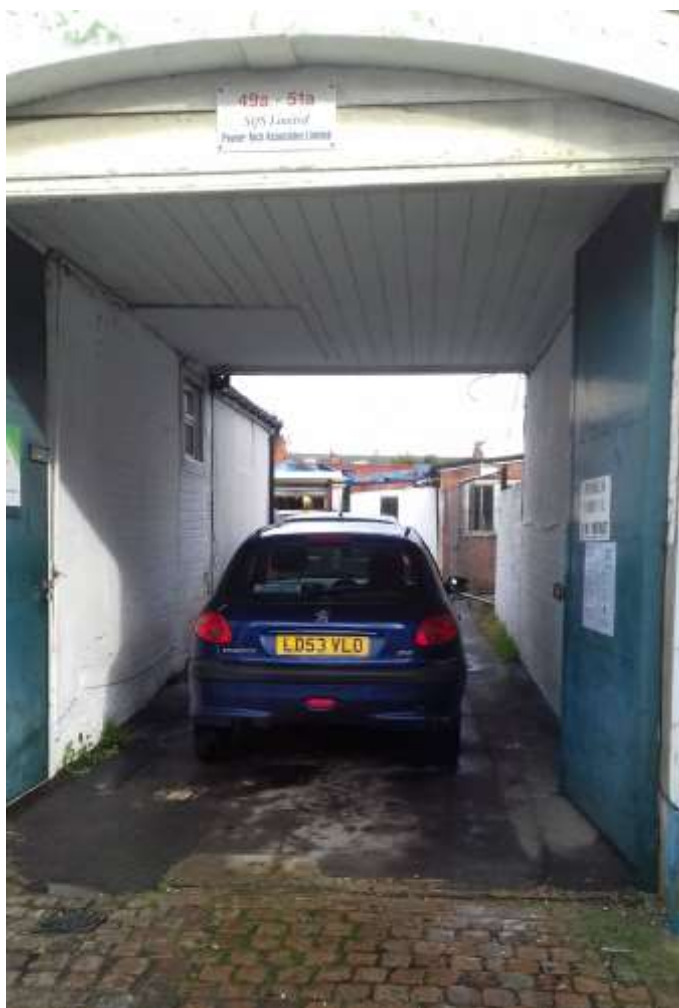
The service yard is currently used for parking for the two residential properties and the commercial unit. Hardstanding is located throughout the site.

**PLATE 1 – ENTRANCE INTO THE SERVICE YARD**

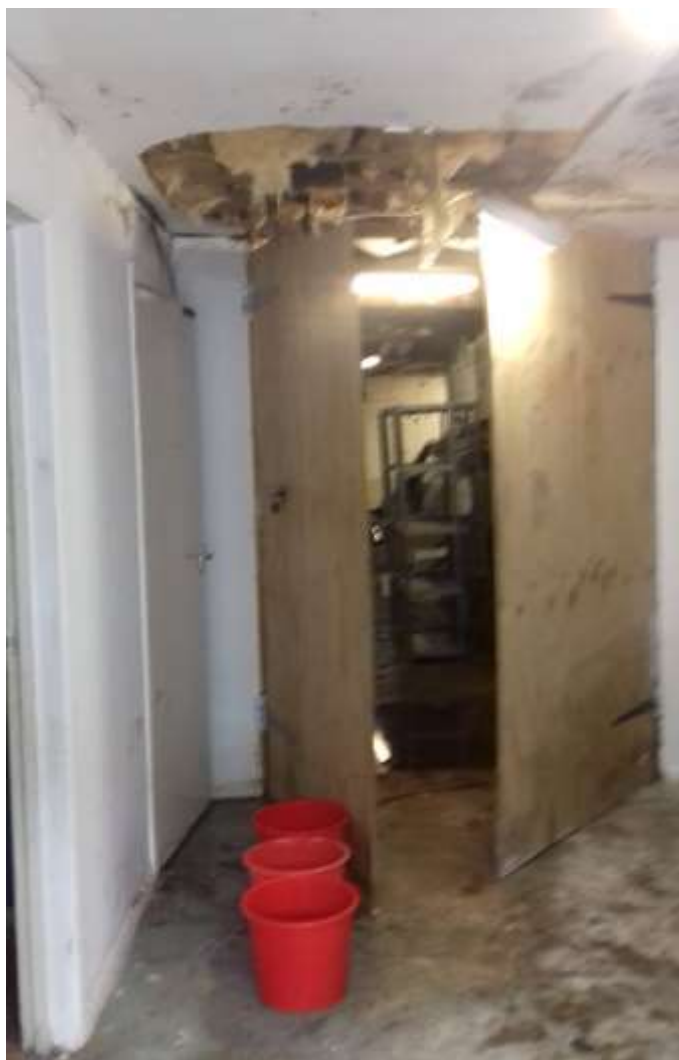
The site is located on the eastern side of George Street and comprises of two mid-terrace houses, with an entrance to a service yard located between the two properties. The eastern section of the site comprises of a single storey building which is used as a commercial office unit and a small workshop containing a car which is currently being rebuilt. At the time of the walkover parts of the single storey building were in dis-repair with damage identified to the ceiling.

**PLATE 2 – WITHIN THE SINGLE STOREY BUILDING WITH DAMAGE TO THE CELING**
