## PRELIMINARY ECOLOGICAL APPRAISAL (BATS) AT 62 ROTHERFIELD WAY EMMER GREEN

Prepared for:  
Mr & Mrs C Goble  
62 Rotherfield Way  
Emmer Green  
Reading  
RG4 8PL

20<sup>th</sup> January 2020

Ref: SPH/PEA01-20/10.01

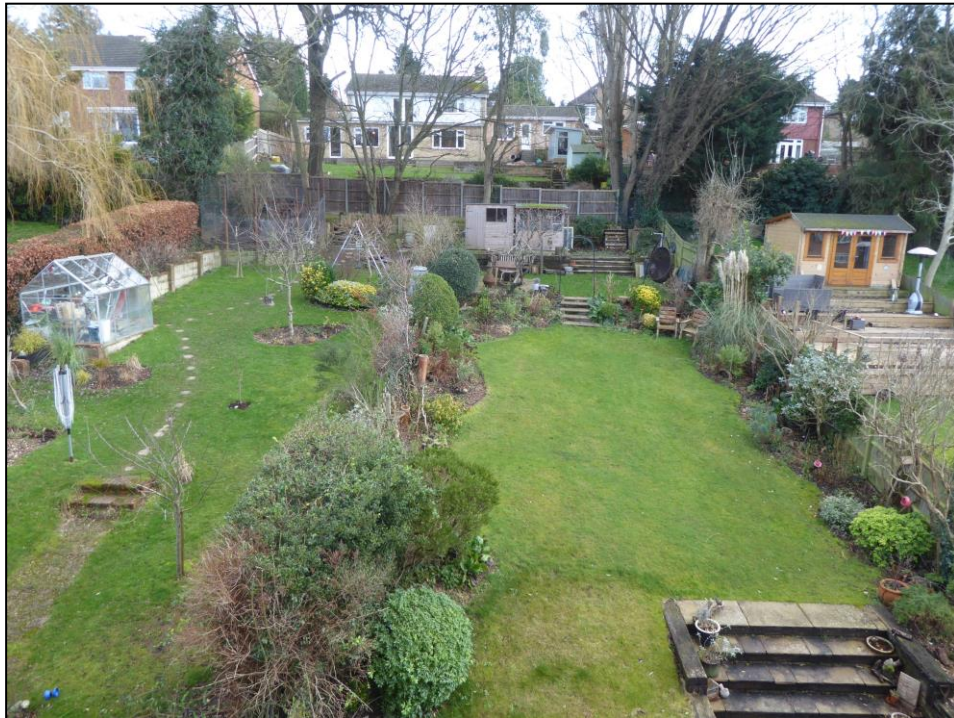
Figure 3. Rear garden. 62 Rotherfield Way, Emmer Green. 10.01.20

The application site, which is located in a residential area to the north of Reading, comprises a detached, brick-built property with attached garage. The remainder of the site comprises a large paved driveway and lawn area at the front with a long rear garden which is mainly laid to lawn with some small shrubs and mature trees on the boundary, see Figure 3 below. The site itself offers some foraging and commuting habitat for bats.

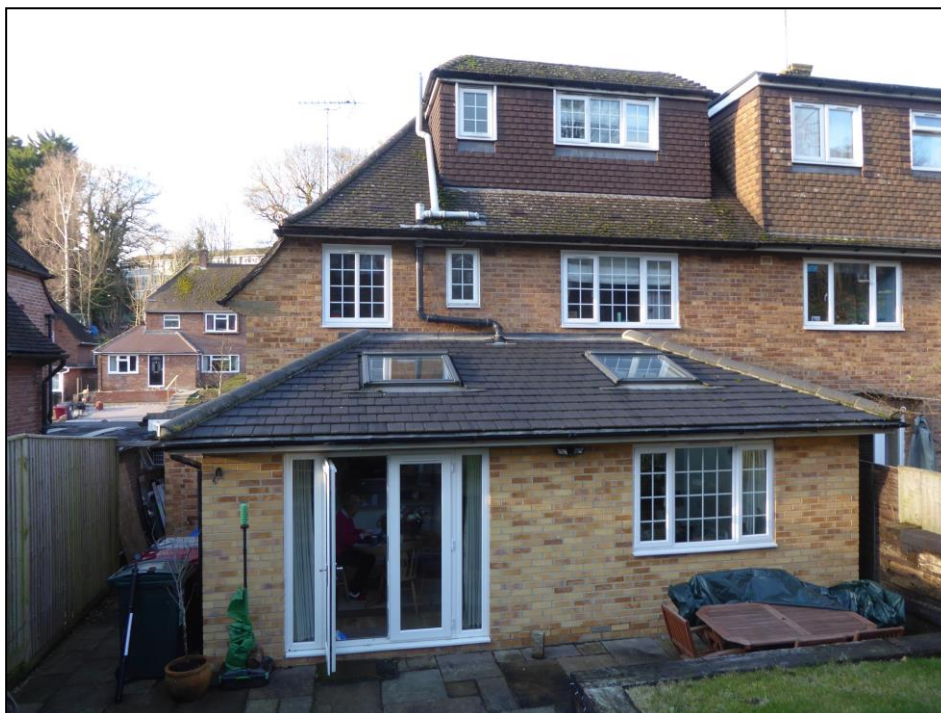
Figure 4. Example of roof structure. 62 Rotherfield Way, Emmer Green. 10.01.20

The property is a semi-detached, brick-built building with cavity walls, which is in a good condition externally. The roof has a mixture of pitched and flat sections due to a number of extensions, see Figure 4 below. The pitch roof sections are covered in close fitting tiles none of which are missing or broken, the ridge tiles are well cemented in and the tiles are close fitting around the front Velux window, see Figure 5 on page 9. The flat rooves are covered with bitumen, which is all tightly sealed with no tears which roosting bats could exploit, see Figure 6 on page 9. There are no gaps in the verges (see Figure 7 on page 10) and the soffits and fascias are all tight to the wall and have no splits or cracks which could be used by roosting bats, see Figure 8 on page 10. The hanging tiles on the rear dormer are all close fitting with no gaps, see Figure 9 on page 10.

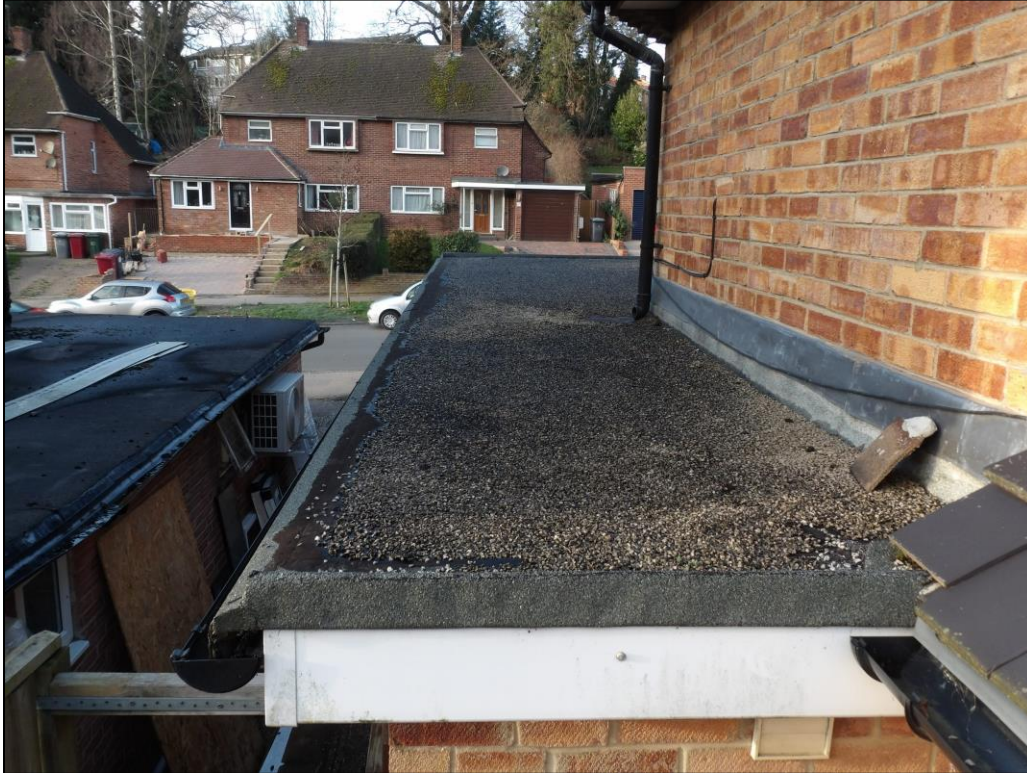
Figure 10. Flat roof over side extension and garage with sealed lead flashing. 62 Rotherfield Way, Emmer Green. 10.01.20

The attached garage and rear side single storey extension have flat rooves that are covered in tightly sealed bitumen that does not afford any roosting opportunities for bats, see Figure 10 on page 11. The lead flashing abutting the rooves to the main property is also well sealed, see Figure 10 on page 11. The soffits and fascias on these buildings are also tight to the wall with no gaps that would be exploited by crevice dwelling bat species, see Figure 11 on page 11.

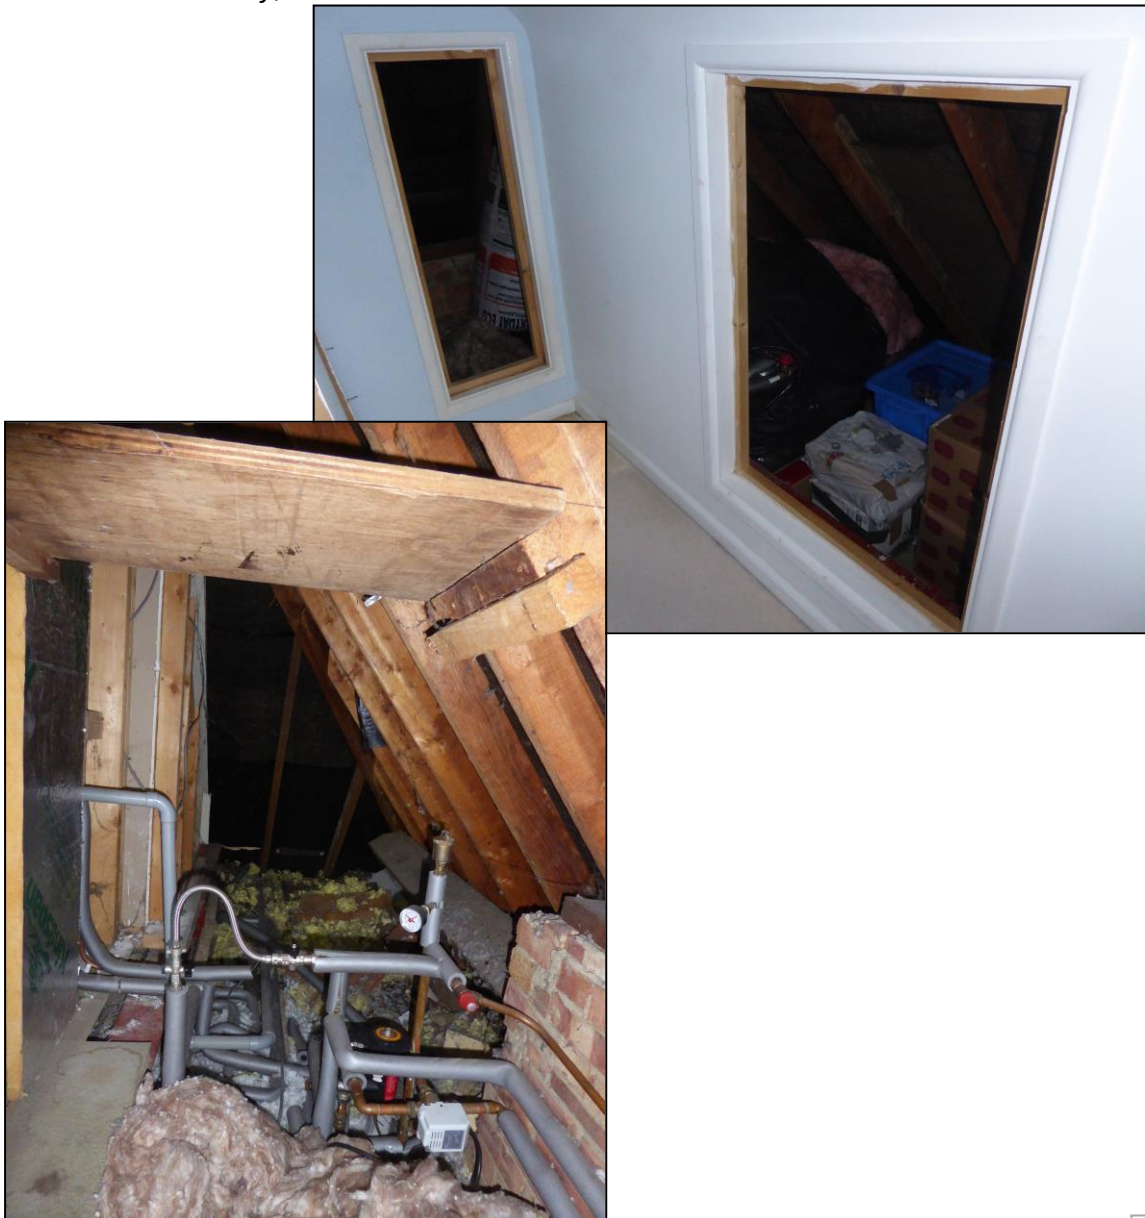
Figure 12. Access to under eaves storage areas and example of under eaves storage.  
62 Rotherfield Way, Emmer Green. 10.01.20

The property had no loft space as it had been converted into habitable accommodation. There were some small areas of under eaves storage which are accessed through doors at floor level, see Figure 12 below. The eaves storage areas are lined with bitumen, which was in good condition, see Figure 13 on page 13.

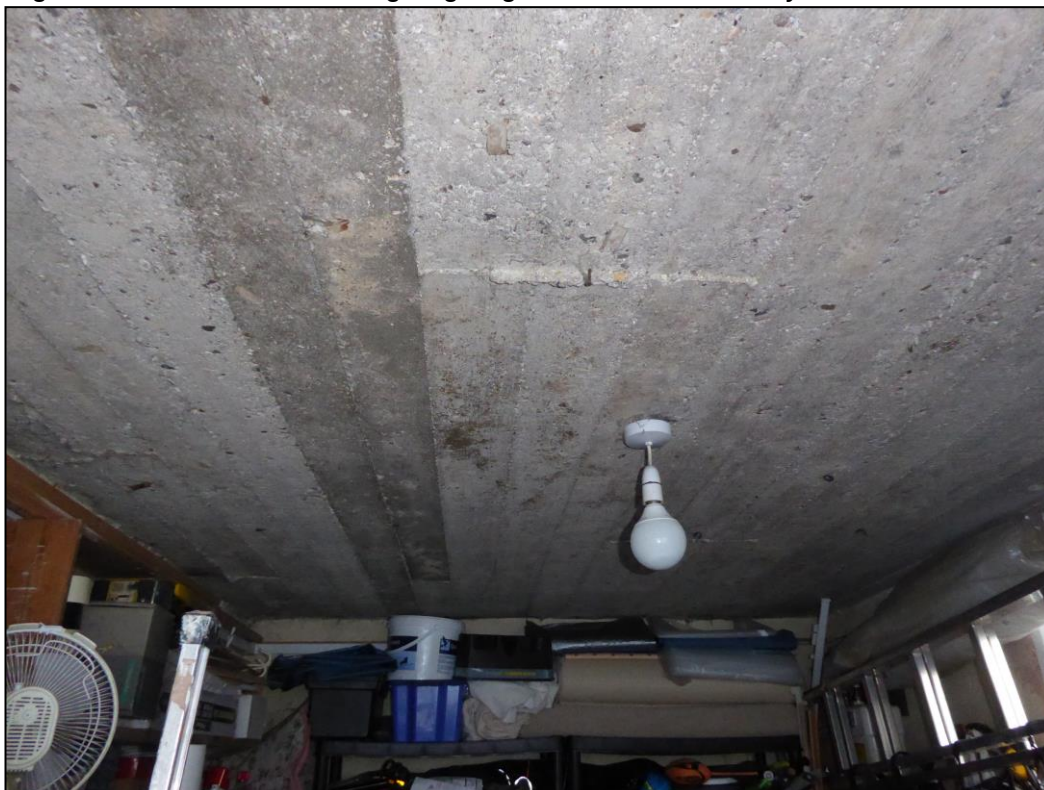
Figure 14. Concrete roof lining of garage. 62 Rotherfield Way, Emmer Green. 10.01.20

The garage is used for personal storage, but this did not hinder the inspection. The roof is concrete and does not afford any roosting opportunities, see Figure 14 on page 14.
