**Station Hill**

**October, 2018**

# STATION HILL

## GEOTECHNICAL AND GEOENVIRONMENTAL DESK STUDY

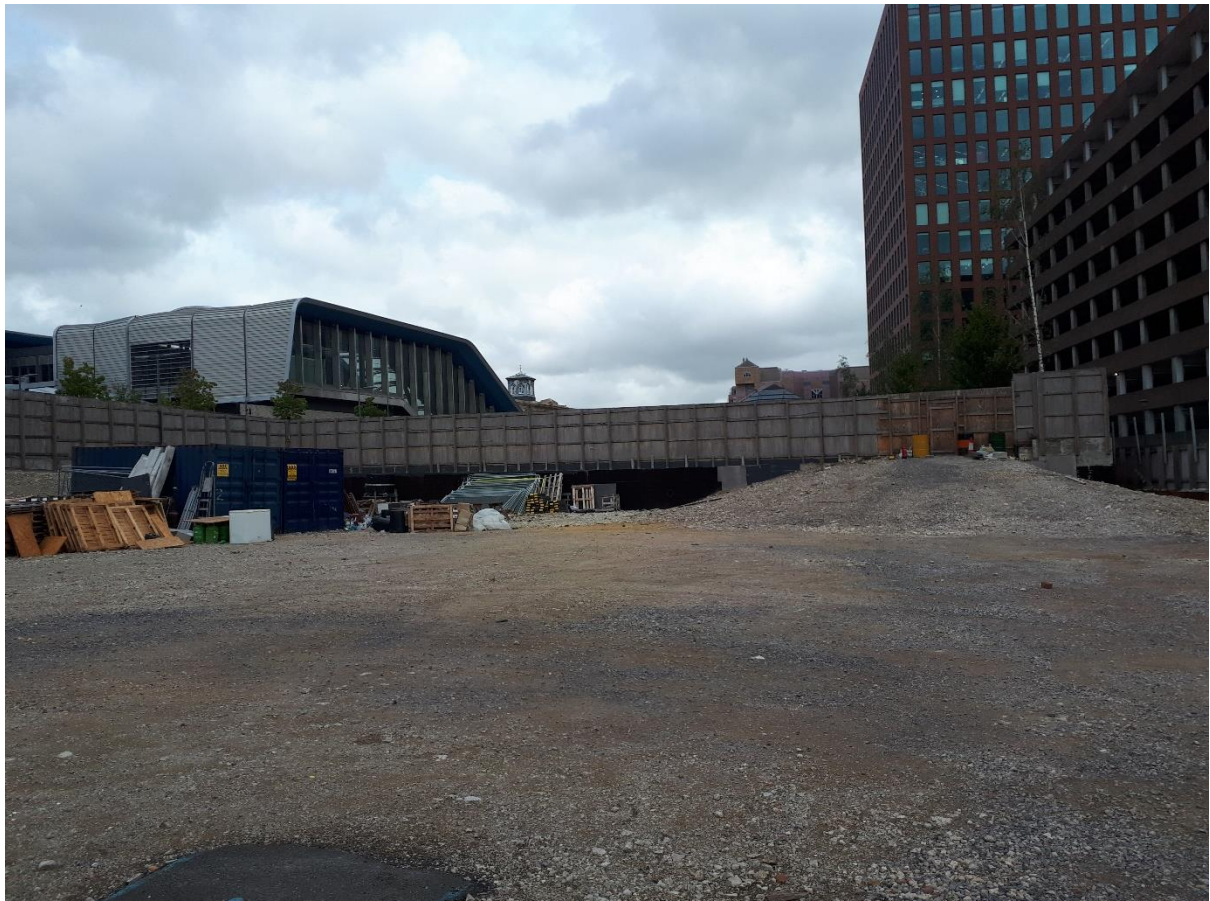
Photo 15: View looking east towards the Temporary Events Space. Showing difference in ground level. (Base of wooden fence represents ground level on the Temporary Events Space.)

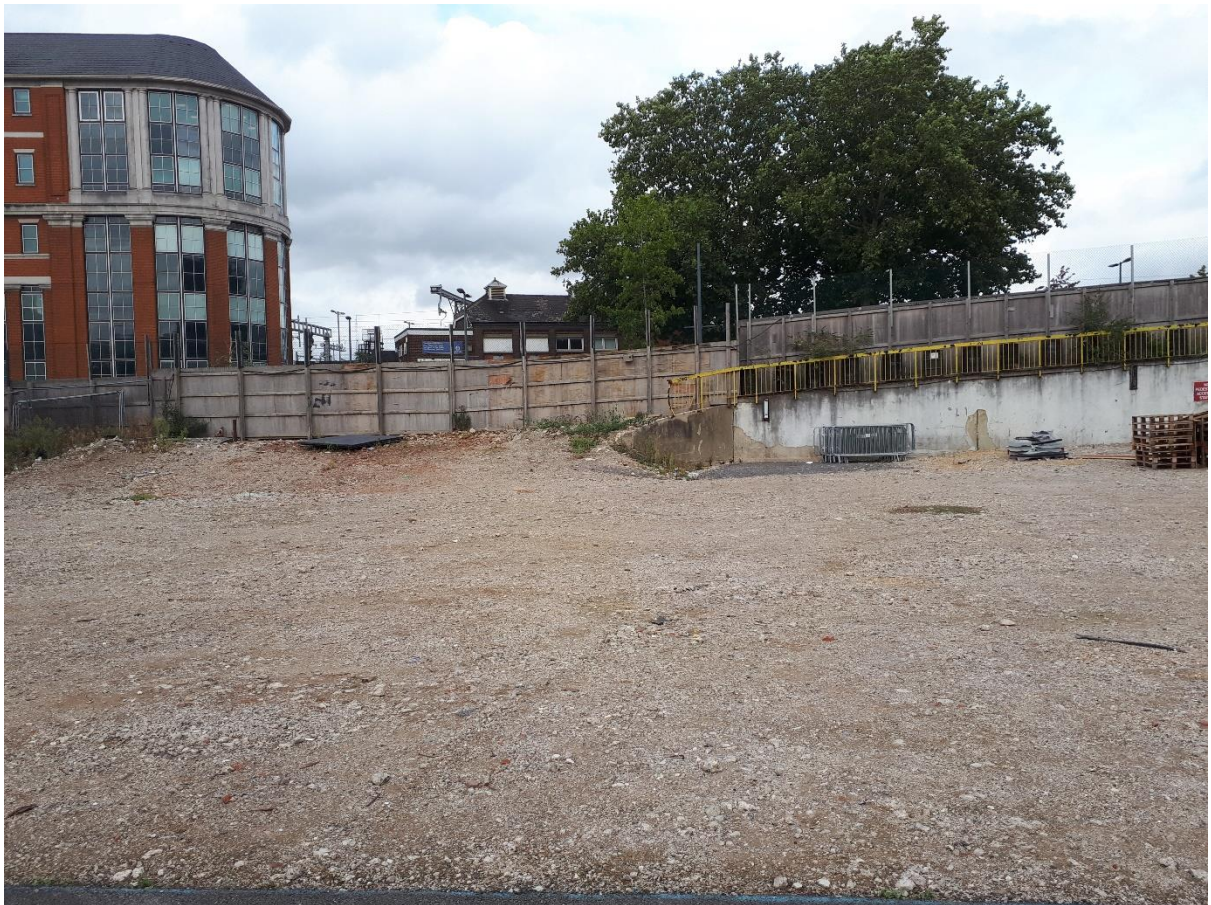
Photo 16: View looking north towards Station Hill Road. Showing rise in topography towards the east.
