## PRELIMINARY BAT ROOST ASSESSMENT

47A HEMDEAN ROAD, CAVERSHAM, READING RG4 7SY

FINAL REPORT

November 2019

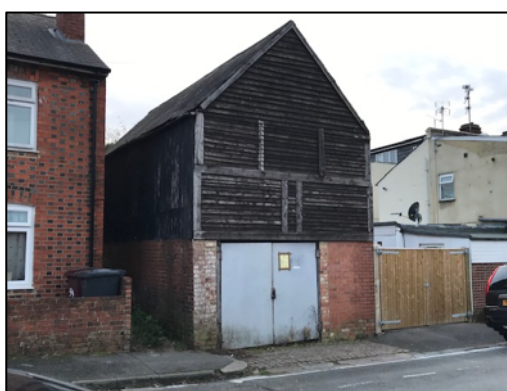
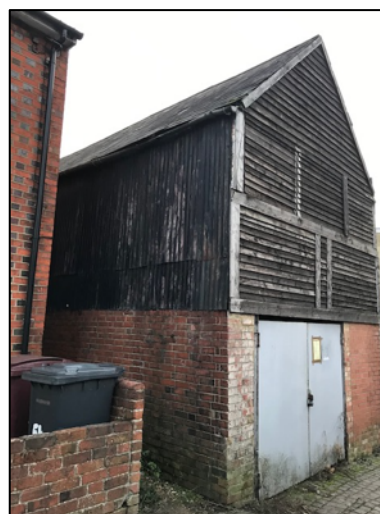
**Figures 1 and 2** - northern and western elevations

The application site supports a single structure: the storage building. The storage building comprises a brick built two-storey structure which rises to a pitched and gable end roof clad with slate roof tiles and cement ridge tiles. The ground floor walls are constructed from brickwork while the first-floor walls are constructed from a timber frame clad with a single layer of corrugated tin sheets (Figures 1 and 2). The north facing gable end is clad with wooden tight-fitting weather boarding.

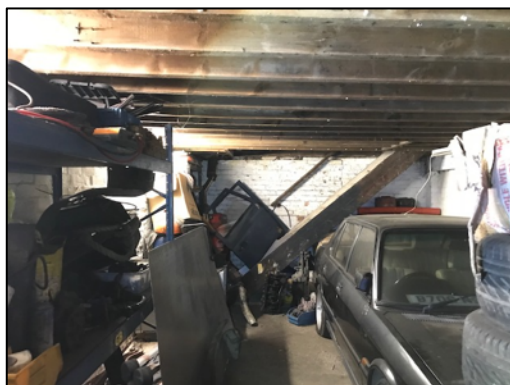
**Figure 3** – ground floor

Internally, the structure supports a ground floor and a first floor which are connected by timber stairs at the southern end of the structure (Figure 3). The structure does not support a roof void and the first floor is open to the ridge line (Figure 4). All of the wall and roof materials are single skin and the undersides of the wooden weather boarding and the corrugated tin sheets are visible (Figure 5). Stored materials are located throughout the structure and these have remained undisturbed for a long period of time. Heavy dust and cobwebbing are present throughout the structure (Figure 6).
