## VALIDATION REPORT

### Block A

**5 to 9 Berkeley Avenue, Reading, Berkshire, RG1 6EL**

CON01-READ-052

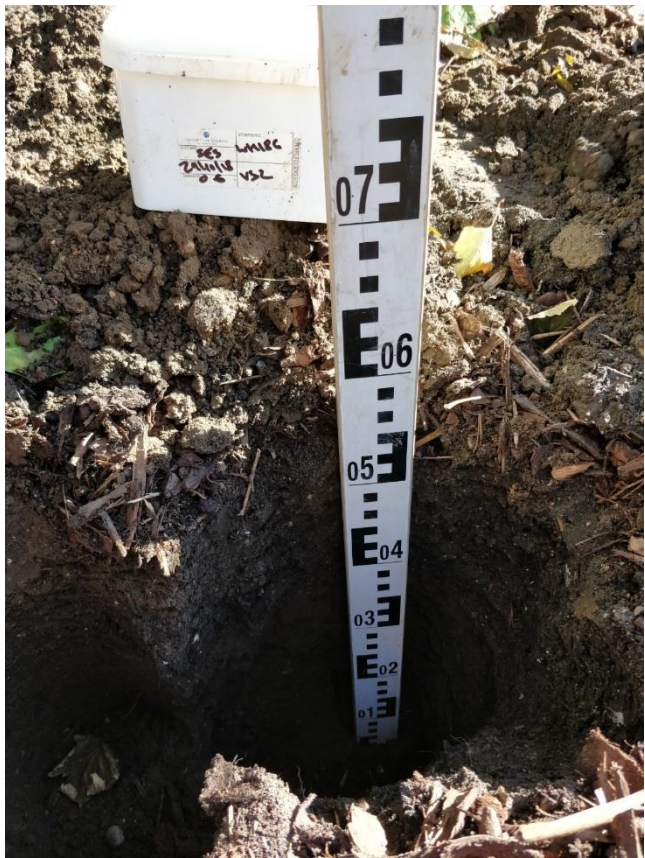
VS02

Loose asbestos fibres were recorded within a sample of subsoil collected from hand pit VS02, located on the eastern side of Block A, at a depth of approximately 0.60m bgl. However, topsoil in this section was replaced following the first sampling visit in October 2018. Asbestos fibres were not recorded in a sample collected from hand pit VS04, positioned in approximately the same location as trial pit VS02.

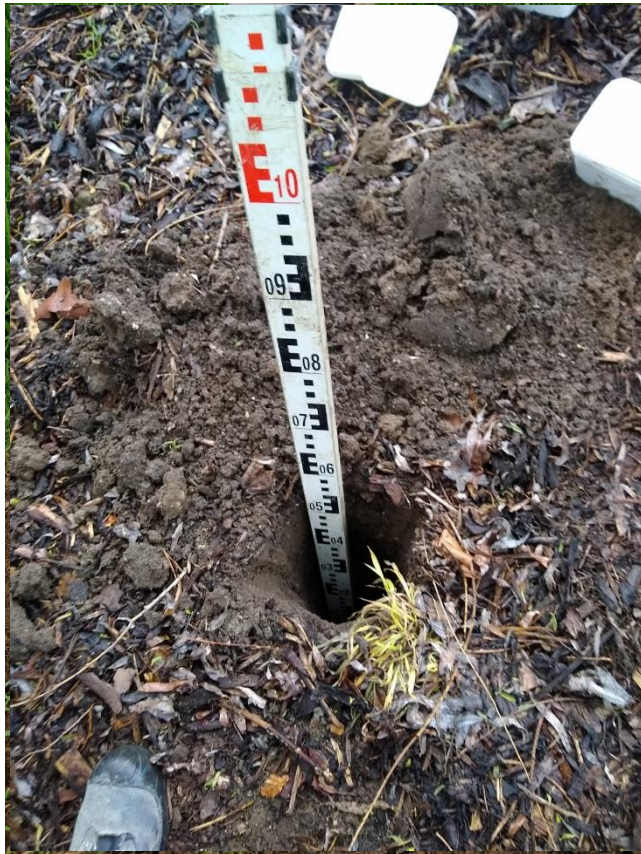
VS05

Loose asbestos fibres were also recorded within a sample of subsoil collected from trial pit VS05, located to the southeast of Block A at a depth of approximately 0.60m bgl. Quantification of this material indicated that asbestos made up less than 0.001% of the sample, by weight and was therefore not considered to represent a significant risk to future site users. Furthermore, the detected fibres were recorded at a depth beneath the 450mm clean cover specified by the Remediation Method Statement. No asbestos fibres were recorded within topsoil, placed above the underlying subsoil layer.
