# Bat Survey Report

35 Upper Redlands

October 2018

| Project Code | Title | Date of Issue |
|---|---|---|
| EBD00540 | 35 Upper Redlands | 18 October 2018 |

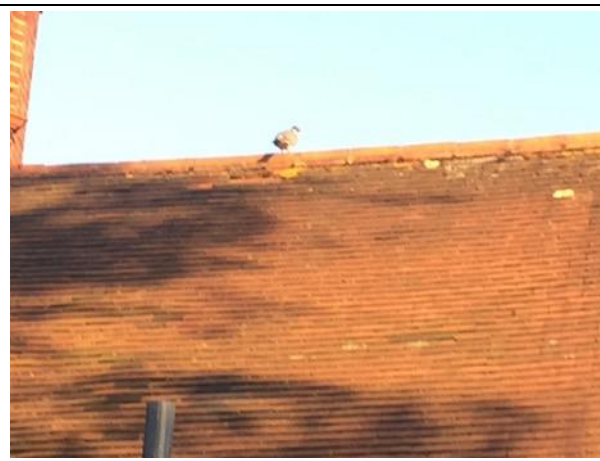
Photo 8: Various gaps under ridge tiles

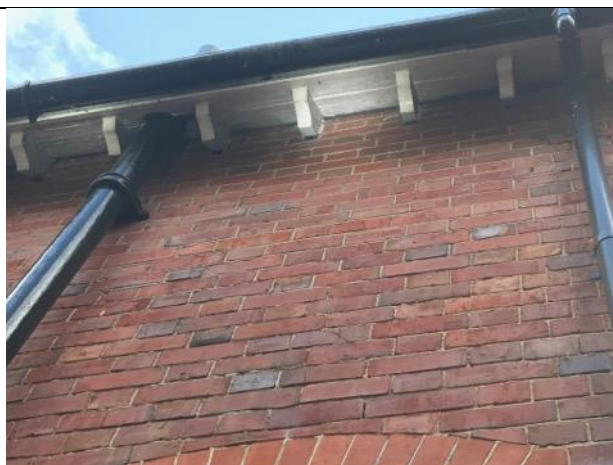
The building was of brick construction with a pitched tiled roof, with brick gable ends and three dormers on the north and south elevations. The eaves were not enclosed within soffit boxes and gaps were visible leading into the loft space along the exposed eaves, particularly on the southern elevation of the building. There were a number of missing, broken and lifted tiles, concentrated on the southern elevation, with only a few missing tiles on the northern elevation. Overall the building and brickwork was in good condition, and no evidence of bats was noted on any exterior elevation.

Photo 7: Various gaps under the eaves

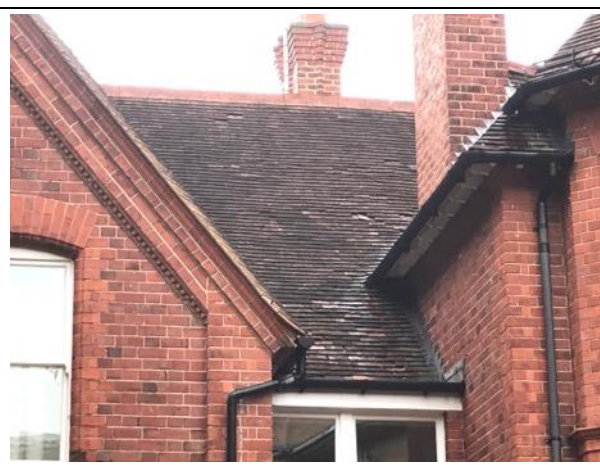
Photo 8: Many broken/ slipped tiles

To satisfy the local plan policy which seeks a net gain for biodiversity, we recommend that the proposed roofing work includes an enhancement for crevice-dwelling bats such as pipistrelles. Six bat access tiles should be installed to replace some of the broken or slipped tiles across the roof (appendix 3).

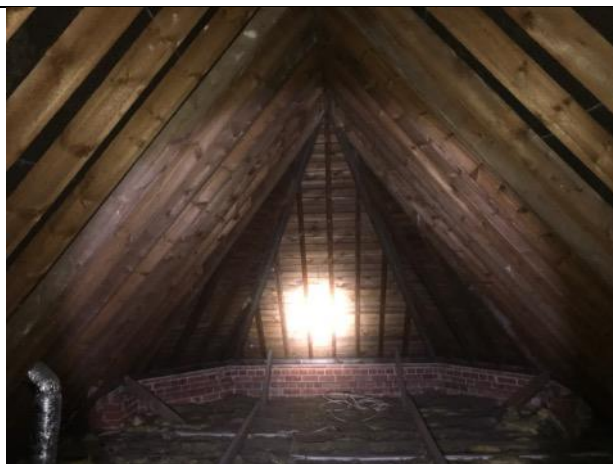
The interior loft space was timber framed and bitumen felt lined, with some boarded areas allowing a thorough search of the loft space. Areas of light ingress were noted at the eaves, as well as through tears in the felt, through which the underneath of the tiles could be seen. 10 bat droppings were identified scattered throughout the loft space, although no clusters of droppings were identified. The majority of bat droppings were identified underneath the ridge, which was lightly cobwebbed. No areas of staining or scratching by bats was noted.

Photo 7: Inside sarked section of loft

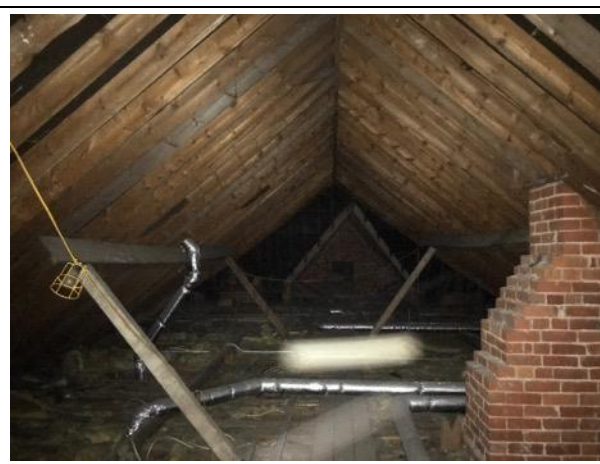
Photo 8: Inside felt lined section of loft

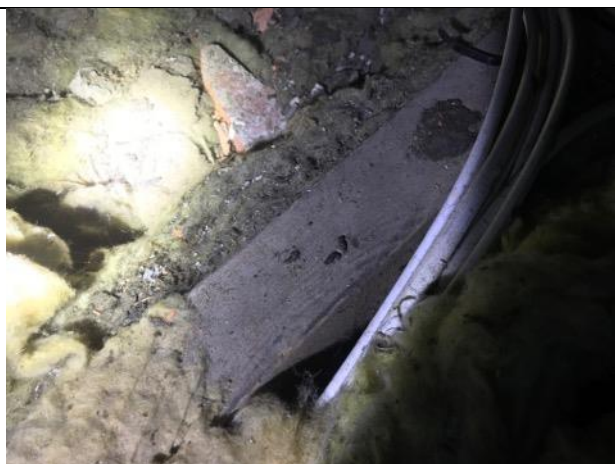
A third party undertook a preliminary roost assessment of the building during early 2018 and identified a small number of bat droppings in the roof space of the building. Detail of the survey was held from the client and therefore Ecology by Design were commissioned to complete the work. A full emergence survey was recommended which was undertaken during June, July and August 2018 which did not identify any evidence of bats emerging or re-entering the building. The preliminary roost assessment was repeated by during September 2018 which identified two very old and deteriorated bat droppings in the loft space but no other evidence of bats. It is considered that these droppings have either been transported into the roof space on stored materials or are the result of an exploratory bat in the past, there is no evidence of roosting.

Photo 7: 3 very old bat droppings in loft

Bats do not pose a constraint to the roof work and no further action for bats is required.

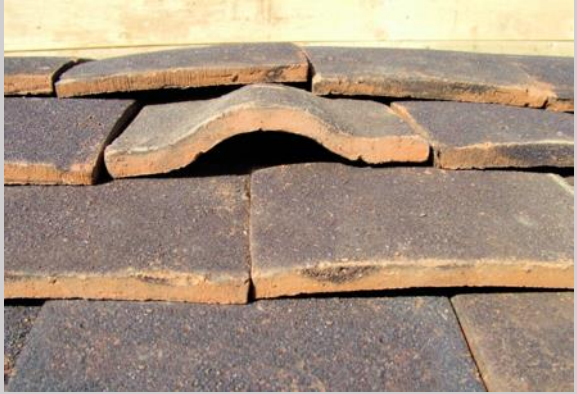
| Products | Description |
|---|---|
| | <p>An example of an access tile for bats. Available from;<br/> <a href="https://www.nhbs.com/bat-access-tile-set">https://www.nhbs.com/bat-access-tile-set</a></p> |
