# Bat Survey of 37 Kidmore End Road, Emer Green, Berkshire, RG4 8SN

Client Mrs J Lavell

Reference L1127.001

Date 16 May 2019

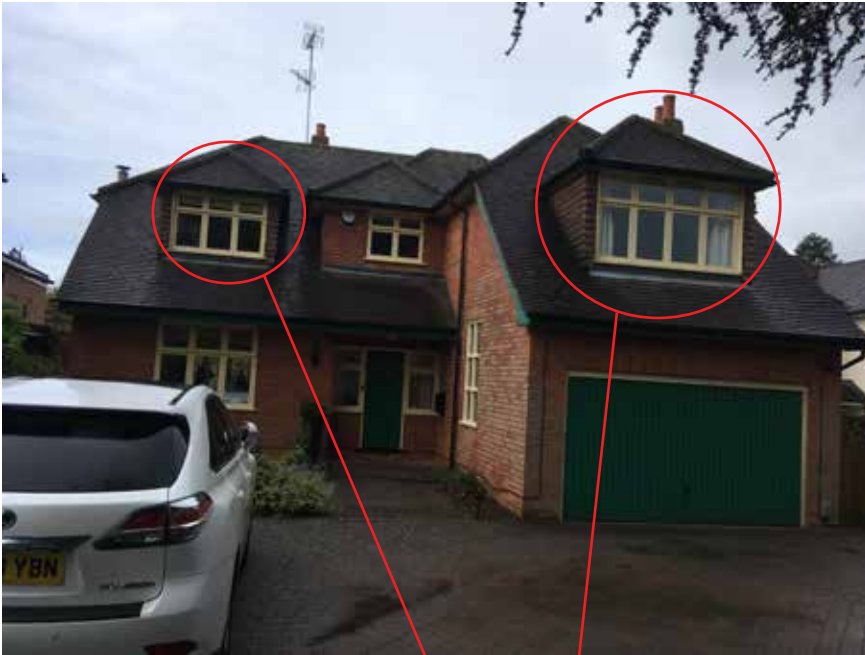
Photograph 1:

Front; eastern elevation

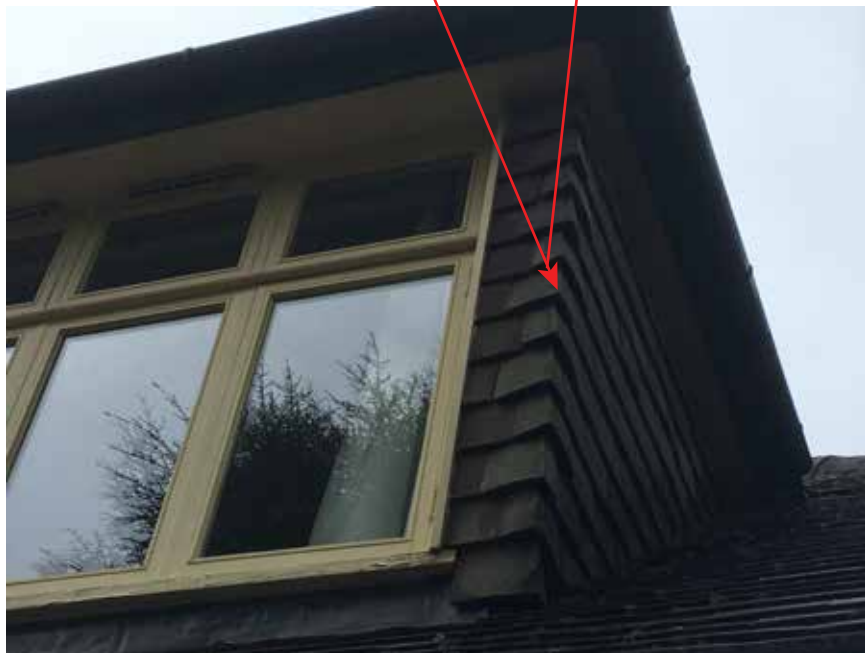
Photograph 2:

of cladding numerous small crevices are present along the tiles bases and while not leading to a building defect do provide significant access points that lead into the shallow, hidden cavities that lay below and are created by the battens that the tiles are hung from. Refer to photograph 2.

Detail illustrating gaps associated with hanging tiles that clad the northern and southern dormers. Neither dormer is planned for any alterations and will remain in situ.

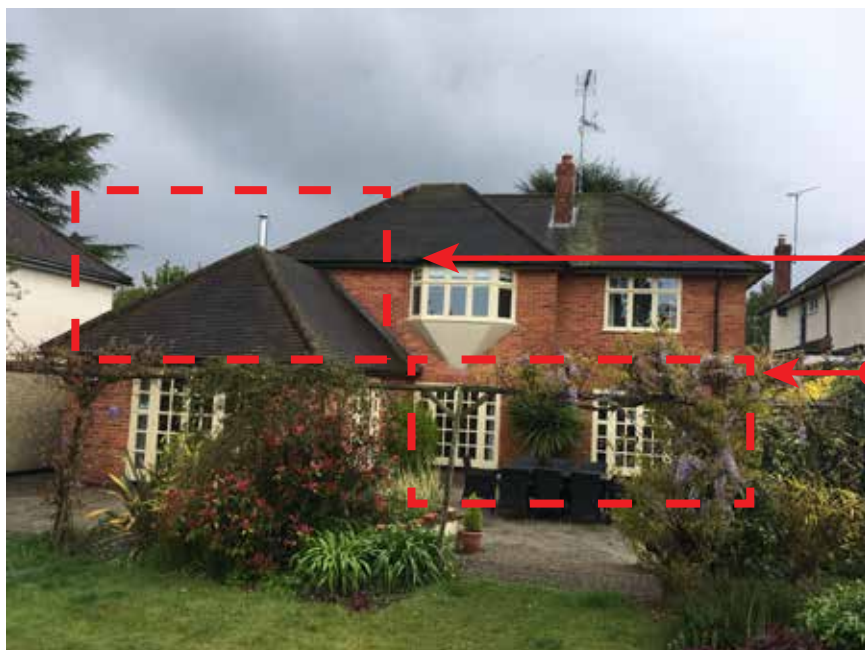
Photograph 3:

Rear; western elevation

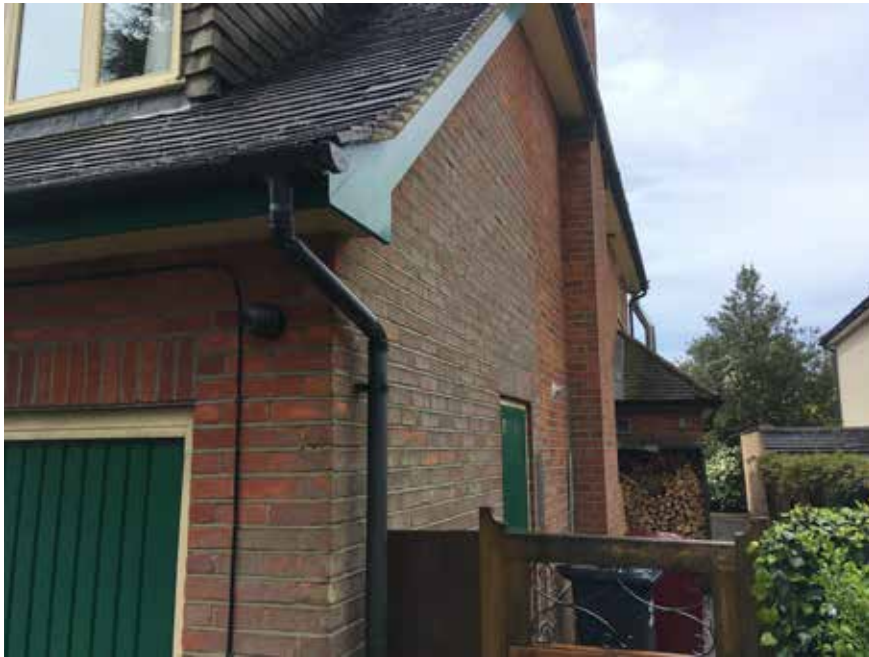
Photograph 4:

Side; northern elevation; the southern elevation is similar

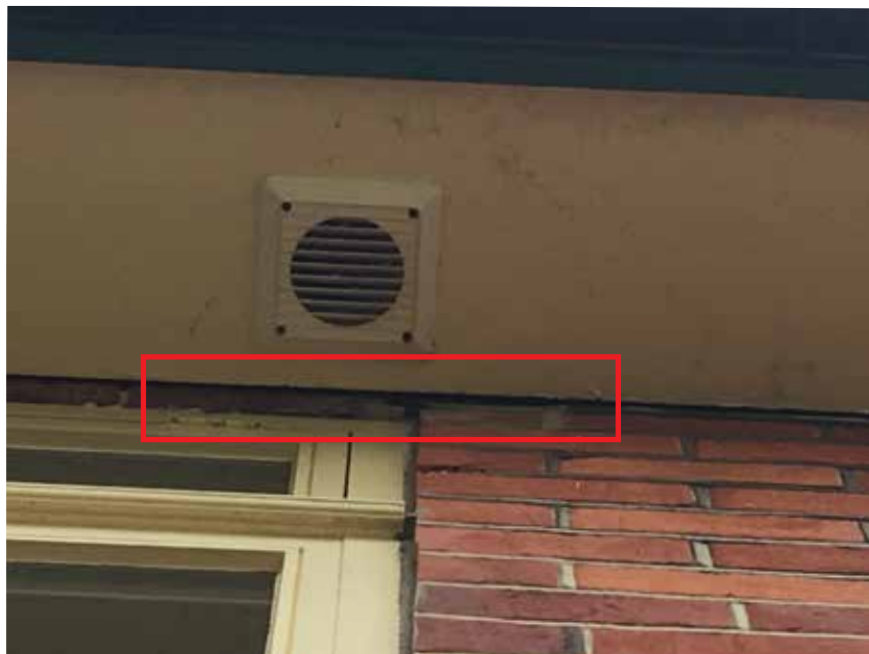
Photograph 5:

The dwelling has a significant roof overhang and is fitted with a simple timber soffit arrangement. Soffits all remain in good order with no evidence of areas of rot, however a few small but significant gaps are present where the horizontal soffit base meets the brickwork and fails to seal tightly; this can be seen on the northern side elevation; refer to photograph 5.

- 3.9. A number of potential access points that bats may use to gain entry to the roof void have been identified and consist of;
- A few gaps associated with soffits; refer to Photograph 5

Example of soffit; the majority fit well; however a few small but significant crevices are present; as highlighted.

- 4.9. Current proposals will involve the retention of the roof void and a likely mitigation plan would involve allowing bats continued access to the roof void; to allow bats continued access to the void, two lead bat arches will require fitting onto the roof. The lead arches will provide bats with continued and secure access points into the roost.
- 4.10. The species of long-eared bat present will need to be confirmed and this can be carried out by DNA analysis of droppings that were gathered from the roost during survey.

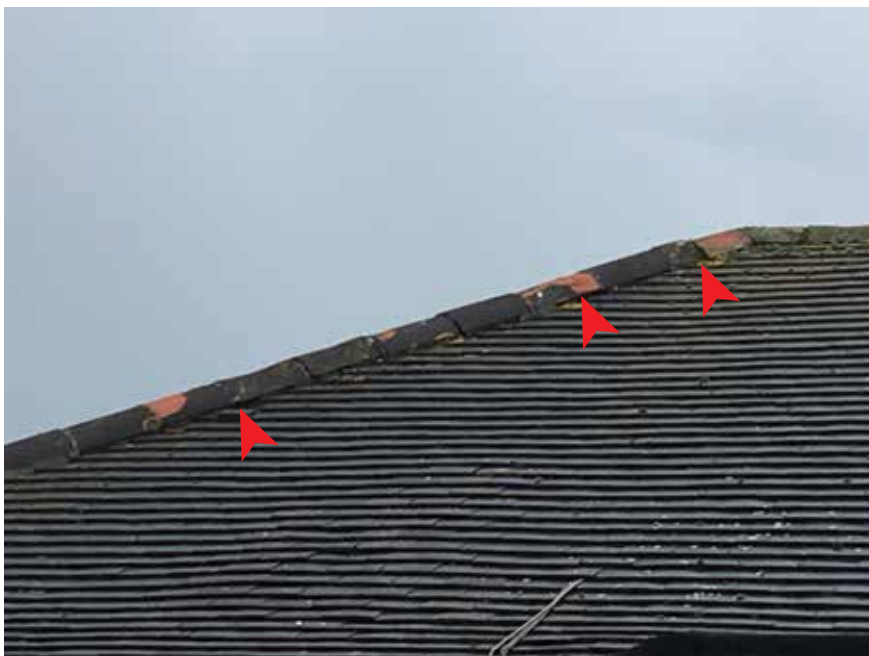
Photograph 6:

- A few ridge tiles with missing bedding mortar; refer to Photograph 6
  - Crevices associated with leadwork around the chimney bases; refer to Photograph 7

Example of ridge tiles; all are present, however a few e.g. on the north-west elevation appear to have areas of missing bedding mortar; as highlighted

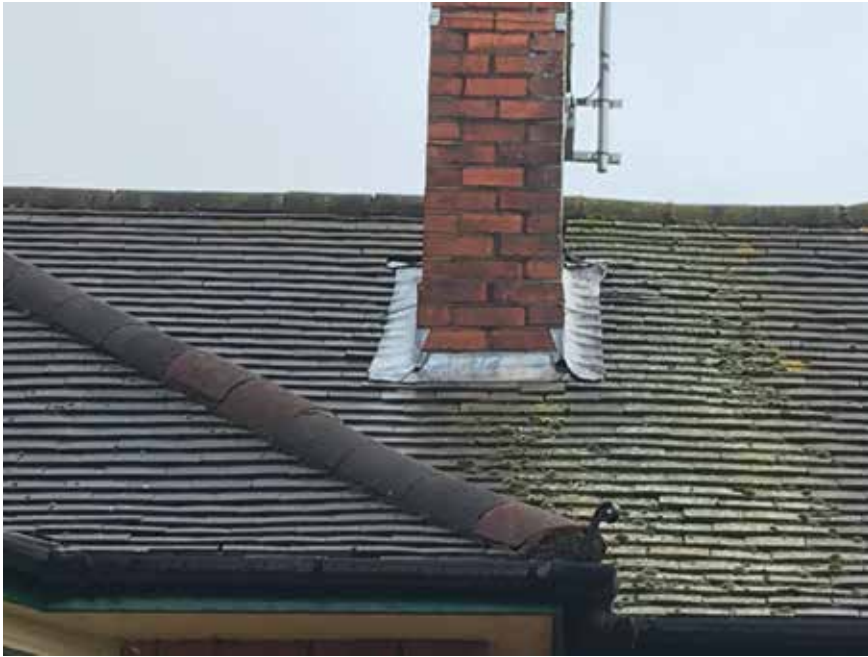
Photograph 7:

The dwelling has two simple red brick chimney stacks, both chimneys remain in good order with all pointing remaining intact. Lead work seals the chimney bases to the roof and while lead work remains in place; there is some evidence of significant lifting on both chimneys; refer to photograph 7.

Crevices associated with leadwork around southern chimney base

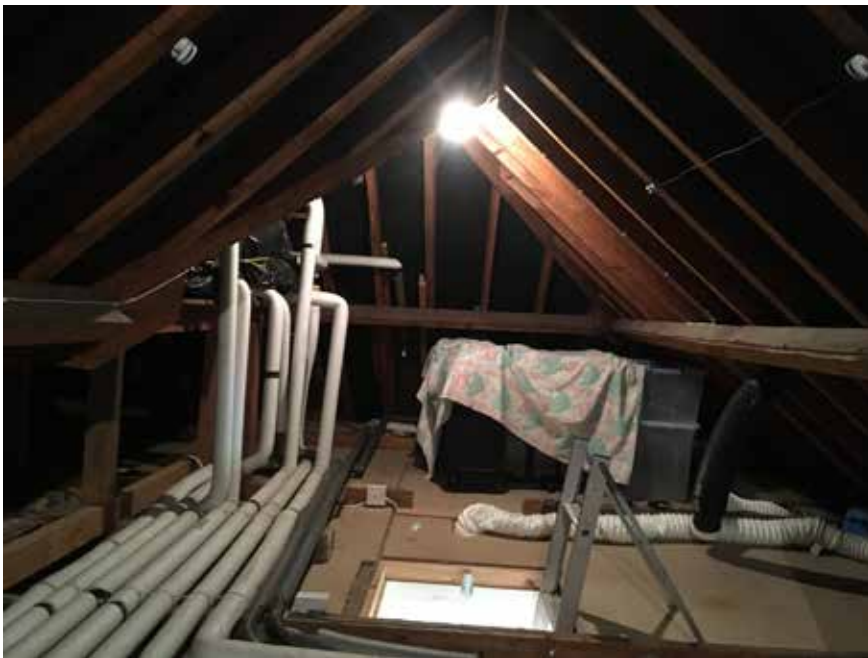
Photograph 8:

Roof void; Northern end

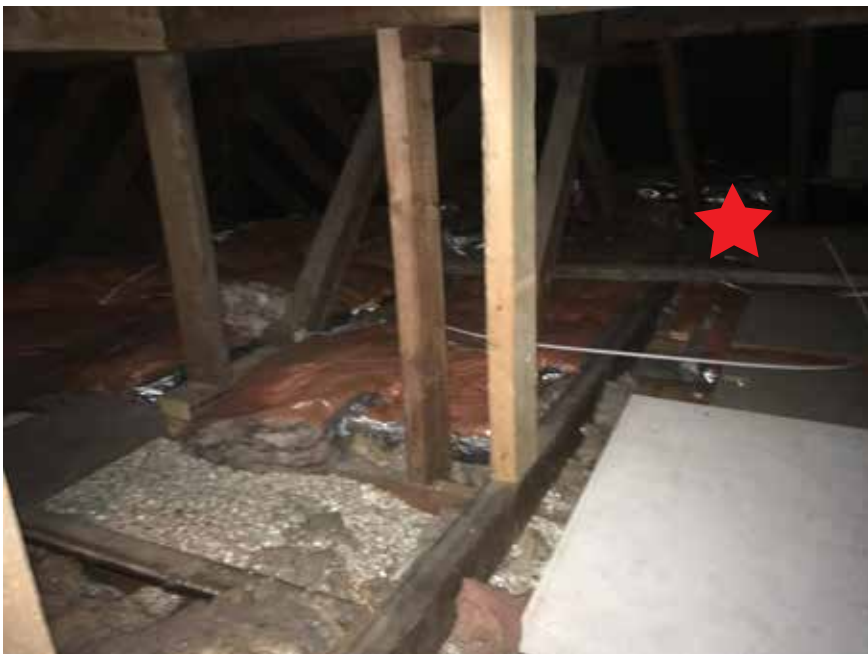
Photograph 9:

- 3.8. The roof void is currently supporting a small roost of long-eared bats. Bat droppings are confined to the southern end of the loft which provides a more secluded area which is away from the loft hatch and where household items are stored.

Roof void; southern end; location of bat droppings. Refer to Target Note 2 within the report and on Figure 2; the survey results drawing.

- 4.7. Due to the building having a confirmed bat roost, it is recommended that up to 3 visits are undertaken comprising evening emergence/dawn re-entry surveys, which should be spread-out by at least a two week gap. Surveys should take place during the main bat activity period; between May and September. The results of the surveys will aim to identify the quantity of bats present and the pattern and usage of the roost and will inform a suitable mitigation strategy for the protection of bats. Surveys will also confirm if any other species of bat is roosting in association with the building.
- 4.8. The survey findings will also assess as to whether the proposals will require a bat mitigation licence.

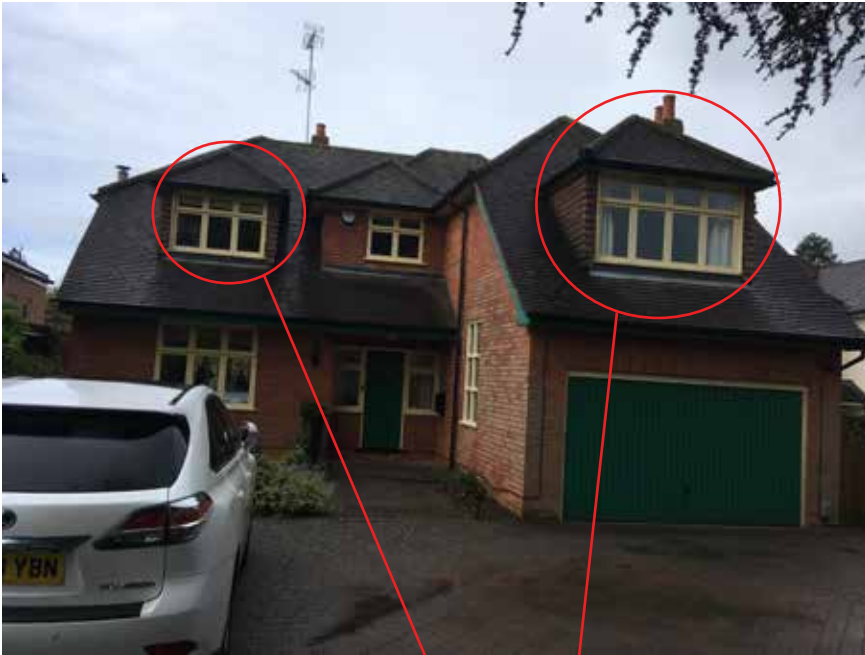
Photograph 1:

Front; eastern elevation

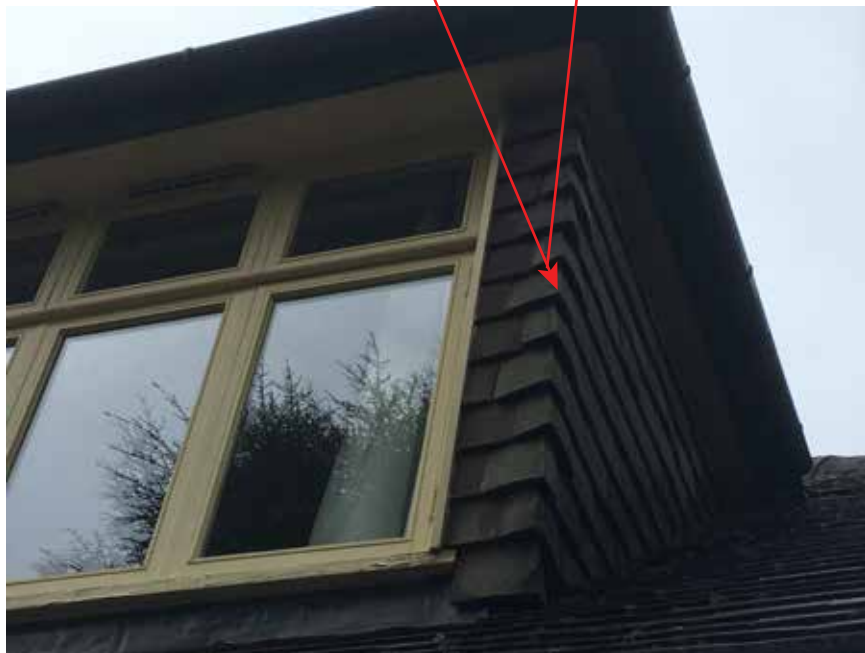
Photograph 2:

of cladding numerous small crevices are present along the tiles bases and while not leading to a building defect do provide significant access points that lead into the shallow, hidden cavities that lay below and are created by the battens that the tiles are hung from. Refer to photograph 2.

Detail illustrating gaps associated with hanging tiles that clad the northern and southern dormers. Neither dormer is planned for any alterations and will remain in situ.

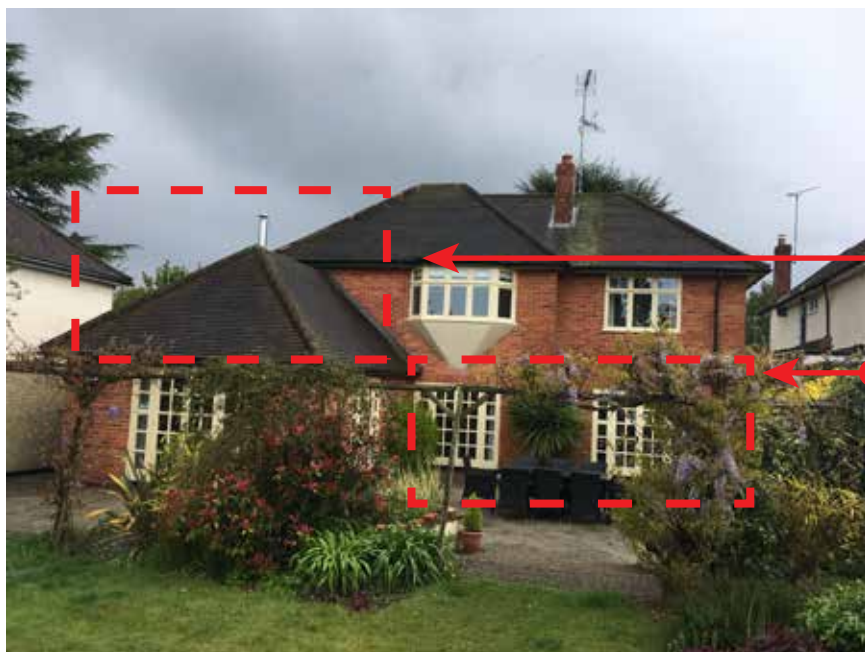
Photograph 3:

Rear; western elevation

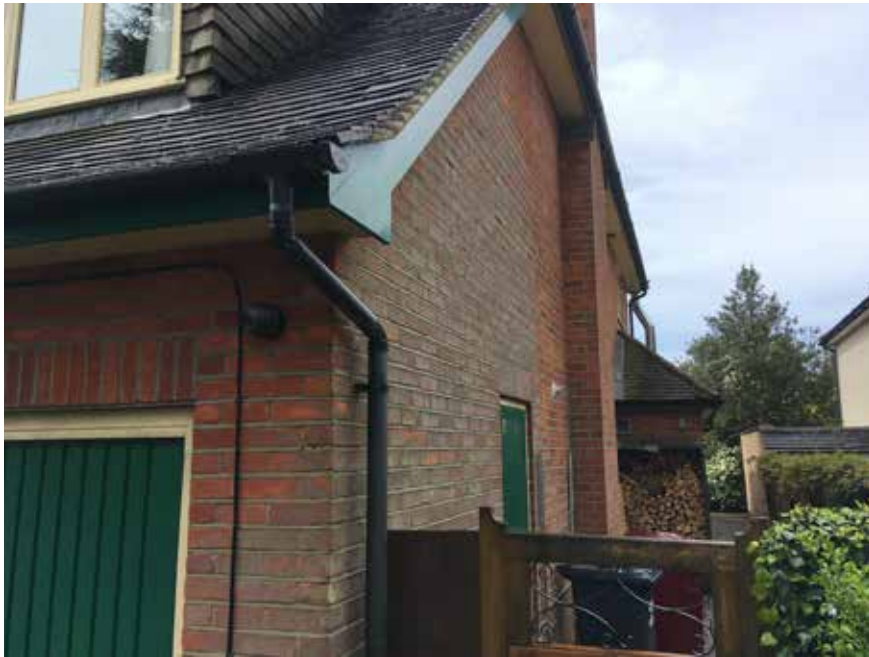
Photograph 4:

Side; northern elevation; the southern elevation is similar

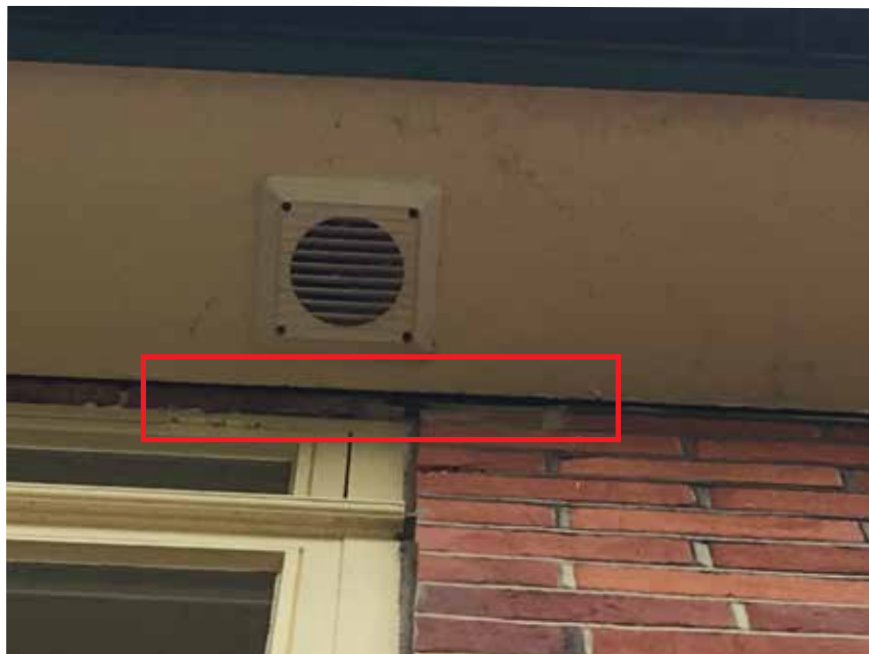
Photograph 5:

The dwelling has a significant roof overhang and is fitted with a simple timber soffit arrangement. Soffits all remain in good order with no evidence of areas of rot, however a few small but significant gaps are present where the horizontal soffit base meets the brickwork and fails to seal tightly; this can be seen on the northern side elevation; refer to photograph 5.

Example of soffit; the majority fit well; however a few small but significant crevices are present; as highlighted.

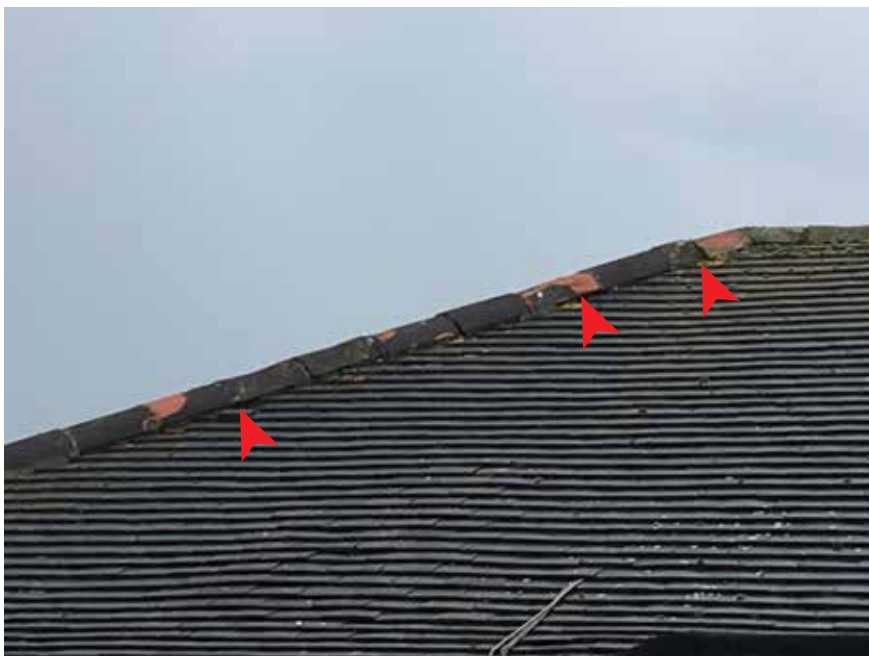
Photograph 6:

- A few ridge tiles with missing bedding mortar; refer to Photograph 6
  - Crevices associated with leadwork around the chimney bases; refer to Photograph 7

Example of ridge tiles; all are present, however a few e.g. on the north-west elevation appear to have areas of missing bedding mortar; as highlighted

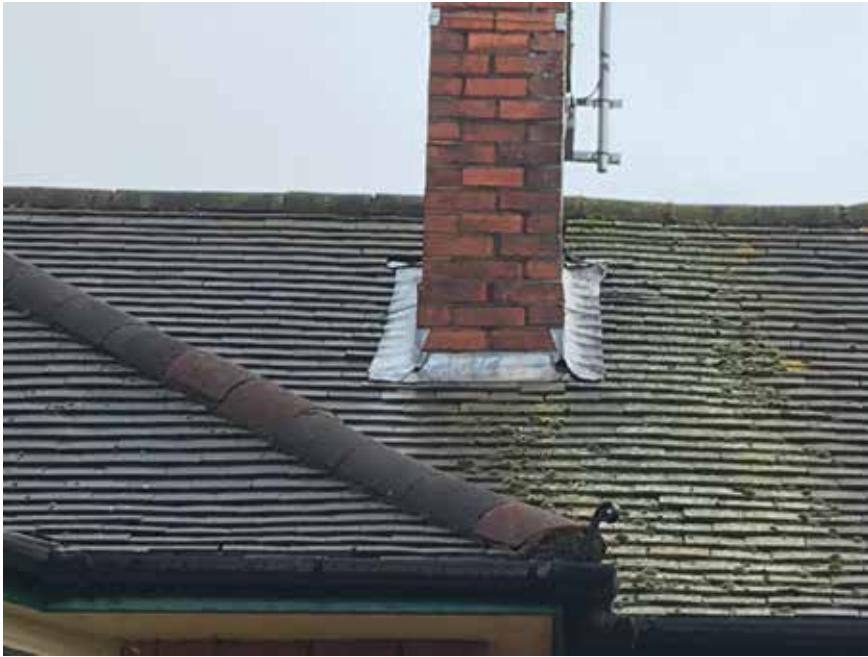
Photograph 7:

Crevices associated with leadwork around southern chimney base

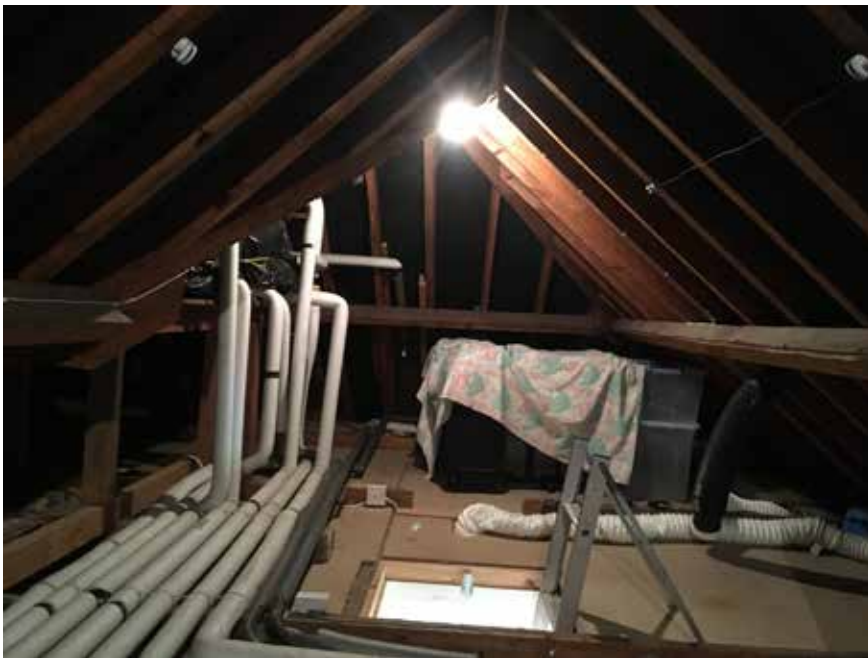
Photograph 8:

Roof void; Northern end

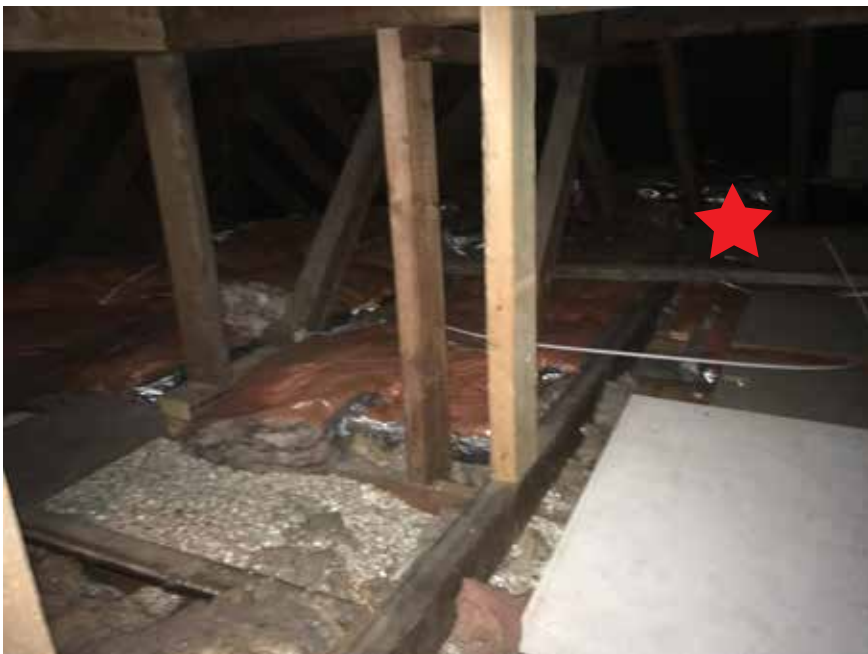
Photograph 9:

Roof void; southern end; location of bat droppings. Refer to Target Note 2 within the report and on Figure 2; the survey results drawing.

- 4.7. Due to the building having a confirmed bat roost, it is recommended that up to 3 visits are undertaken comprising evening emergence/dawn re-entry surveys, which should be spread-out by at least a two week gap. Surveys should take place during the main bat activity period; between May and September. The results of the surveys will aim to identify the quantity of bats present and the pattern and usage of the roost and will inform a suitable mitigation strategy for the protection of bats. Surveys will also confirm if any other species of bat is roosting in association with the building.
- 4.8. The survey findings will also assess as to whether the proposals will require a bat mitigation licence.
