**Terramech Investigations Ltd**

## Envirocheck<sup>®</sup> Report:

### Mining and Ground Stability Datasheet

DISCOVERY STATEMENT

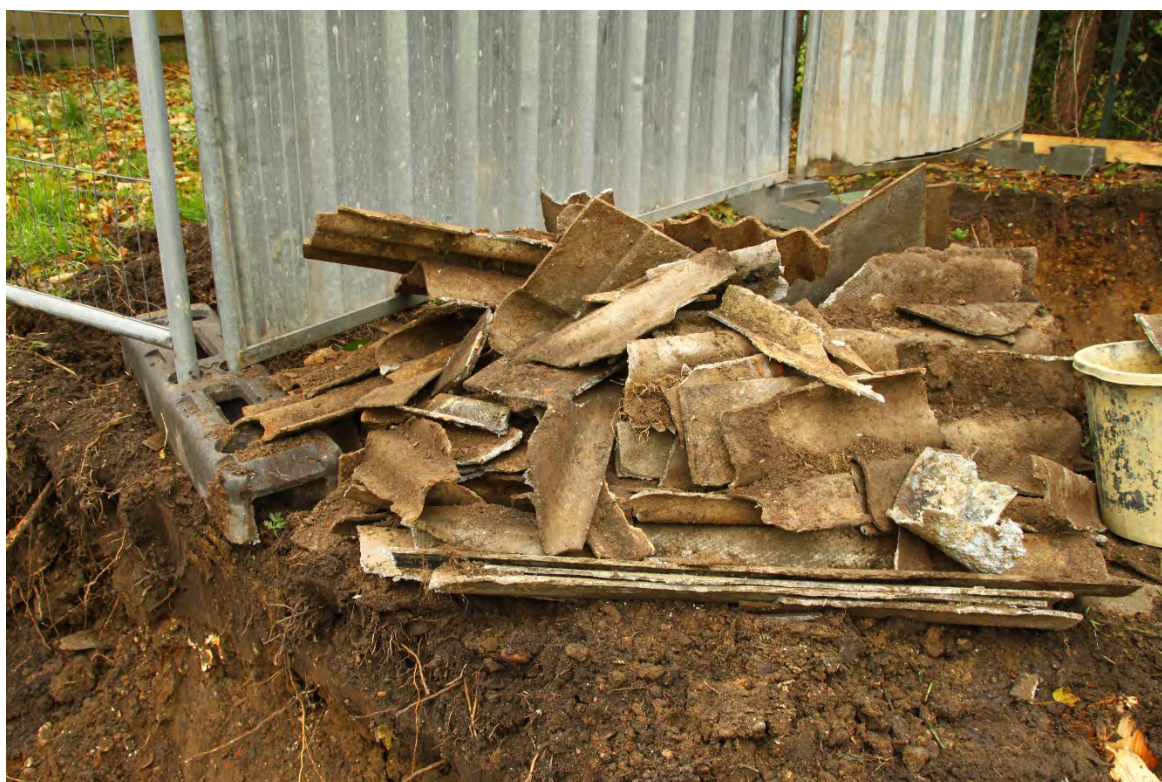
These former stables may have been repaired or roofed completely with corrugated asbestos cement boards. There is some potential for any hardcore or rubble used at this site historically to have included fragments of asbestos cement roof board.

If the fragments are intact and un weathered, the risks are negligible however, it would be prudent to ensure that there are no residues in garden areas.

Any fragments found over the proposed new building foot print should be hand picked before the ground is covered by the new building. Any errant fibres left behind below the building would not pose any risk to human health.

If very weathered friable fragments of roof board are found, or in the very unlikely even that other asbestos products are discovered, work in that area should be halted and the discovery notified.

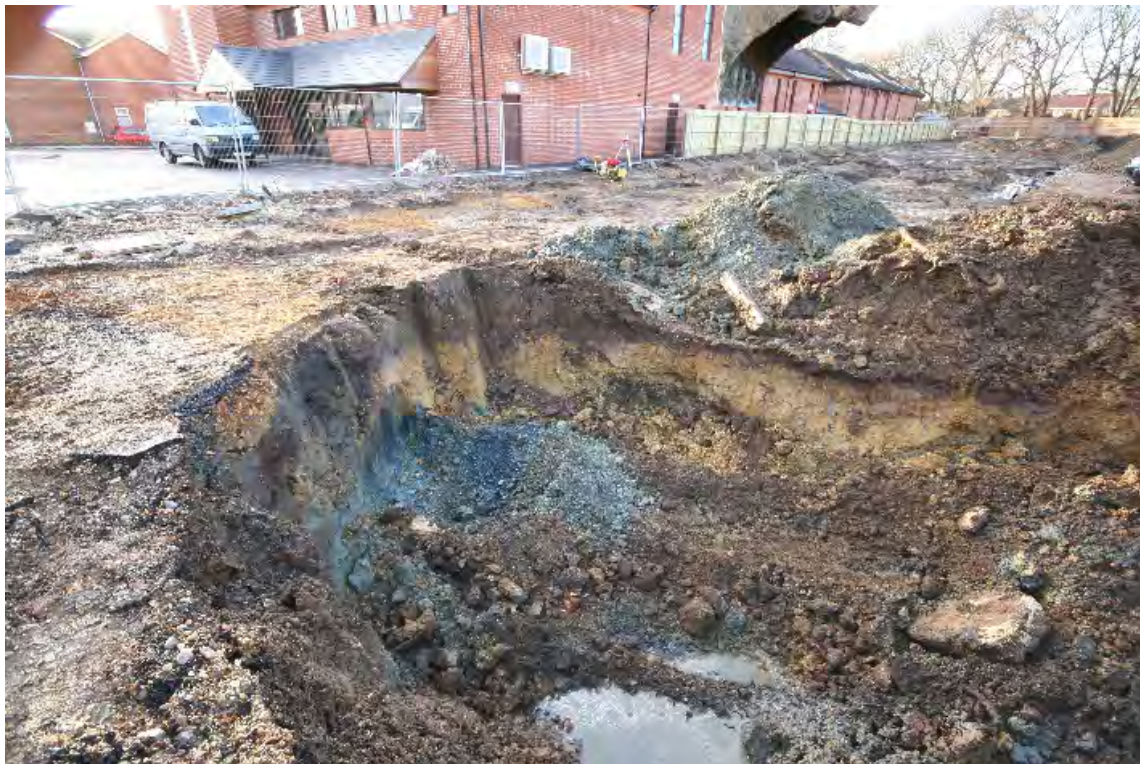
Sometimes, where the hydrocarbons have become absorbed by naturally orange brown coloured soils (due to natural Iron compounds), the soils can become stained a blue/grey colour as shown in the picture above where diesel had leaked into the ground.

Old engine oil will stain soils black, sometimes the oil can become emulsified and appear as a pale coffee coloured paste.

As discussed, fuel and lubricants may have entered the ground during the use of the site as a repair garage. Most site workers should be aware of the types of odour associated with petrol, diesel and old engine oil.

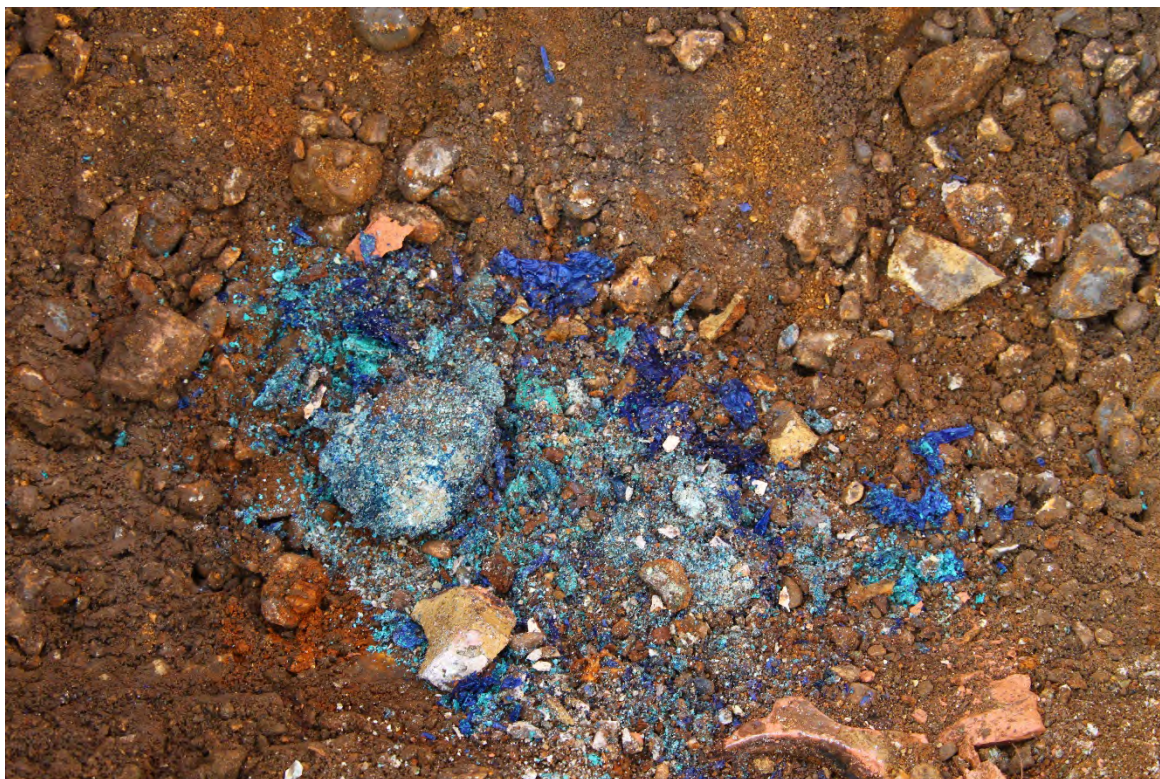
The site may also have been used historically by a printing firm. There is potential for inks and pigments to have entered the ground on or around the garage. The picture above shows residues from a printing works in Reading where metal based pigments had encrusted an old drainage pipe.

Most small print shops have limited potential to contaminate the ground however, if any signs of odorous solvents or discoloured soils are found work should stop in that area and the discovery notified.
