### Stadium Way, Reading – Bat Scoping Survey

- 1.1 Greengage Environmental Ltd was commissioned by SHP Opportunity Fund General Partner Ltd to undertake a bat scoping survey at a site located off Stadium Way in Reading, Berkshire.

- 1.2 This report has been produced to accompany a planning application for the site. Proposals seek for demolition of the existing buildings and erection of a new warehouse building with associated landscaping, vehicle access and parking.

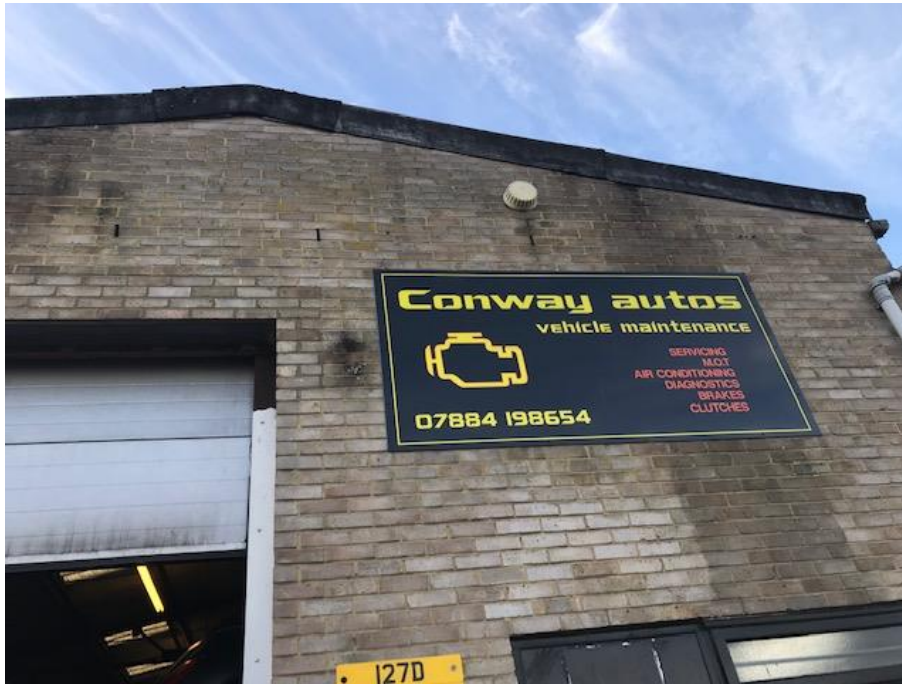
| Building Ref. and existing use | Potential Roosting Features | Roosting bat value and survey requirements |
|---|---|---|
| 1. Conway Autos | Gaps under roofing membrane on northern and southern elevations.<br>No internal roof voids.<br>See Fig 4.1 | Moderate potential:<br>Further endoscope survey confirming likely-absence |

**Figure 4.1 Loose overhanging roofing membrane Building 1**

- 5.2 As a precautionary approach, it is recommended that demolition is preceded by a soft-strip of roofing materials, soffit and fascia boards to be overseen by an ecologist.

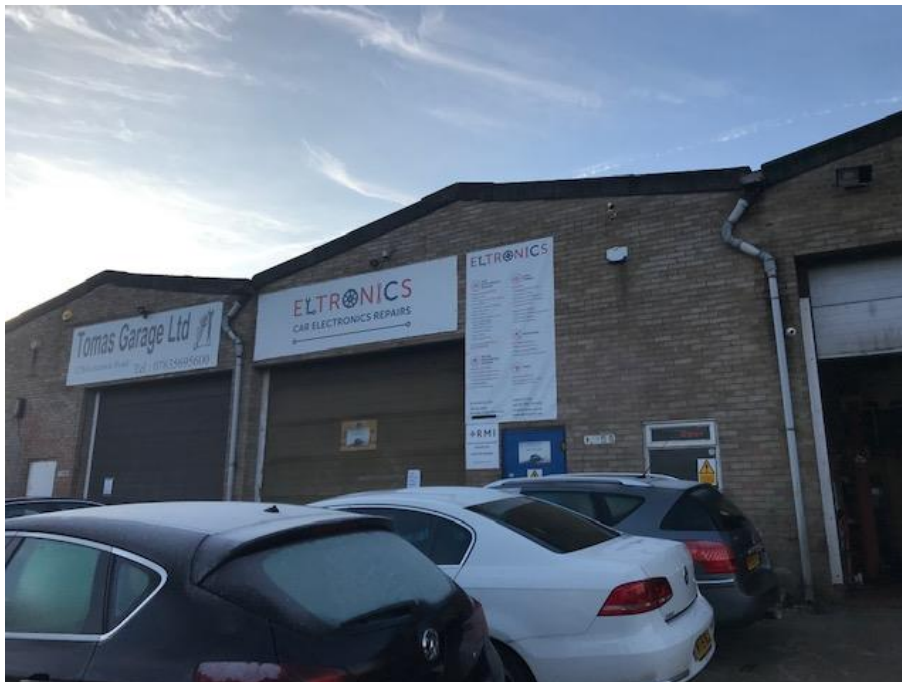
| Building Ref. and existing use | Potential Roosting Features | Roosting bat value and survey requirements |
|---|---|---|
| 2. Eltronics | Gaps under roofing membrane on northern and southern elevations.<br>No internal roof voids.<br>See Fig 4.2 | |
| 3. Tomas Garage Ltd | Gaps under roofing membrane on northern and southern elevations.<br>Hole in brickwork with possible access into wall cavity.<br>No internal roof voids.<br>See Fig 4.2 | |

**Figure 4.2 Loose overhanging roofing membrane Buildings 2 and 3**

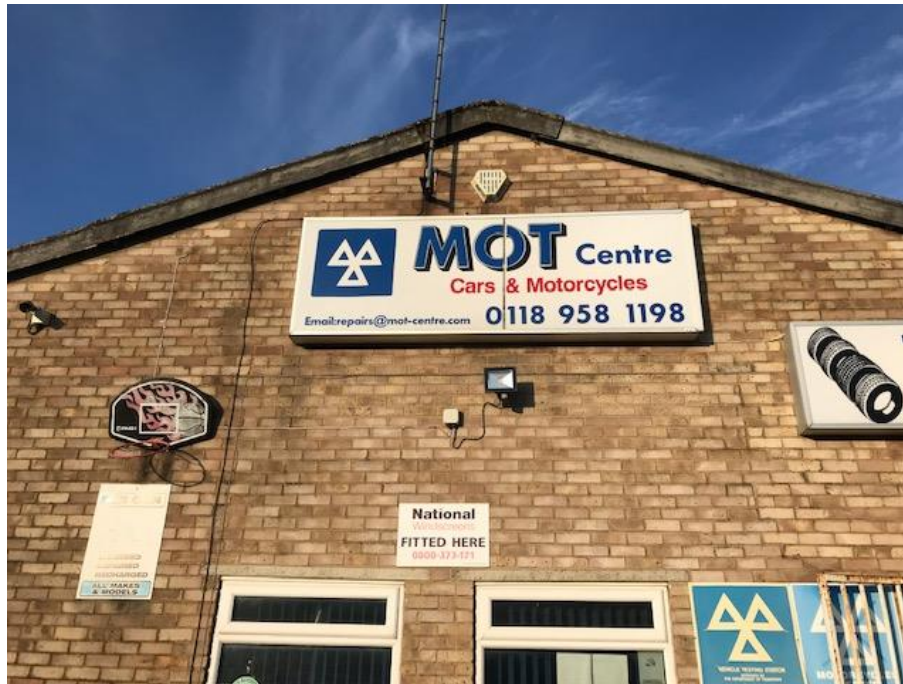
| Building Ref. and existing use | Potential Roosting Features | Roosting bat value and survey requirements |
|---|---|---|
| 4. MOT Centre | Small strip of rotten wooden fascia boarding on southern elevation of building.<br>Hole in brickwork with possible access into wall cavity.<br>No internal roof voids.<br>See Figs 4.3, 4.4 and 4.5 | |

**Figure 4.3 Large gaps under mounted wooden fascia boarding on Building 4 (not suitable for roosting)**

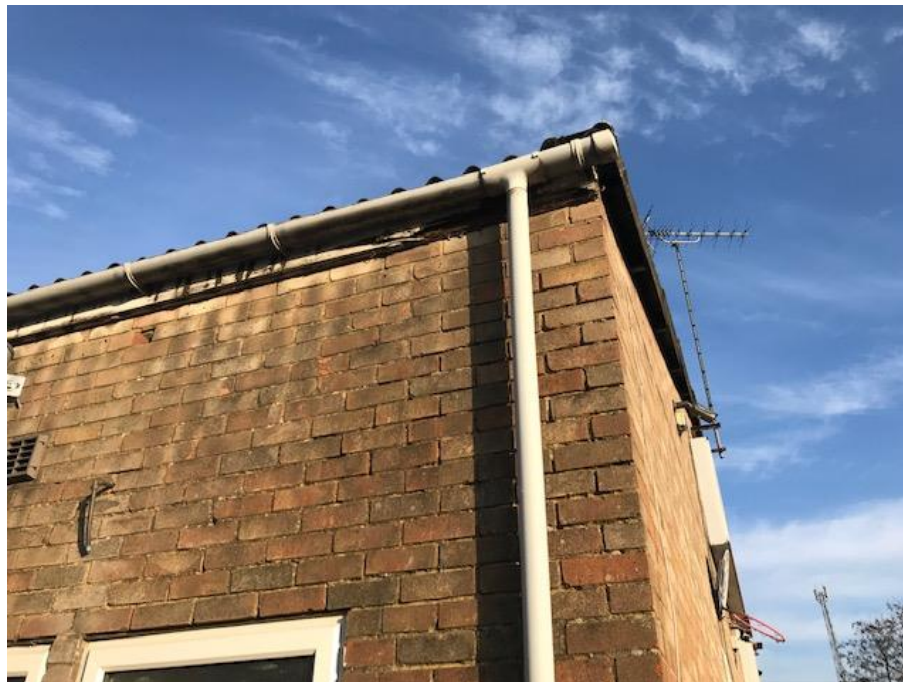
**Figure 4.4 Rotten wooden fascia board on Building 4**

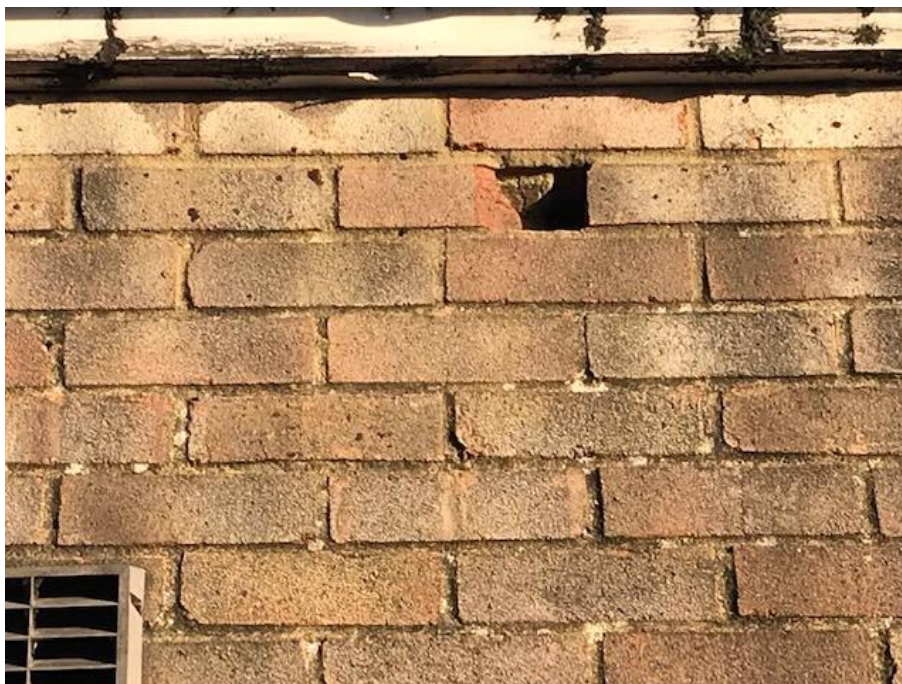
**Figure 4.5 Hole in brickwork below fascia possibly leading to internal wall cavity on Building 4.**

- 4.16 Demolition should therefore be undertaken outside of breeding bird season (March – August inclusive) or following a nesting bird check by a suitably qualified ecologist who confirms absence.

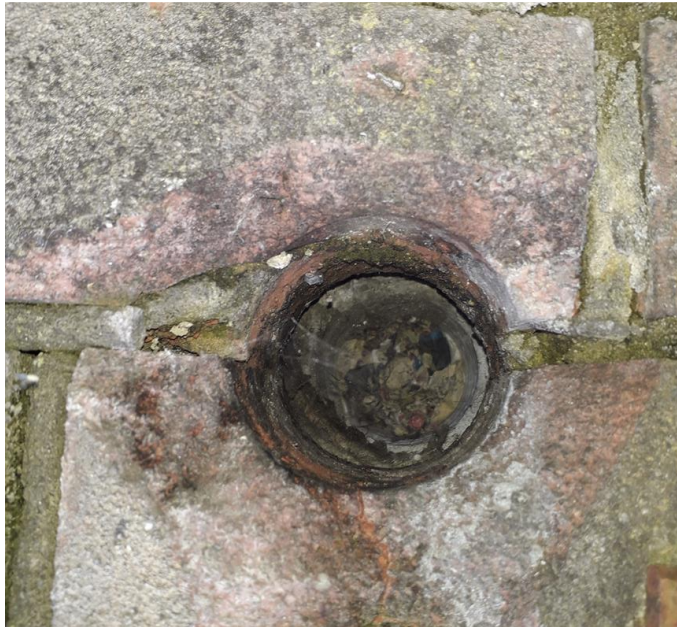
unlikely to support roosting bats. The holes in the brickwork were confirmed to be small gaps where old drain piping had been removed. Photographs taken on the endoscope survey are provided at figures 4.6-4.9 below.

**Figure 4.6 Hole in brickwork – old drain pipe**

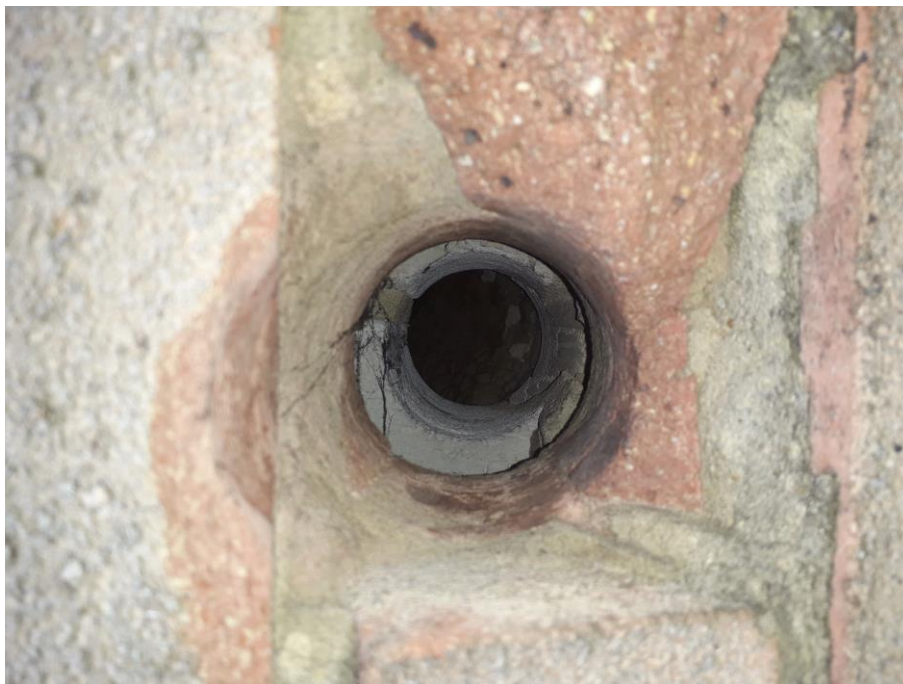
**Figure 4.7 Hole in brickwork – old drain pipe**

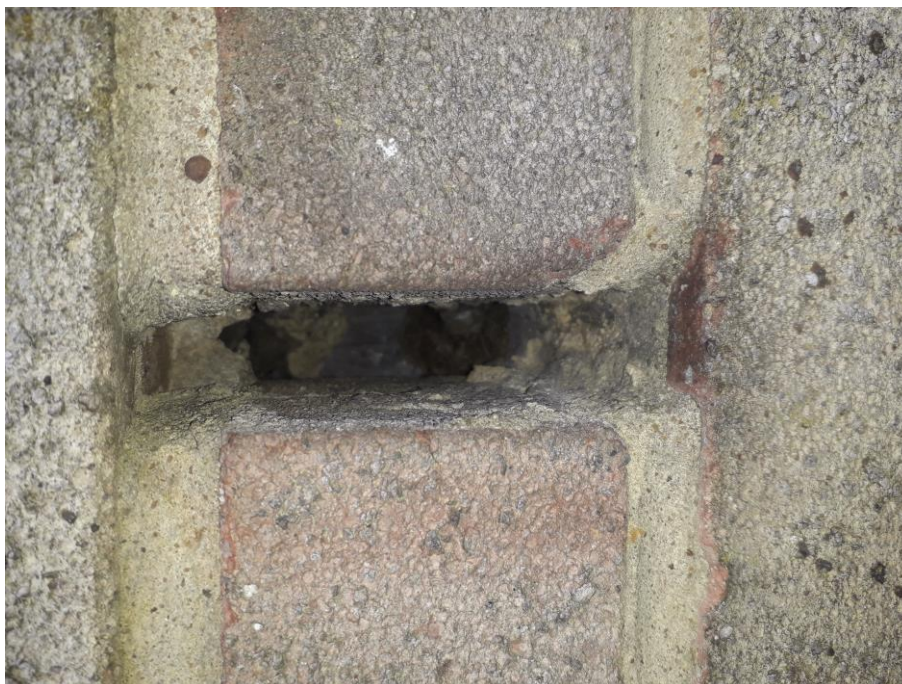
**Figure 4.8 Hole in brickwork – missing mortar**

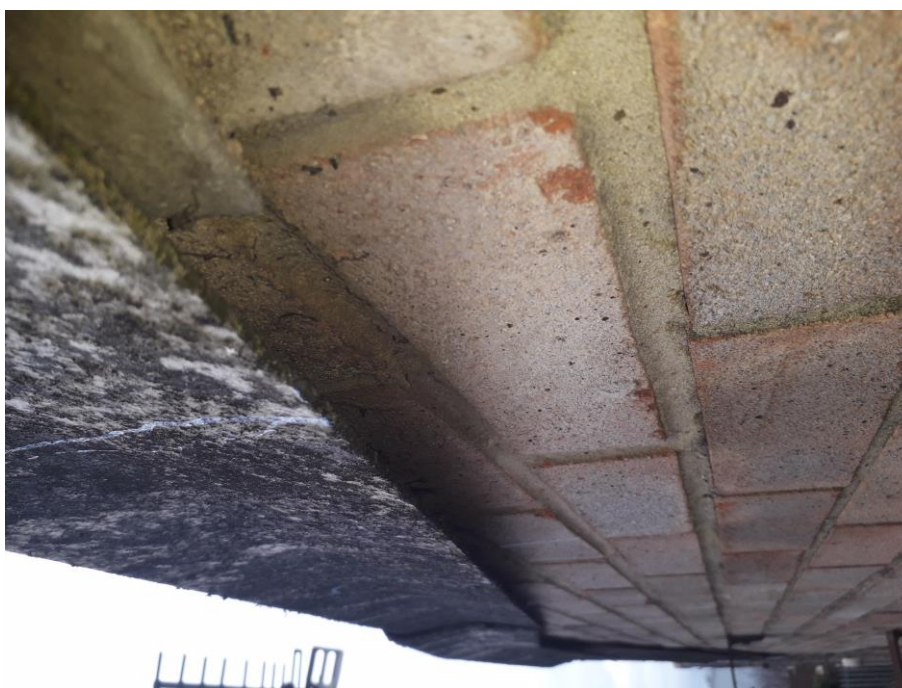
**Figure 4.9 Gaps under roofing material**

- 4.14 No live bats or evidence of roosting was identified by the endoscope survey and roosting bats are confirmed as likely-absent from the building.

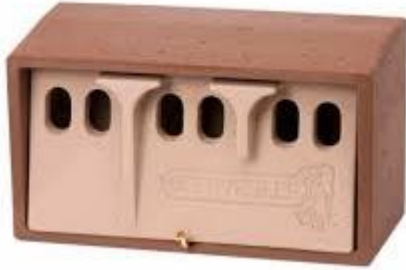
**Figure 5.2 House sparrow terrace (Schwegler 1SP)**

- Integrated bird boxes in the new building – at least two house sparrow terraces should be incorporated into the new building (see Fig 5.2). The boxes should be integrated into the building fabric at 2-5m height on north/east facing elevations.
