# Bat Survey of 10 Pegs Green Close, Reading, Berkshire

**Client** Mr and Mrs Akhtar

**Reference** A1133.001

**Date** 8 April 2019

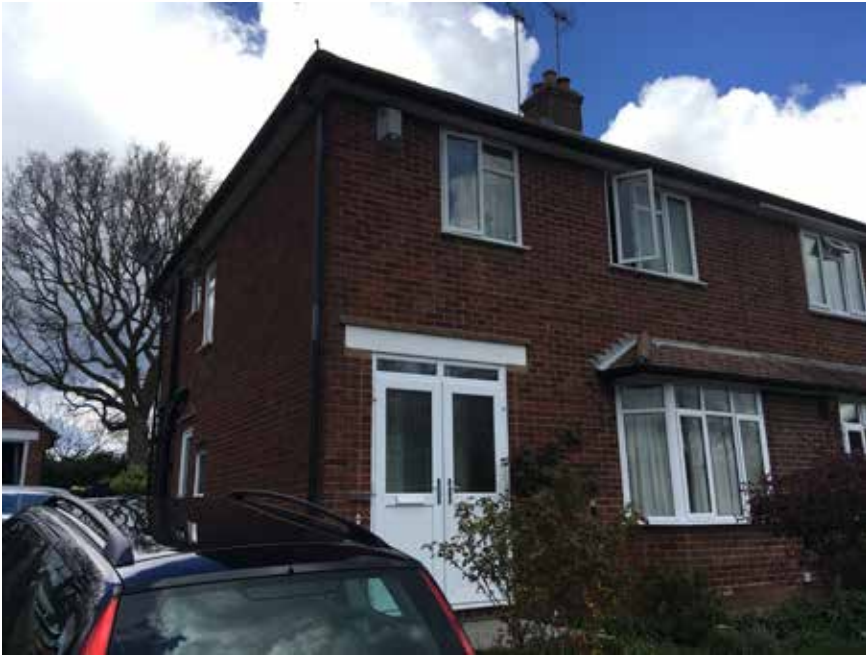
Photograph 1:

Front (southern) and side (western) elevation

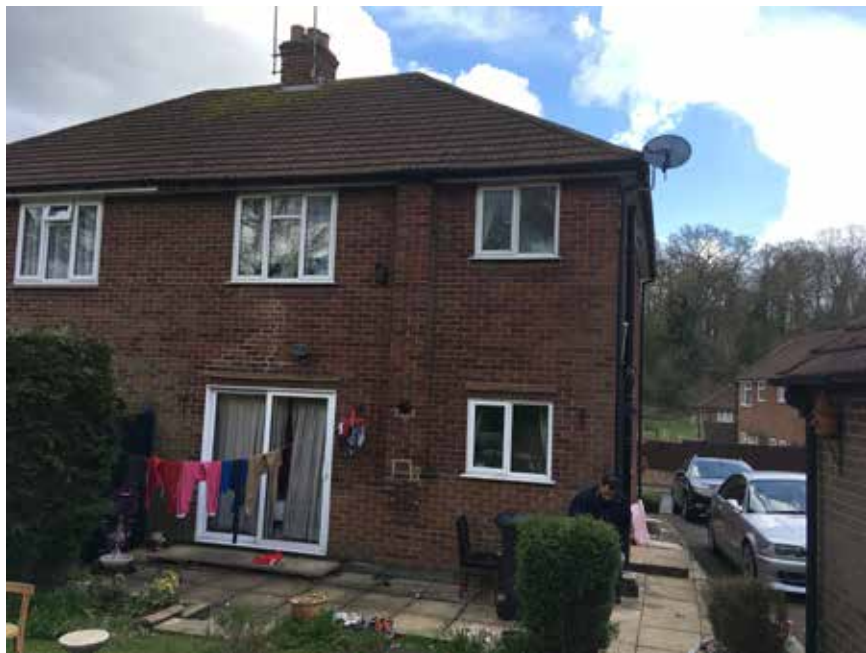
Photograph 2:

Rear (northern) elevation

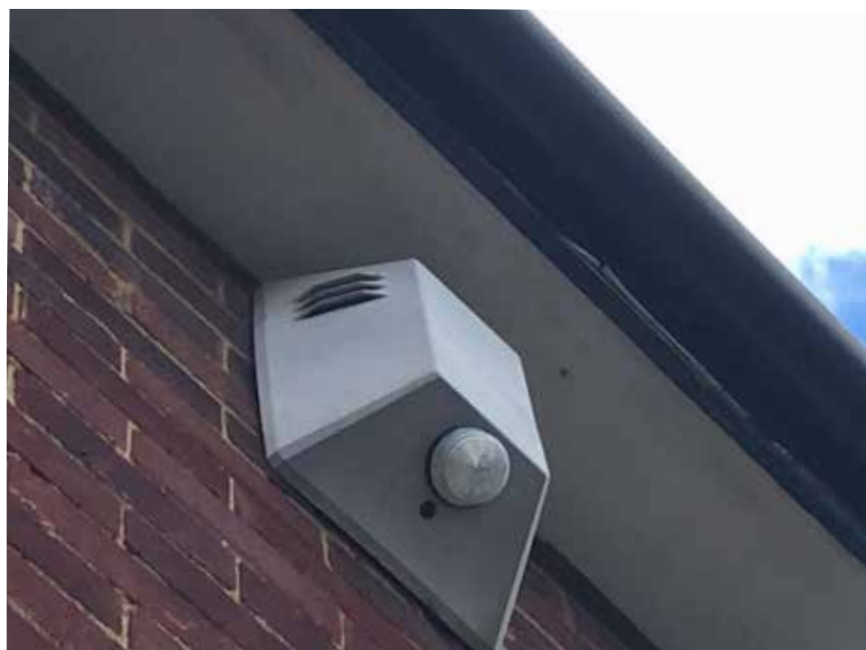
Photograph 3:

Example of tight fitting soffit; typical throughout

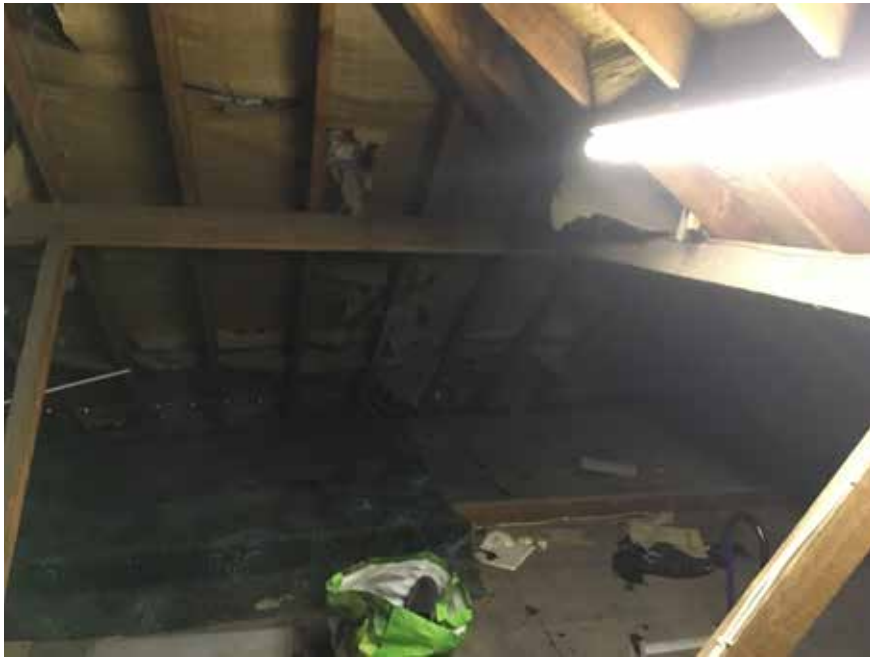
Photograph 4:

| Building | Feature | Feature Description | Bat suitability |
|---|---|---|---|
| | Interior | <p>A single and spacious square shaped roof void forms the loft with floor to ridge height of approximately 2.5 m. The loft is uncomplicated and allowed for a full and thorough examination. The roof is supported by standard style cut and pitch roof constructed using modern gauged timber with no complex carpentry or significant complexities. Tar paper forms the sarking layer and is generally in poor condition with numerous tears and holes which leads to the exposure of the underside of the tiles in various places; however due to the tight-fitting interlocking nature of the tiles no significant gaps are present.</p> | |

Loft

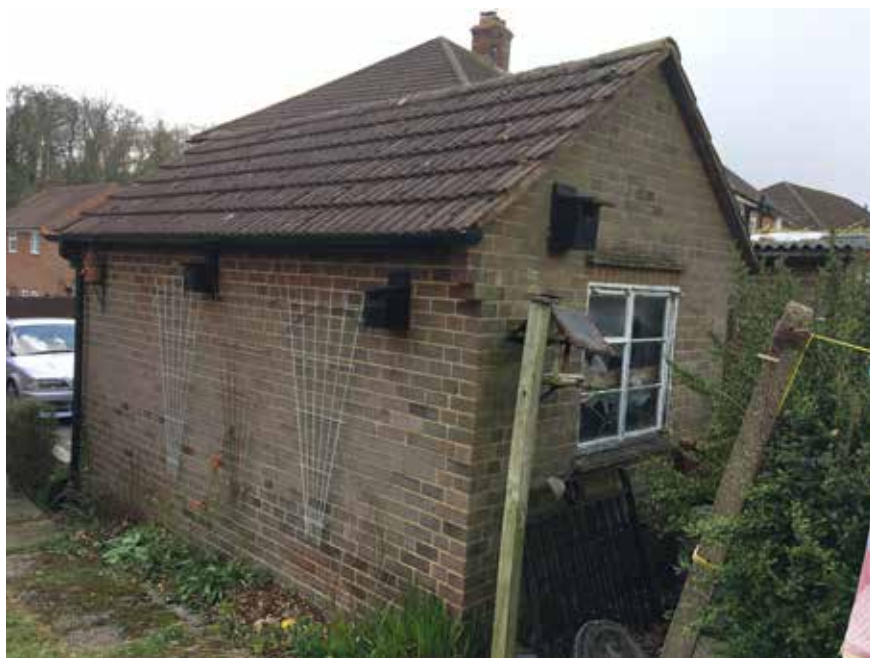
Photograph 5:

Garage; Northern gable and side (eastern) elevation

- 4.5. Prior to the demolition of the garage a careful check should be carried out on the three wooden bird boxes present on the exterior garage wall and If birds are found

to be nesting or rearing young then works must be delayed until all young have left the nest. Birds are afforded legal protection as discussed under paragraph 1.9.

- 4.6. If no active bird nests were found to be present then it is recommended to remove the boxes and relocate onto the trunk of the mature oak tree *Quercus robur* in the north-east corner of the garden. Place boxes securely on the tree and at least 2 m off the ground.

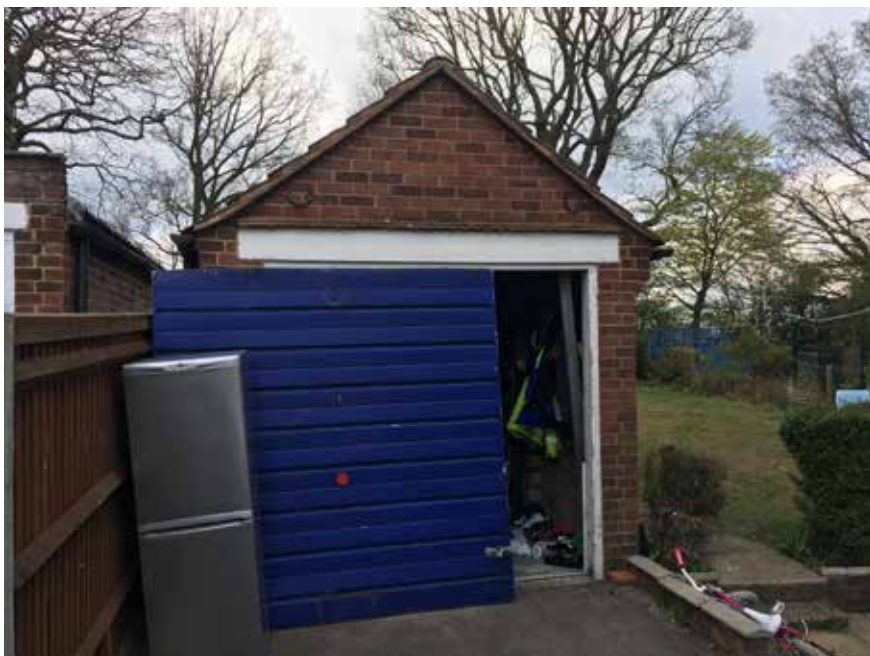
Photograph 6:

Garage; southern gable

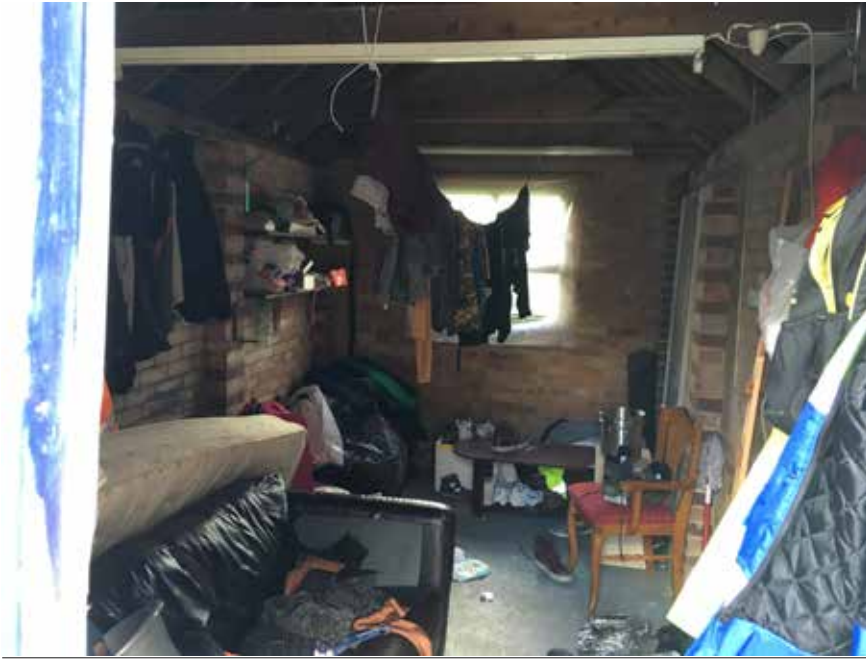
Photograph 7:

| Building | Feature | Feature Description | Bat suitability |
|---|---|---|---|
| | | <p>The garage provides one single bay, clear to apex. Traditional type 1 f sarking felt is on show and remains intact throughout.</p> <p>Internal walls are well-pointed brick and due to the poorly fitting door the interior is well lit and draughty. The interior of the garage is in regular use as a laundry drying area and general store.</p> | |

Garage; internal

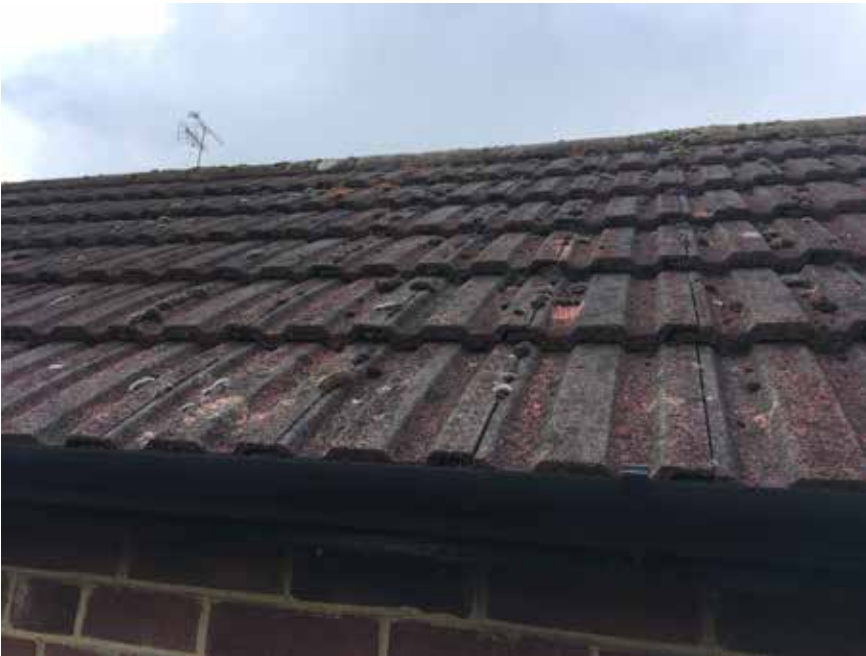
Photograph 8:

| Building | Feature | Feature Description | Bat suitability |
|---|---|---|---|
| | Roof | <p><i>Dwelling</i></p> <p>The dwelling has a simple square shaped hipped roof, which is entirely clad with modern style Ludlow interlocking concrete tiles. All are present and due to the interlocking nature of the tiles, no significant crevices are present. Simple ridge and hip tiles are also present, and all remain well-cemented in place.</p> <p>A slight roof hang on the eaves elevations necessitates the use of soffits, which remain in very good condition, sealing well to the roof eaves and top course of masonry, with no obvious entry points that may lead into the cavity or roof void.</p> <p><i>Garage</i></p> | |

| Building | Feature | Feature Description | Bat suitability |
|---|---|---|---|
| | | <p>The garage has a simple double pitched roof clad with the same type of concrete interlocking tile and simple concrete ridges that are used on the house; all remain present and well seated in place and for the same reasons discussed above provide no significant crevices. Both roof verges remain well-sealed with mortar.</p> <p>Simple fascias carry the guttering and no significant cavities / crevices are present.</p> | |

Roof of dwelling and garage; covered with tight fitting 'Ludlow' interlocking concrete tiles throughout.
