## PHASE 1 PRELIMINARY RISK ASSESSMENT

71-73 CAVERSHAM ROAD, READING, BERKSHIRE RG1 8JA

JER8219  
PHASE 1 PRELIMINARY RISK  
ASSESSMENT  
V1  
October 2019

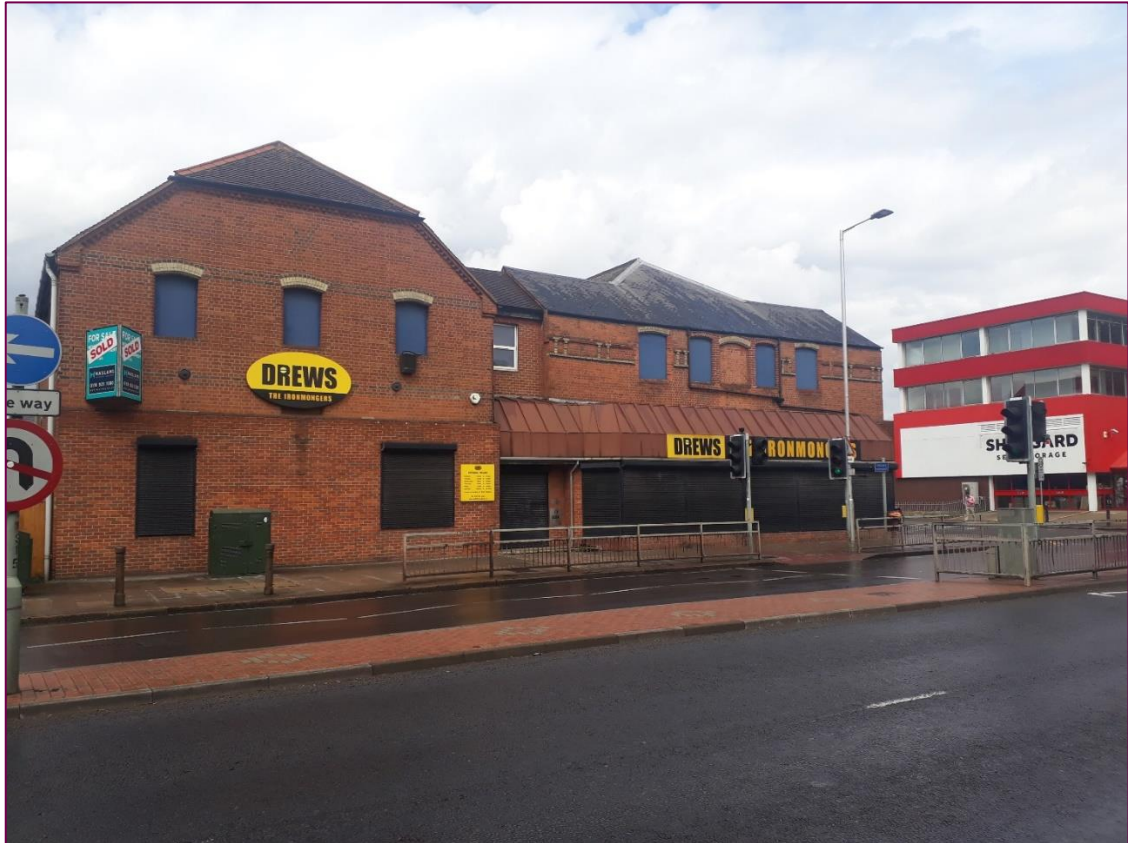
General view of the site. For further photos see Appendix B.

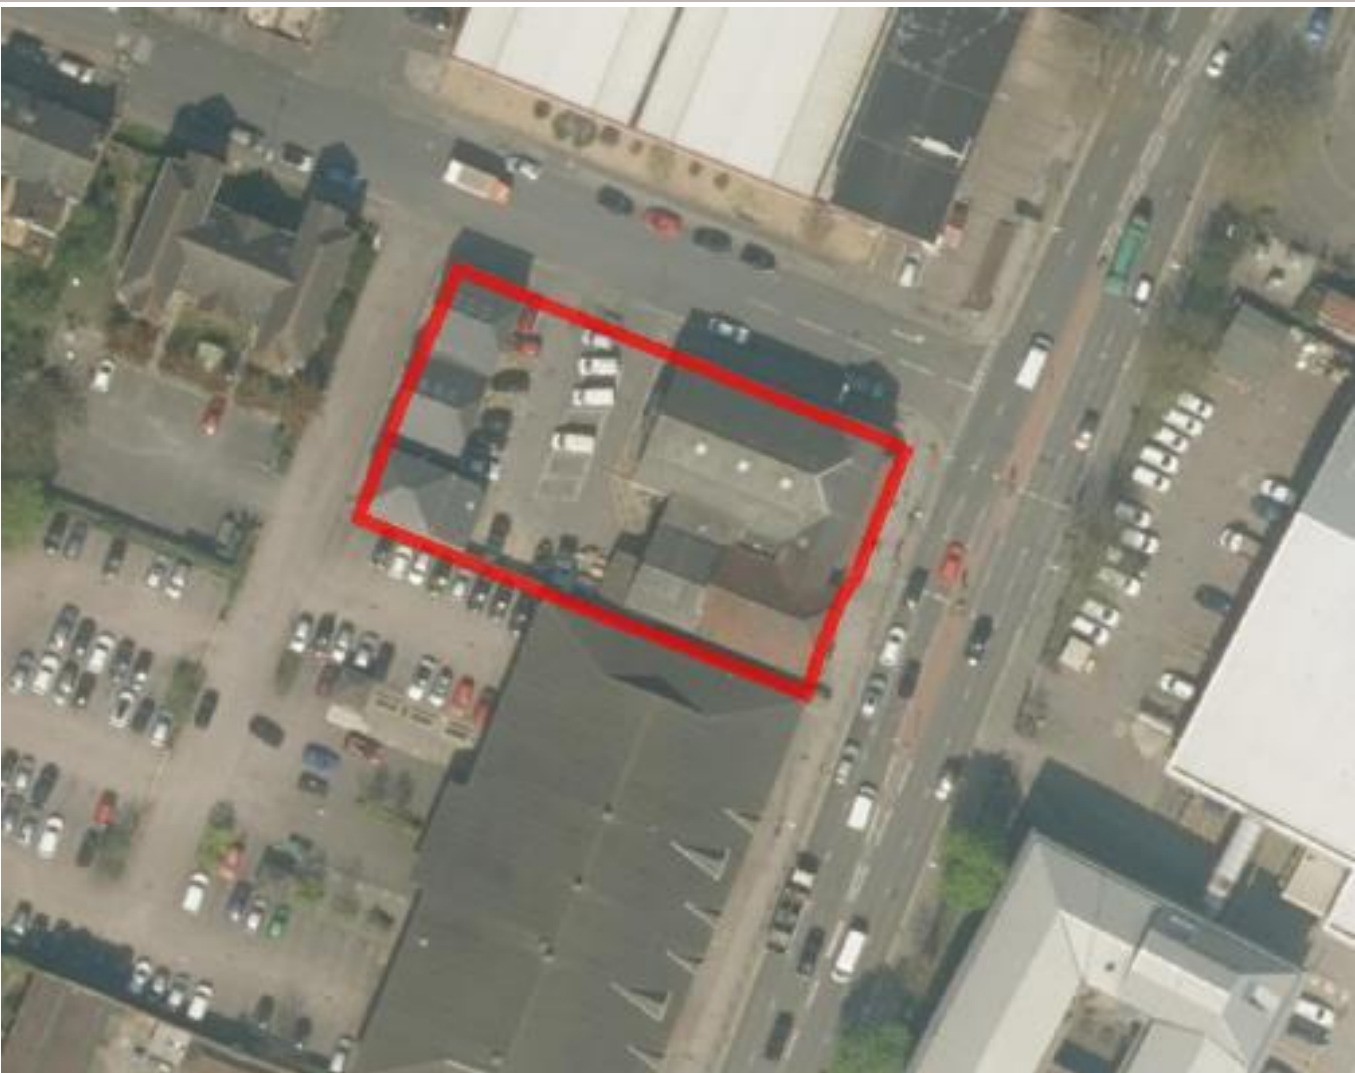
**Figure 2:** Site Boundary Plan

- 2.1.1 This section of the report is based upon observations made during a site visit carried out on 12<sup>th</sup> August 2019. Access to the office premises in the west of the site was not permitted as part of the site walkover. A site boundary plan is provided as Figure 2. Selected photos are shown in Appendix B.

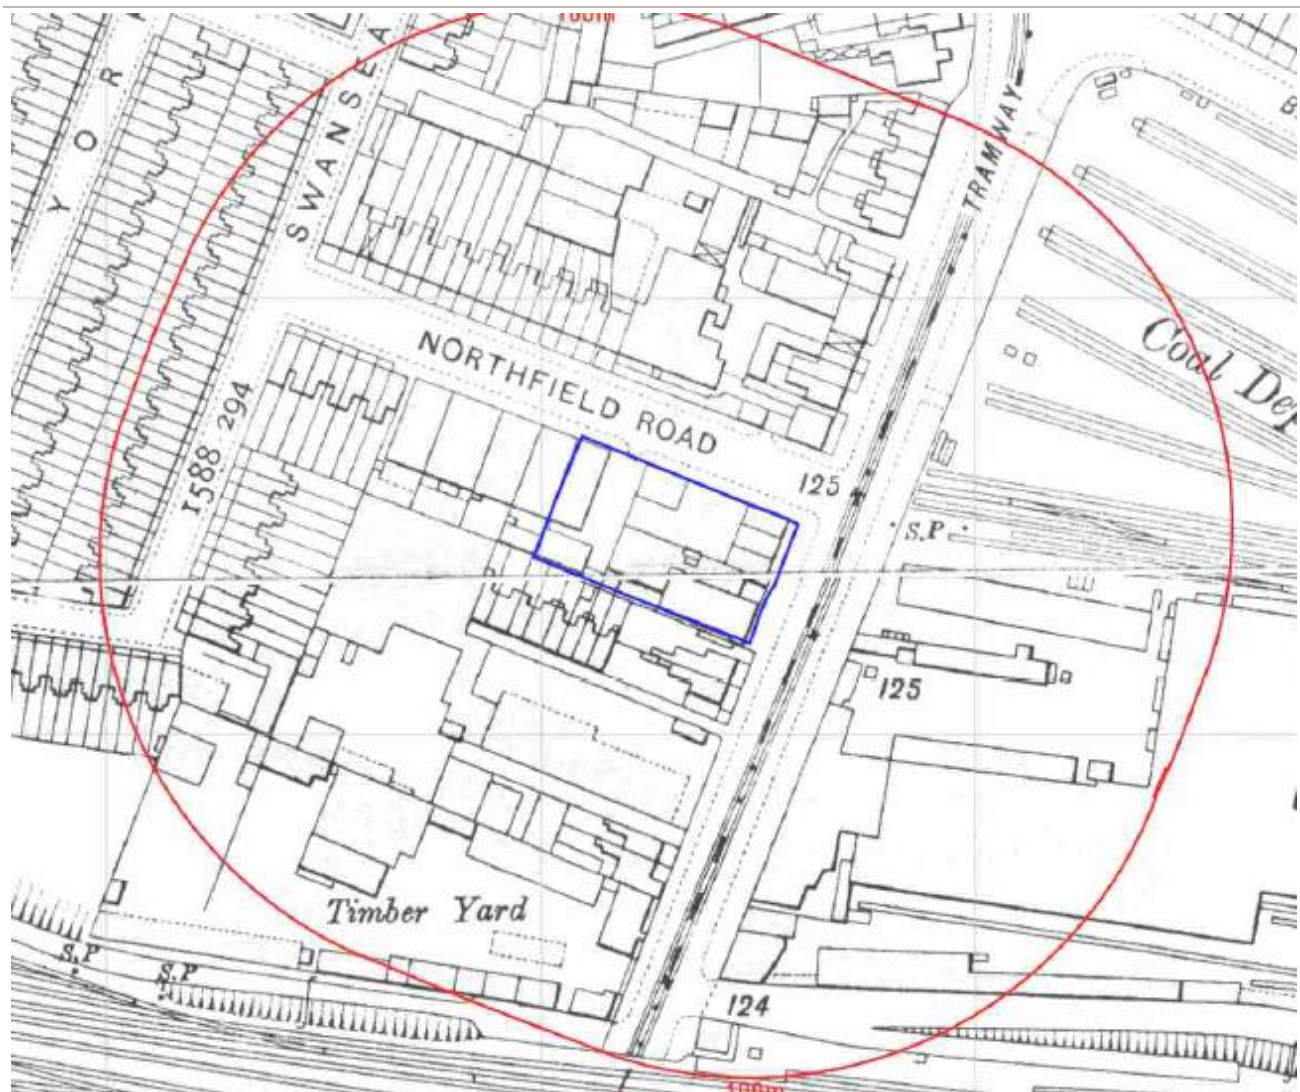
Figure 5: Historical Map Extract 1912

| On-site Land Use and Features | Dates |
|---|---|
| Then the central and eastern buildings were indicated to be divided into three individual buildings. | 1912 to c.1956 |

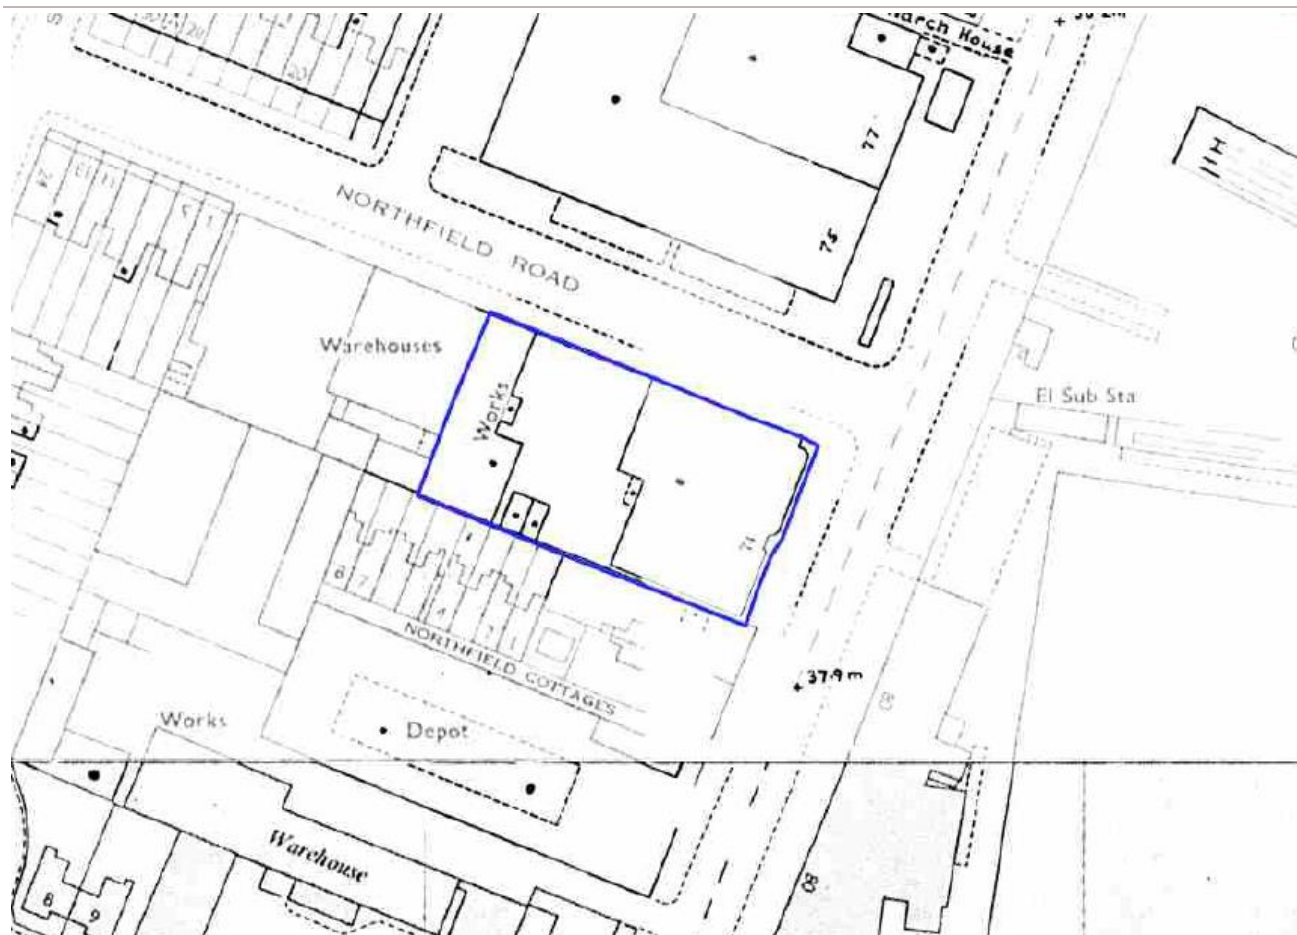
**Figure 8:** Historical Map Extract 1979

| On-site Land Use and Features | Dates |
|---|---|
| Then the motor accessories warehouse was no longer indicated, and the building was reduced in size. The photographic works was indicated as a works and two small structures were indicated adjacent to the works in the southwest. | 1979 to c. 1993 |

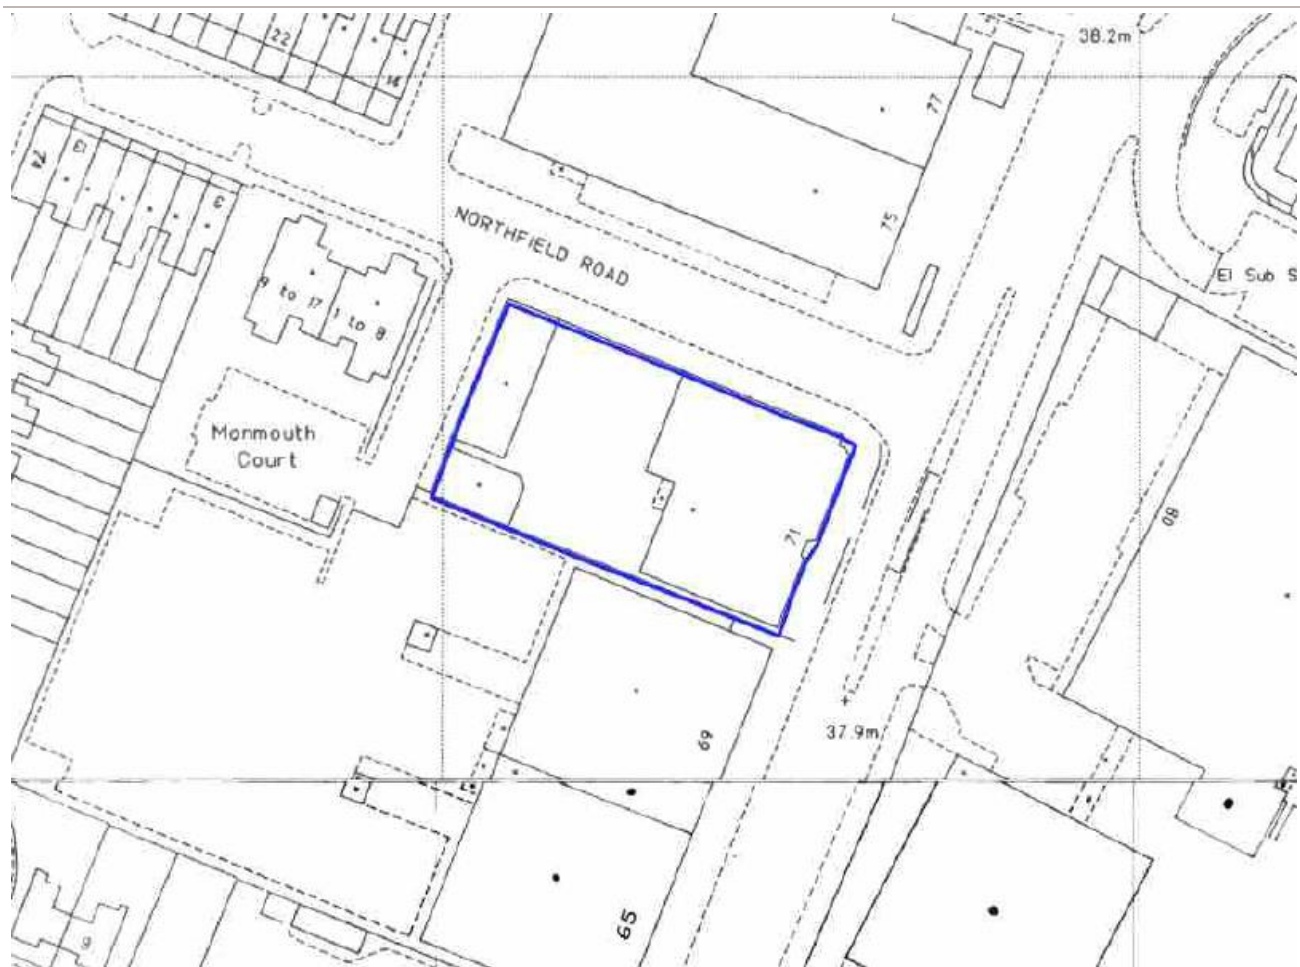
Figure 9: Historical Map Extract 1993

| On-site Land Use and Features | Dates |
|---|---|
| The building layout along the western boundary comprises two rectangular buildings in a reverse 'L' shape configuration and the two small structures in the southwest were no longer indicated. This appears to represent the present-day site layout. | 1993 to c.2014 |

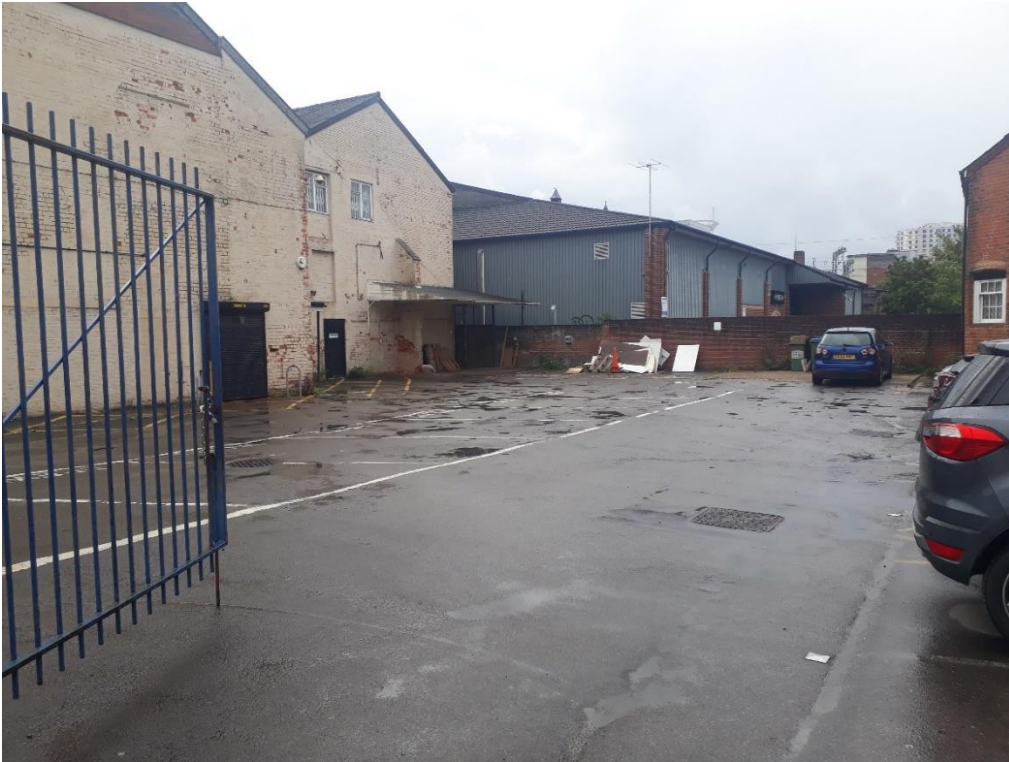
**Photograph 1: The rear of 71-73 Caversham Road and tarmac area located in the centre of the site.**

| Section | Description |
|---|---|
| Site Layout: | At the time of the walkover the site comprised approximately 60% building cover and 40% tarmac cover. The larger building known as 71-73 Caversham Road (formerly used for retail) was located in the east of the site with three smaller individual office buildings in the west. An external area of hardstanding in the centre of the site was used for car parking (see Photo 1, Appendix B). |

| Section | Description |
|---|---|
| Surface Cover: | The external areas in the centre of the site comprised tarmac of reasonable to fair quality. An indentation in the tarmac was noted running north to south across the site. The former retail building fronted immediately onto pavement with Caversham Road beyond.<br><br>Internal areas of 71-73 Caversham Road comprised concrete in the north and brick in the south of the ground floor. |

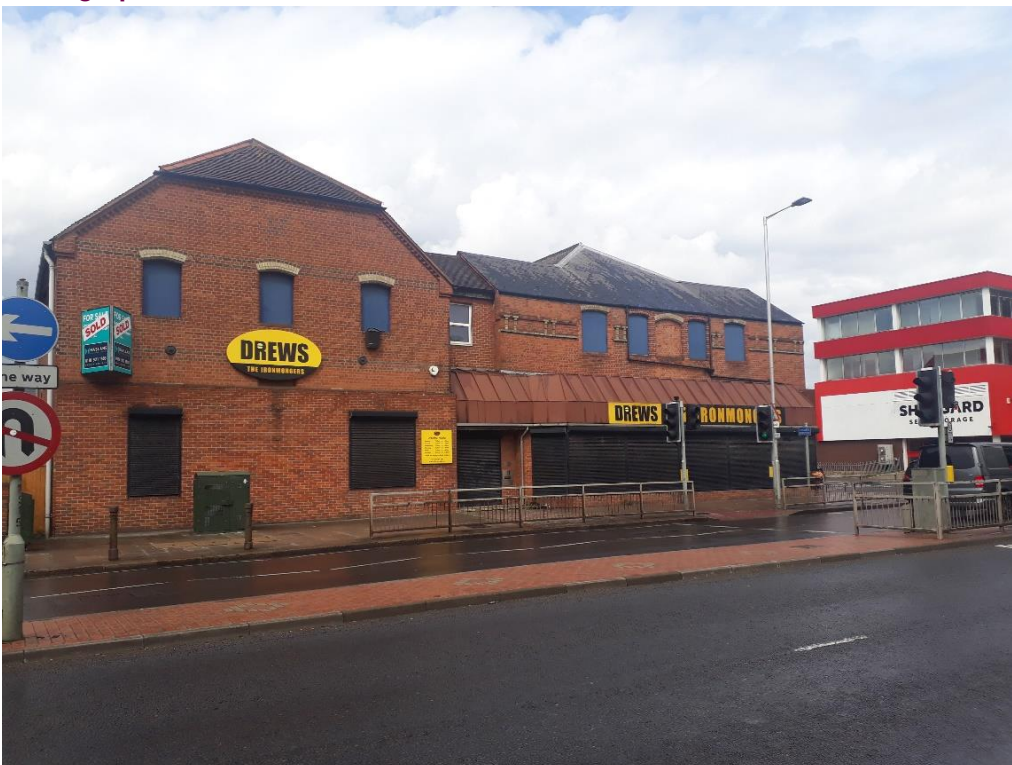
**Photograph 2: Front of 71-73 Caversham Road**

| Section | Description |
|---|---|
| Building Structure(s): | All buildings on site were two storeys in height and of brick construction with pitched roofs (See photo 2, Appendix B). |

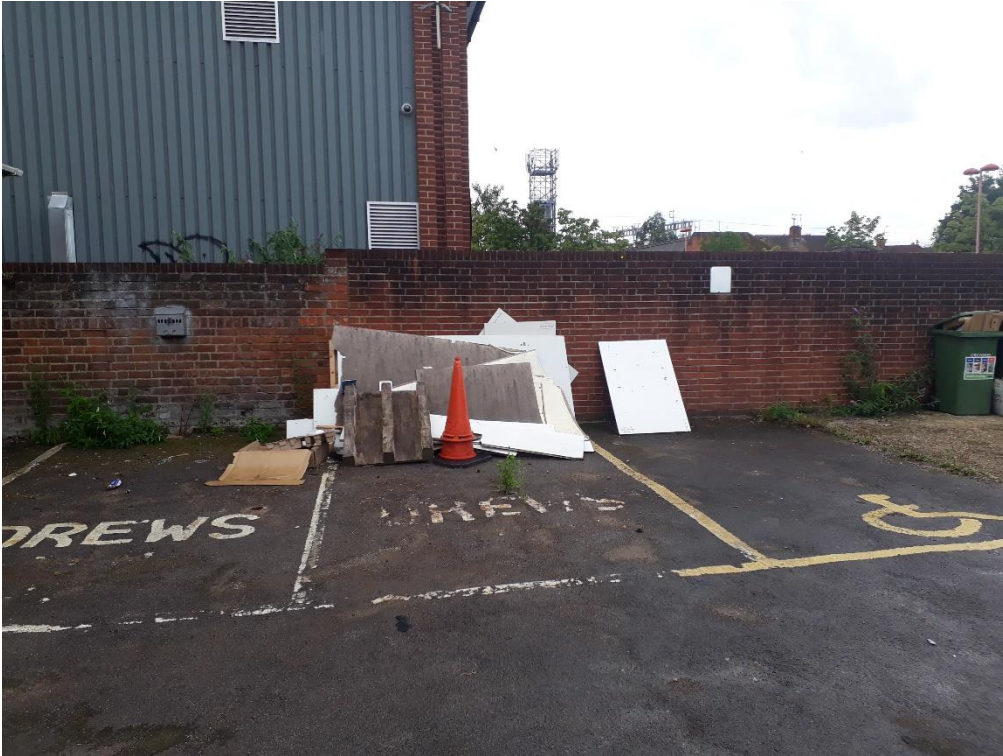
**Photograph 3: Pallets and wooden waste observed in parking space on southern boundary**

| Section | Description |
|---|---|
| Waste: | Wooden pallets and panels were observed to the rear of 71-73 Caversham Road and in the external area of tarmac hardstanding (See photo 3, Appendix B). General waste accumulation was observed in a gated side-alley running from the front to the rear of 71-73 Caversham Road, along the southern boundary of the site.<br><br>A waste storage area was located in the south of the site (See photo 4, Appendix B). This consisted of a 1,000 litre general waste wheeled bin and a 200 litre recycling waste bin relating to the offices in the west of the site. |

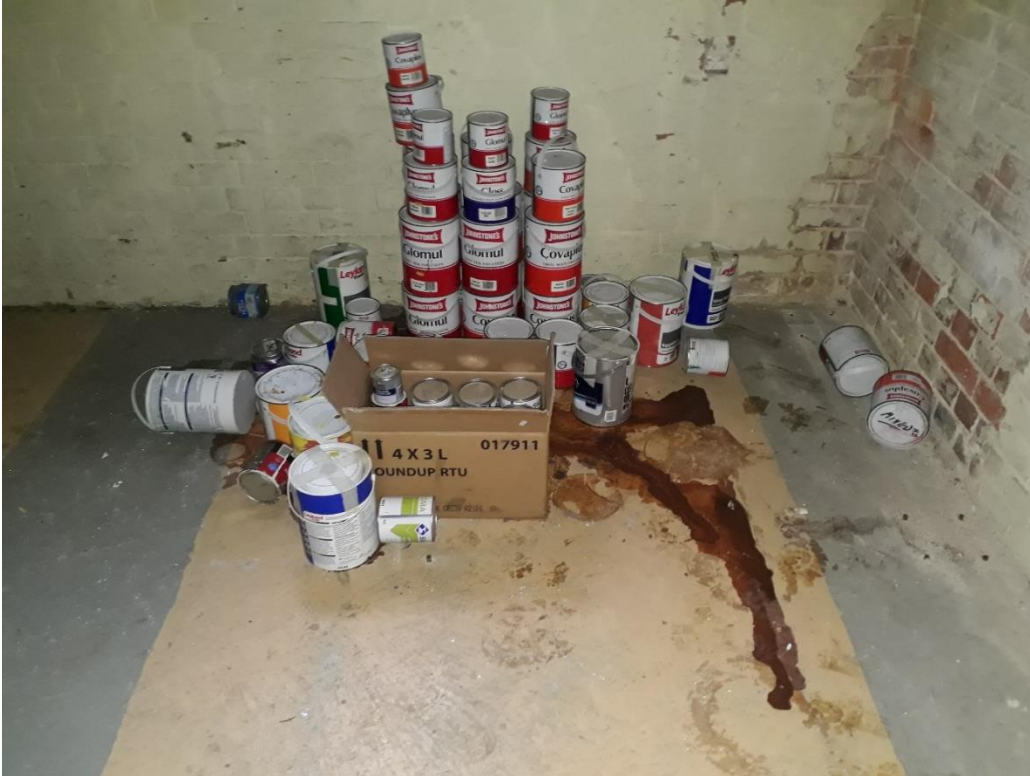
**Photograph 5: Paint storage area located on the ground floor of 71-73 Caversham Road.**

| Section | Description |
|---|---|
| Visual Evidence of Contamination: | Evidence of paint spillage was observed in a former paint storage area in the south west corner on the ground floor of 71-73 Caversham Road (See photo 5, Appendix B). |
