**PHASE 1 ENVIRONMENTAL INVESTIGATION**

**NO 4178/19**

**GARAGES AT 14-16, ELDON TERRACE,**

**PROPOSED HOUSING DEVELOPMENT**

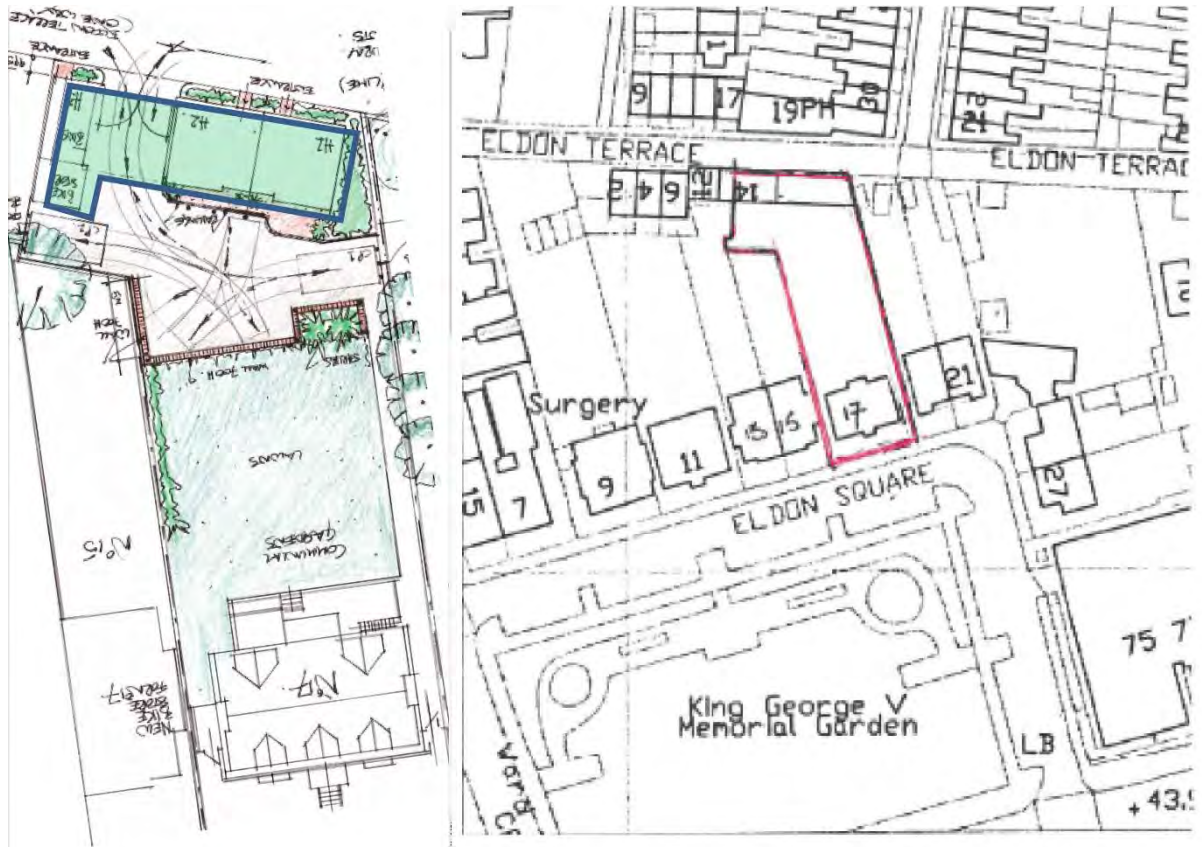
*Above left, a plan showing the proposed development above right the site extents from the planning documents*

- 2.4 The maps and plans presented in this report show an outline of the entire property including the house and garden to 17 Eldon Square as shown on the 180274/FUL planning conditions document (extracts above). The proposed development area however, comprises just the garage area on the northern side of the site with a new garden wall marking an internal boundary.

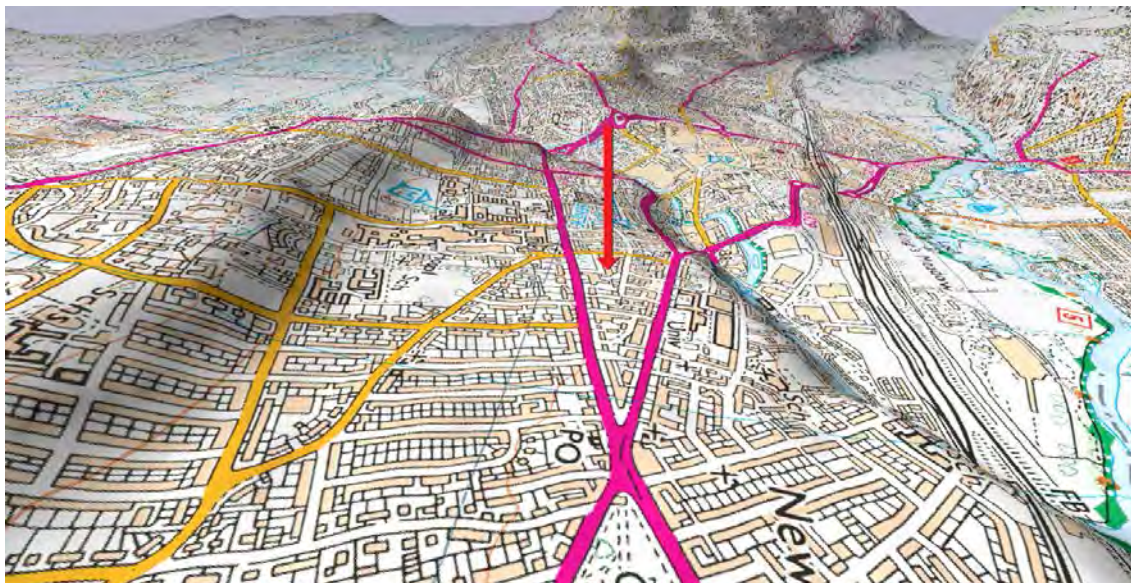
*Above a copy of the 1 to 25,000 scale map rendered according the height data given on these maps. (Note the vertical scale is greatly exaggerated to allow the topography to be visualised)*

- 3.10 The site lies on the southern side of the Thames Valley with ground levels dropping down to the north and the base of the valley. At this location the Thames Valley is over 1km wide between the hills of Caversham to the north and hills of Reading/Tilehurst to the south.

- 3.11 The site lies very close to the confluence of the River Thames and the River Kennet (890m to the north west). This side of the Thames Valley is cut through at an oblique angle by the valley of the River Kennet. This unusual course is a result of glaciation where ice sheets forced the Kennet Northward to join the new course of the River Thames which was itself diverted southward from its original route towards Welwyn Garden City and an estuary in East Anglia.
- 3.12 We would expect to have found a number of streams and brooks running down the valley towards either the River Thames or the River Kennet in this area however, this is an urban area where such streams and brooks would have been placed in culverts below the streets.

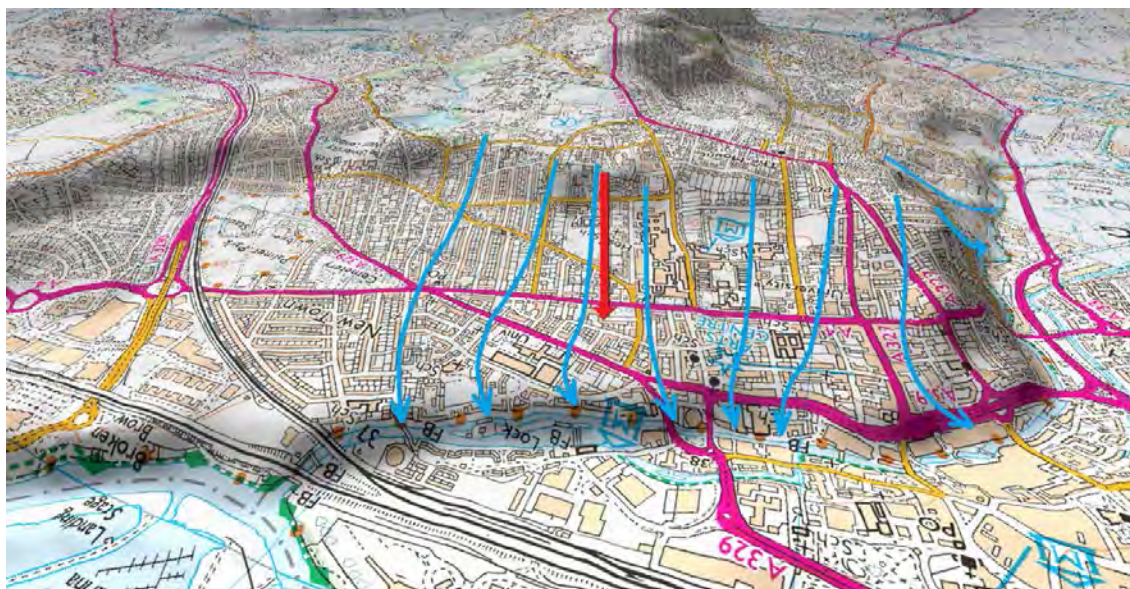
*Above a copy of the 1 to 25,000 scale 3d map showing the potential routes for contaminants that could migrate onto the site.*

- 3.15 Given the northward downhill flow of shallow groundwater in the Taplow Gravel and the northward flow of water intercepted by the drainage of the area, we would expect that contamination could plausibly move from areas to the south of the site.
- 3.16 Contaminant migration from other directions would be considered implausible, with the exception of ground gases and fuel vapours.

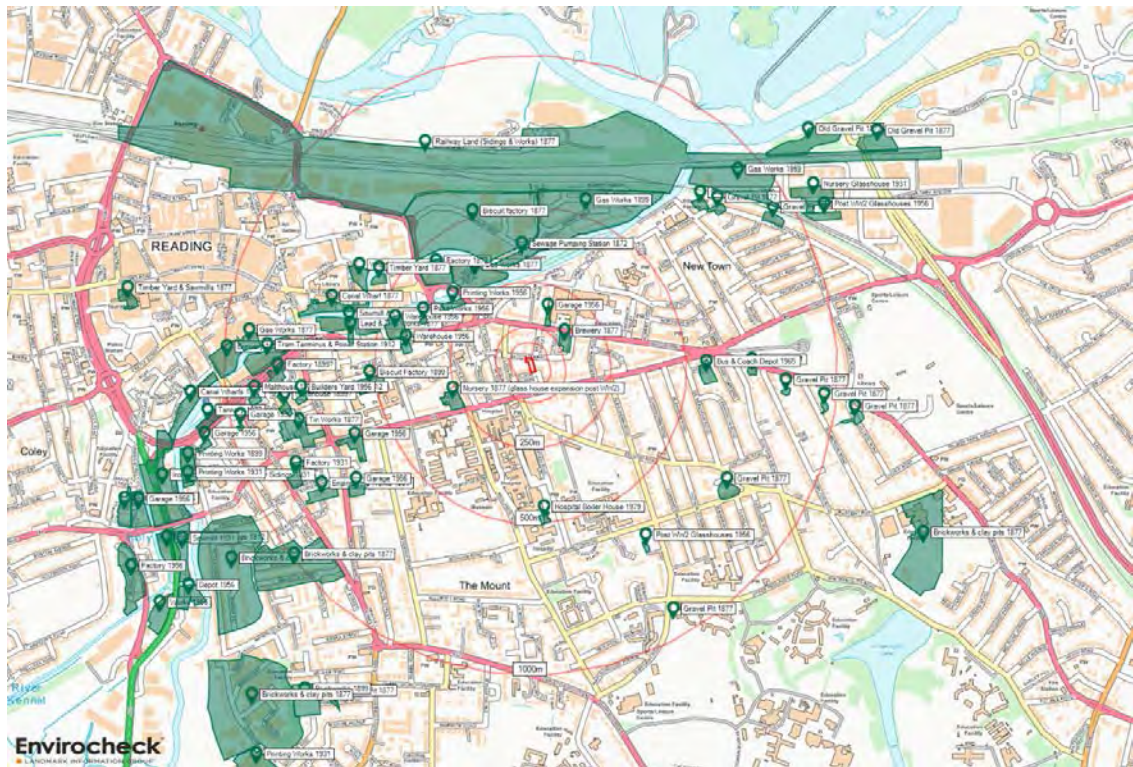
*A section of the 2014 O-S Open map with the locations of features seen on preceding historic O-S maps.*

4.22 The historic maps have shown that Reading has gone through a massive industrial expansion from well before the first of the maps in 1877, to the world war 2 period. After the war much of the industrialised land was turned to housing and other uses. The maps showed that the areas of industry followed the line of the Kennet and Avon Canal curving in from the south west, the geological outcrop of the Lambeth Group to the south west and the railway to the north.

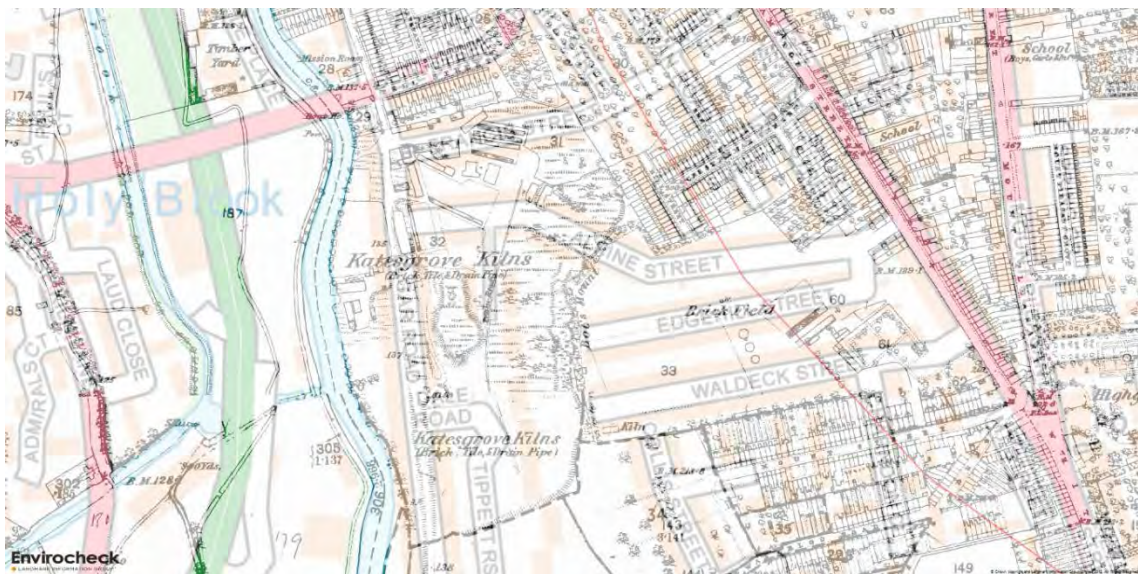
*Above, the 1877 map overlain on a 2019 map showing Katesgrove Kilns some 1.1km south west of the site.*

- 5.24 We have seen a number of excavations within the mapping area for Eldon Terrace. The 1877 showed some large brickworks over 1km south west of the site named Katesgrove Kilns and Waterloo Kilns. Both areas are now covered by houses or commercial premises.
