## **PRELIMINARY ECOLOGICAL APPRAISAL (BATS) AT 11 HOLMES ROAD READING**

**Prepared for:  
Mr A Rashid  
11 Holmes Road  
Reading  
RG6 7BH**

**16<sup>th</sup> October 2019**

**Ref: SPH/PEA19-01/09.10**

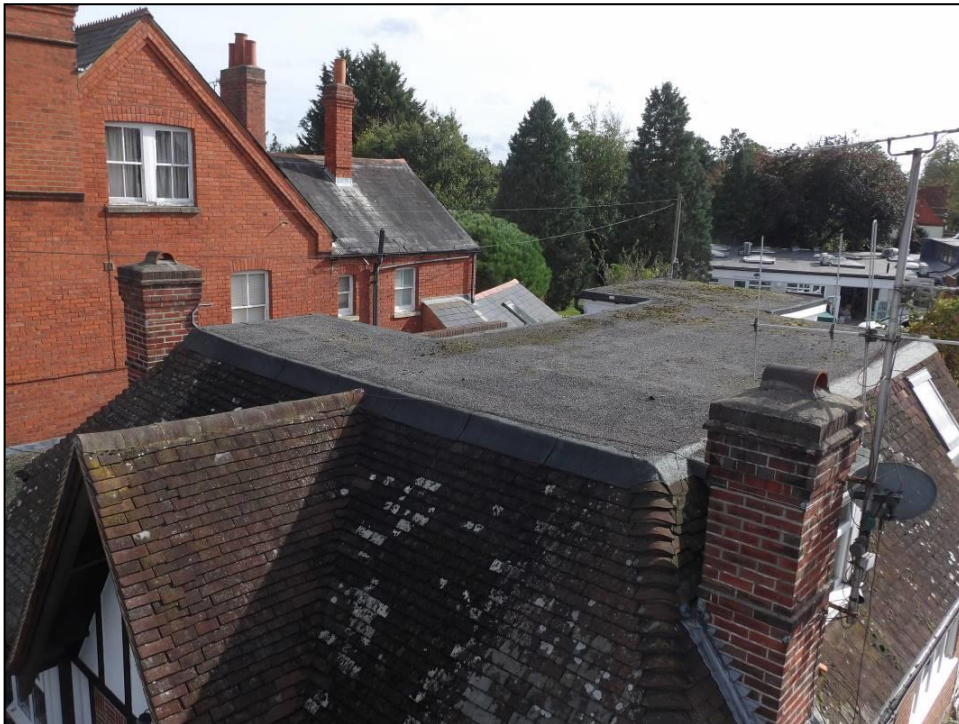
Figure 3. Example of roof structure. 11 Holmes Road, Reading. 09.10.19

The property is a detached, brick-built building with cavity walls, which is in a fair condition externally. The roof has a mixture of pitched and flat sections due to a number of extensions, see Figure 3 on page 8. The pitch roof sections are covered in close fitting tiles and has undergone repairs with various odd shaped tiles none of which are missing or broken, see Figure 4 on page 8. The flat rooves are covered with bitumen, which is all tightly sealed with no tears which roosting bats could exploit, see Figure 5 on page 9. There are no gaps between the tiles on the pitched roof and bitumen on the flat roof sections in which roosting bats could utilise (see Figure 6 on page 9) and the soffits and fascias are all tight to the wall and have no splits or cracks which could be used by roosting bats, see Figure 7 on page 10.

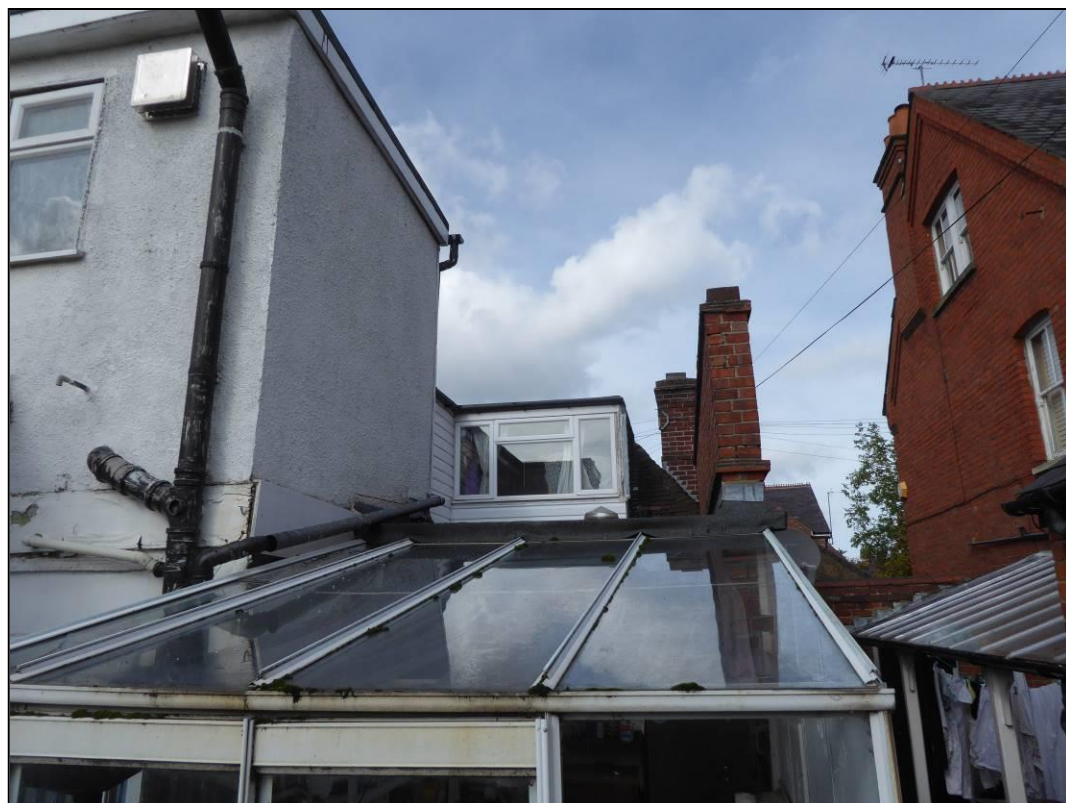
Figure 8. The glass conservatory. 11 Holmes Road, Reading. 09.10.19

There is a glass conservatory to the rear of the property, but this does not have any roosting opportunities for bats, see Figure 8 on page 10. There were some small sections of cladding around the roof windows, but these were all tightly sealed with no features in which roosting bats could exploit, see Figure 9 on page 11.
