## Preliminary bat roost assessment

| Site Location | 55 Eastern Avenue, Reading, Berkshire, RG1 5SQ |
| Document reference | CE1313 |

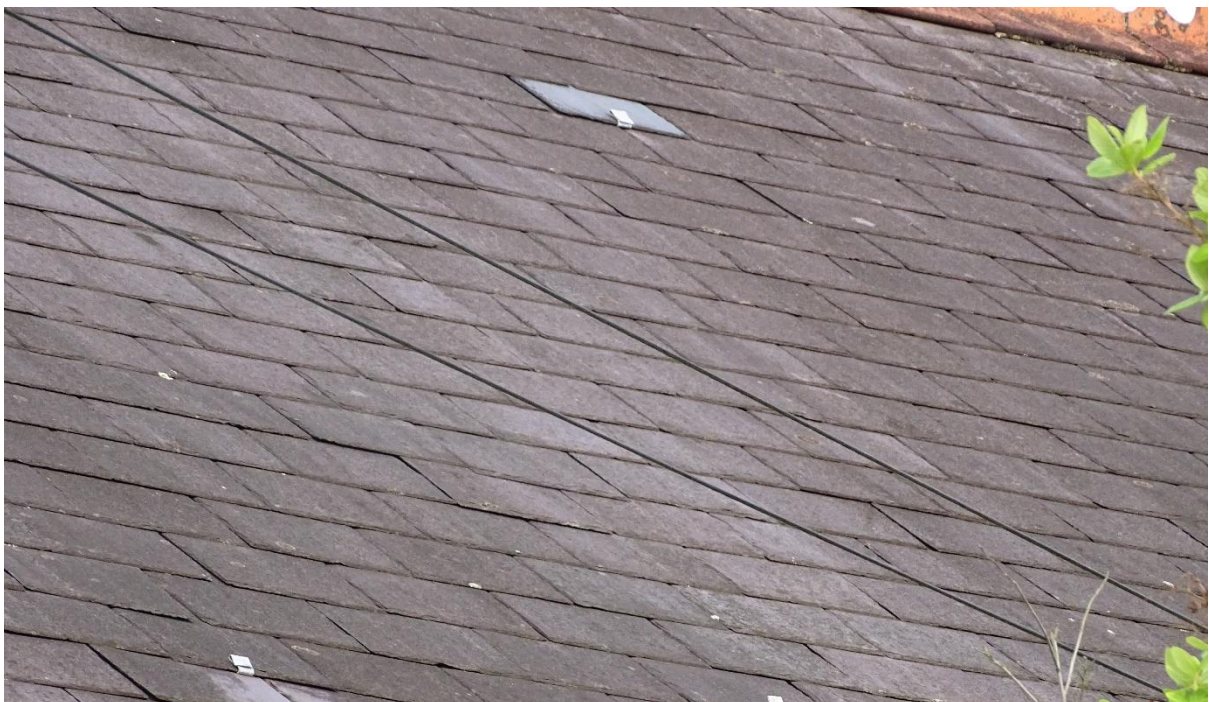
Image 2 – Close view of the roof coverings to the front West facing elevation where no features of value to bats were noted within

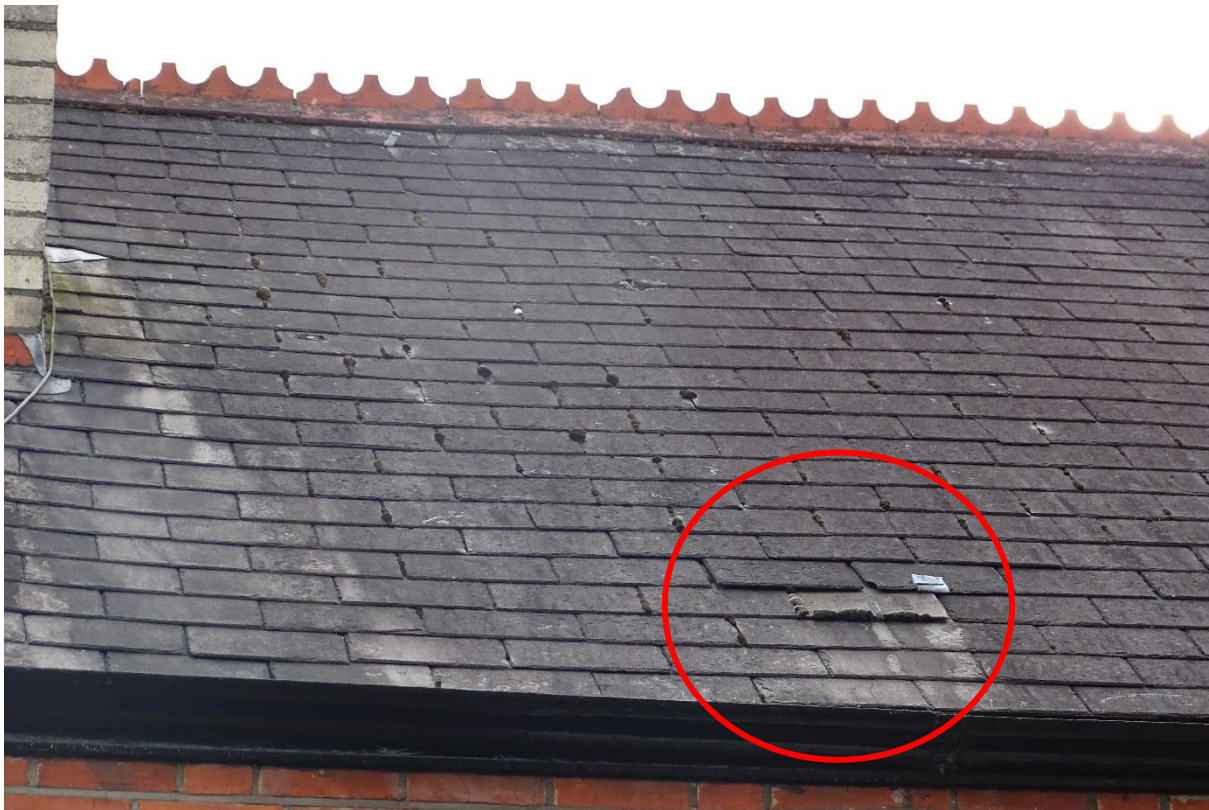
| EXTERNAL | Features of value to bats | Notes |
|---|---|---|
| Roof coverings | NO | A single lifted tile viewed externally looked to offer a suitable roosting/access feature for bats. However from an internal inspection the coverings demonstrated no gaps or evidence from bats. See image 5. |

Image 5 – Rear East facing roof coverings demonstrating a lifted area of tiles

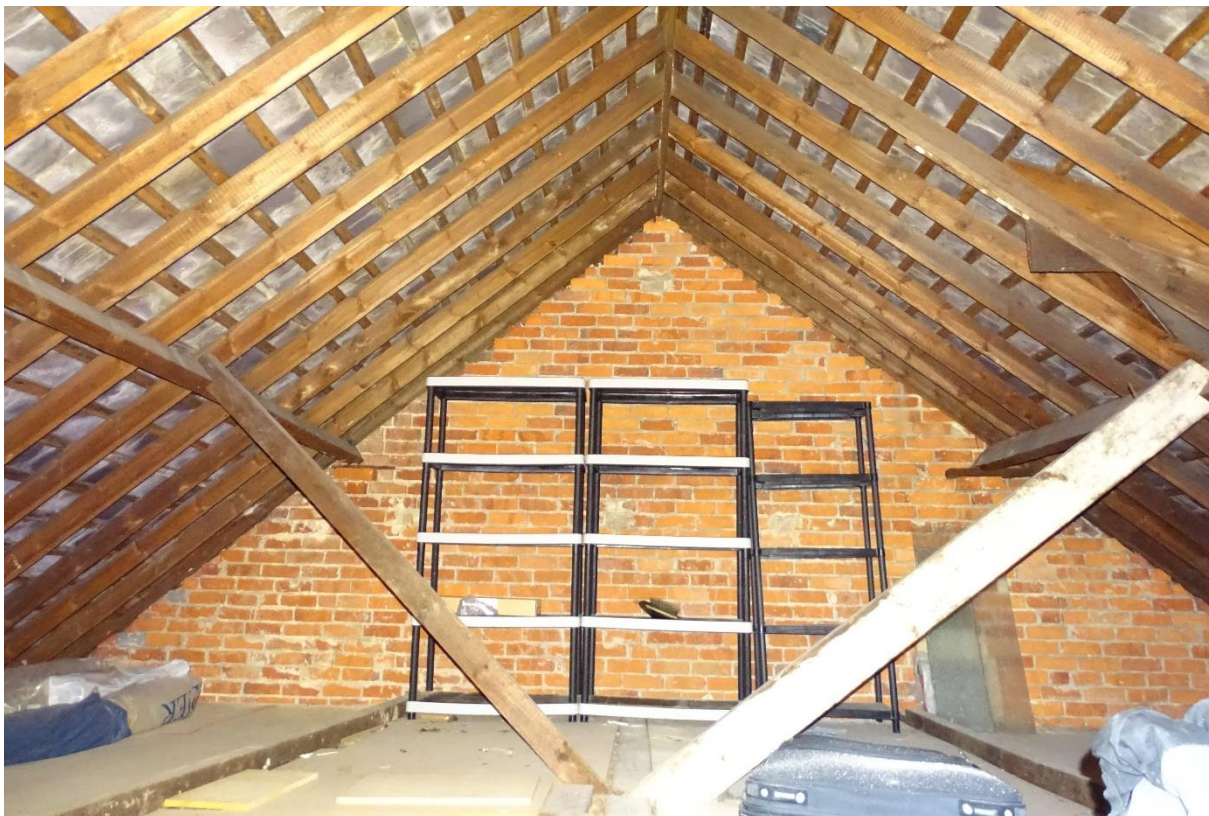
| INTERNAL | Features of value to bats | Notes |
|---|---|---|
| Floor coverings | YES | Insulation & timber boarding, access available throughout all void space areas for inspection. See image 6, 8. |

Image 6 – Internal view from within the roof void spaces of the property

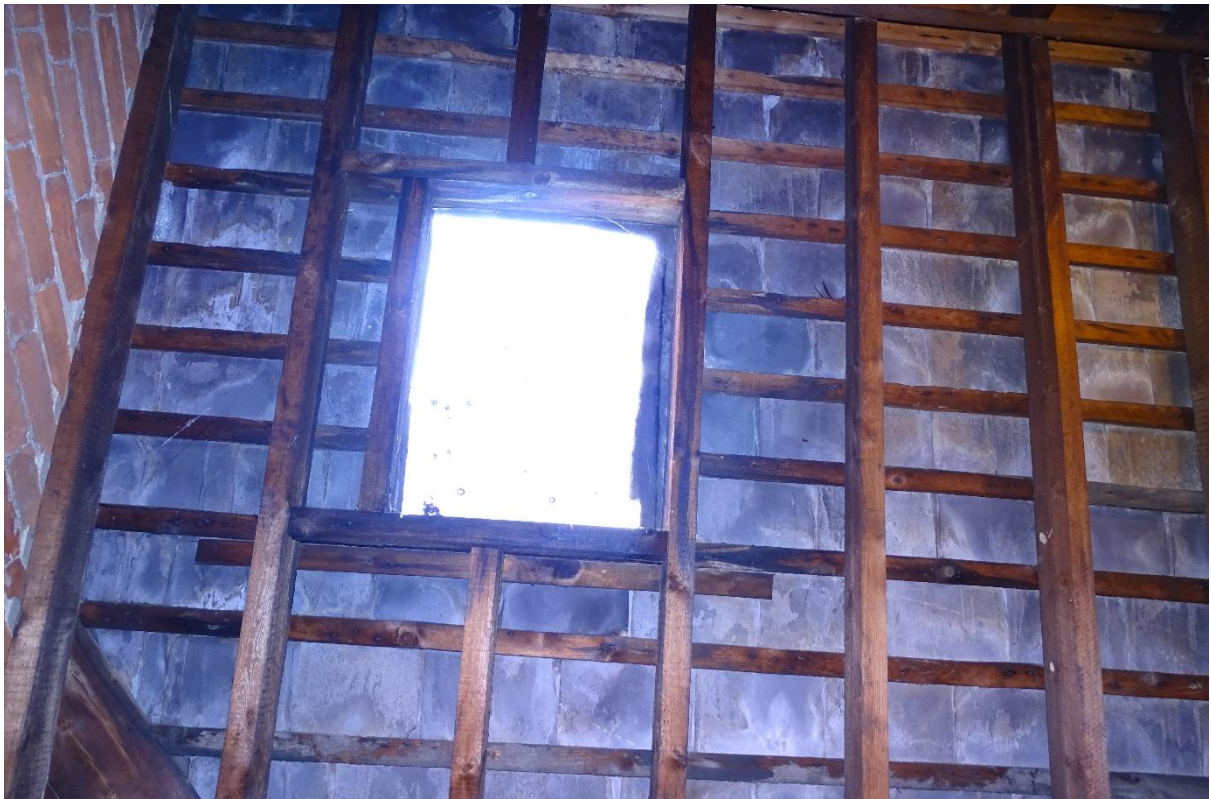
| INTERNAL | Features of value to bats | Notes |
|---|---|---|
| Membrane coverings | NO | No covering below the roof tiles. See image 7 |
| Protruding daylight | YES | Two roof lights offer a good level of natural lighting within the void spaces. See Image 7. |

Image 7 – Roof lights within the roof coverings which offer a good level of natural lighting within the roof void spaces throughout

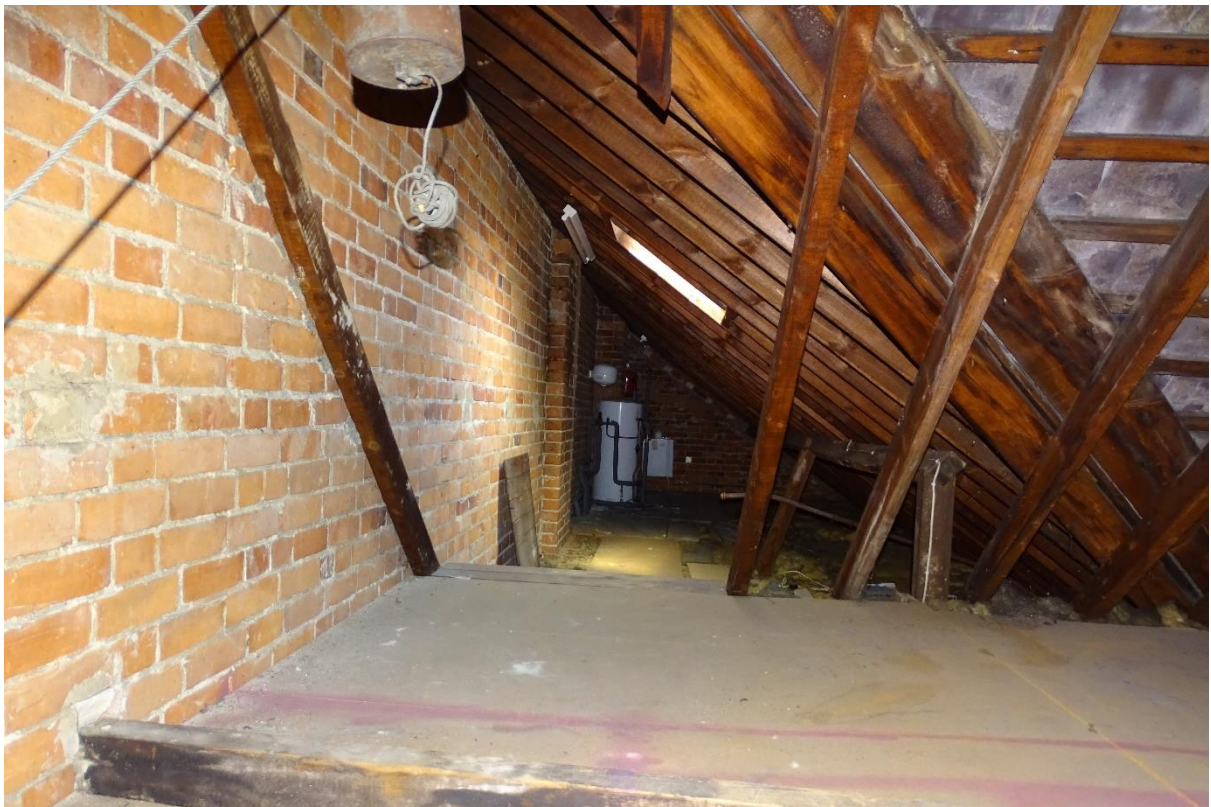
Image 8 – Internal view from within the roof void spaces of the property
